Pavement Condition Report

Long Prairie Municipal Airport (14Y)

December 2016

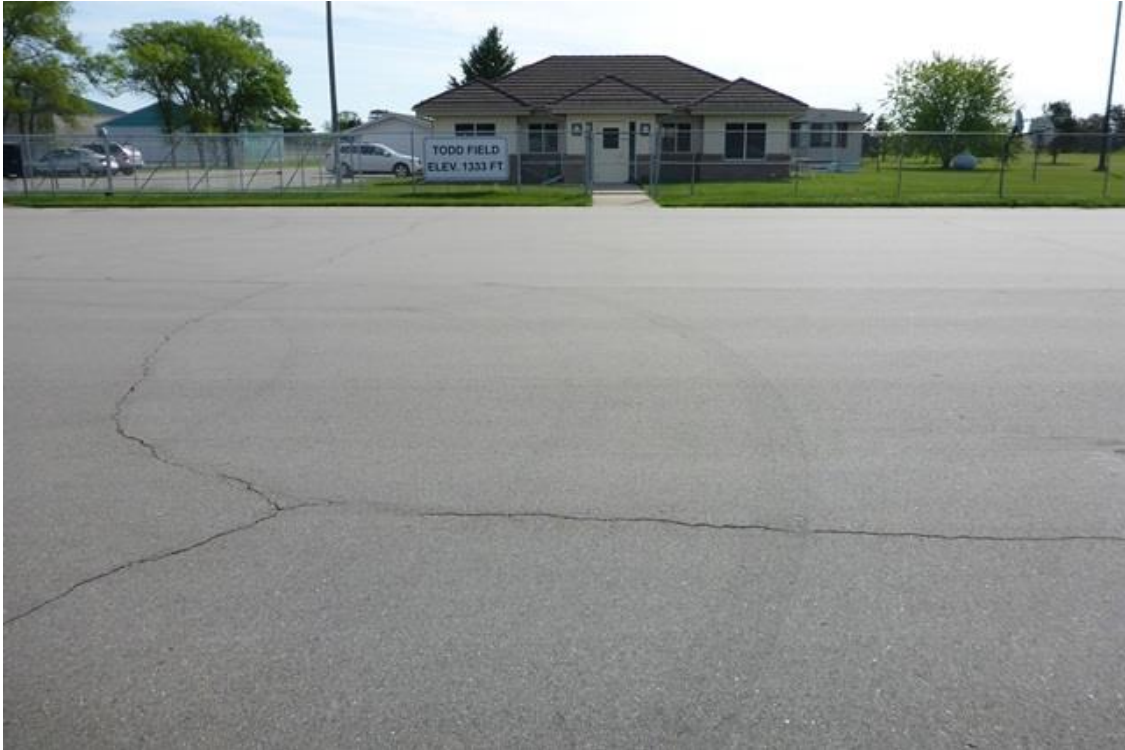
14Y APA 001 (PCI = 84)

Network:	14Y	Name:	LONG PRAIRIE						
Branch:	APA	Name:	APRON A	Use:	APRON	Area:	113,300 SqFt		
Section:	001	of 2	From:	100	To:	353	Last Const.:	10/1/2013	
Surface:	AAC	Family:	MN2013 Asphalt Aprons	Zone:	W	Category:	3	Rank:	S
Area:	59,760 SqFt	Length:	350 Ft	Width:	175 Ft				
Slabs:	Slab Length:	Ft	Slab Width:	Ft	Joint Length:	Ft			
Shoulder:	Street Type:		Grade:	0	Lanes:	0			
Section Comments:	slated for recon Fall 2013								
Last Insp. Date:	5/29/2016	TotalSamples:	16	Surveyed:	4				
Conditions:	PCI: 84								
Inspection Comments:									
Sample Number:	100	Type:	R	Area:	5000.00 SqFt	PCI:	85		
Sample Comments:									
48	L & T CR	L	266.00	Ft					
Sample Number:	201	Type:	R	Area:	5000.00 SqFt	PCI:	84		
Sample Comments:									
48	L & T CR	L	287.00	Ft					
Sample Number:	300	Type:	R	Area:	5000.00 SqFt	PCI:	81		
Sample Comments:									
48	L & T CR	L	357.00	Ft					
Sample Number:	302	Type:	R	Area:	5000.00 SqFt	PCI:	86

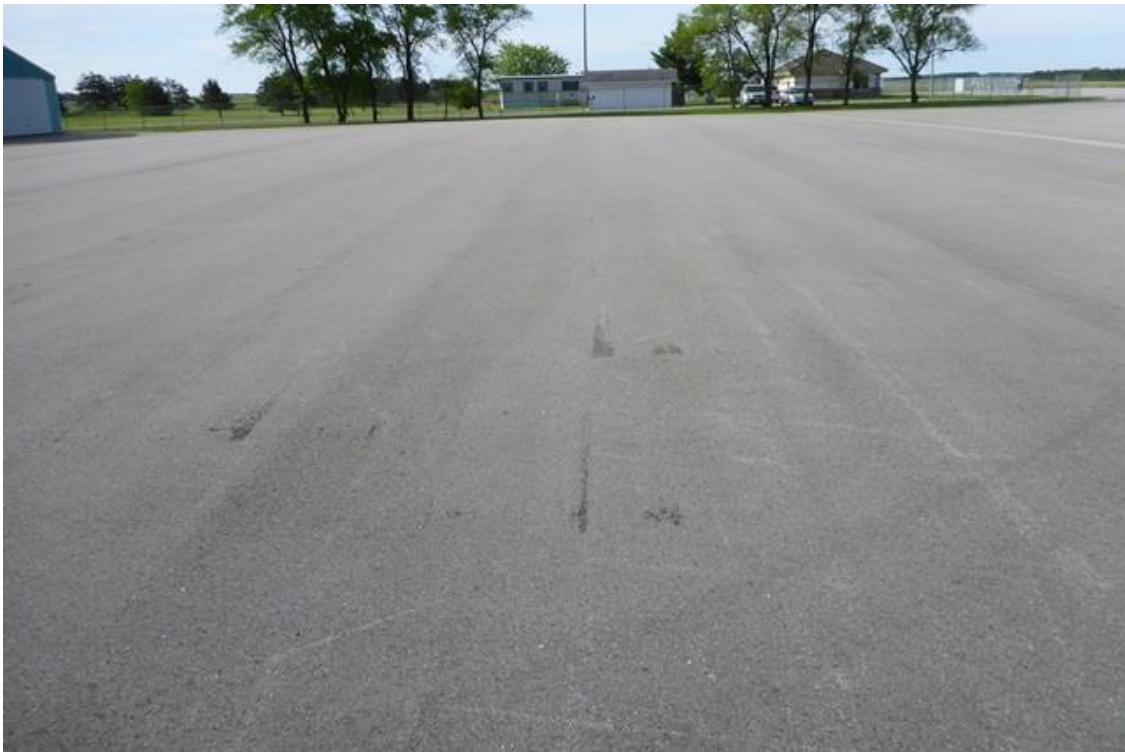
14Y APA 002 (PCI = 100)

Network:	14Y	Name:	LONG PRAIRIE						
Branch:	APA	Name:	APRON A	Use:	APRON	Area:	113,300 SqFt		
Section:	002	of 2	From:	100	To:	401	Last Const.:	10/1/2013	
Surface:	AC	Family:	MN2013 Asphalt Aprons	Zone:	W	Category:	3	Rank:	S
Area:	53,540 SqFt	Length:	250 Ft	Width:	210 Ft				
Slabs:	Slab Length:	Ft	Slab Width:	Ft	Joint Length:	Ft			
Shoulder:	Street Type:	Grade:	0	Lanes:	0				
Section Comments:	slated for recon Fall 2013								
Last Insp. Date:	5/29/2016	TotalSamples:	12	Surveyed:	3				
Conditions:	PCI: 100								
Inspection Comments:									
Sample Number:	101	Type:	R	Area:	5000.00 SqFt	PCI:	100		
Sample Comments:	<No Distress>								
Sample Number:	200	Type:	R	Area:	5000.00 SqFt	PCI:	100		
Sample Comments:	<No Distress>								
Sample Number:	301	Type:	R	Area:	5000.00 SqFt	PCI:	100		
Sample Comments:	<No Distress>

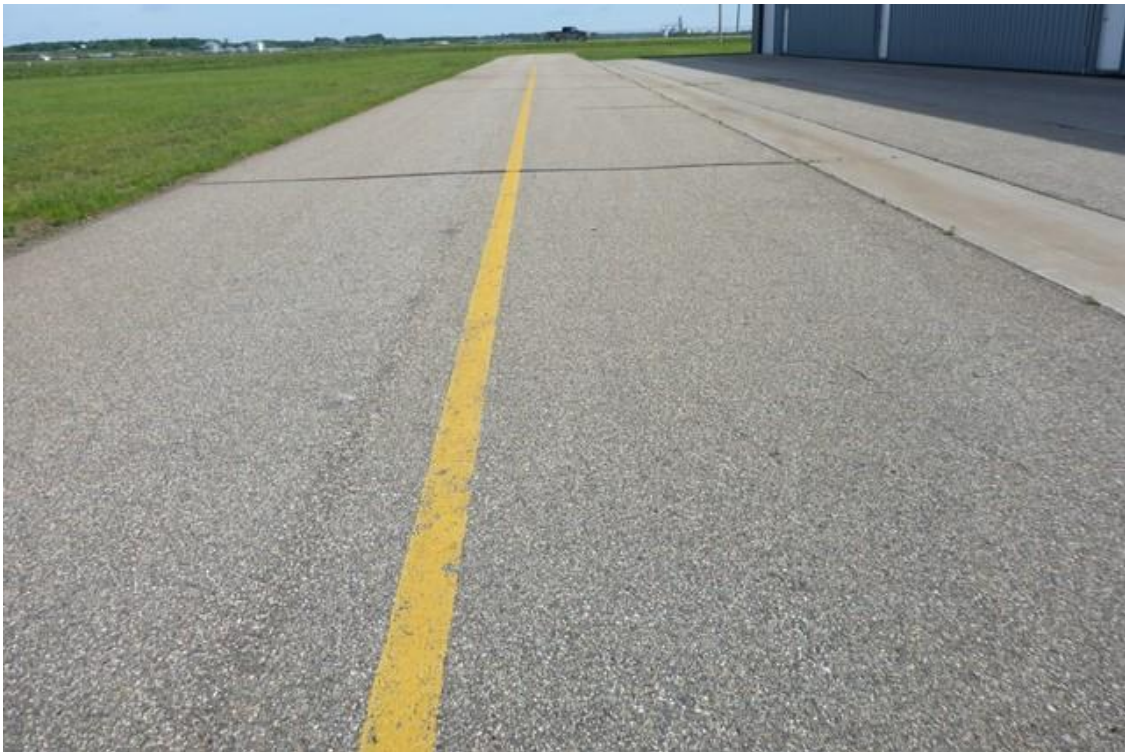
14Y TLA 001 (PCI = 90)

Network:	14Y	Name:	LONG PRAIRIE						
Branch:	TLA	Name:	Taxilane A	Use:	TAXILANE	Area:	15,440 SqFt		
Section:	001	of 2	From:	102	To:	103	Last Const.: 6/1/2008		
Surface:	AC	Family:	MN2013 Asphalt Taxilanes	Zone:	W	Category:	3	Rank:	T
Area:	6,940 SqFt	Length:	455 Ft	Width:	20 Ft				
Slabs:	Slab Length:	Ft	Slab Width:	Ft	Joint Length:	Ft			
Shoulder:	Street Type:		Grade:	0	Lanes:	0			
Section Comments:	Estimated LCD								
Last Insp. Date:	5/29/2016	TotalSamples:	2	Surveyed:	1				
Conditions:	PCI: 90								
Inspection Comments:									
Sample Number:	103	Type:	R	Area:	4000.00 SqFt	PCI:	90		
Sample Comments:									
48	L & T CR	L	116.00	Ft
