Pavement Condition Report

Pinecreek Border Airport (48Y)

December 2016

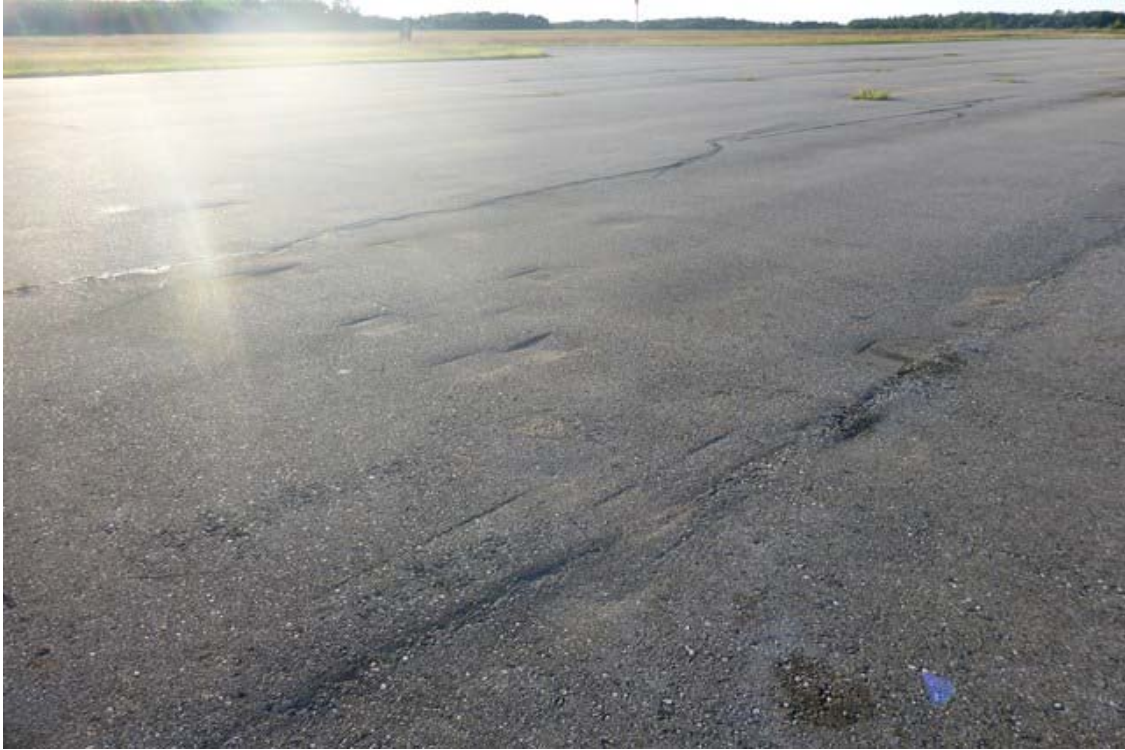
48Y APA 001 (PCI = 71)

Branch ID	Section ID	Surface type ¹	Section area (SF)	LCD ²	2013 PCI	2016 PCI	Drop in PCI/Yr ³	% Deduct due to		Distress types
								Load ⁴	Climate ⁵	
APA	001	AC	57,750	2009	82	71	4	19	70	Depression, L&T Crack, Rutting, Swell, Weathering
APB	001	AC	30,500	2009	74	62	5	-	98	L&T Crack, Ravelling, Swell, Weathering
CTA	001	AC	27,725	2009	67	64	5	-	100	L&T Crack, Weathering
RY1533	001	AC	257,350	2009	66	63	5	-	100	L&T Crack, Weathering

Section / Work	Sum of Work Qty (Ft, SqFt)	Sum of Work Cost (\$)
APA::001	Preventative: PCI Before: 71 After: 77	1,445
Crack Sealing - AC	377	460
Patching - AC Shallow	73	561
Surface Treatment	847	424
APB::001	Preventative: PCI Before: 62 After: 69	479
Crack Sealing - AC	186	227
Patching - AC Shallow	3	23
Surface Treatment	457	229
CTA::001	Preventative: PCI Before: 64 After: 69	548
Crack Sealing - AC	368	449
Surface Treatment	198	99
RY1533::001	Preventative: PCI Before: 63 After: 68	6,352
Crack Sealing - AC	3,815	4,654
Patching - AC Shallow	101	773
Surface Treatment	1,849	924
Grand Total		8,825
