Pavement Condition Report

Red Lake Falls Municipal Airport (D81)

December 2016

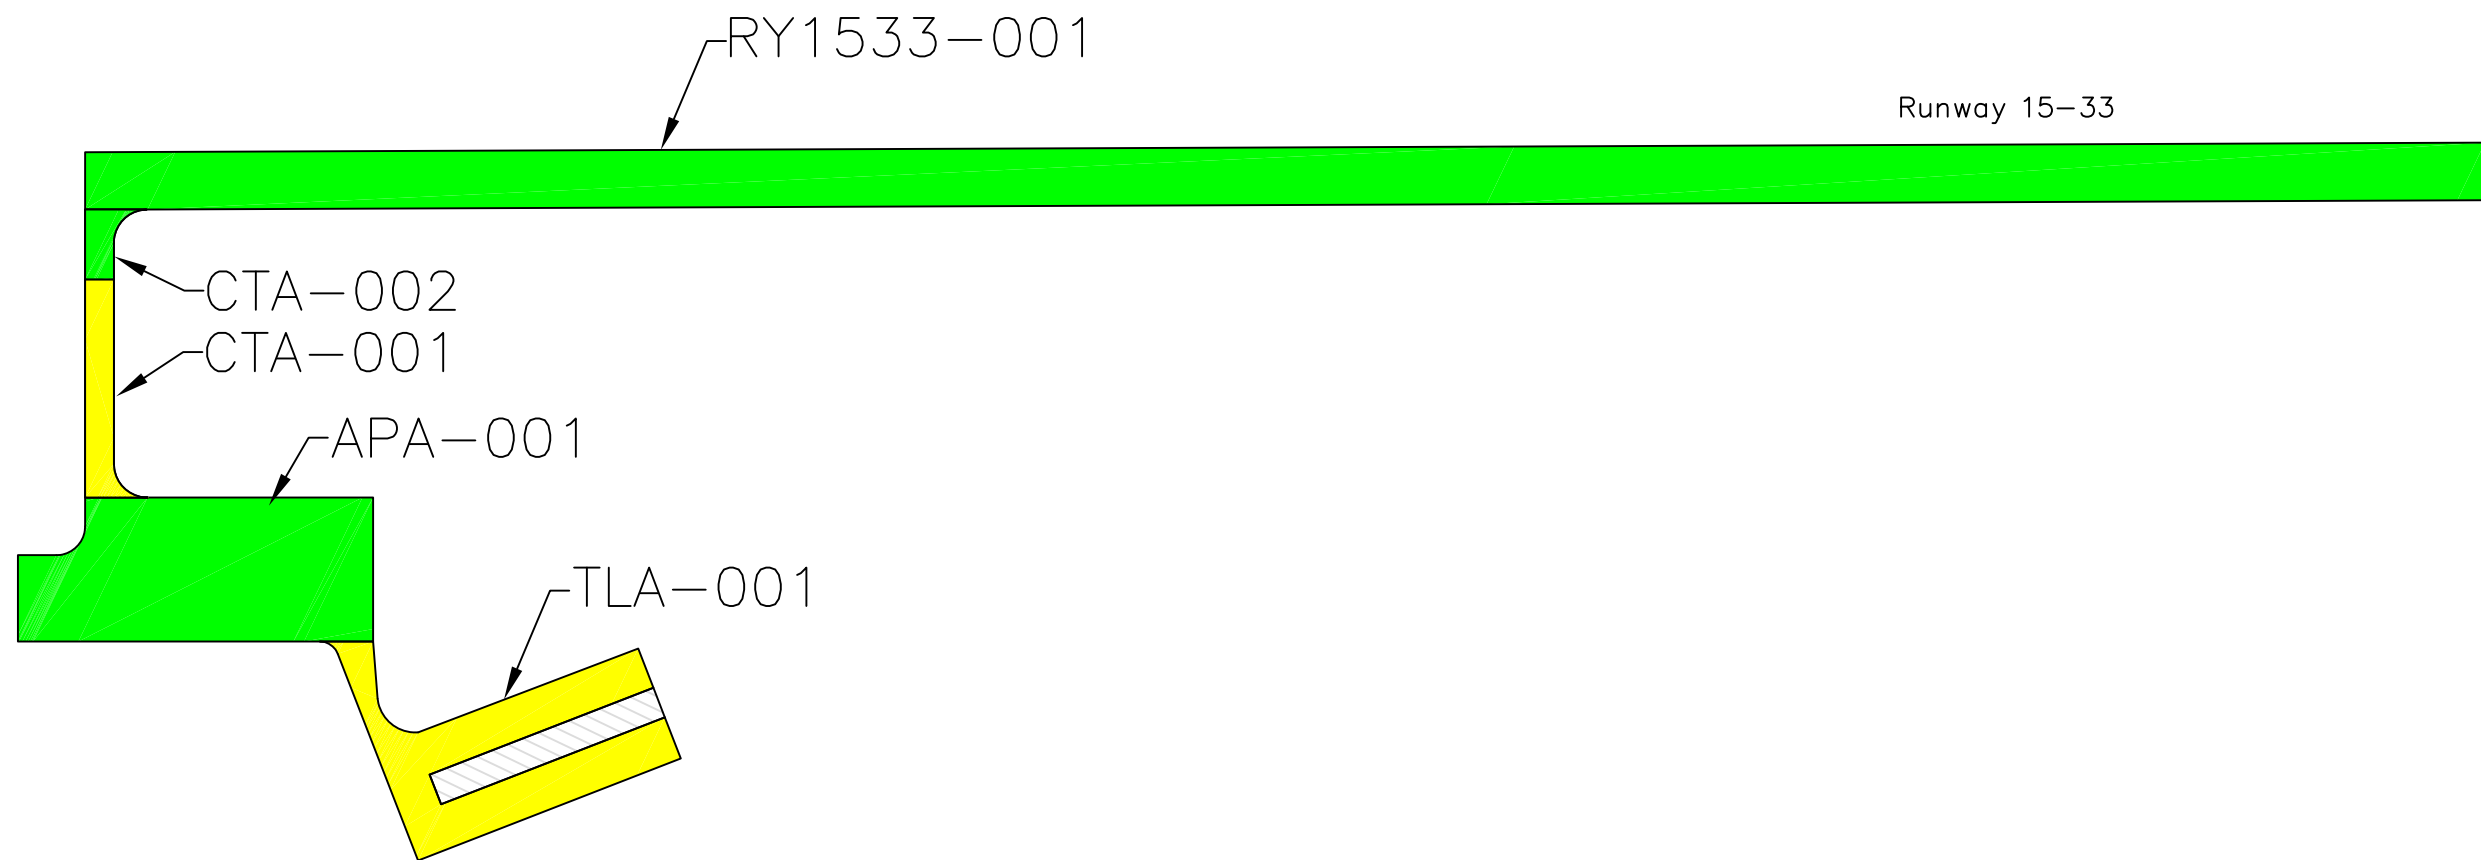
Figure 4. 2016 Pavement Condition Index Rating at Red Lake Falls Municipal Airport (D81).

Note: Overlay (2014) showing a high amount of reflective cracking and higher than normal PCI deterioration.
