# Pavement Condition Report

## Jackson Municipal Airport (MJQ)

**December 2016**

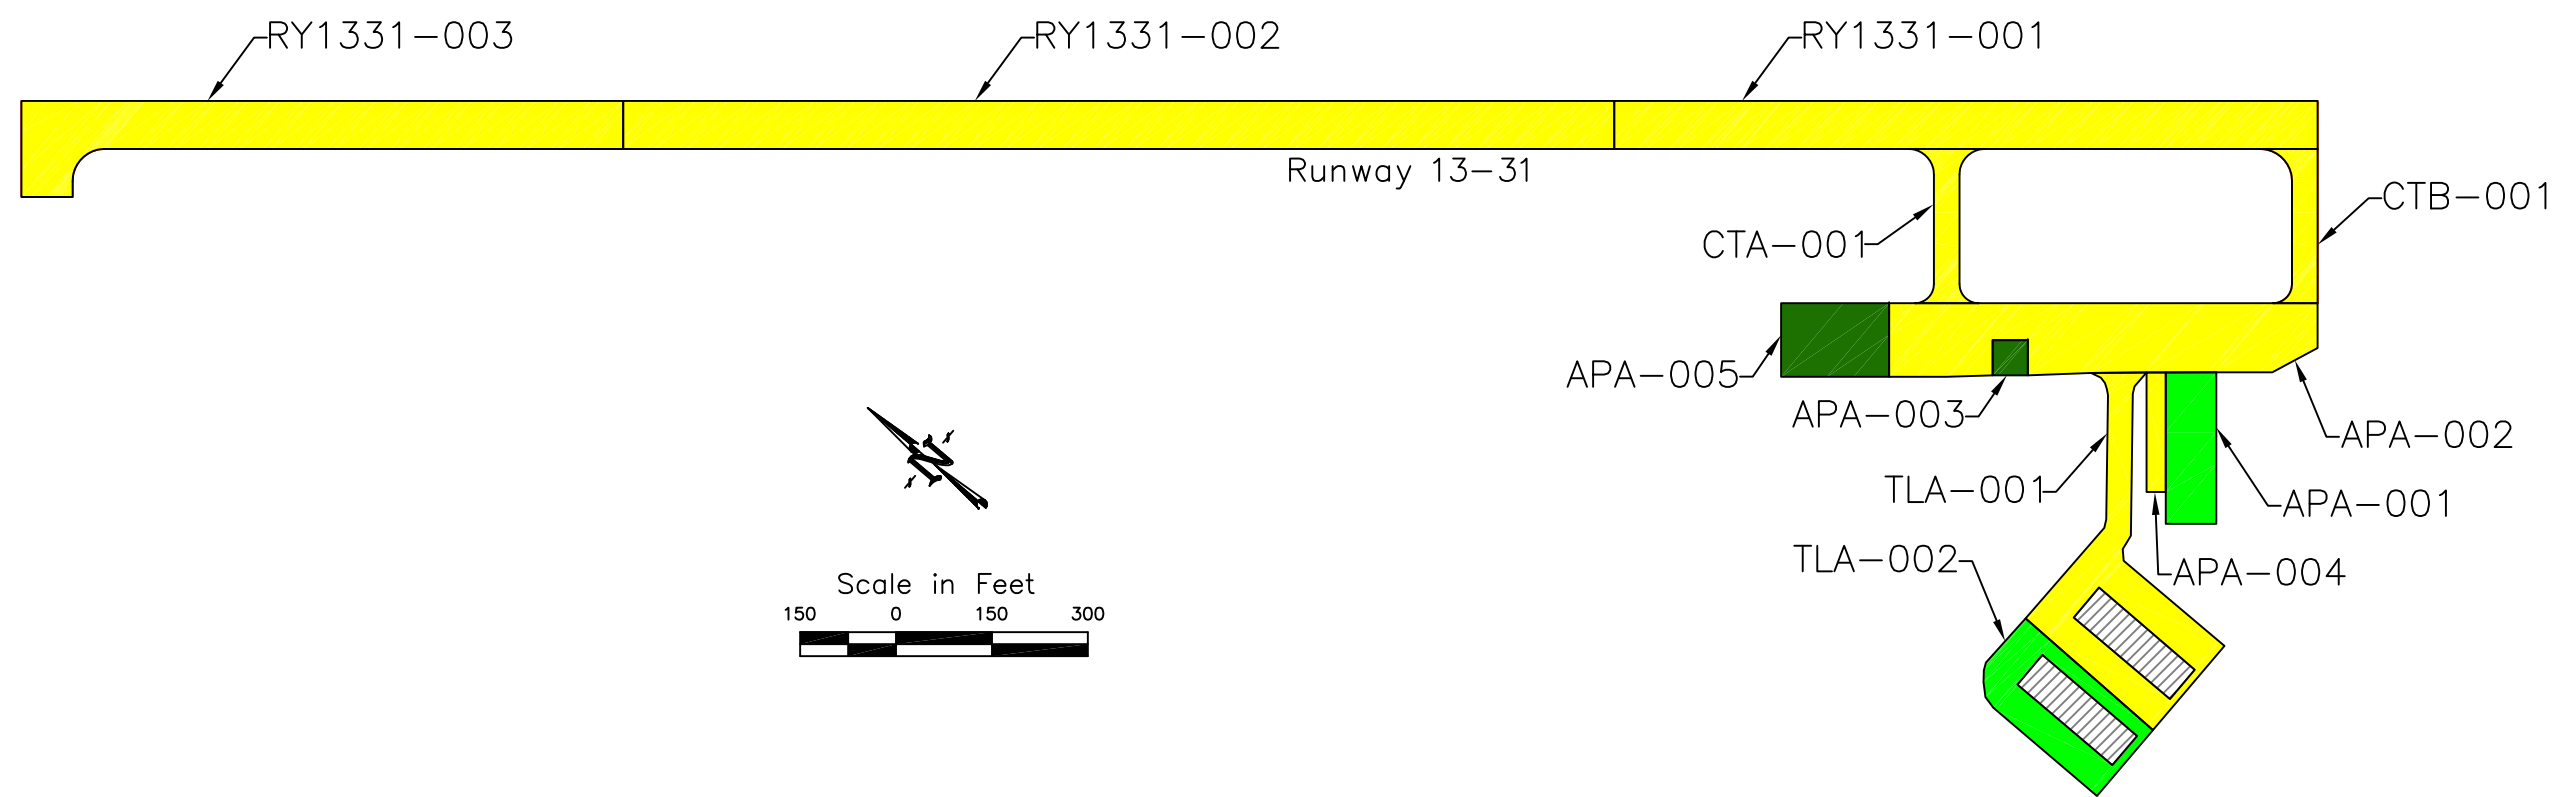
Figure 4. 2016 Pavement Condition Index Rating at Jackson Municipal Airport (MJQ).

Branch ID	Section ID	Surface type <sup>1</sup>	Section area (SF)	LCD <sup>2</sup>	2013 PCI	2016 PCI	Drop in PCI/Yr <sup>3</sup>	% Deduct due to		Distress types
								Load <sup>4</sup>	Climate <sup>5</sup>	
APA	001	AC	18,468	2001	77	72	2	-	100	L&T CR, Weathering
APA	002	AC	70,847	1995	71	67	2	-	100	L&T CR, Weathering
APA	003	PCC	3,025	1995	100	98	< 1	-	100	JT Seal Damage
APA	004	AC	5,400	2001	72	64	2	44	52	Alligator CR, L&T CR, Swell, Weathering
APA	005	AC	18,928	2011	100	93	1	-	100	L&T CR
CTA	001	AC	10,550	1995	72	66	2	-	100	L&T CR, Weathering
CTB	001	AC	9,872	1995	67	61	2	-	100	L&T CR, Weathering
RY1331	001	AC	82,500	1995	68	61	2	12	88	Alligator CR, Block CR, L&T CR
RY1331	002	AC	116,250	1995	67	61	2	30	70	Alligator CR, Block CR, L&T CR
RY1331	003	AC	76,835	1995	65	64	2	18	82	Alligator CR, L&T CR
TLA	001	AC	44,450	2000	67	62	2	36	62	Alligator CR, L&T CR, Swell
TLA	002	AC	24,010	2001	76	75	2	-	100	L&T CR

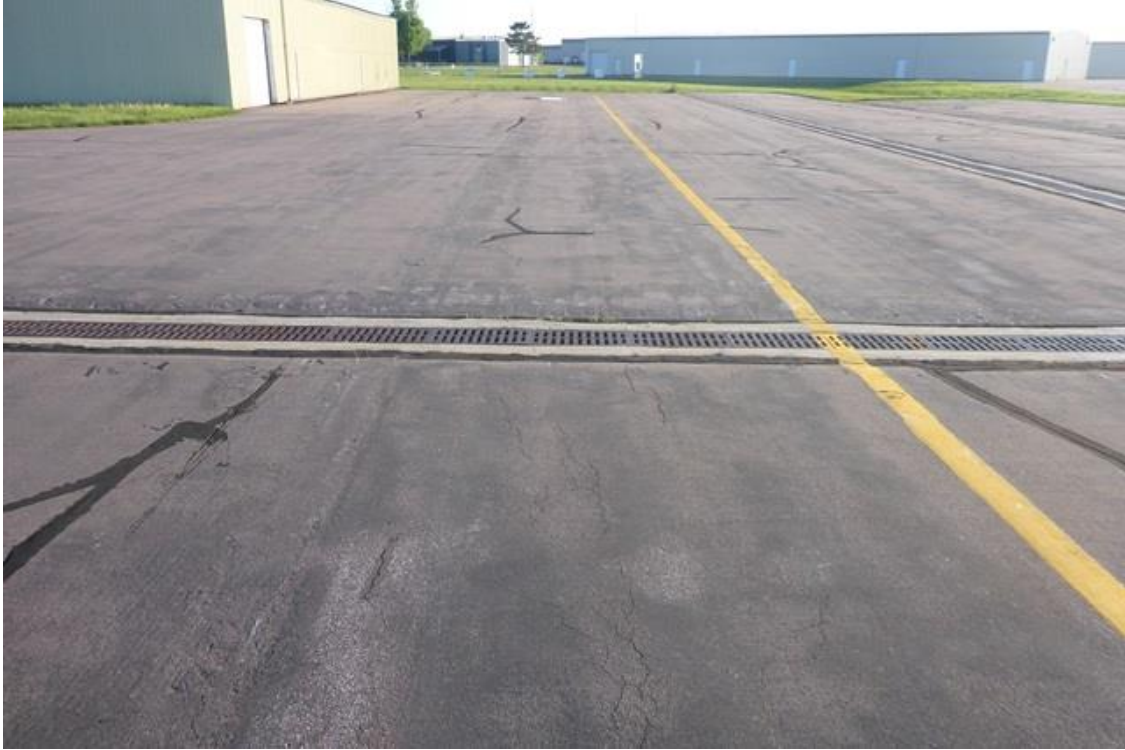
MJQ APA 001 (PCI = 72)

**Conditions:** PCI: 72

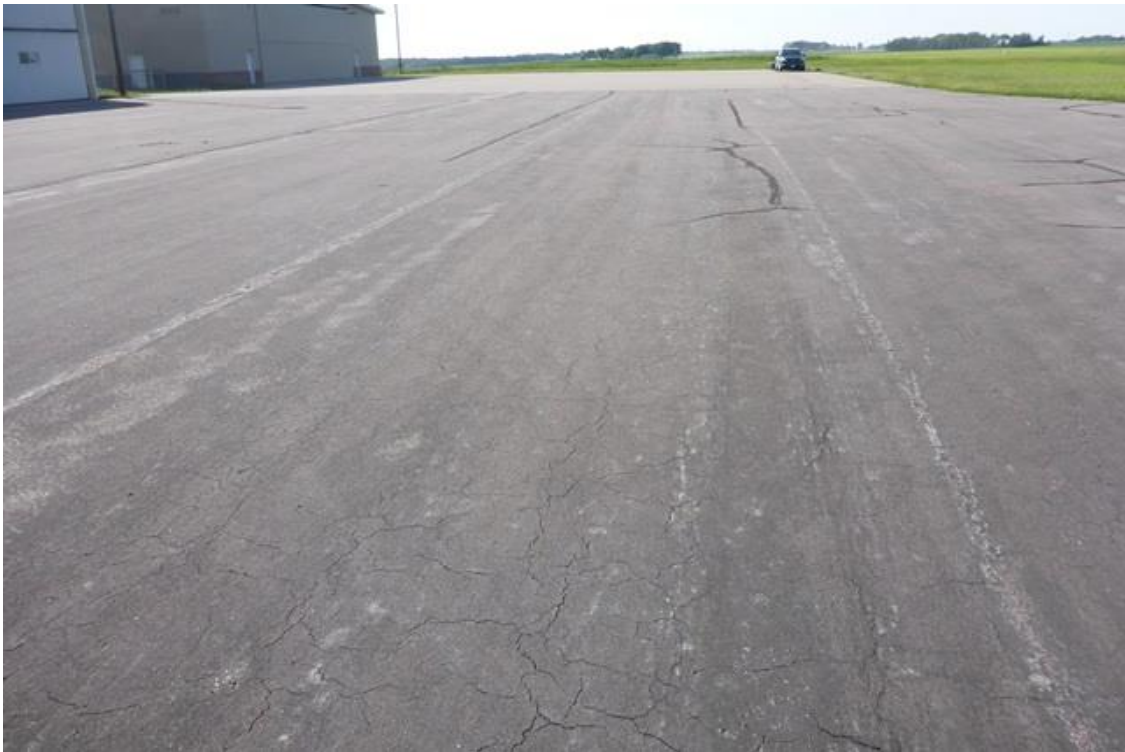
MJQ APA 002 (PCI = 67)

**Conditions:** PCI: 67

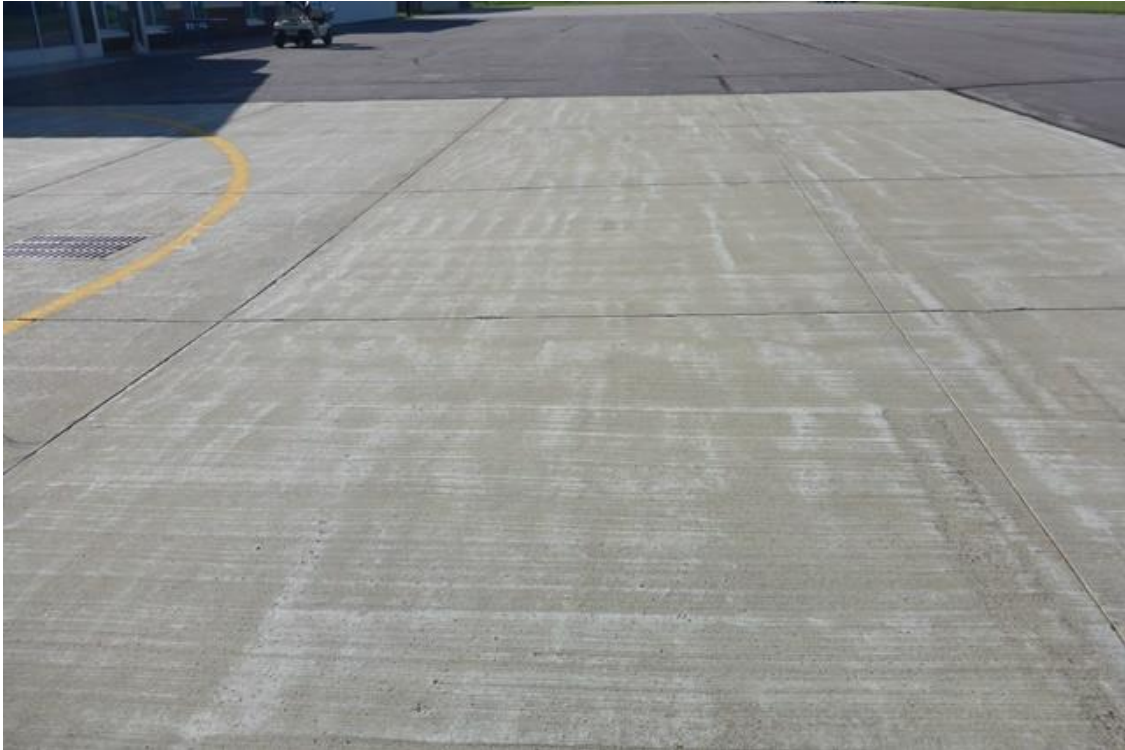
MJQ APA 003 (PCI = 98)

**Conditions:** PCI: 98

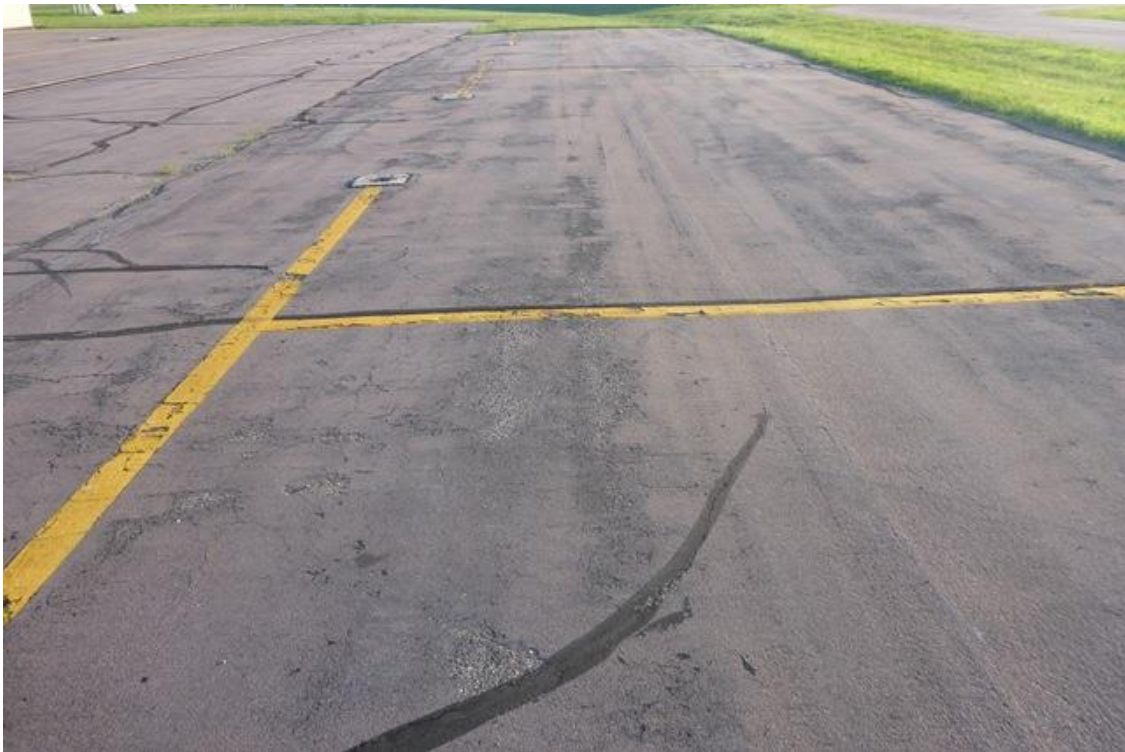
MJQ APA 004 (PCI = 64)

**Conditions:** PCI: 64

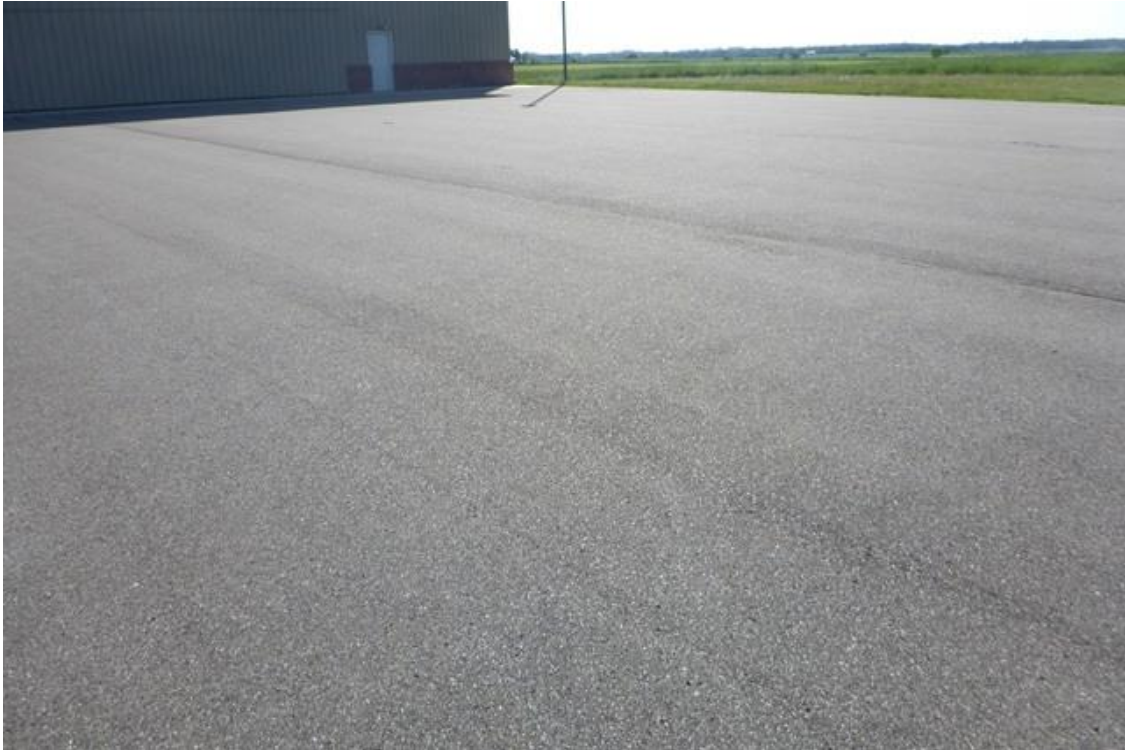
MJQ APA 005 (PCI = 93)

**Conditions:** PCI: 93

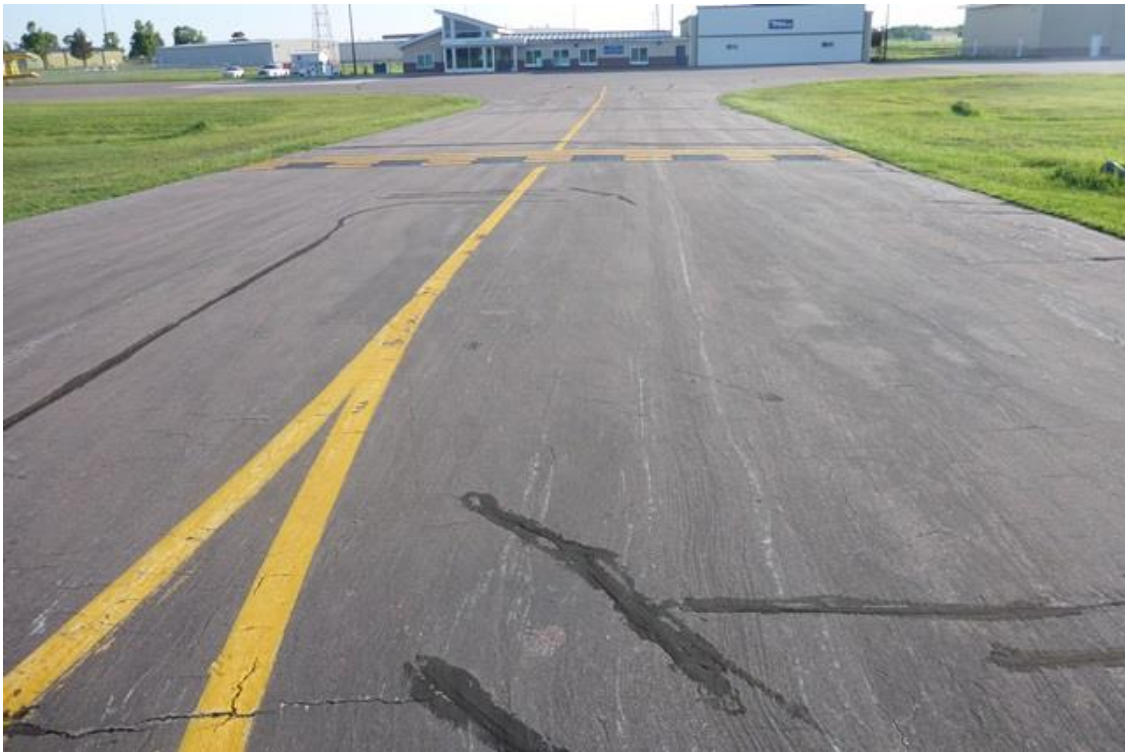
MJQ CTA 001 (PCI = 66)

**Conditions:** PCI: 66

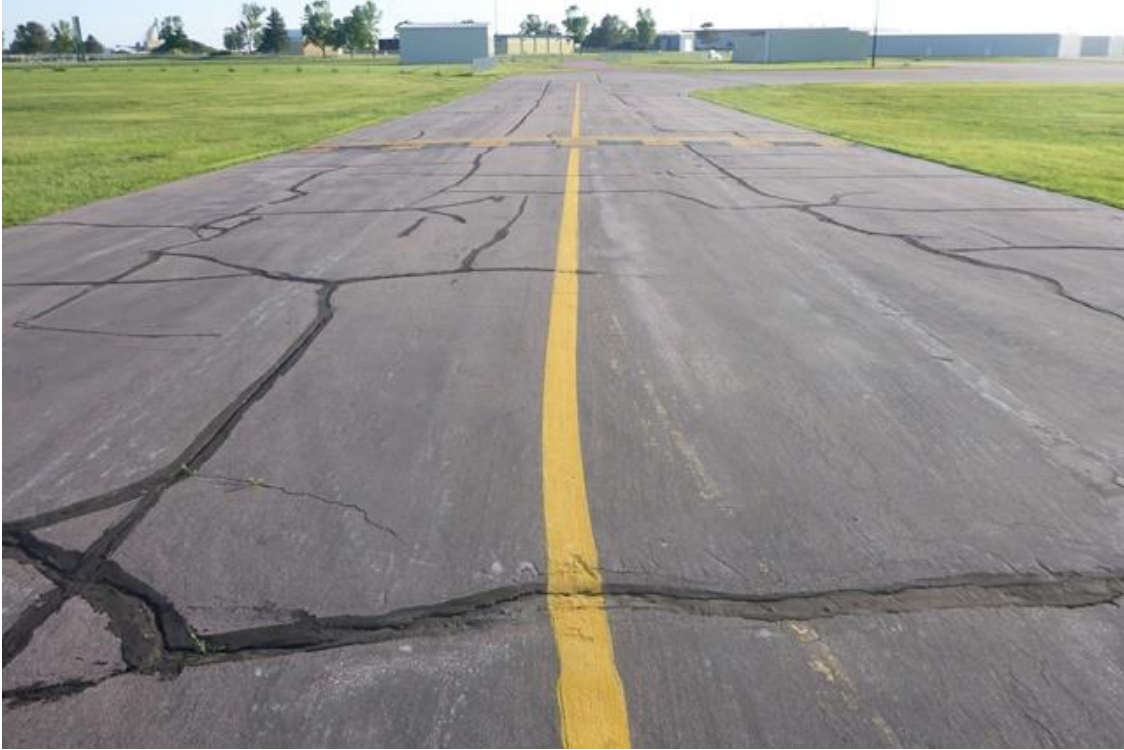
MJQ CTB 001 (PCI = 61)

**Conditions:** PCI: 61

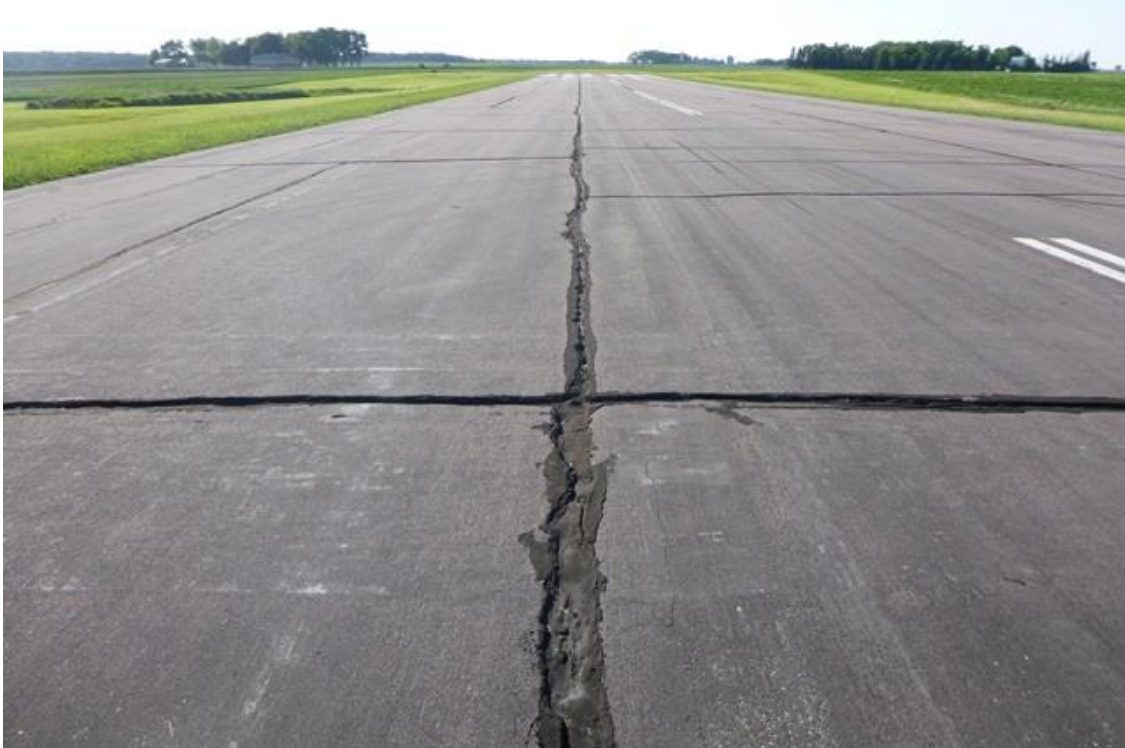
MJQ RY1331 003 (PCI = 64)

**Conditions:** PCI: 64

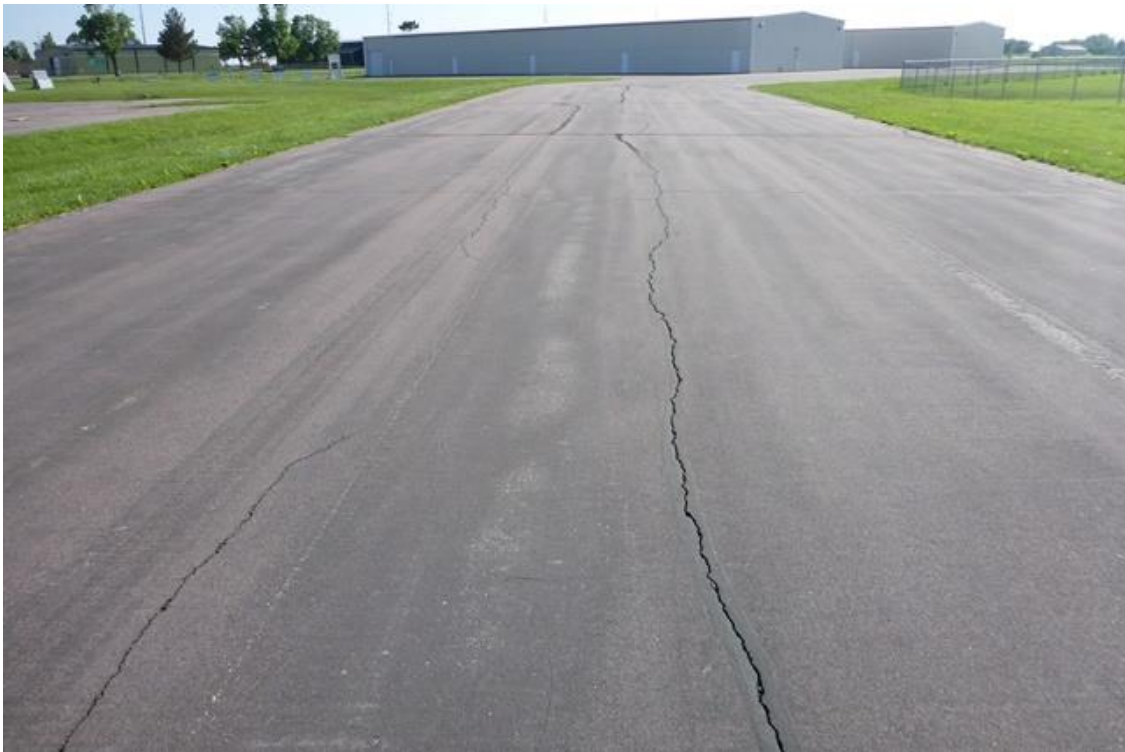
MJQ TLA 001 (PCI = 62)

**Conditions:** PCI: 62

<b>TLA::001</b>	<b>Preventative: PCI Before: 62 After: 74</b>	<b>5,428</b>
Crack Sealing - AC	984	1,200
Patching - AC Deep	370	4,229
<b>TLA::002</b>	<b>Preventative: PCI Before: 75 After: 78</b>	<b>381</b>
Crack Sealing - AC	312	381
<b>Grand Total</b>		<b>22,600</b>
