# Pavement Condition Report

## Orr Regional Airport (ORB)

**December 2016**

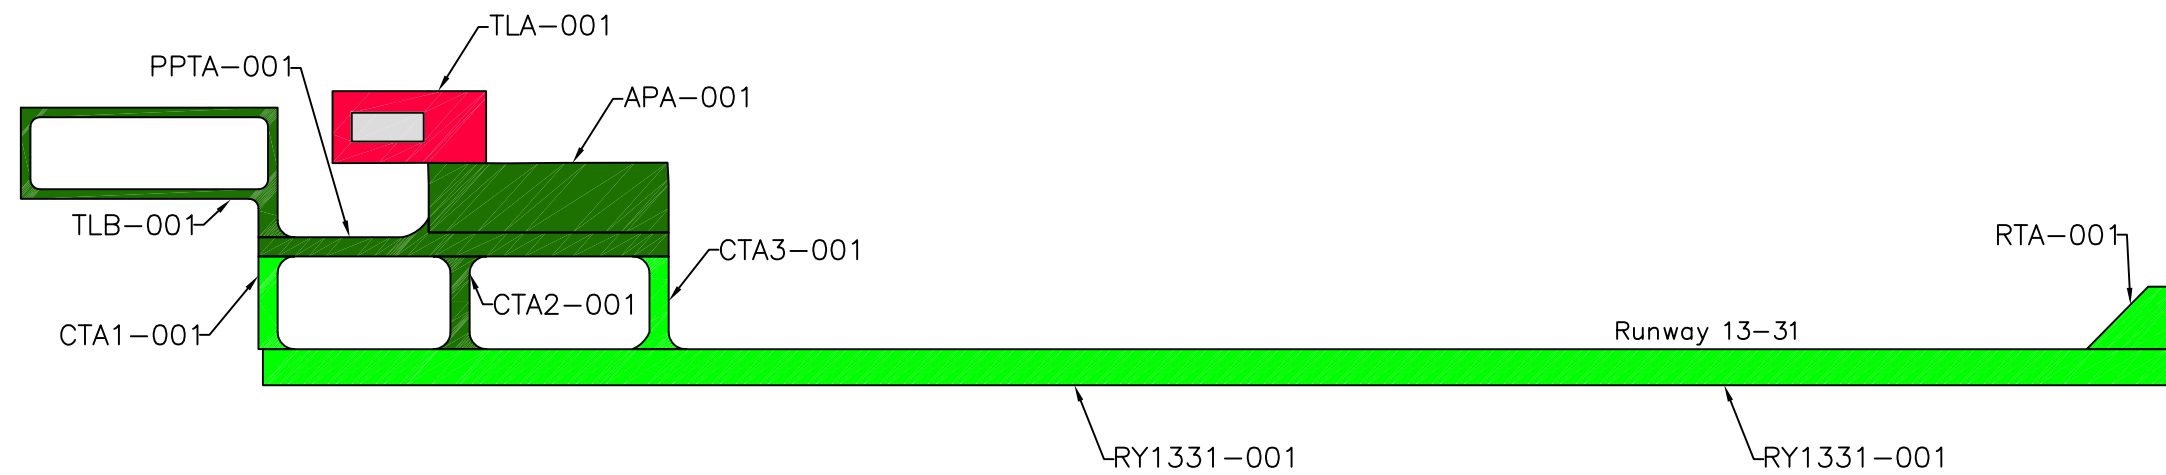
Figure 4. 2016 Pavement Condition Index Rating at Orr Regional Airport (ORB).

Figures 5 and 6 present the overall PCI for ORB by area distribution and pavement use, respectively. Table 3 presents the PCI summary for each section at ORB, including the drop in PCI per year. Generally, pavement sections will deteriorate between 1 and 3 PCI points per year. Sections deteriorating at higher rates may need maintenance above the normal application rates and should be closely monitored in case major repairs become necessary earlier than expected.

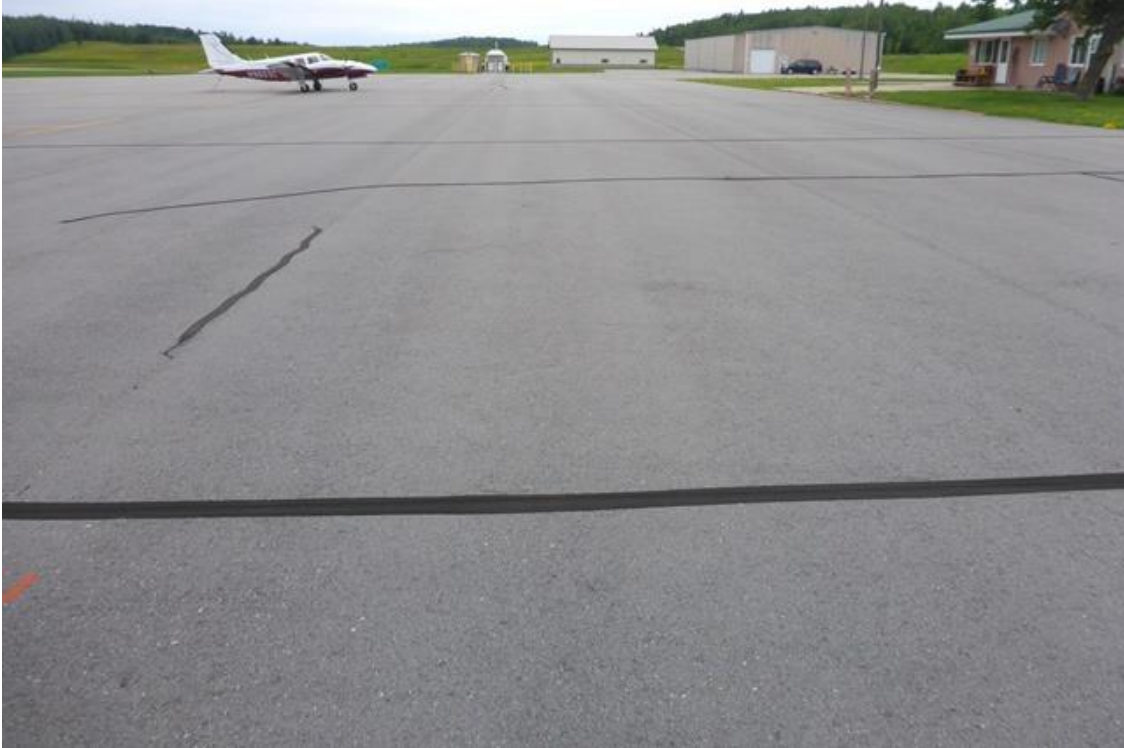
ORB APA 001 (PCI = 92)

Conditions: PCI: 92

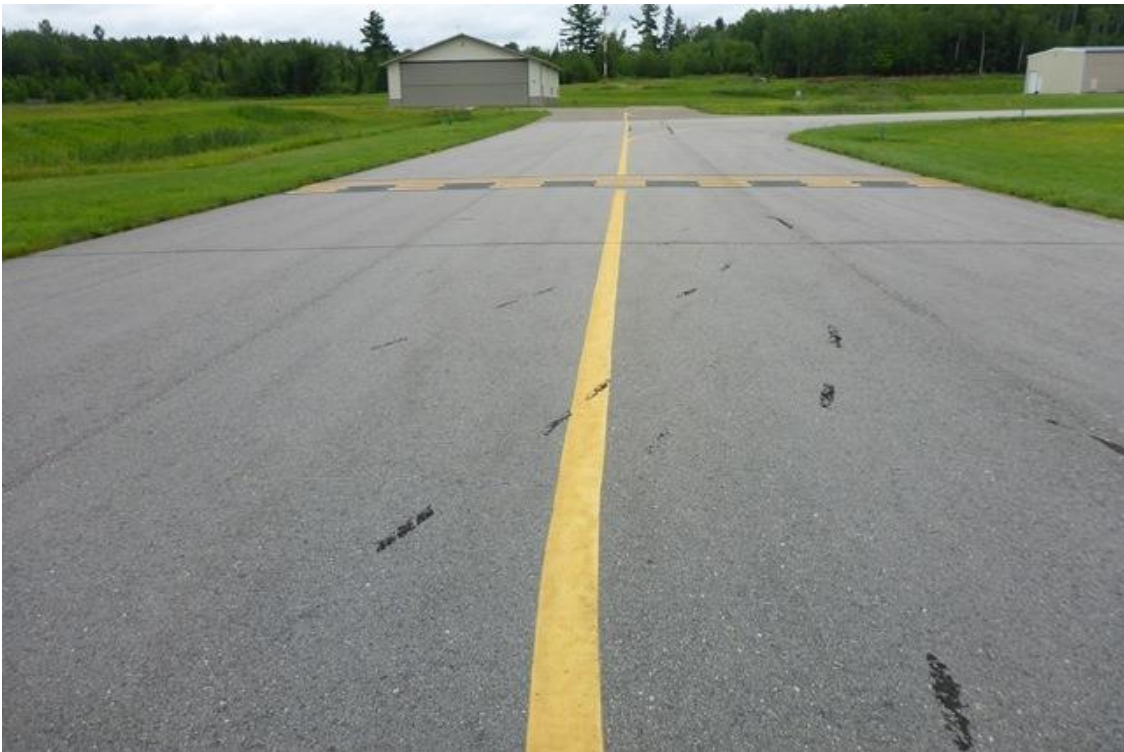
ORB CTA1 001 (PCI = 84)

**Conditions:** PCI: 84

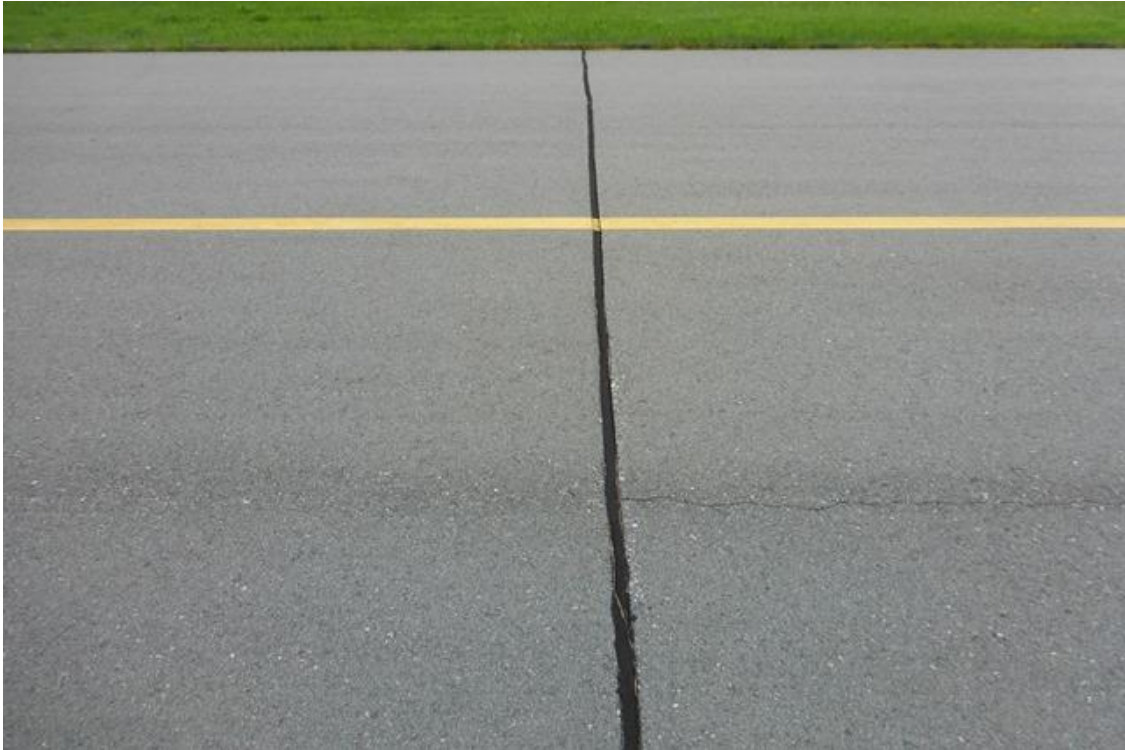
ORB CTA2 001 (PCI = 86)

**Conditions:** PCI: 86

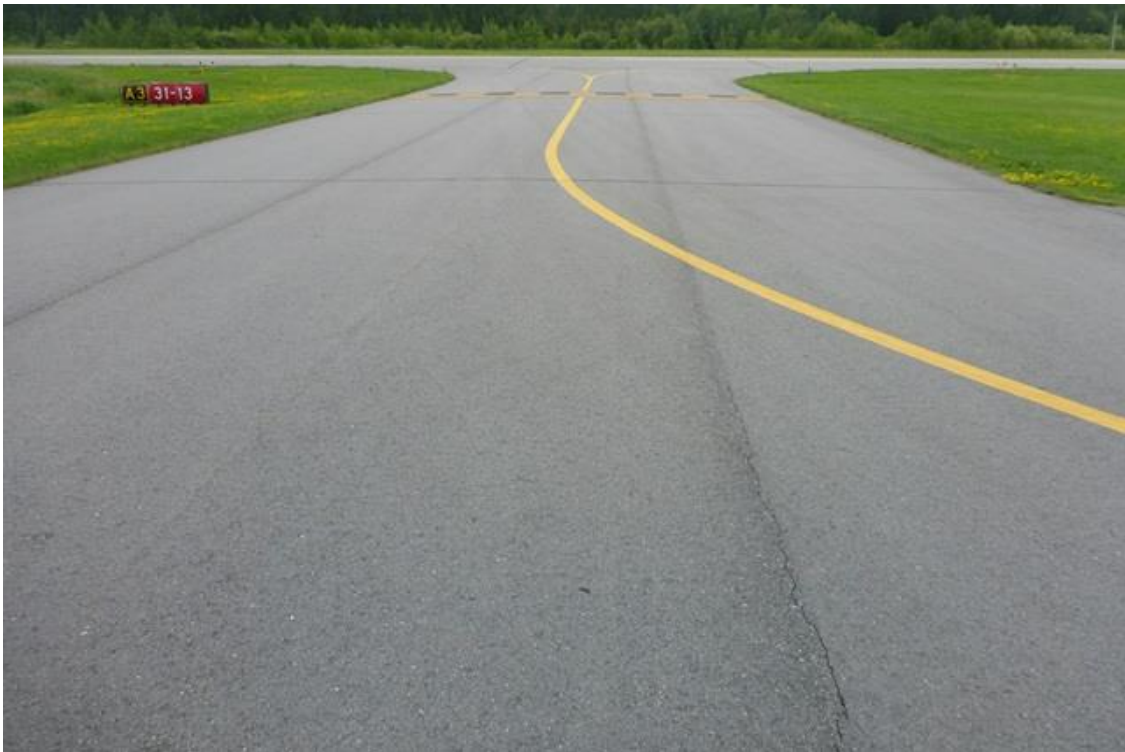
ORB CTA3 001 (PCI = 84)

**Conditions:** PCI: 84

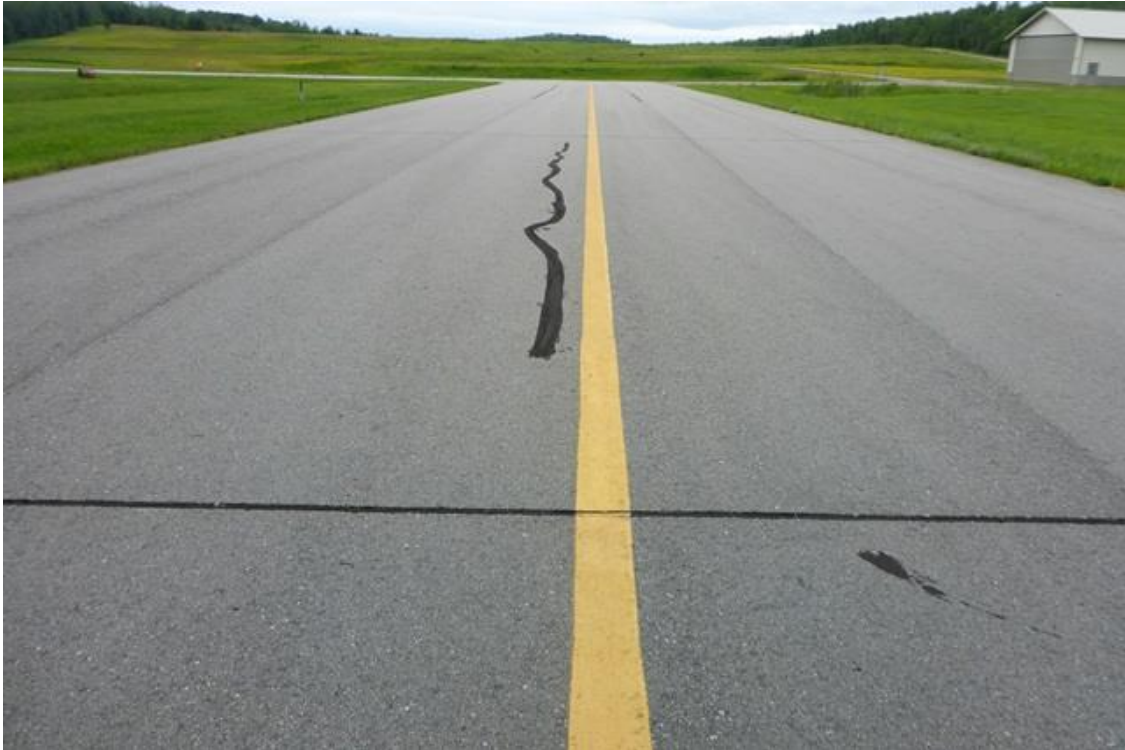
ORB PPTA 001 (PCI = 91)

**Conditions:** PCI: 91

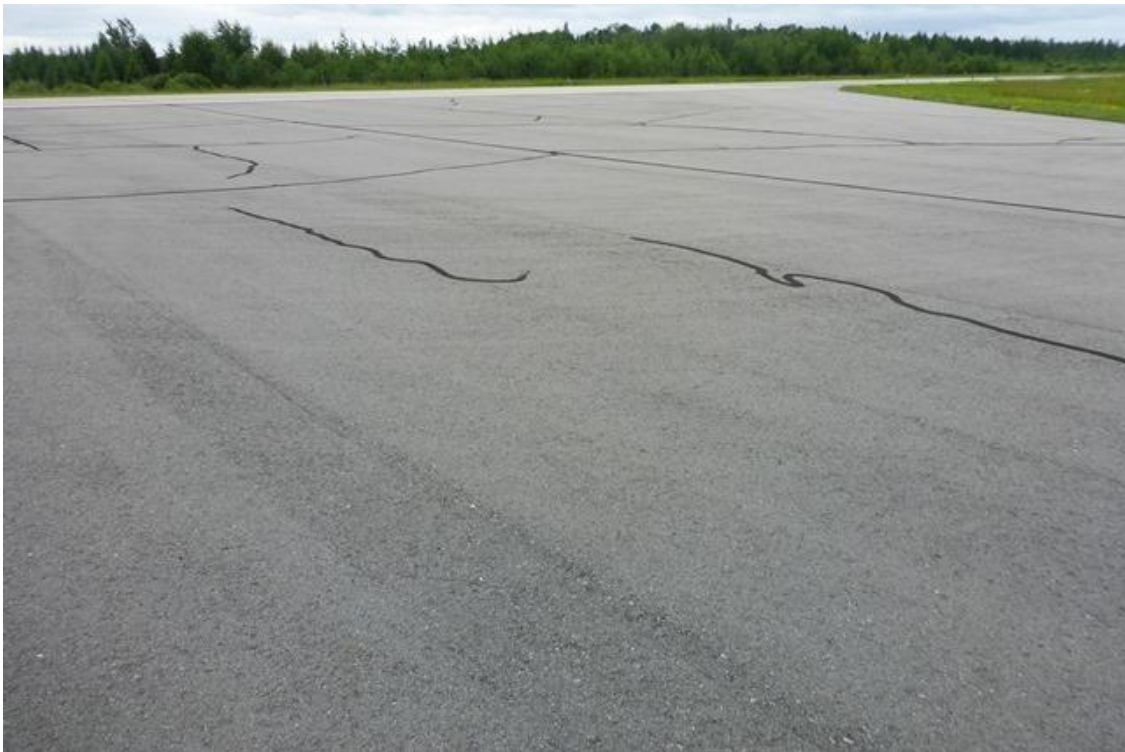
ORB RTA 001 (PCI = 82)

**Conditions:** PCI: 82

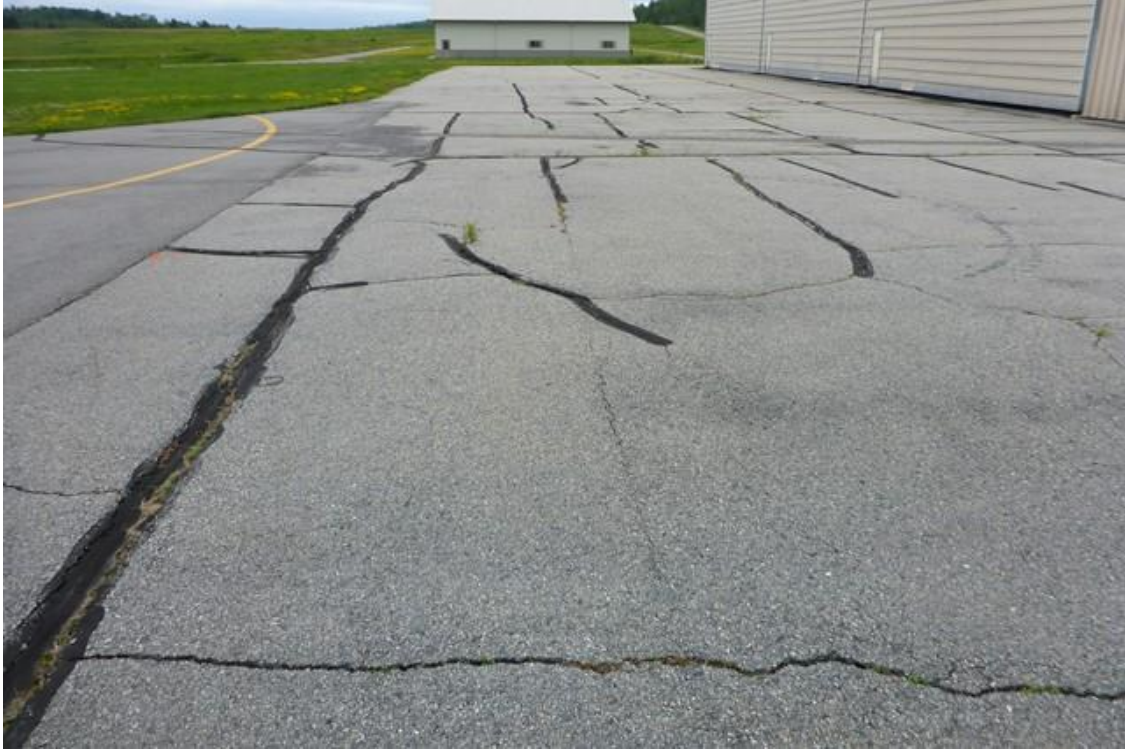
ORB TLA 001 (PCI = 31)

<b>Conditions:</b>	PCI: 31
--------------------	---------
