# Pavement Condition Report

## Longville Municipal Airport (XVG)

**December 2016**

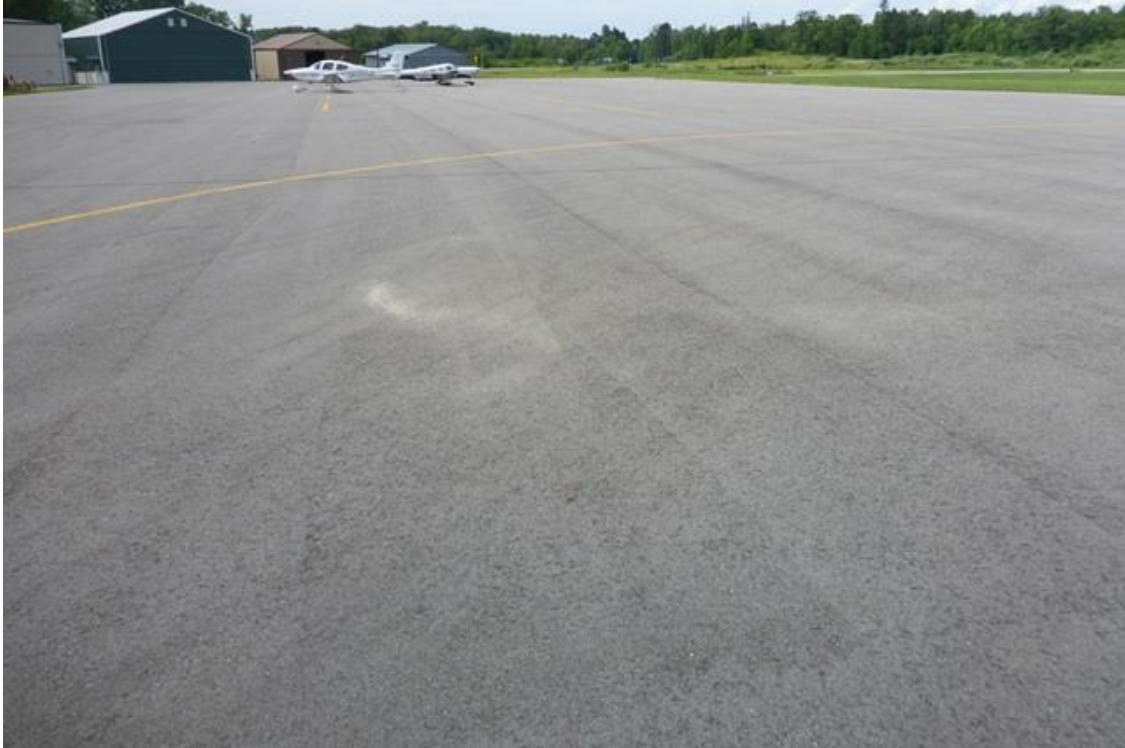
XVG APA 001 (PCI = 97)

**Conditions:** PCI: 97

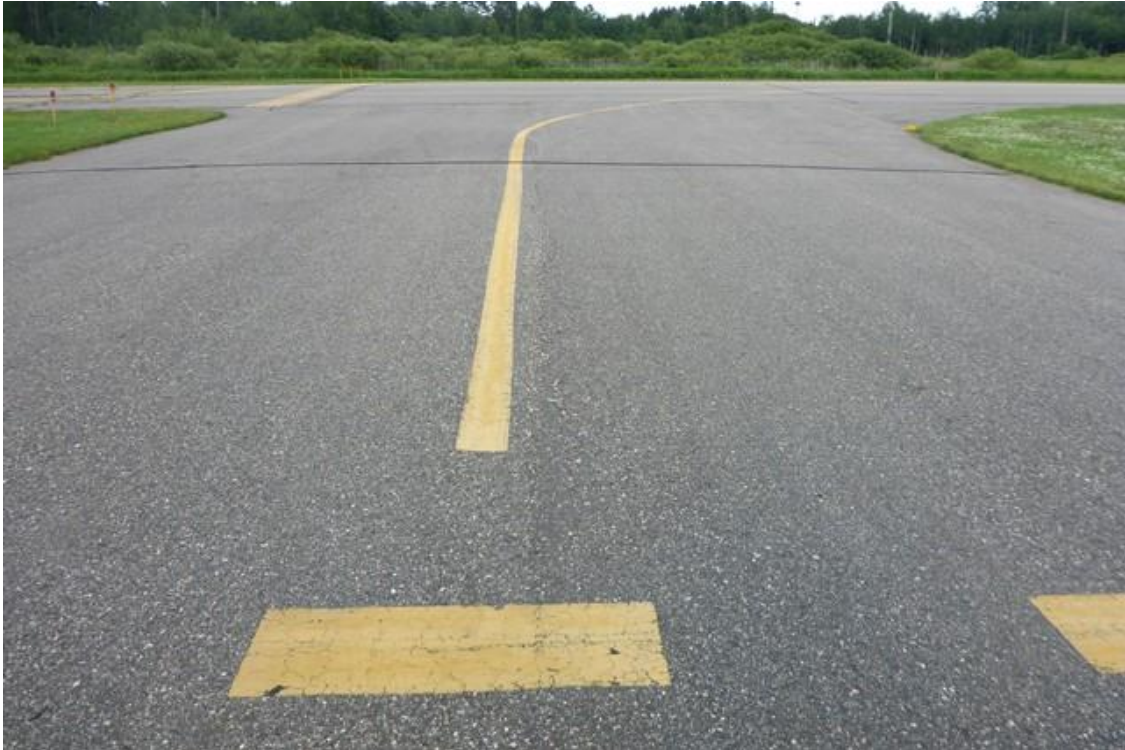
XVG CTB 002 (PCI = 85)

**Conditions:** PCI: 85

Section / Work	Sum of Work Qty (Ft, SqFt)	Sum of Work Cost (\$)
<b>CTB::002</b>	<b>Preventative: PCI Before 85 After: 85</b>	<b>5</b>
Crack Sealing - AC	4	5
<b>CTC::001</b>	<b>Restorative: PCI Before 58 After: 62</b>	<b>901</b>
Crack Sealing - AC	49	60
Surface Treatment	325	162
Patching - AC Shallow	88	679
<b>RY1331::001</b>	<b>Preventative: PCI Before 78 After: 79</b>	<b>119</b>
Crack Sealing - AC	98	119
<b>TLC::001</b>	<b>Preventative: PCI Before 69 After: 75</b>	<b>788</b>
Crack Sealing - AC	110	134
Surface Treatment	986	493
Patching - AC Deep	14	161
<b>Grand Total</b>		<b>1,814</b>

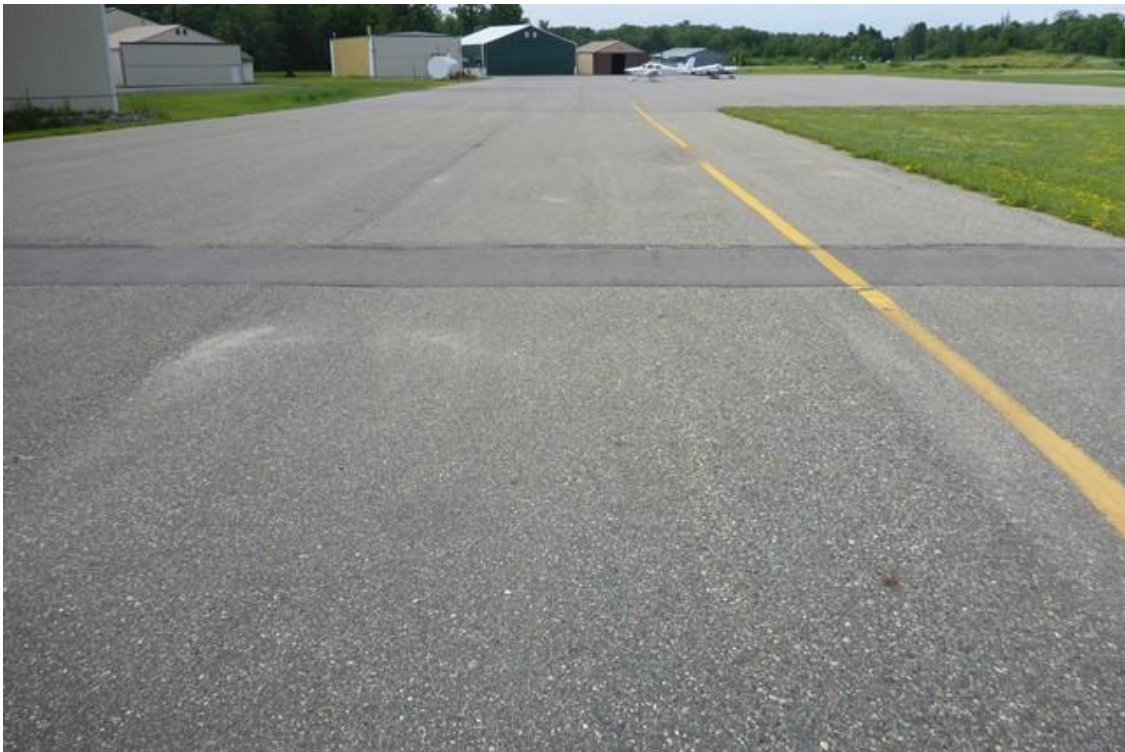
XVG CTC 001 (PCI = 58)

**Conditions:** PCI: 58

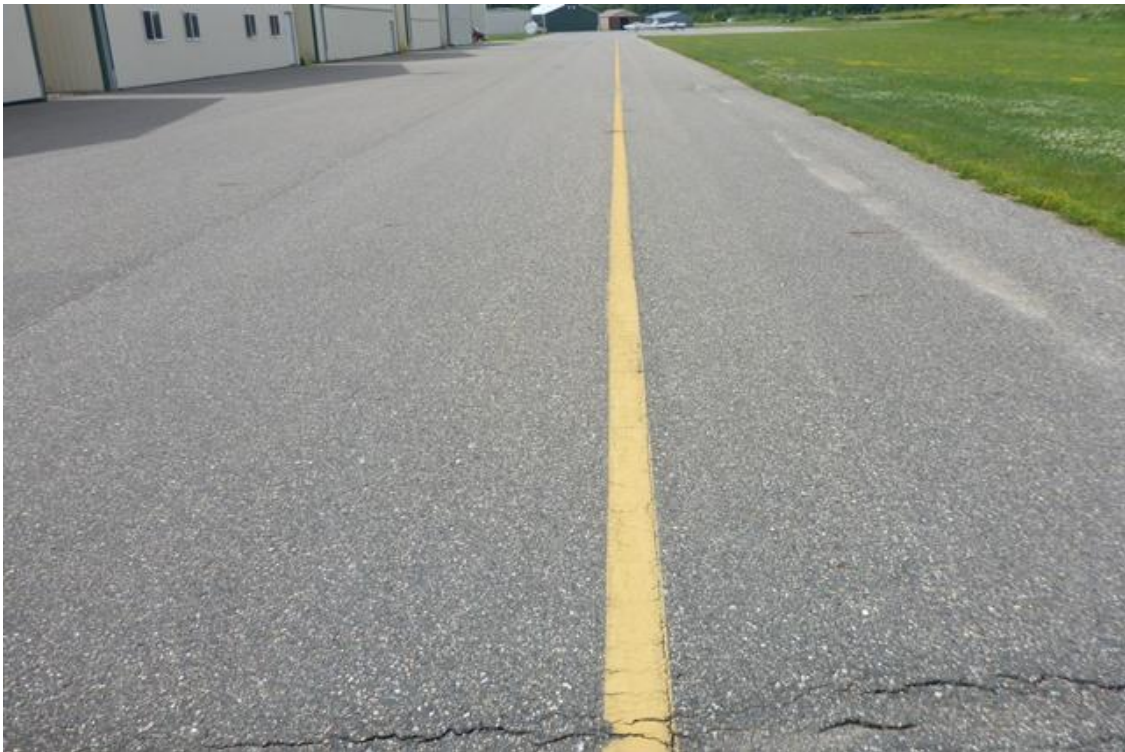
XVG TLC 001 (PCI = 69)

**Conditions:** PCI: 69
