Pavement Condition Report

Walker Municipal Airport (Y49)

December 2016

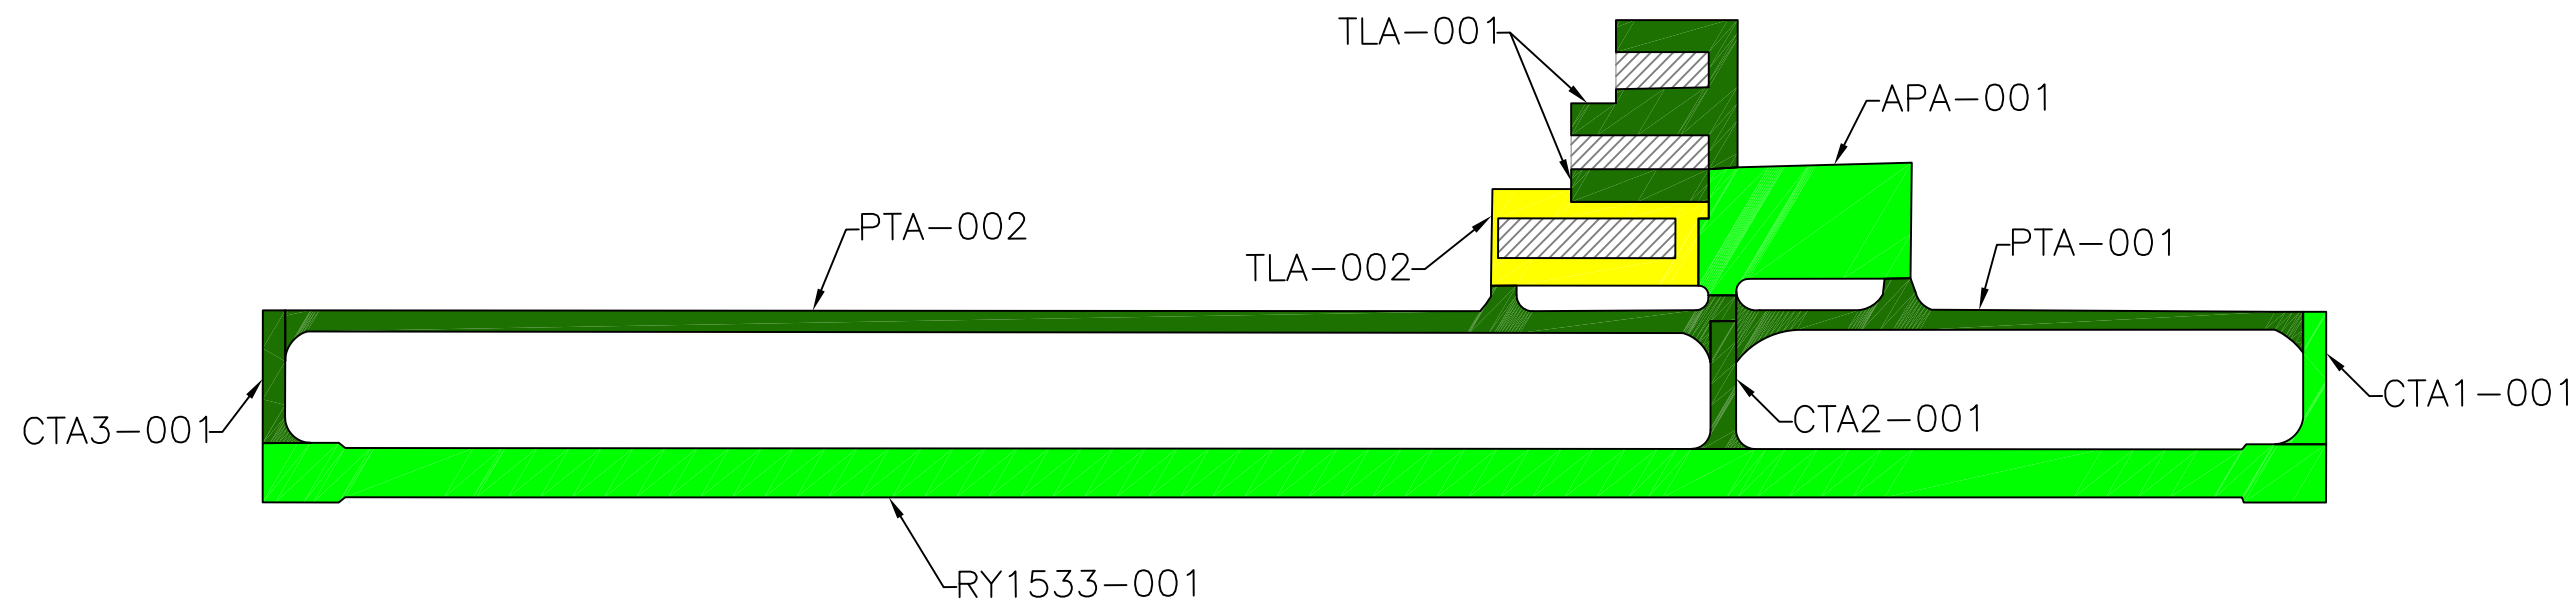
Figure 4. 2016 Pavement Condition Index Rating at Walker Municipal Airport (Y49).

Active maintenance and crack sealing at the airport has improved the condition of some pavement cracks, and improved some pavement section conditions.

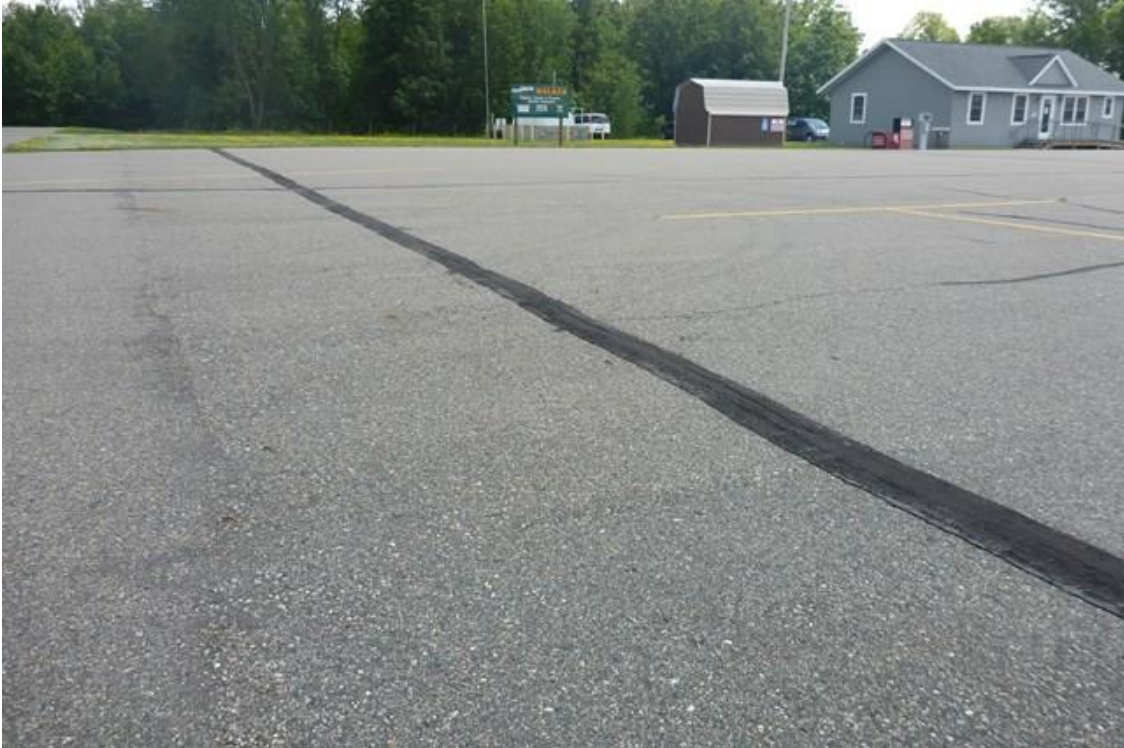
Y49 APA 001 (PCI = 83)

Network: Y49				Name: WALKER		
Branch: APA	Name: APRON A	Use: APRON	Area: 55,900 SqFt			
Section: 001	of 1	From: 100	To: 402	Last Const.: 10/20/2007		
Surface: AC	Family: MN2013 Asphalt Aprons	Zone: N	Category: 3	Rank: S		
Area: 55,900 SqFt	Length: 300 Ft	Width: 175 Ft				
Slabs:	Slab Length: Ft	Slab Width: Ft	Joint Length: Ft			
Shoulder:	Street Type:	Grade: 0	Lanes: 0			
Section Comments:						
Last Insp. Date: 7/9/2016	TotalSamples: 12	Surveyed: 3				
Conditions: PCI: 83						
Inspection Comments: cs satsfa toty						
Sample Number: 101	Type: R	Area: 5000.00 SqFt	PCI: 86			
Sample Comments:						
48	L & T CR	M	25.00 Ft			
48	L & T CR	L	125.00 Ft			
Sample Number: 200	Type: R	Area: 5000.00 SqFt	PCI: 83			
Sample Comments:						
53	RUTTING	L	3.00 SqFt			
48	L & T CR	L	50.00 Ft			
52	RAVELING	M	1.00 SqFt			
Sample Number: 302	Type: R	Area: 5000.00 SqFt	PCI: 80			
Sample Comments:						
48	L & T CR	M	28.00 Ft

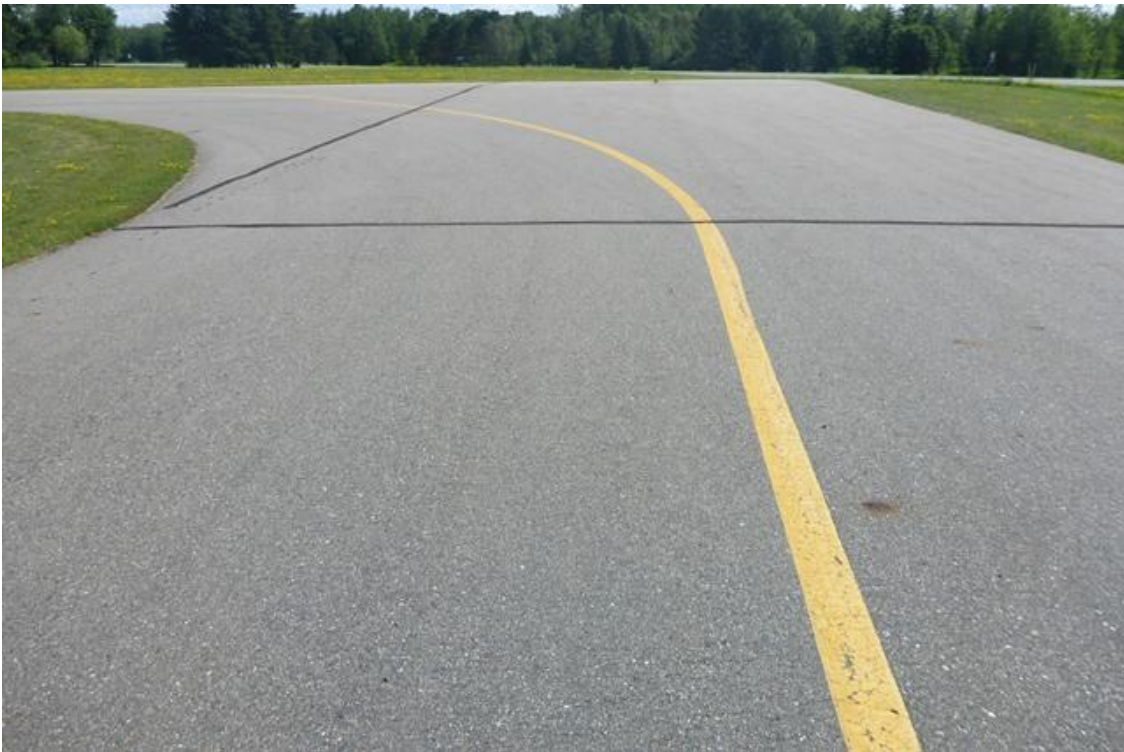
Y49 CTA1 001 (PCI = 77)

Conditions: PCI: 77

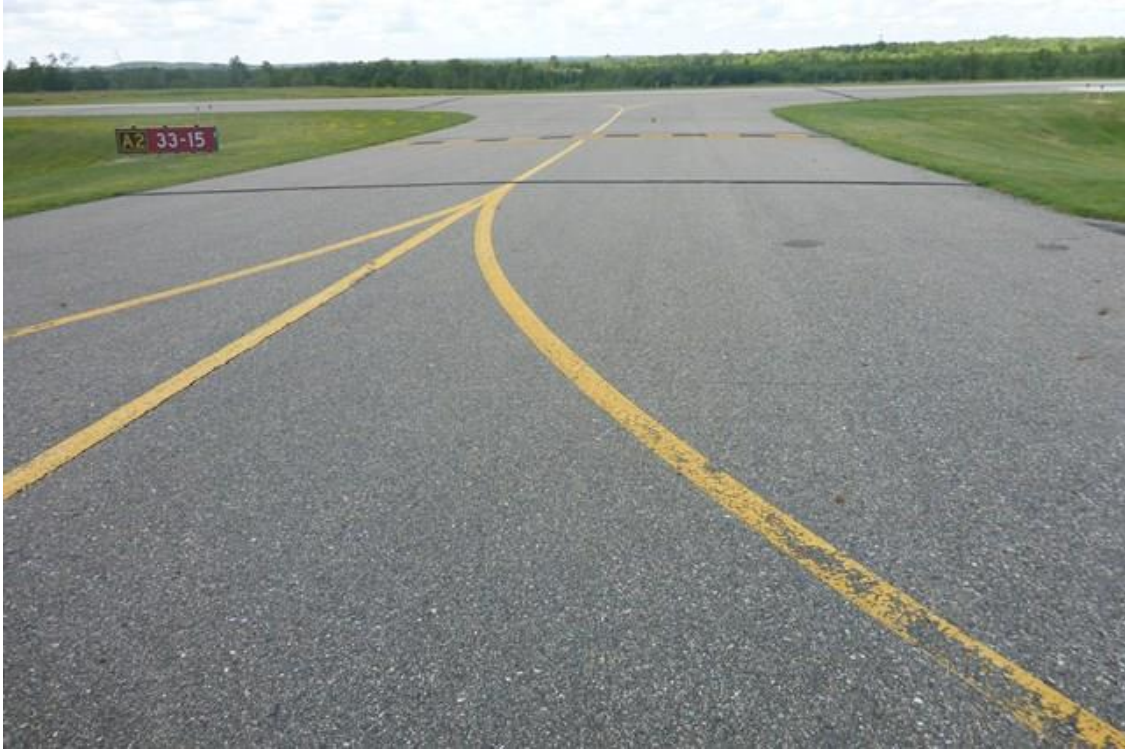
Y49 CTA2 001 (PCI = 86)

Network:	Y49	Name:	WALKER						
Branch:	CTA2	Name:	CONNECTOR TAXIWAY A2	Use:	TAXIWAY	Area:	8,400 SqFt		
Section:	001	of 1	From:	100	To:	101	Last Const.: 10/20/2007		
Surface:	AC	Family:	MN2013 Asphalt Taxiways	Zone:	N	Category:	3	Rank:	P
Area:	8,400 SqFt	Length:	200 Ft	Width:	40 Ft				
Slabs:		Slab Length:	Ft	Slab Width:	Ft	Joint Length:	Ft		
Shoulder:		Street Type:		Grade:	0	Lanes:	0		
Section Comments:									
Last Insp. Date:	7/9/2016	TotalSamples:	2	Surveyed:	1				
Conditions:	PCI: 86								
Inspection Comments:									
Sample Number:	101	Type:	R	Area:	3600.00 SqFt	PCI:	86		
Sample Comments:									
48	L & T CR	L	163.00 Ft

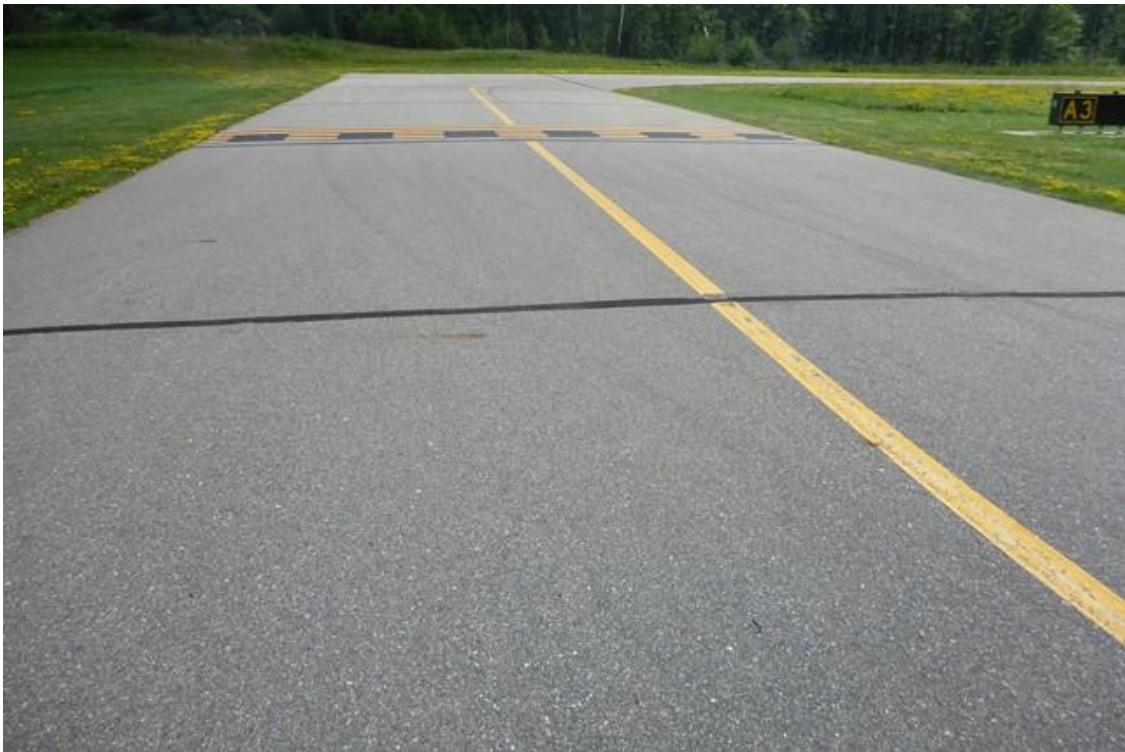
Y49 CTA3 001 (PCI = 86)

Network:	Y49	Name:	WALKER						
Branch:	CTA3	Name:	Connector Taxiway A3	Use:	TAXIWAY	Area:	7,860 SqFt		
Section:	001	of 1	From:	PTA	To:	RW 15	Last Const.:	9/28/2010	
Surface:	AC	Family:	MN2013 Asphalt Taxiways	Zone:	N	Category:	3	Rank:	P
Area:	7,860 SqFt	Length:	215 Ft	Width:	35 Ft				
Slabs:		Slab Length:	Ft	Slab Width:	Ft	Joint Length:	Ft		
Shoulder:		Street Type:		Grade:	0	Lanes:	0		
Section Comments:									
Last Insp. Date:	7/9/2016	TotalSamples:	2	Surveyed:	1				
Conditions:	PCI: 86								
Inspection Comments:									
Sample Number:	100	Type:	R	Area:	3835.00 SqFt	PCI:	87		
Sample Comments:									
53	RUTTING	L	2.00	SqFt					
48	L & T CR	L	70.00	Ft

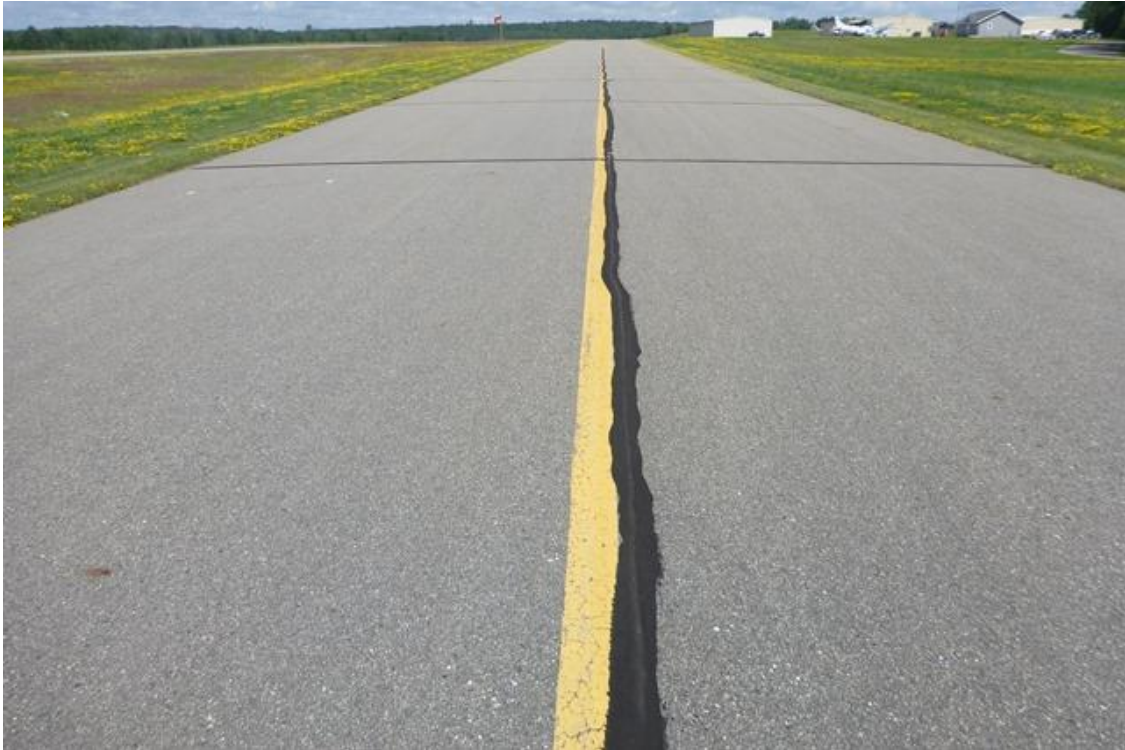
Y49 PTA 001 (PCI = 86)

Network:	Y49	Name:	WALKER						
Branch:	PTA	Name:	Parallel Taxiway A	Use:	TAXIWAY	Area:	115,500 SqFt		
Section:	001	of 2	From:	CTA1	To:	CTA2	Last Const.: 9/28/2010		
Surface:	AC	Family:	MN2013 Asphalt Taxiways	Zone:	N	Category:	3	Rank:	P
Area:	32,975 SqFt	Length:	885 Ft	Width:	35 Ft				
Slabs:		Slab Length:	Ft	Slab Width:	Ft	Joint Length:	Ft		
Shoulder:		Street Type:		Grade:	0	Lanes:	0		
Section Comments:									
Last Insp. Date:	7/9/2016	TotalSamples:	10	Surveyed:	3				
Conditions:	PCI: 86								
Inspection Comments:									
Sample Number:	101	Type:	R	Area:	3500.00 SqFt	PCI:	83		
Sample Comments:									
48	L & T CR		L	213.00	Ft				
Sample Number:	104	Type:	R	Area:	3500.00 SqFt	PCI:	88		
Sample Comments:									
48	L & T CR		L	127.00	Ft				
Sample Number:	107	Type:	R	Area:	3500.00 SqFt	PCI:	88		
Sample Comments:									
48	L & T CR		L	138.00	Ft

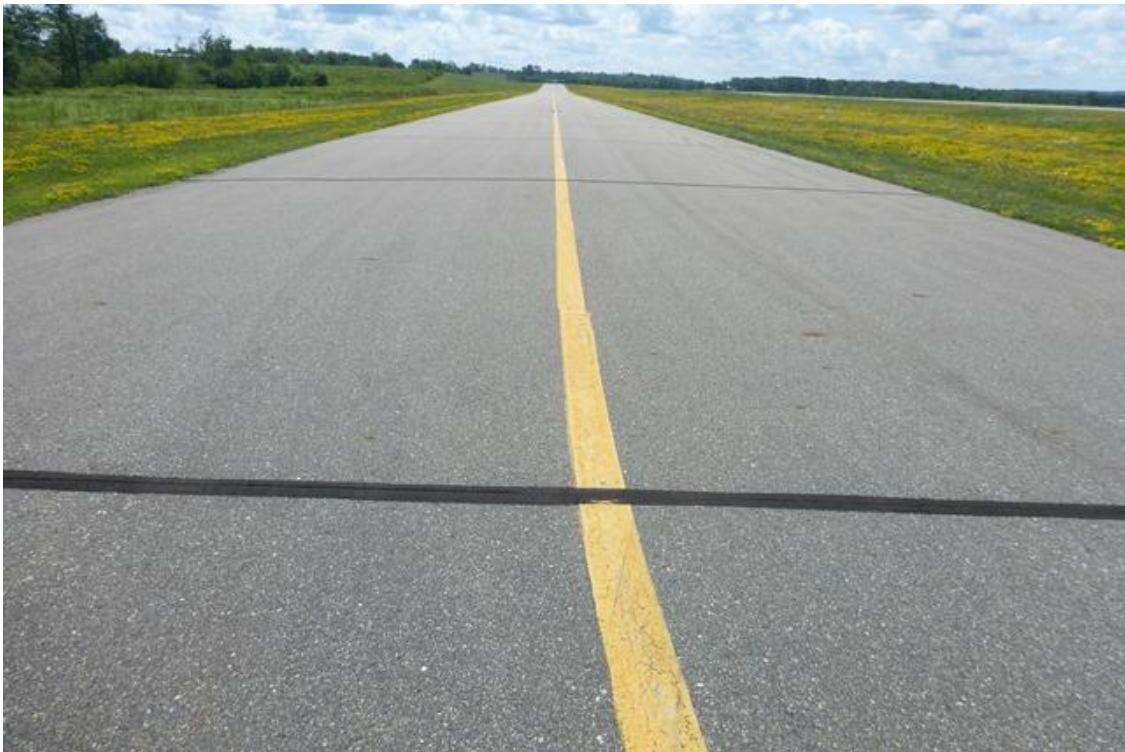
Y49 PTA 002 (PCI = 89)

Network:	Y49	Name:	WALKER						
Branch:	PTA	Name:	Parallel Taxiway A	Use:	TAXIWAY	Area:	115,500 SqFt		
Section:	002	of 2	From:	CTA2	To:	CTA3	Last Const.: 9/28/2010		
Surface:	AC	Family:	MN2013 Asphalt Taxiways	Zone:	N	Category:	3	Rank:	P
Area:	82,525 SqFt	Length:	2,255 Ft	Width:	35 Ft				
Slabs:		Slab Length:	Ft	Slab Width:	Ft	Joint Length:	Ft		
Shoulder:		Street Type:		Grade:	0	Lanes:	0		
Section Comments:									
Last Insp. Date:	7/9/2016	TotalSamples:	23	Surveyed:	4				
Conditions:	PCI: 89								
Inspection Comments:									
Sample Number:	202	Type:	R	Area:	3500.00 SqFt	PCI:	85		
Sample Comments:									
48	L & T CR	L	182.00	Ft					
Sample Number:	207	Type:	R	Area:	3500.00 SqFt	PCI:	90		
Sample Comments:									
48	L & T CR	L	111.00	Ft					
Sample Number:	212	Type:	R	Area:	3500.00 SqFt	PCI:	90		
Sample Comments:									
48	L & T CR	L	105.00	Ft					
Sample Number:	217	Type:	R	Area:	3500.00 SqFt	PCI:	90

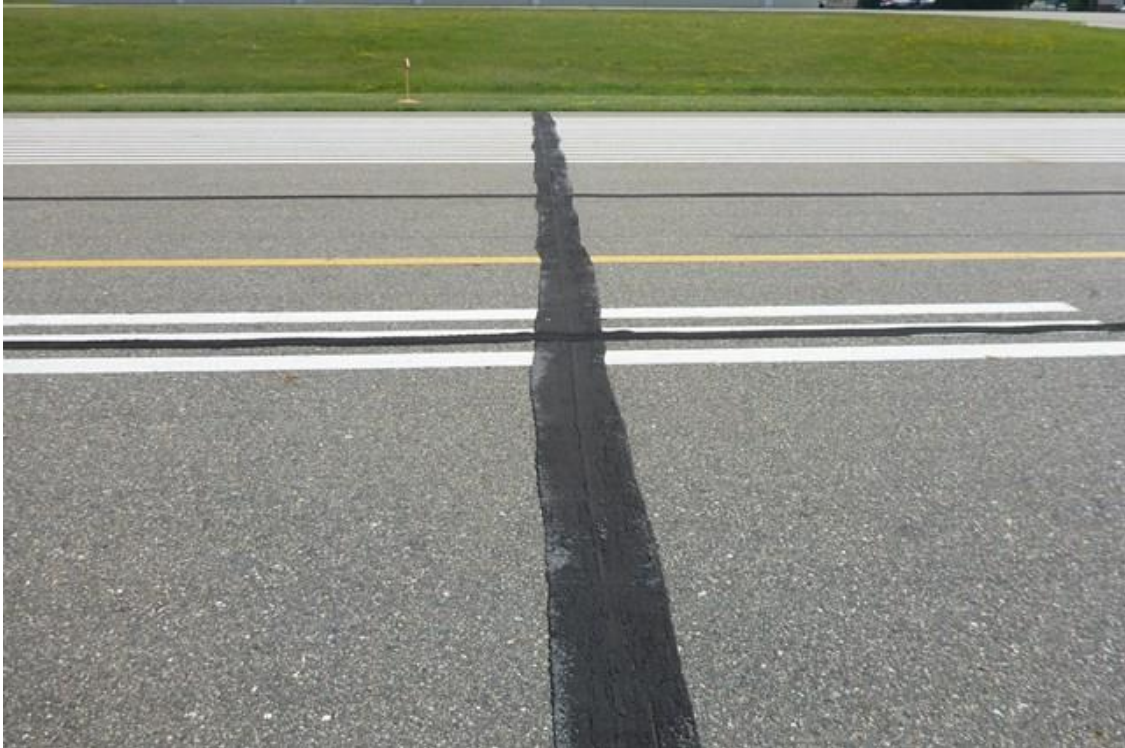
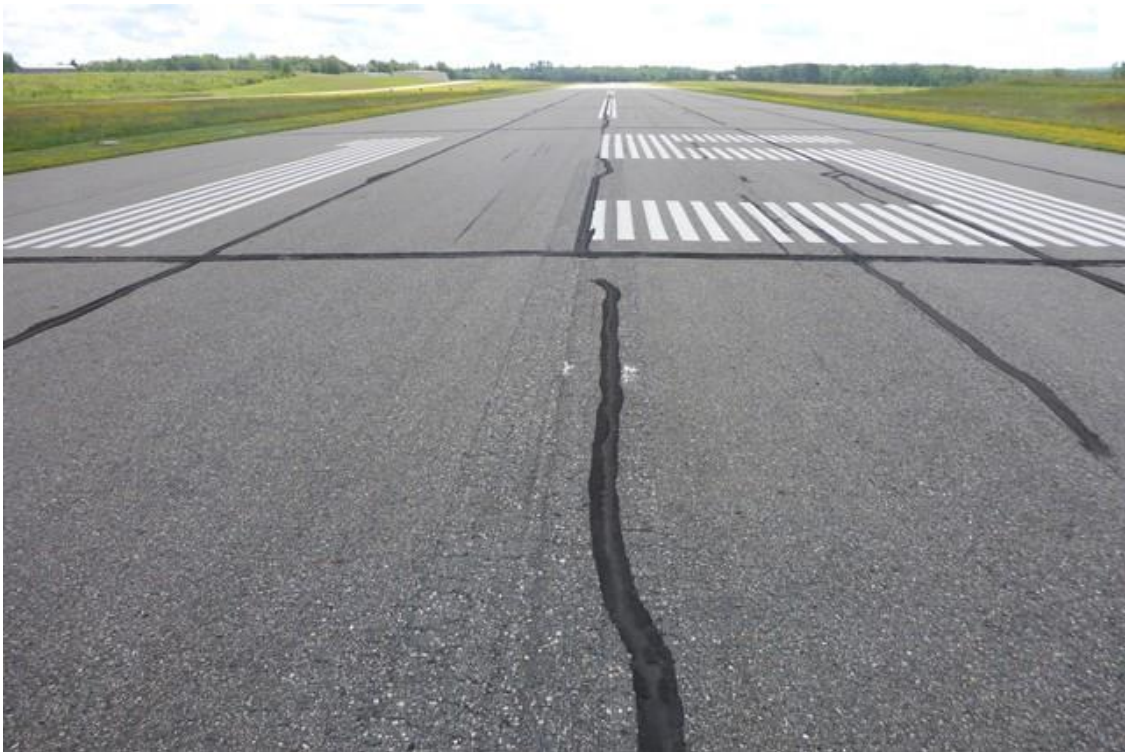
Y49 RY1533 001 (PCI = 75)

Network:	Y49	Name:	WALKER						
Branch:	RY1533	Name:	RUNWAY 15-33	Use:	RUNWAY	Area:	246,500 SqFt		
Section:	001	of 1	From:	100	To:	164	Last Const.: 6/20/2008		
Surface:	AC	Family:	MN2013 Asphalt Runways	Zone:	N	Category:	3	Rank:	P
Area:	246,500 SqFt	Length:	3,220 Ft	Width:	75 Ft				
Slabs:		Slab Length:	Ft	Slab Width:	Ft	Joint Length:	Ft		
Shoulder:		Street Type:		Grade:	0	Lanes:	0		
Section Comments:									
Last Insp. Date:	7/9/2016	TotalSamples:	65	Surveyed:	8				
Conditions:	PCI: 75								
Inspection Comments: new cs since l ins est 2014									
Sample Number:	104	Type:	R	Area:	3750.00 SqFt	PCI:	84		
Sample Comments:									
48	L & T CR	L	117.00	Ft					
48	L & T CR	L	98.00	Ft					
Sample Number:	113	Type:	R	Area:	3750.00 SqFt	PCI:	86		
Sample Comments:									
48	L & T CR	L	182.00	Ft					
Sample Number:	122	Type:	R	Area:	3750.00 SqFt	PCI:	80		
Sample Comments:									
48	L & T CR	L	286.00	Ft					
Sample Number:	131	Type:	R	Area:	3750.00 SqFt	PCI:	77

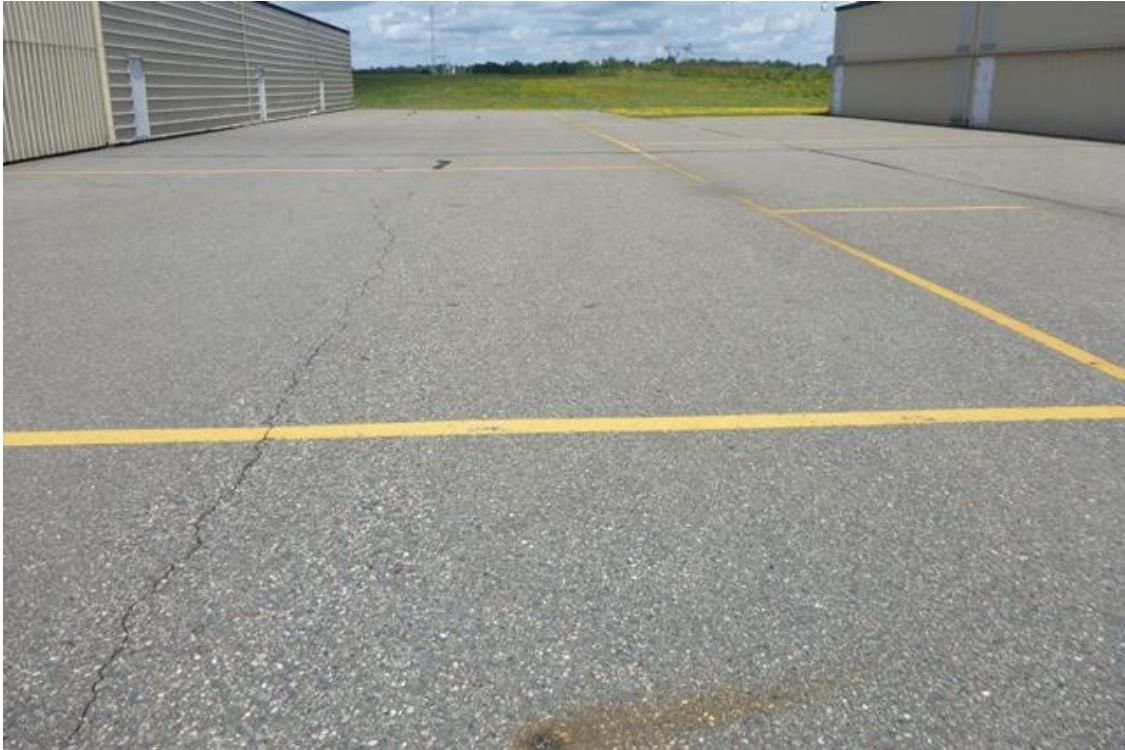
Y49 TLA 001 (PCI = 89)

Conditions: PCI: 89

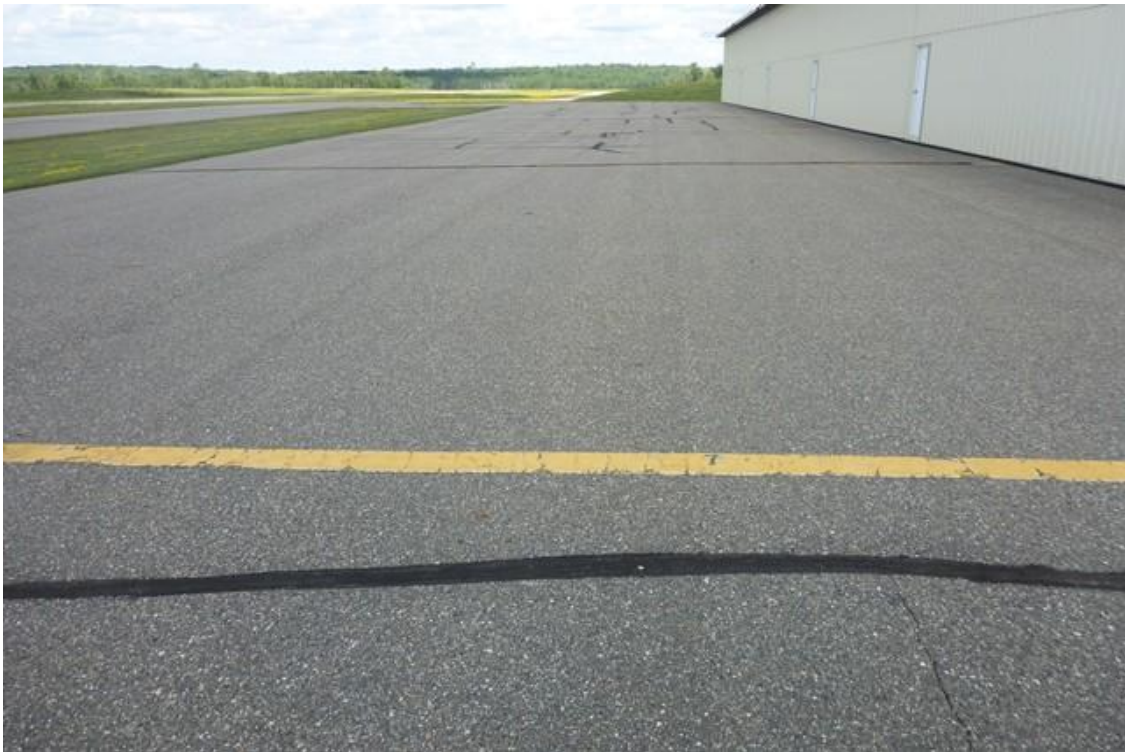
Y49 TLA 002 (PCI = 69)

Conditions: PCI: 69
