Pavement Condition Report

Cambridge Municipal Airport (CBG)

December 2017

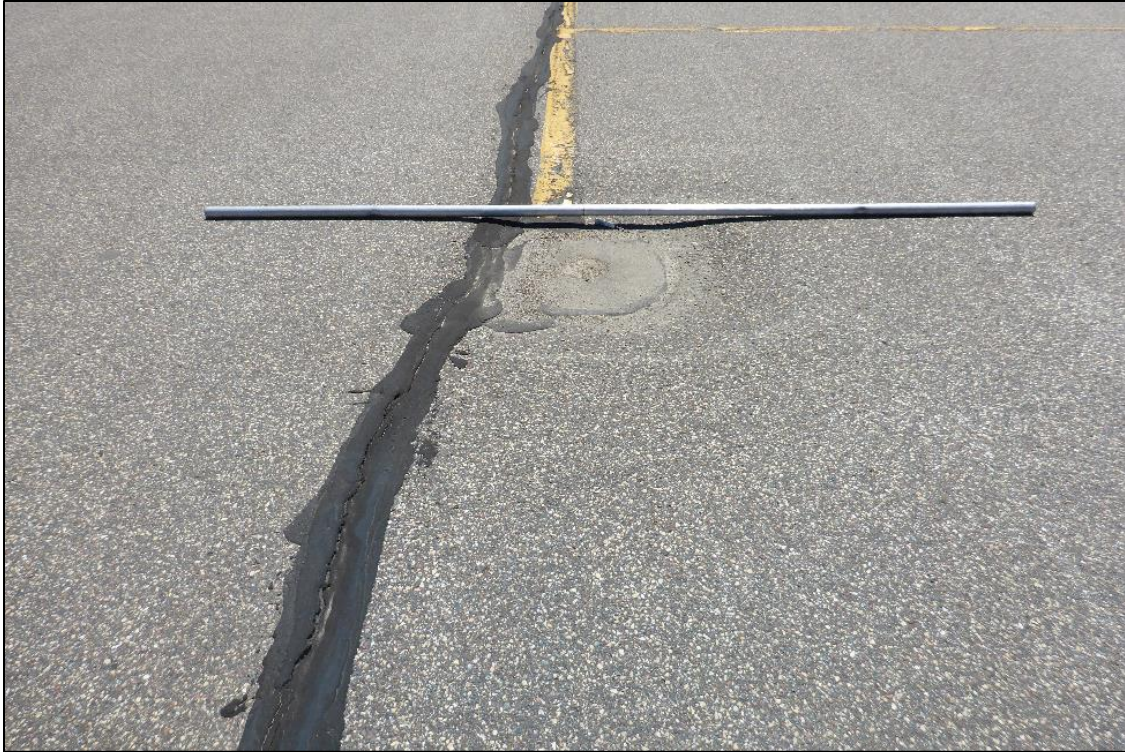
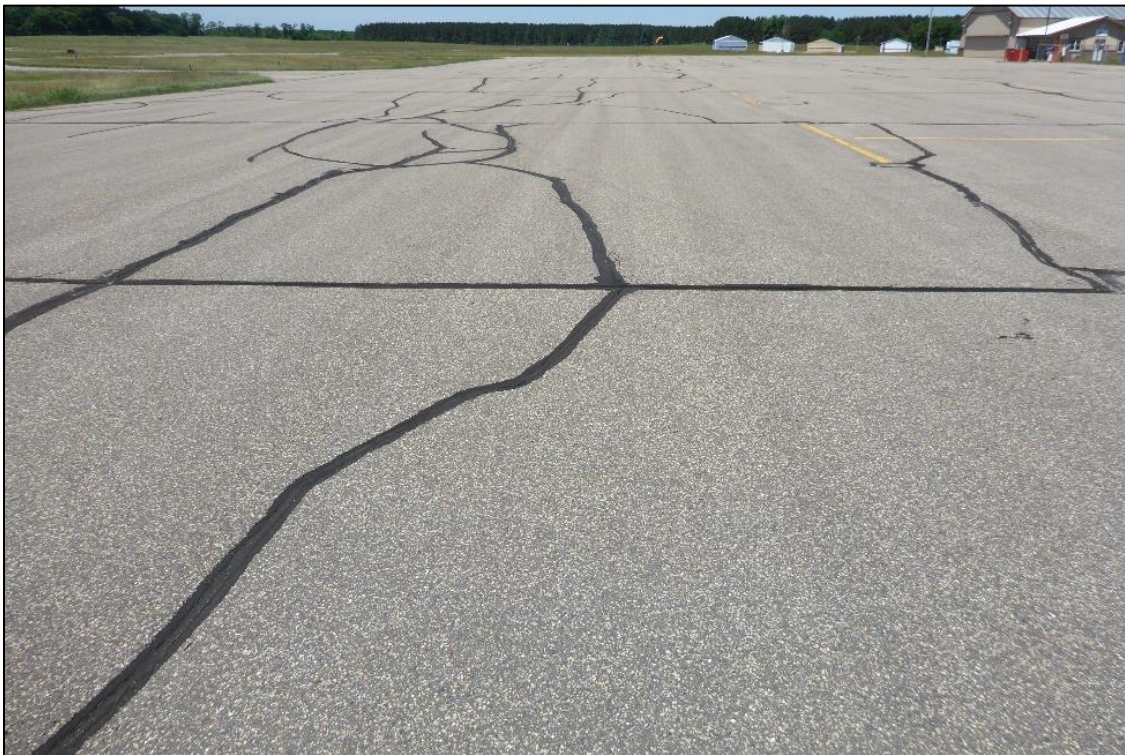
CBG APA 001 (PCI = 71)

Network: CBG				Name: CAMBRIDGE		
Branch: APA	Name: APRON A	Use: APRON	Area: 119,250 SqFt			
Section: 001	of 1	From: 100	To: 405	Last Const.: 9/27/2005		
Surface: AAC	Family: MN2013 Asphalt Aprons	Zone: E	Category: 1	Rank: S		
Area: 119,250 SqFt	Length: 650 Ft	Width: 180 Ft				
Slabs:	Slab Length: Ft	Slab Width: Ft	Joint Length: Ft			
Shoulder:	Street Type:	Grade: 0	Lanes: 0			
Section Comments:						
Last Insp. Date: 6/6/2017	Total Samples: 26	Surveyed: 6				
Conditions: PCI: 71						
Inspection Comments:						
Sample Number: 100	Type: R	Area: 5000.00 SqFt	PCI: 65			
Sample Comments:						
48	L & T CR	M	17.00 Ft			
57	WEATHERING	L	5000.00 SqFt			
48	L & T CR	L	583.00 Ft			
Sample Number: 103	Type: R	Area: 5000.00 SqFt	PCI: 69			
Sample Comments:						
48	L & T CR	L	431.00 Ft			
48	L & T CR	M	18.00 Ft			
57	WEATHERING	L	5000.00 SqFt			
Sample Number: 201	Type: R	Area: 5000.00 SqFt	PCI: 71			
Sample Comments:

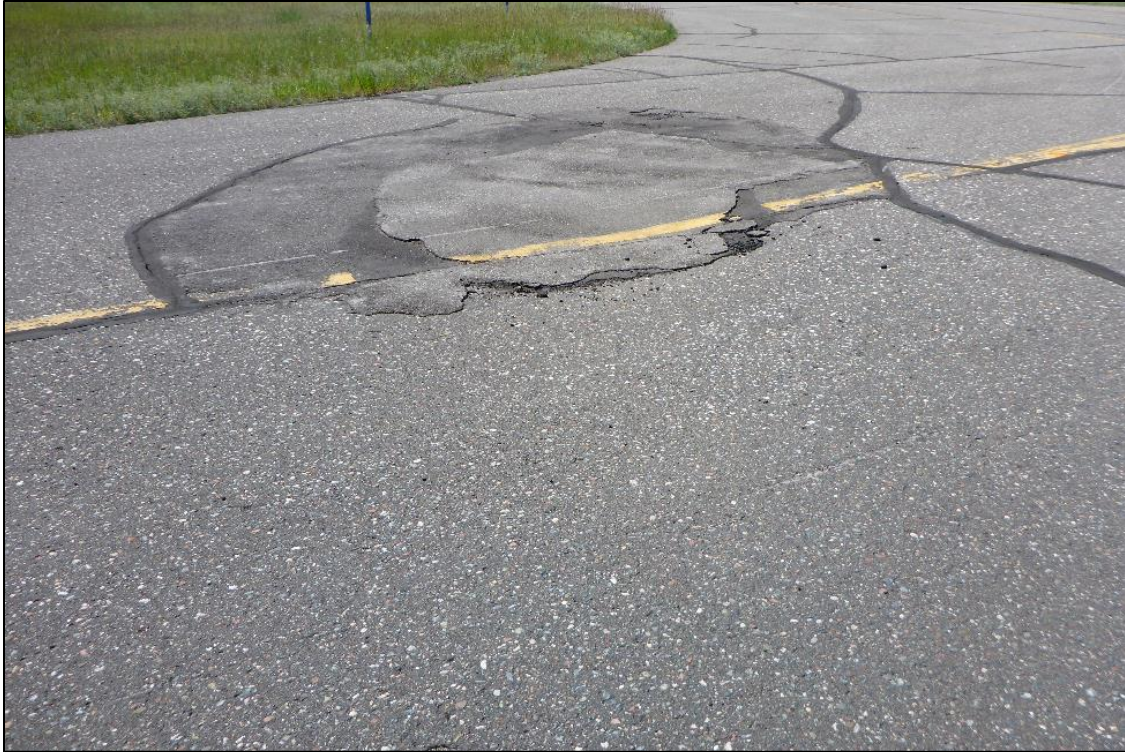
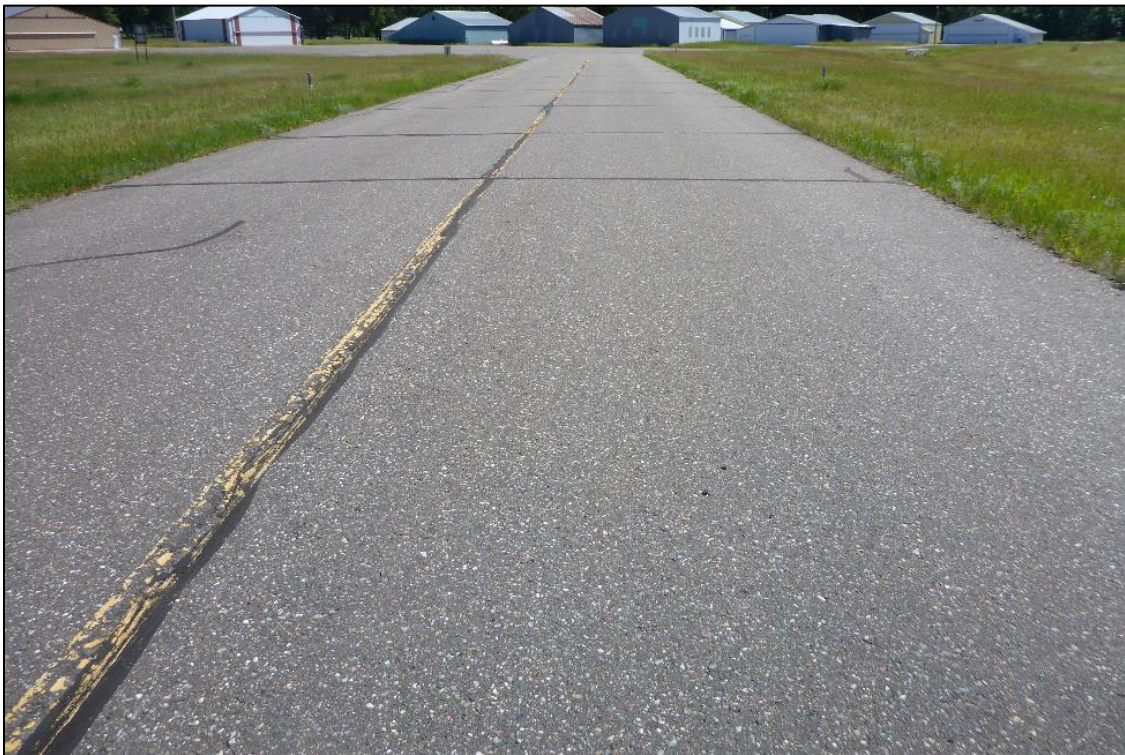
CBG CTA 001 (PCI = 64)

Network:	CBG		Name:	CAMBRIDGE					
Branch:	CTA	Name:	CONNECTING TAXIWAY A	Use:	TAXIWAY	Area:	25,100 SqFt		
Section:	001	of 1	From:	100	To:	110	Last Const.:	12/28/2000	
Surface:	AAC	Family:	MN2013 Asphalt Taxiways	Zone:	E	Category:	1	Rank:	P
Area:	25,100 SqFt	Length:	620 Ft	Width:	30 Ft	Joint Length:	Ft		
Slabs:		Slab Length:	Ft	Slab Width:	Ft	Joint Length:	Ft		
Shoulder:		Street Type:		Grade:	0	Lanes:	0		
Section Comments:									
Last Insp. Date:	6/6/2017		TotalSamples:	6	Surveyed:	3			
Conditions:	PCI:	64							
Inspection Comments:									
Sample Number:	101	Type:	R	Area:	3000.00 SqFt	PCI:	62		
Sample Comments:									
48	L & T CR	L		354.00	Ft				
48	L & T CR	M		12.00	Ft				
57	WEATHERING	M		100.00	SqFt				
57	WEATHERING	L		2900.00	SqFt				
Sample Number:	102	Type:	A	Area:	3000.00 SqFt	PCI:	48		
Sample Comments:									
45	DEPRESSION	L		200.00	SqFt				
45	DEPRESSION	M		88.00	SqFt				
48	L & T CR	L		333.00	Ft

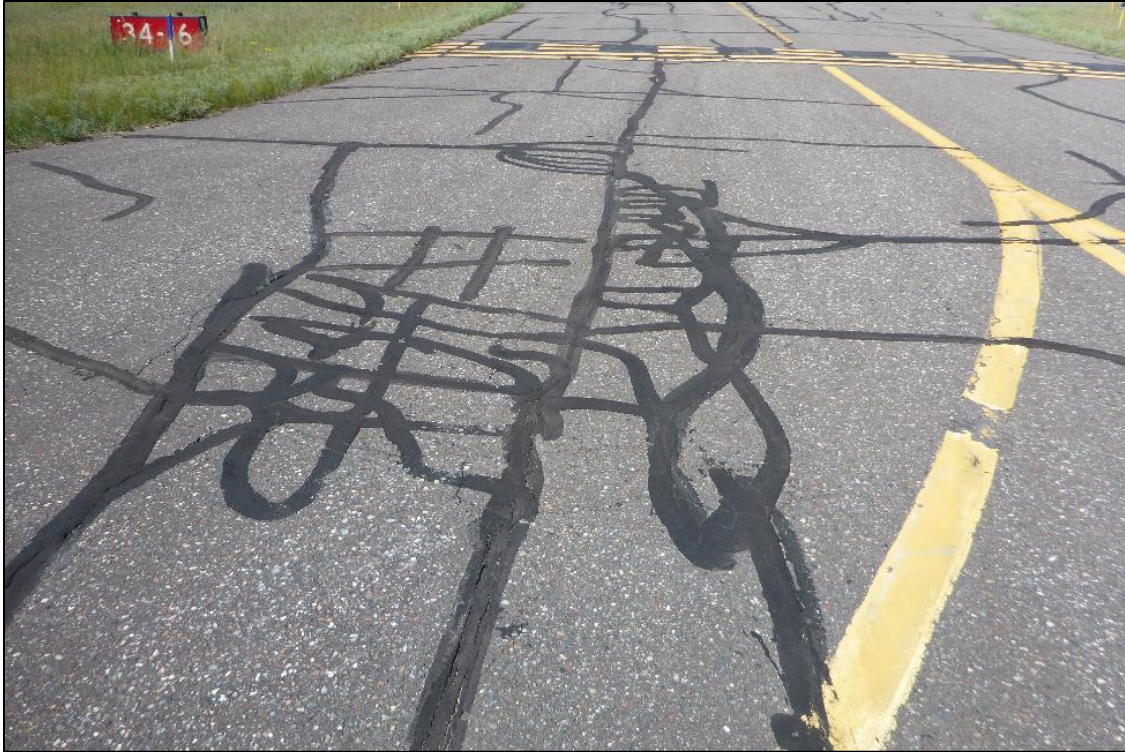
CBG CTB 001 (PCI = 50)

Conditions: PCI: 50

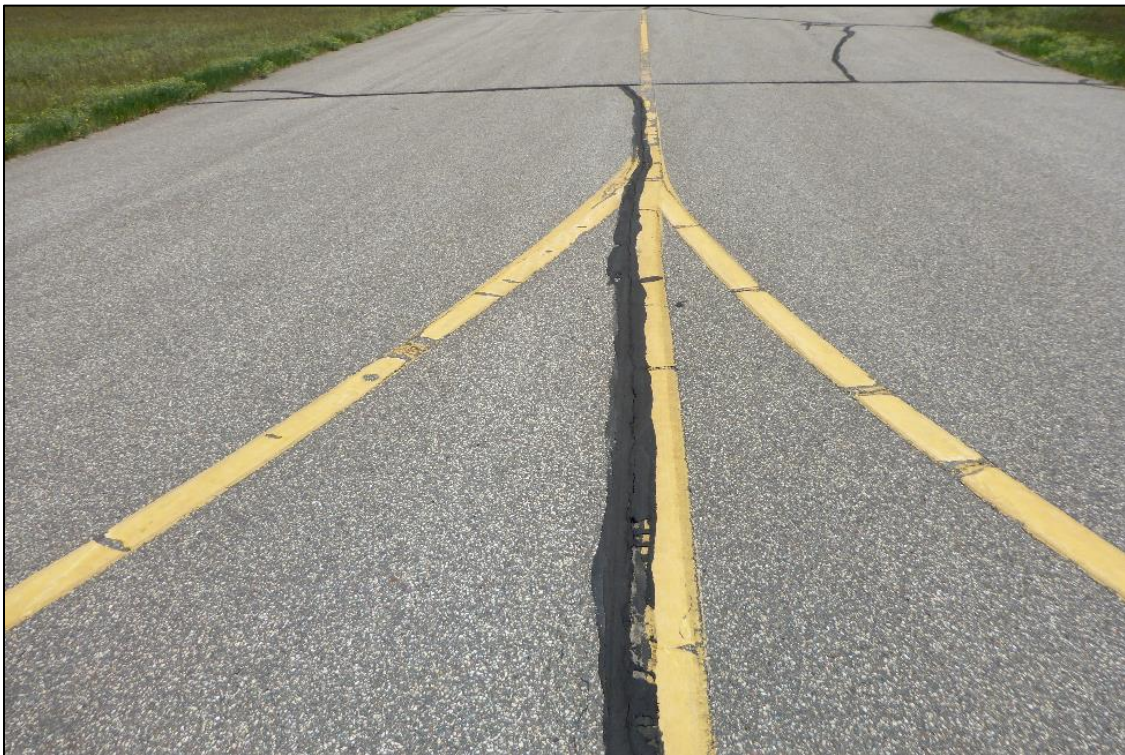
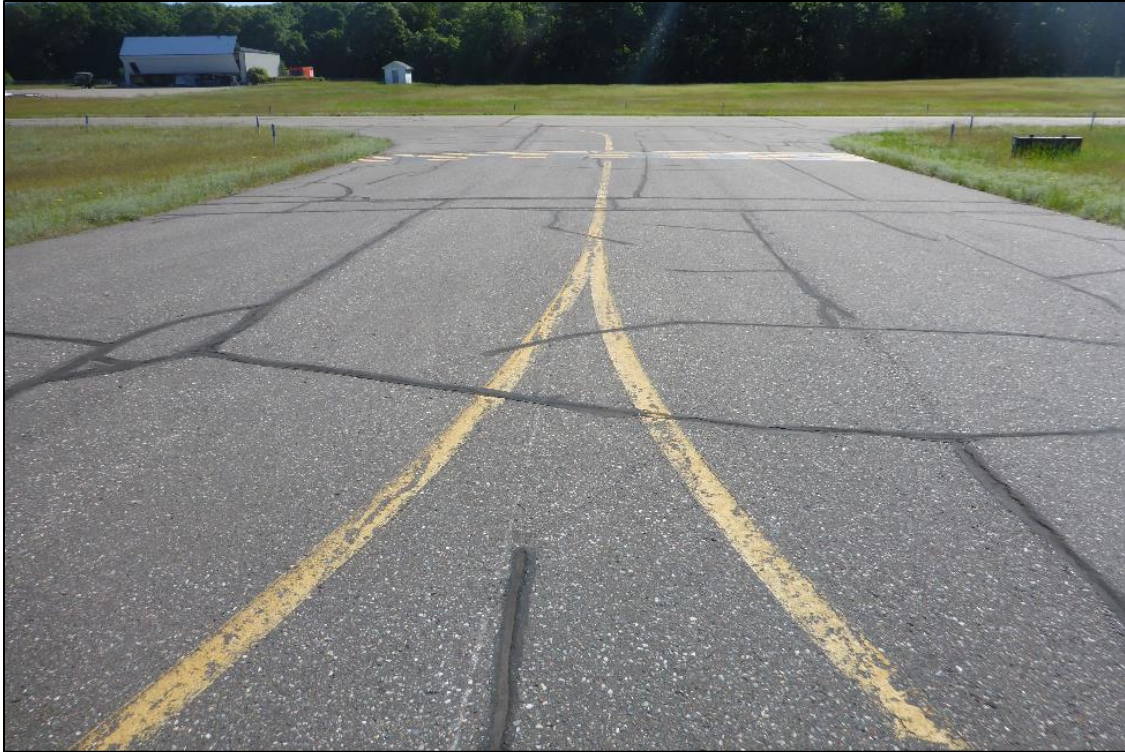
CBG CTBX 001 (PCI = 78)

Conditions: PCI: 78

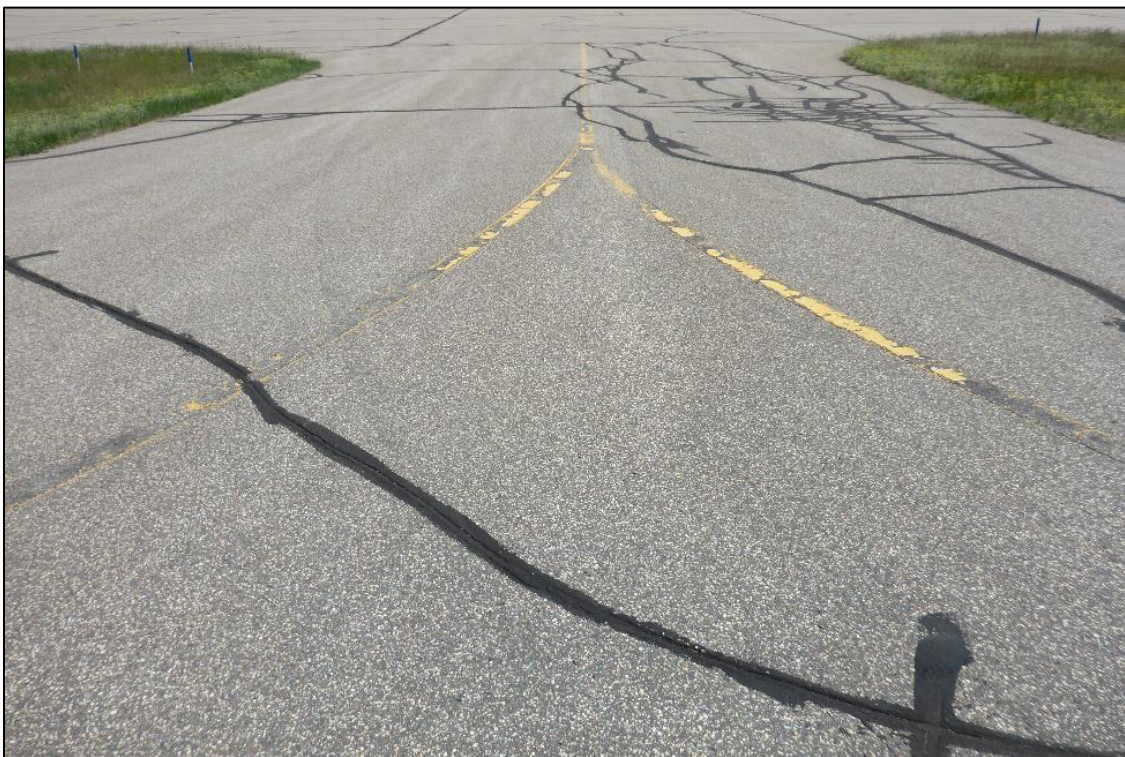
CBG CTD 001 (PCI = 53)

Conditions: PCI: 53

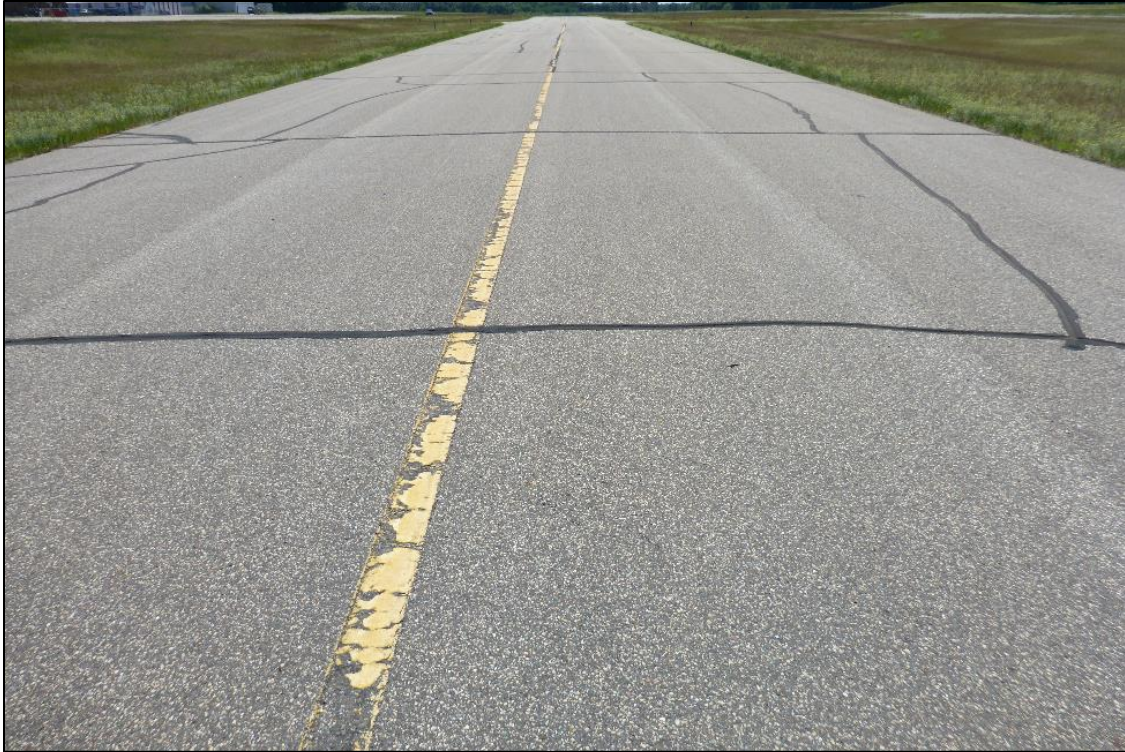
CBG PPTA 001 (PCI = 68)

Network:	CBG	Name:	CAMBRIDGE						
Branch:	PPTA	Name:	PARTIAL PARALLEL TAXIWAY A	Use:	TAXIWAY	Area:	61,000 SqFt		
Section:	001	of 1	From:	200	To:	215	Last Const.:	9/27/2005	
Surface:	AAC	Family:	MN2013 Asphalt Taxiways	Zone:	E	Category:	1	Rank:	P
Area:	61,000 SqFt	Length:	2,065 Ft	Width:	40 Ft				
Slabs:		Slab Length:	Ft	Slab Width:	Ft	Joint Length:	Ft		
Shoulder:		Street Type:		Grade:	0	Lanes:	0		
Section Comments:									
Last Insp. Date:	6/6/2017	TotalSamples:	15	Surveyed:	4				
Conditions:	PCI: 68								
Inspection Comments:									
Sample Number:	202	Type:	R	Area:	4000.00 SqFt	PCI:	73		
Sample Comments:									
48	L & T CR	L	354.00	Ft					
57	WEATHERING	L	4000.00	SqFt					
Sample Number:	206	Type:	R	Area:	4000.00 SqFt	PCI:	69		
Sample Comments:									
48	L & T CR	M	11.00	Ft					
48	L & T CR	L	333.00	Ft					
57	WEATHERING	L	4000.00	SqFt					
Sample Number:	210	Type:	R	Area:	4000.00 SqFt	PCI:	69		
Sample Comments:

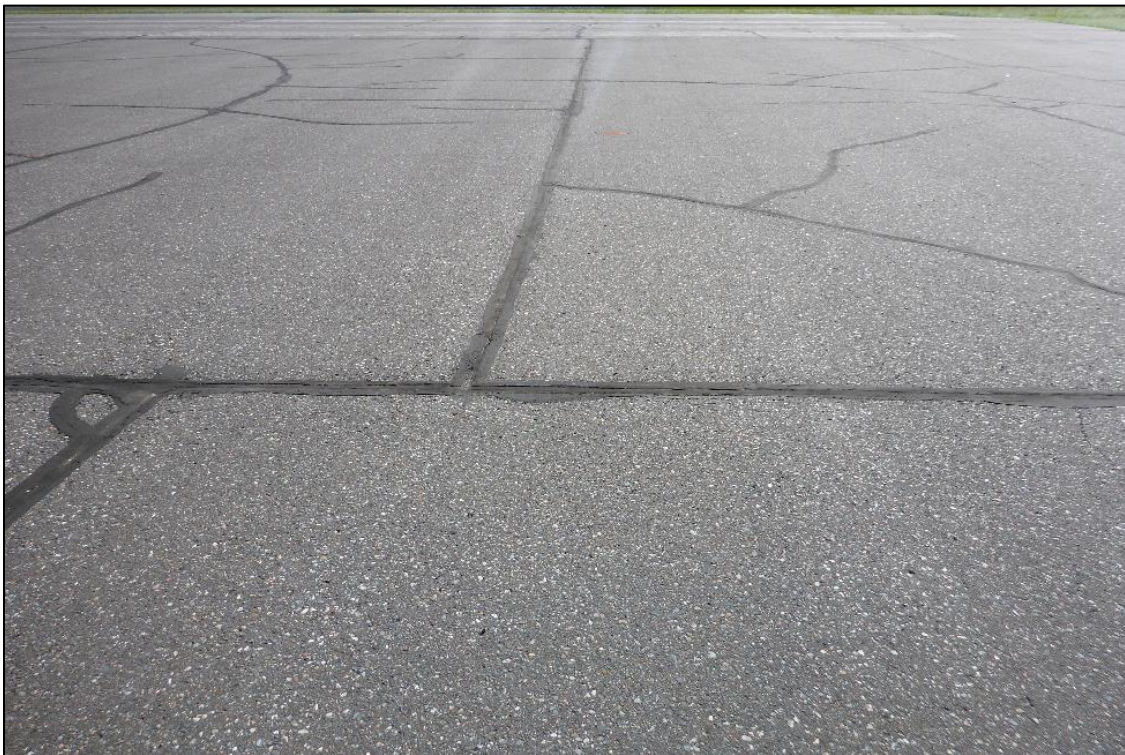
CBG RTA 001 (PCI = 62)

Conditions: PCI: 62

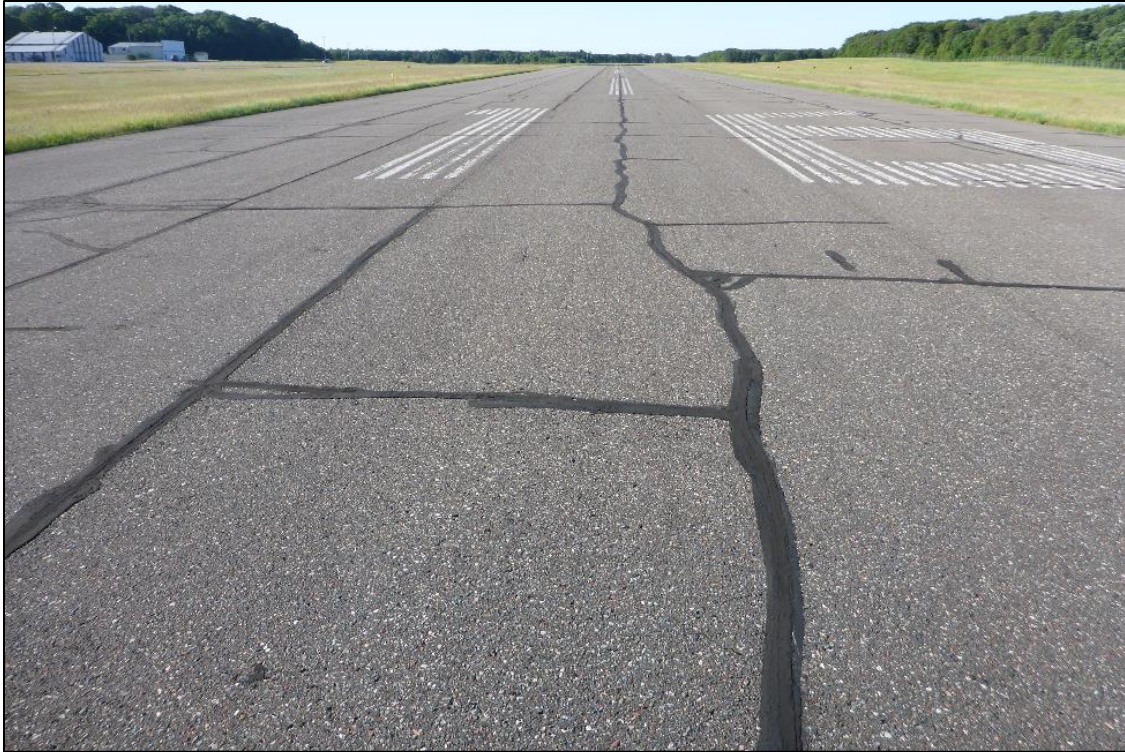
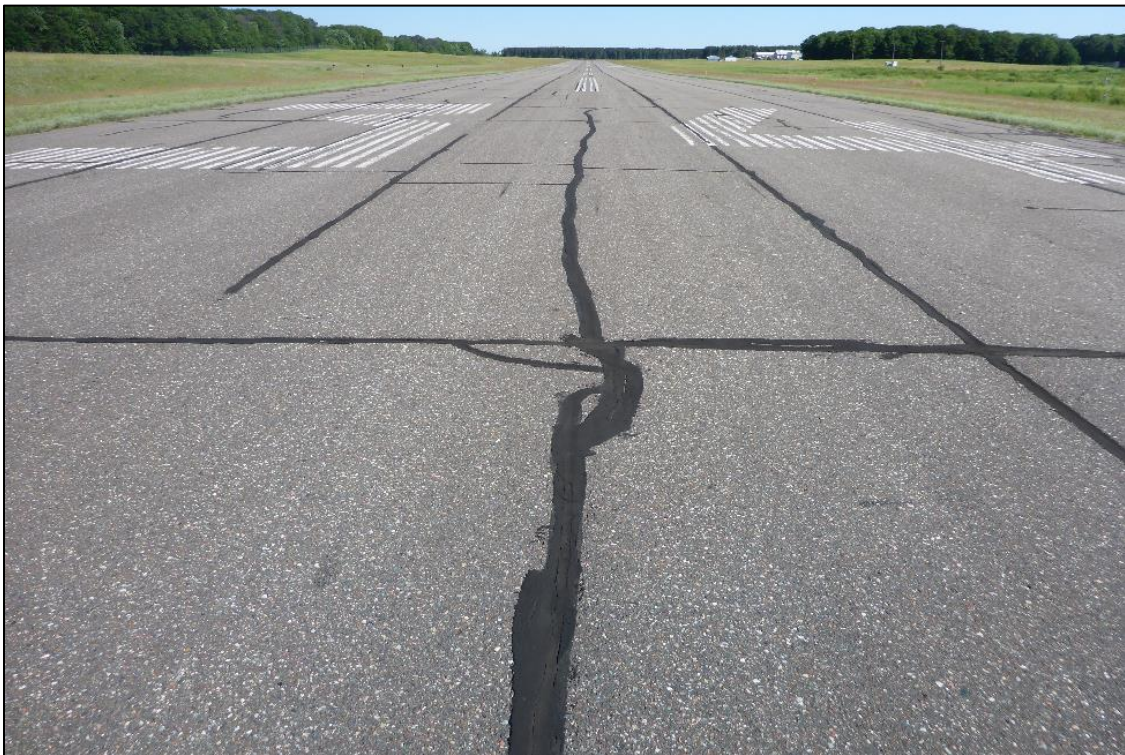
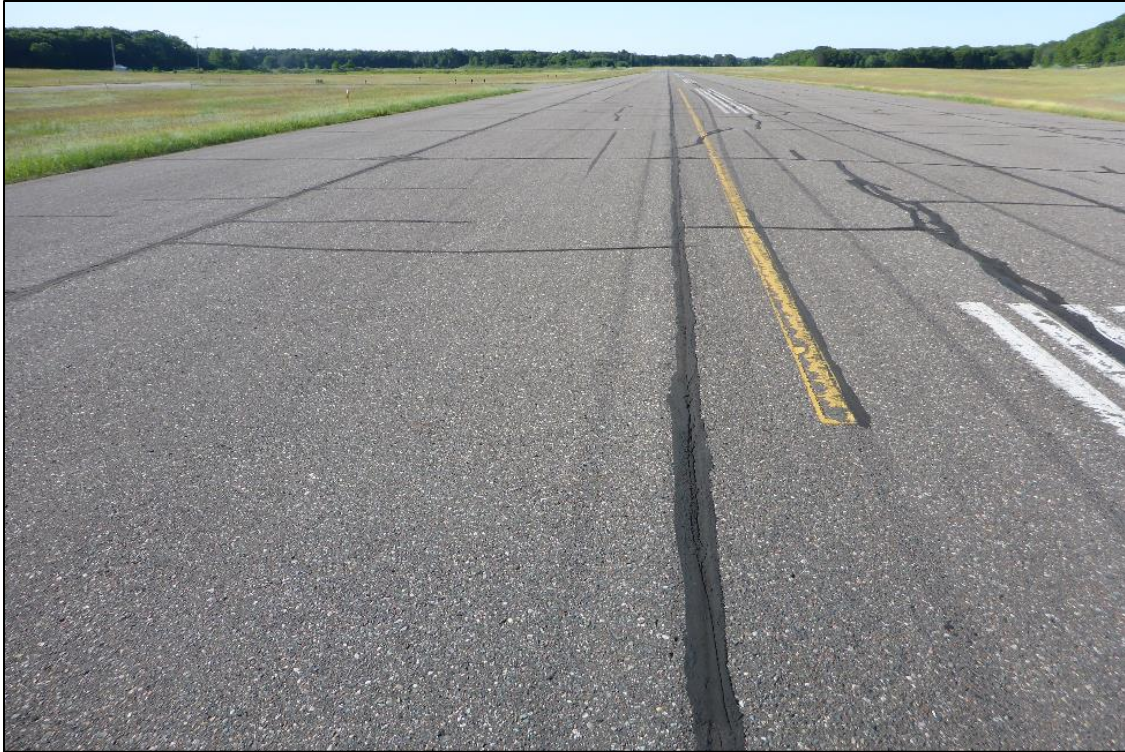
CBG RY1634 001 (PCI = 61)

Network:	CBG		Name:	CAMBRIDGE					
Branch:	RY1634	Name:	RUNWAY 16-34	Use:	RUNWAY	Area:	300,000 SqFt		
Section:	001	of 1	From:	100	To:	179	Last Const.:	12/28/2000	
Surface:	AAC	Family:	MN2013 Asphalt Runways	Zone:	E	Category:	1	Rank:	P
Area:	300,000 SqFt	Length:	4,000 Ft	Width:	75 Ft				
Slabs:		Slab Length:	Ft	Slab Width:	Ft	Joint Length:	Ft		
Shoulder:		Street Type:		Grade:	0	Lanes:	0		
Section Comments:									
Last Insp. Date:	6/6/2017	TotalSamples:	80	Surveyed:	11				
Conditions:	PCI: 61								
Inspection Comments:									
Sample Number:	105	Type:	R	Area:	3750.00 SqFt	PCI:	65		
Sample Comments:									
48	L & T CR	L	428.00	Ft					
48	L & T CR	M	7.00	Ft					
57	WEATHERING	M	3000.00	SqFt					
48	L & T CR	H	4.00	Ft					
Sample Number:	114	Type:	R	Area:	3750.00 SqFt	PCI:	58		
Sample Comments:									
48	L & T CR	L	712.00	Ft					
48	L & T CR	M	10.00	Ft					
57	WEATHERING	M	3000.00	SqFt					
Sample Number:	123	Type:	R	Area:	3750.00 SqFt	PCI:	66

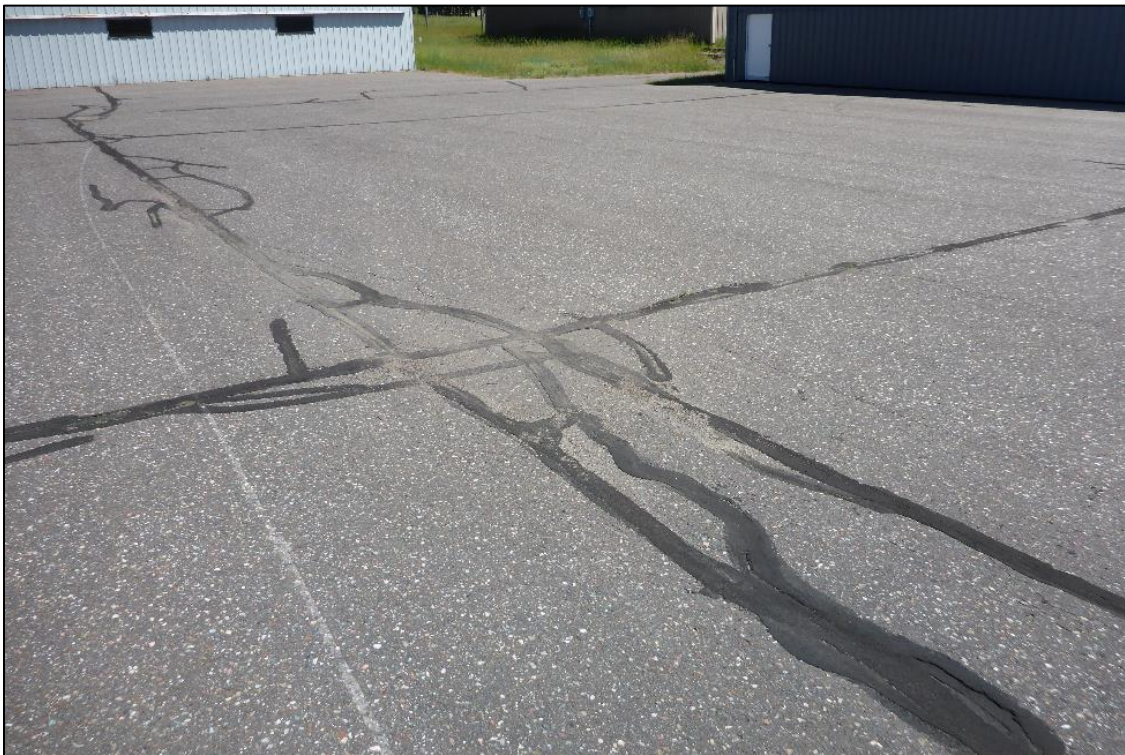
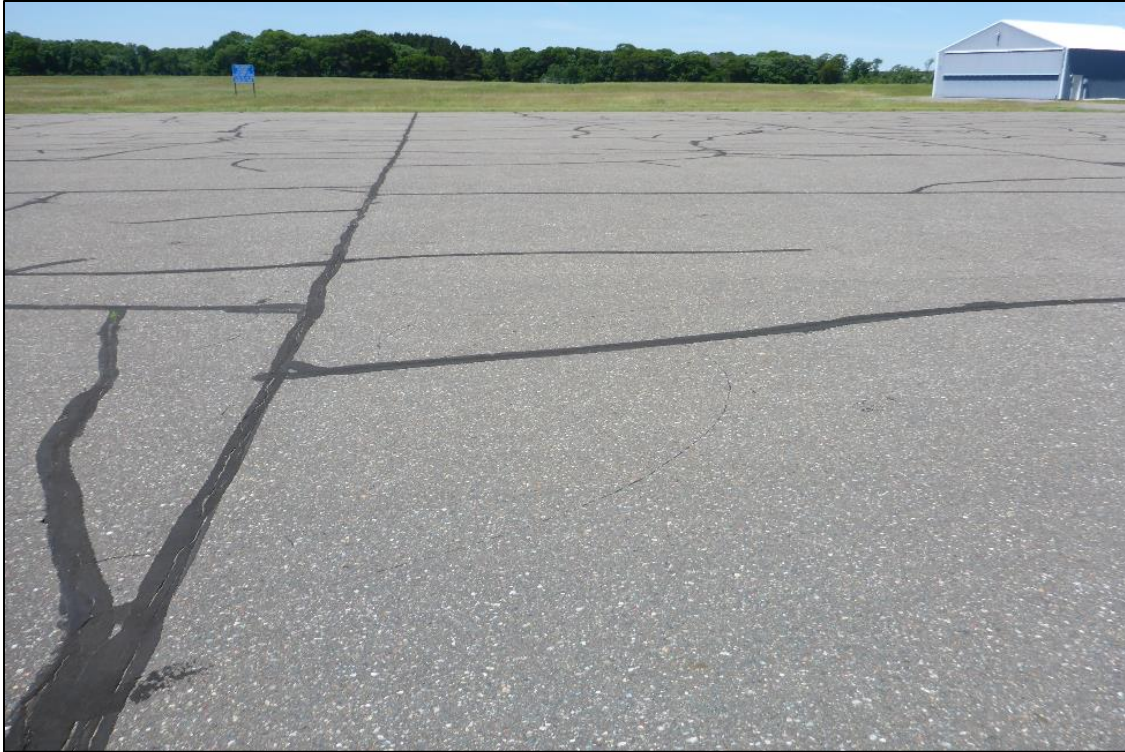
CBG TLA 001 (PCI = 53)

Network:	CBG		Name:	CAMBRIDGE					
Branch:	TLA	Name:	Taxilane A	Use:	TAXILANE	Area:	146,900 SqFt		
Section:	001	of 4	From:	100	To:	902	Last Const.:	12/28/2000	
Surface:	AAC	Family:	MN2013 Asphalt Taxilanes	Zone:	E	Category:	1	Rank:	T
Area:	113,200 SqFt	Length:	550 Ft	Width:	275 Ft	Joint Length:	Ft		
Slabs:		Slab Length:	Ft	Slab Width:	Ft	Joint Length:	Ft		
Shoulder:		Street Type:		Grade:	0	Lanes:	0		
Section Comments:									
Last Insp. Date:	6/6/2017		TotalSamples:	30	Surveyed:	5			
Conditions:	PCI:	53							
Inspection Comments:									
Sample Number:	200	Type:	R	Area:	5000.00 SqFt	PCI:	48		
Sample Comments:									
57	WEATHERING	M		1250.00	SqFt				
57	WEATHERING	L		3750.00	SqFt				
48	L & T CR	L		911.00	Ft				
48	L & T CR	M		12.00	Ft				
41	ALLIGATOR CR	M		21.00	SqFt				
Sample Number:	301	Type:	R	Area:	5000.00 SqFt	PCI:	53		
Sample Comments:									
41	ALLIGATOR CR	M		18.00	SqFt				
48	L & T CR	L		652.00	Ft

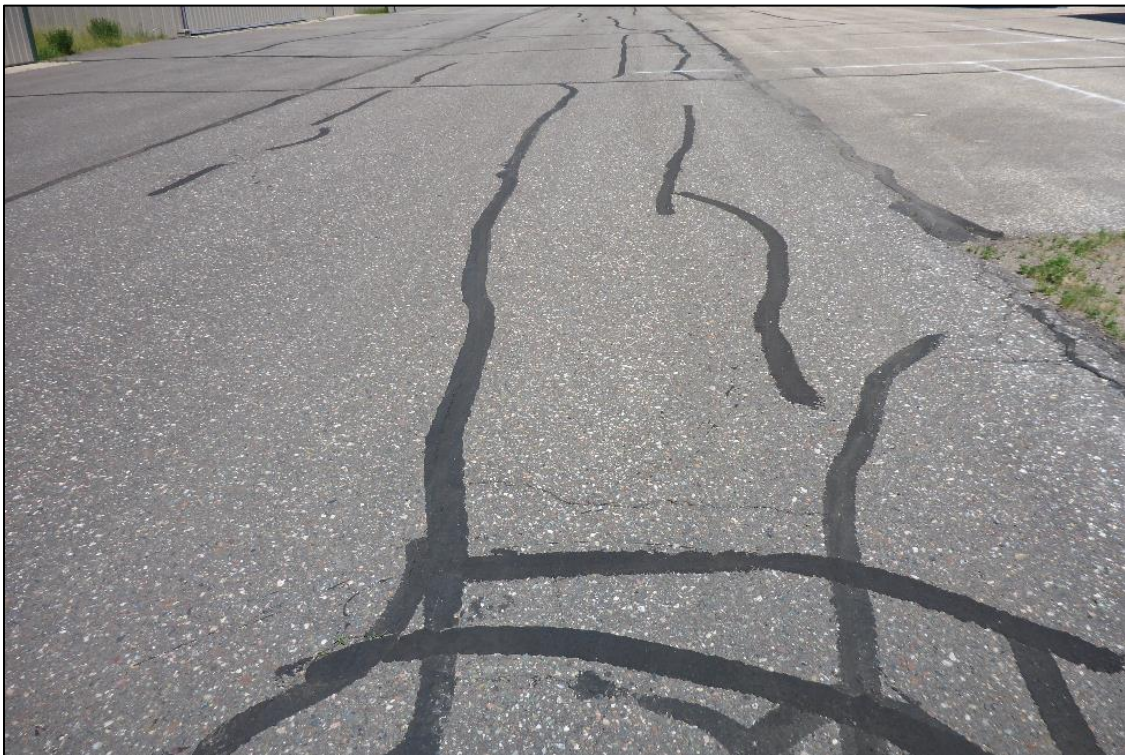
CBG TLA 002 (PCI = 61)

Network:	CBG		Name:	CAMBRIDGE					
Branch:	TLA	Name:	Taxilane A	Use:	TAXILANE	Area:	146,900 SqFt		
Section:	002	of 4	From:	903	To:	906	Last Const.:	12/28/2000	
Surface:	AC	Family:	MN2013 Asphalt Taxilanes	Zone:	E	Category:	1	Rank:	T
Area:	12,200 SqFt	Length:	610 Ft	Width:	20 Ft				
Slabs:		Slab Length:	Ft	Slab Width:	Ft	Joint Length:	Ft		
Shoulder:		Street Type:		Grade:	0	Lanes:	0		
Section Comments:									
Last Insp. Date:	6/6/2017	TotalSamples:	4	Surveyed:	1				
Conditions:	PCI: 61								
Inspection Comments:									
Sample Number:	905	Type:	R	Area:	3000.00 SqFt	PCI:	61		
Sample Comments:									
48	L & T CR	L	471.00	Ft					
57	WEATHERING	M	650.00	SqFt					
57	WEATHERING	L	2350.00	SqFt

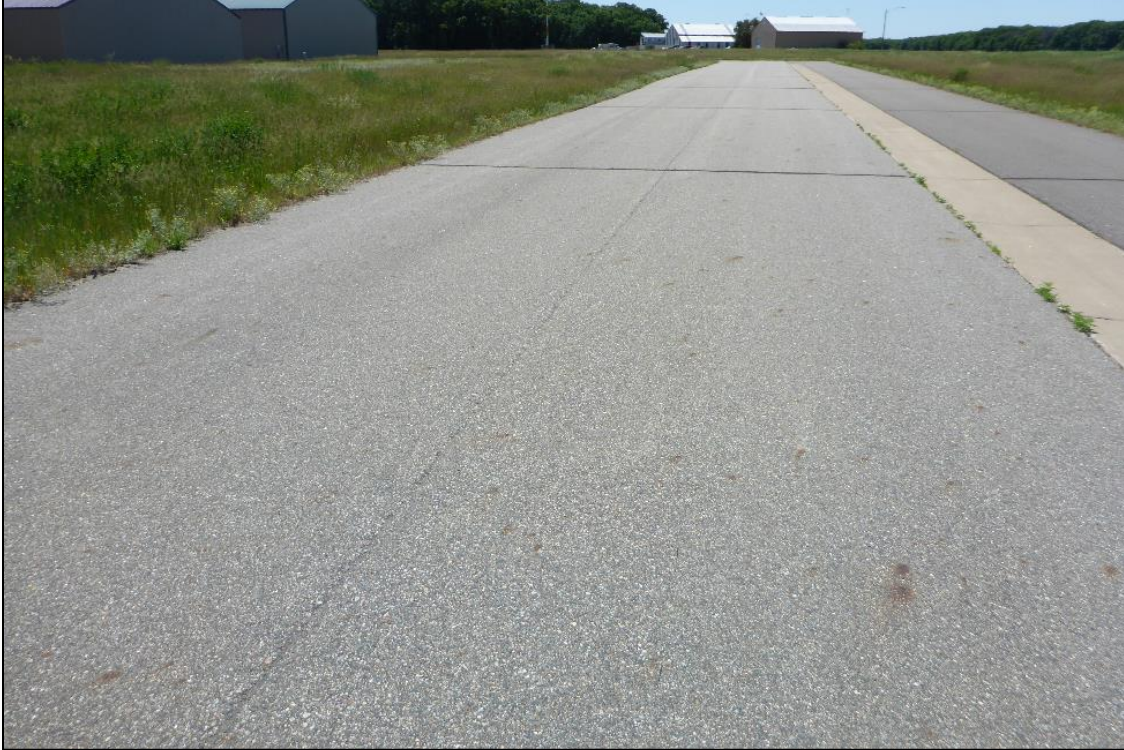
CBG TLA 003 (PCI = 86)

Network:	CBG	Name:	CAMBRIDGE						
Branch:	TLA	Name:	Taxilane A	Use:	TAXILANE	Area:	146,900 SqFt		
Section:	003	of 4	From:	503	To:	507	Last Const.:	9/27/2006	
Surface:	AC	Family:	MN2013 Asphalt Taxilanes	Zone:	E	Category:	1	Rank:	T
Area:	14,000 SqFt	Length:	700 Ft	Width:	20 Ft				
Slabs:		Slab Length:	Ft	Slab Width:	Ft	Joint Length:	Ft		
Shoulder:		Street Type:		Grade:	0	Lanes:	0		
Section Comments:									
Last Insp. Date:	6/6/2017	TotalSamples:	5	Surveyed:	1				
Conditions:	PCI: 86								
Inspection Comments:									
Sample Number:	504	Type:	R	Area:	3000.00 SqFt	PCI:	86		
Sample Comments:									
48	L & T CR	L	83.00	Ft					
57	WEATHERING	L	2000.00	SqFt

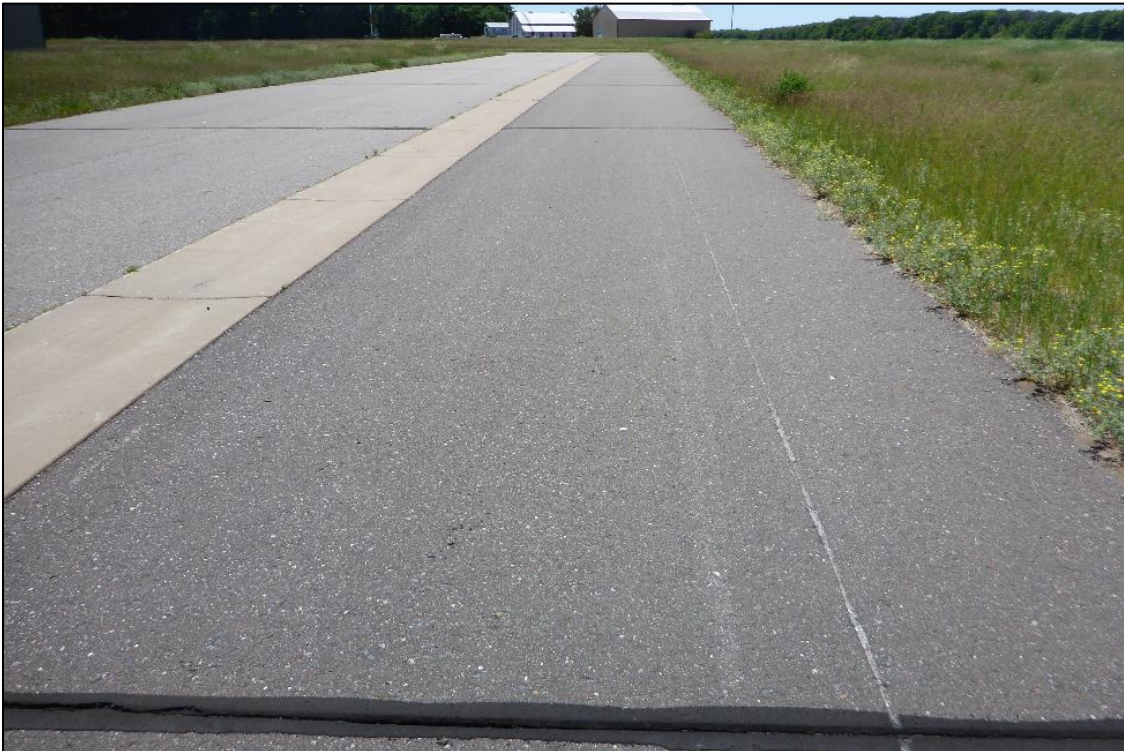
CBG TLA 004 (PCI = 89)

Network:	CBG	Name:	CAMBRIDGE						
Branch:	TLA	Name:	Taxilane A	Use:	TAXILANE	Area:	146,900 SqFt		
Section:	004	of 4	From:	403	To:	405	Last Const.:	8/1/2008	
Surface:	AC	Family:	MN2013 Asphalt Taxilanes	Zone:		Category:		Rank:	T
Area:	7,500 SqFt	Length:	500 Ft	Width:	15 Ft				
Slabs:		Slab Length:	Ft	Slab Width:	Ft	Joint Length:		Ft	
Shoulder:		Street Type:		Grade:	0	Lanes:	0		
Section Comments:									
Last Insp. Date:	6/6/2017	TotalSamples:	3	Surveyed:	1				
Conditions:	PCI: 89								
Inspection Comments:									
Sample Number:	404	Type:	R	Area:	2250.00 SqFt	PCI:	89		
Sample Comments:									
48	L & T CR		L		80.00 Ft
