Pavement Condition Report

Cloquet/Carlton County Airport (COQ)

December 2017

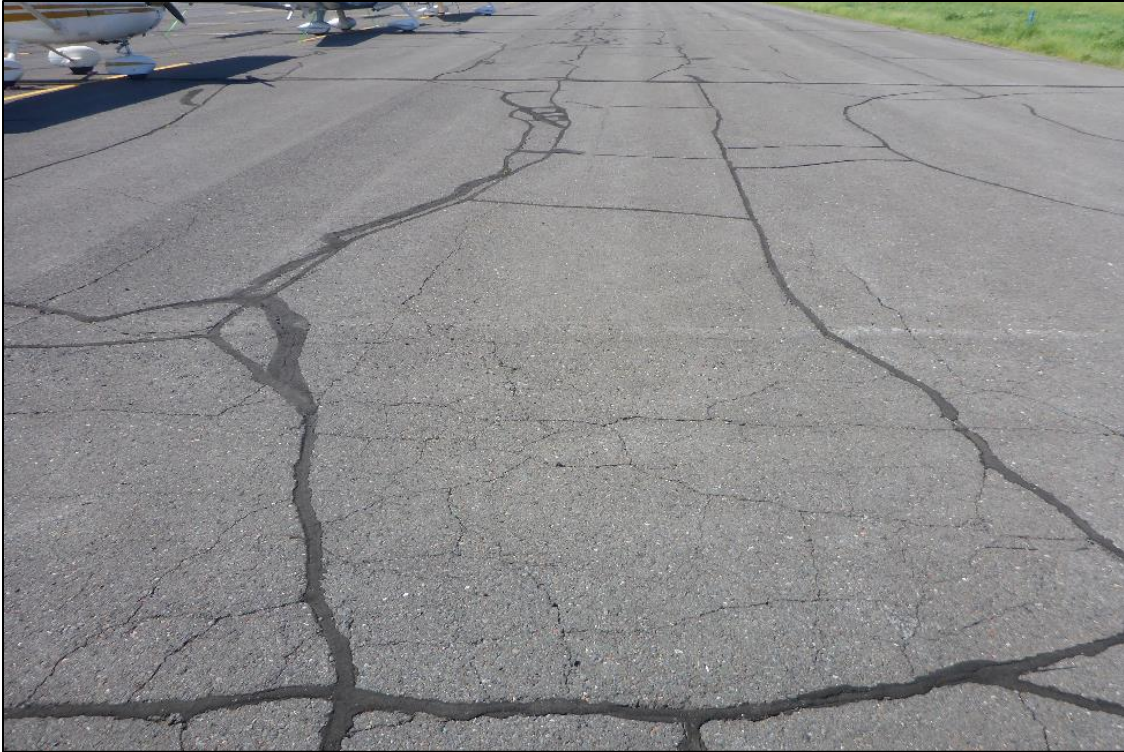
COQ APA 001 (PCI = 53)

Network:	COQ	Name:	CLOQUET						
Branch:	APA	Name:	APRON A	Use:	APRON	Area:	107,500 SqFt		
Section:	001	of	1	From:	100	To:	604	Last Const.:	9/7/2000
Surface:	AC	Family:	MN2013 Asphalt Aprons	Zone:	N	Category:	1	Rank:	S
Area:	107,500 SqFt	Length:	535 Ft	Width:	145 Ft				
Slabs:		Slab Length:	Ft	Slab Width:	Ft	Joint Length:	Ft		
Shoulder:		Street Type:		Grade:	0	Lanes:	0		
Section Comments:									
Last Insp. Date:	6/9/2017	Total Samples:	23	Surveyed:	4				
Conditions:	PCI: 53								
Inspection Comments:									
Sample Number:	101	Type:	R	Area:	5000.00 SqFt	PCI:	54		
Sample Comments:									
41	ALLIGATOR CR		L	60.00	SqFt				
48	L & T CR		L	878.00	Ft				
48	L & T CR		M	72.00	Ft				
57	WEATHERING		L	5000.00	SqFt				
Sample Number:	202	Type:	R	Area:	5000.00 SqFt	PCI:	37		
Sample Comments:									
41	ALLIGATOR CR		M	120.00	SqFt				
41	ALLIGATOR CR		L	63.00	SqFt				
48	L & T CR		L	780.00	Ft				
48	L & T CR		M	30.00	Ft

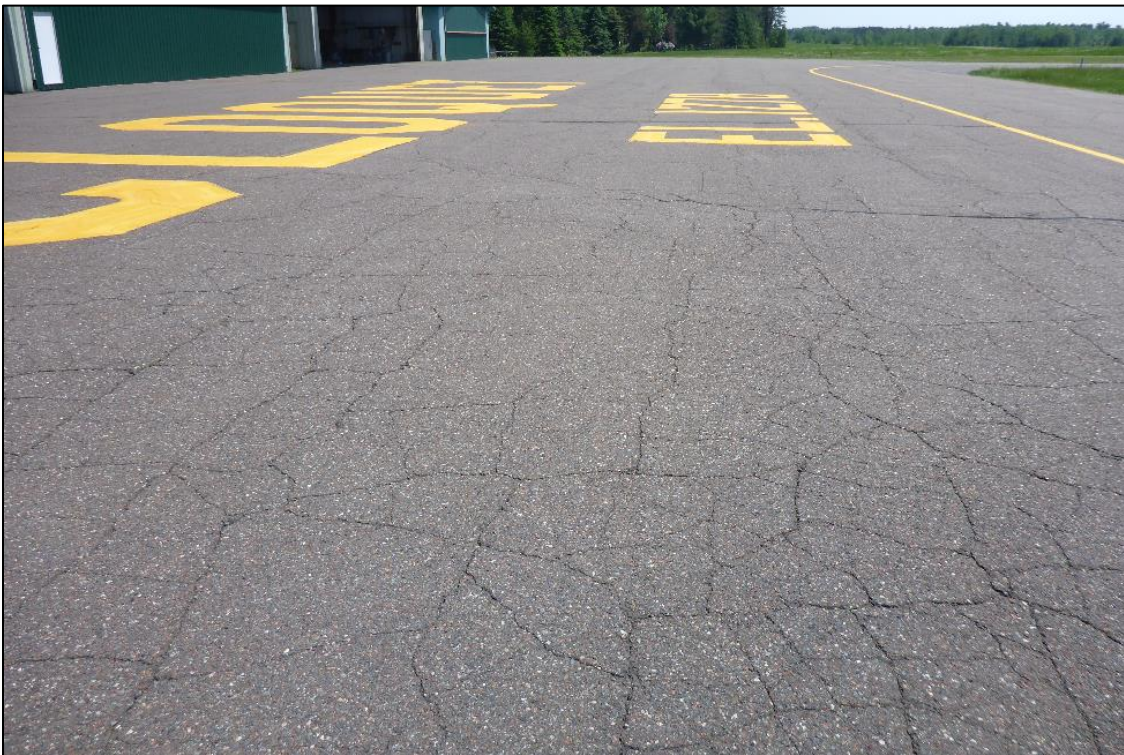
COQ APB 001 (PCI = 14)

Network:	COQ	Name:	CLOQUET						
Branch:	APB	Name:	APRON B	Use:	APRON	Area:	35,200 SqFt		
Section:	001	of 1	From:	100	To:	203	Last Const.:	9/30/1980	
Surface:	AC	Family:	MN2013 Asphalt Aprons	Zone:	N	Category:	1	Rank:	S
Area:	35,200 SqFt	Length:	352 Ft	Width:	100 Ft				
Slabs:	Slab Length:	Ft	Slab Width:	Ft	Joint Length:	Ft			
Shoulder:	Street Type:		Grade:	0	Lanes:	0			
Section Comments:									
Last Insp. Date:	6/9/2017	TotalSamples:	8	Surveyed:	2				
Conditions:	PCI: 14								
Inspection Comments:									
Sample Number:	100	Type:	R	Area:	5000.00 SqFt	PCI:	8		
Sample Comments:									
43	BLOCK CR	M	2700.00	SqFt					
43	BLOCK CR	H	1800.00	SqFt					
41	ALLIGATOR CR	M	500.00	SqFt					
57	WEATHERING	M	1000.00	SqFt					
Sample Number:	102	Type:	R	Area:	5000.00 SqFt	PCI:	20		
Sample Comments:									
41	ALLIGATOR CR	M	150.00	SqFt					
41	ALLIGATOR CR	H	50.00	SqFt					
43	BLOCK CR	M	4850.00	SqFt					
57	WEATHERING	M	2500.00	SqFt

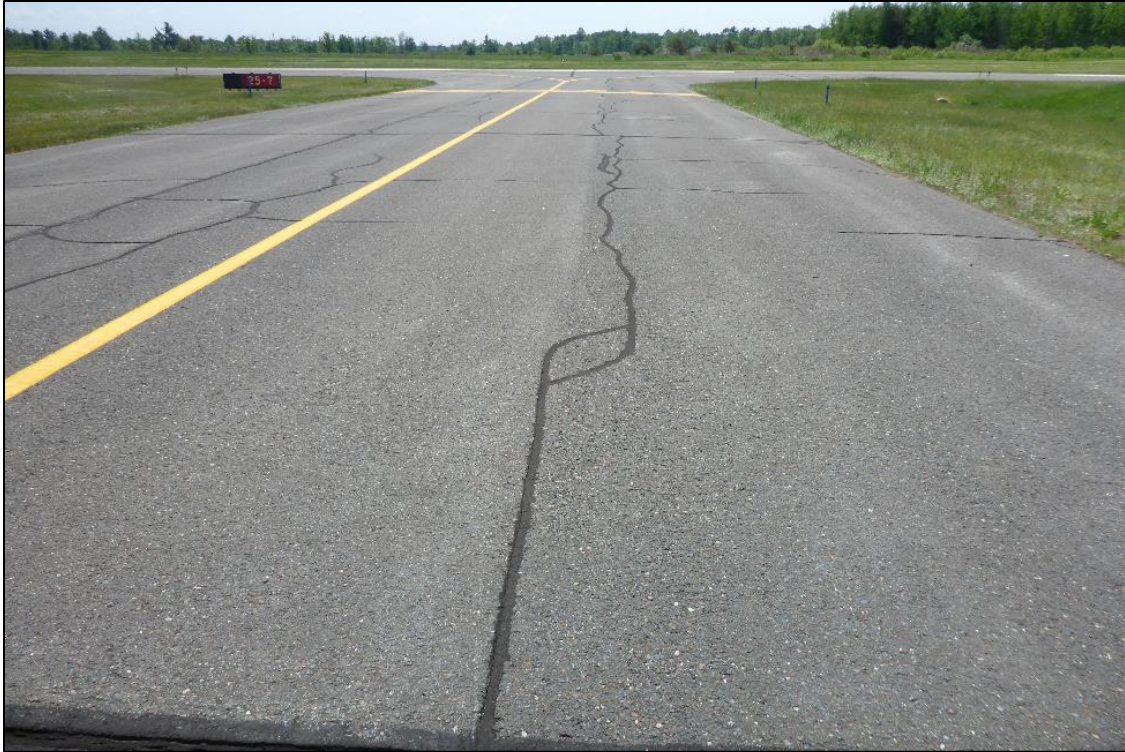
COQ CTB1 001 (PCI = 59)

Network:	COQ	Name:	CLOQUET						
Branch:	CTB1	Name:	CONNECTING TAXIWAY B1	Use:	TAXIWAY	Area:	11,900 SqFt		
Section:	001	of 1	From:	100	To:	101+52	Last Const.:	9/7/2000	
Surface:	AAC	Family:	MN2013 Asphalt Taxiways	Zone:	N	Category:	1	Rank:	P
Area:	11,900 SqFt	Length:	252 Ft	Width:	40 Ft				
Slabs:		Slab Length:	Ft	Slab Width:	Ft	Joint Length:	Ft		
Shoulder:		Street Type:		Grade:	0	Lanes:	0		
Section Comments:									
Last Insp. Date:	6/9/2017	TotalSamples:	3	Surveyed:	2				
Conditions:	PCI: 59								
Inspection Comments:									
Sample Number:	100	Type:	R	Area:	4672.00 SqFt	PCI:	56		
Sample Comments:									
48	L & T CR	L	718.00	Ft					
41	ALLIGATOR CR	L	12.00	SqFt					
48	L & T CR	M	15.00	Ft					
57	WEATHERING	M	600.00	SqFt					
Sample Number:	101	Type:	R	Area:	4000.00 SqFt	PCI:	63		
Sample Comments:									
48	L & T CR	L	539.00	Ft					
48	L & T CR	M	85.00	Ft					
57	WEATHERING	M	1500.00	SqFt

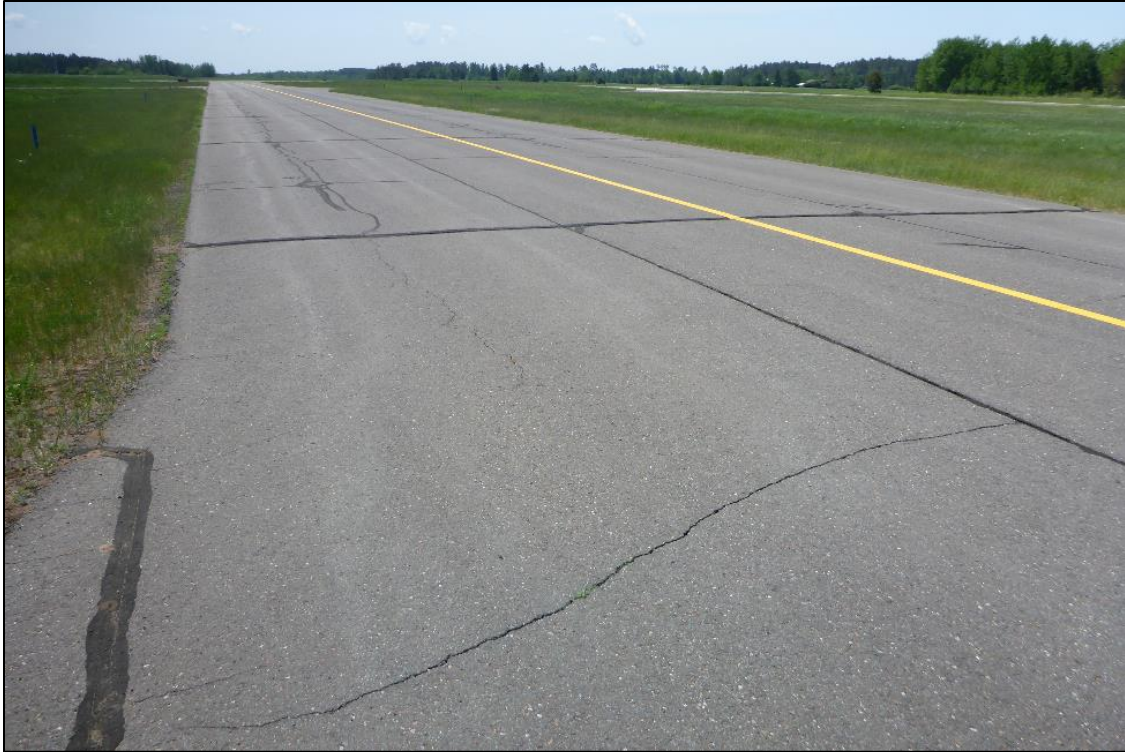
COQ PPTA 001 (PCI = 46)

Network:	COQ	Name:	CLOQUET						
Branch:	PPTA	Name:	PART PARALLEL TAXIWAY A	Use:	TAXIWAY	Area:	67,800 SqFt		
Section:	001	of 1	From:	100	To:	115	Last Const.:	9/7/2000	
Surface:	AC	Family:	MN2013 Asphalt Taxiways	Zone:	N	Category:	1	Rank:	S
Area:	67,800 SqFt	Length:	1,632 Ft	Width:	40 Ft				
Slabs:		Slab Length:	Ft	Slab Width:	Ft	Joint Length:	Ft		
Shoulder:		Street Type:		Grade:	0	Lanes:	0		
Section Comments:									
Last Insp. Date:	6/9/2017	TotalSamples:	16	Surveyed:	5				
Conditions:	PCI: 46								
Inspection Comments:									
Sample Number:	102	Type:	R	Area:	4800.00 SqFt	PCI:	52		
Sample Comments:									
41	ALLIGATOR CR	L	22.00	SqFt					
41	ALLIGATOR CR	M	4.00	SqFt					
48	L & T CR	L	598.00	Ft					
48	L & T CR	M	33.00	Ft					
57	WEATHERING	L	2500.00	SqFt					
57	WEATHERING	M	100.00	SqFt					
Sample Number:	104	Type:	R	Area:	4000.00 SqFt	PCI:	26		
Sample Comments:									
41	ALLIGATOR CR	M	312.00	SqFt

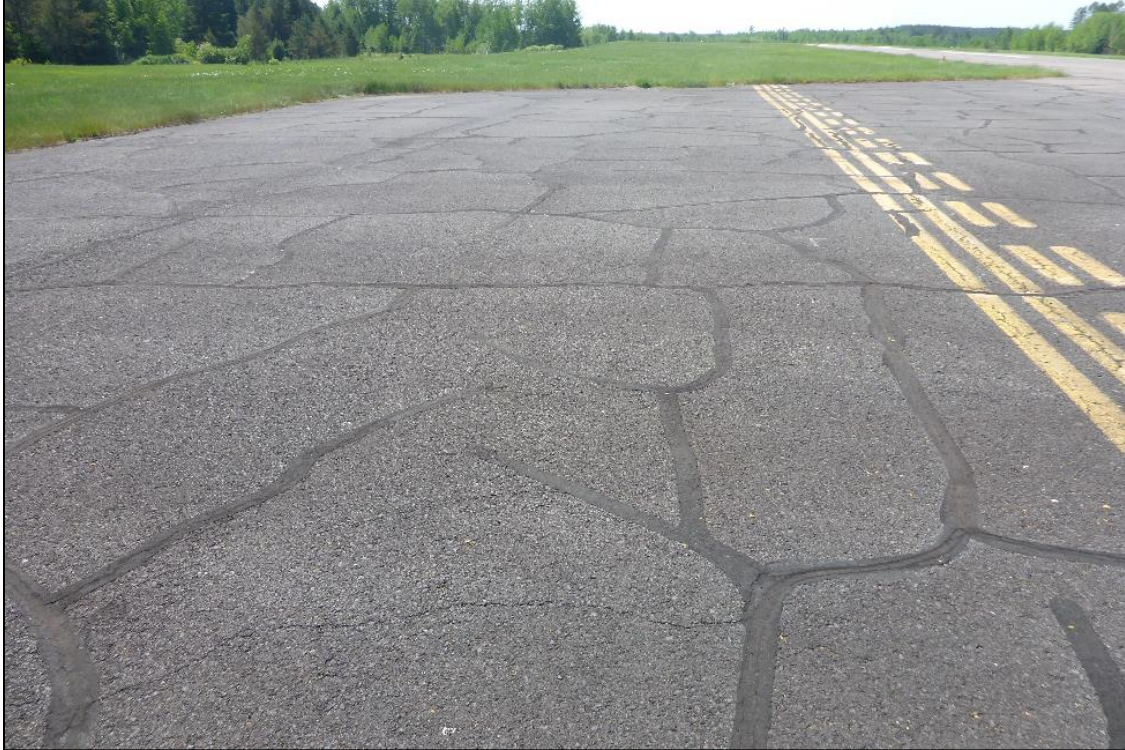
COQ RTA2 001 (PCI = 59)

Network:	COQ	Name:	CLOQUET						
Branch:	RTA2	Name:	RUNWAY TURNAROUND 2	Use:	TAXIWAY	Area:	9,400 SqFt		
Section:	001	of 1	From:	261	To:	263	Last Const.:	9/30/1989	
Surface:	AC	Family:	MN2013 Asphalt Taxiways	Zone:	N	Category:	1	Rank:	S
Area:	9,400 SqFt	Length:	125 Ft	Width:	75 Ft				
Slabs:		Slab Length:	Ft	Slab Width:	Ft	Joint Length:	Ft		
Shoulder:		Street Type:		Grade:	0	Lanes:	0		
Section Comments:	cracksealed since 08 - delta from 52L to 57L								
Last Insp. Date:	6/9/2017	TotalSamples:	3	Surveyed:	1				
Conditions:	PCI: 59								
Inspection Comments:									
Sample Number:	262	Type:	R	Area:	3850.00 SqFt	PCI:	59		
Sample Comments:									
43	BLOCK CR	L	3850.00	SqFt					
57	WEATHERING	M	1200.00	SqFt

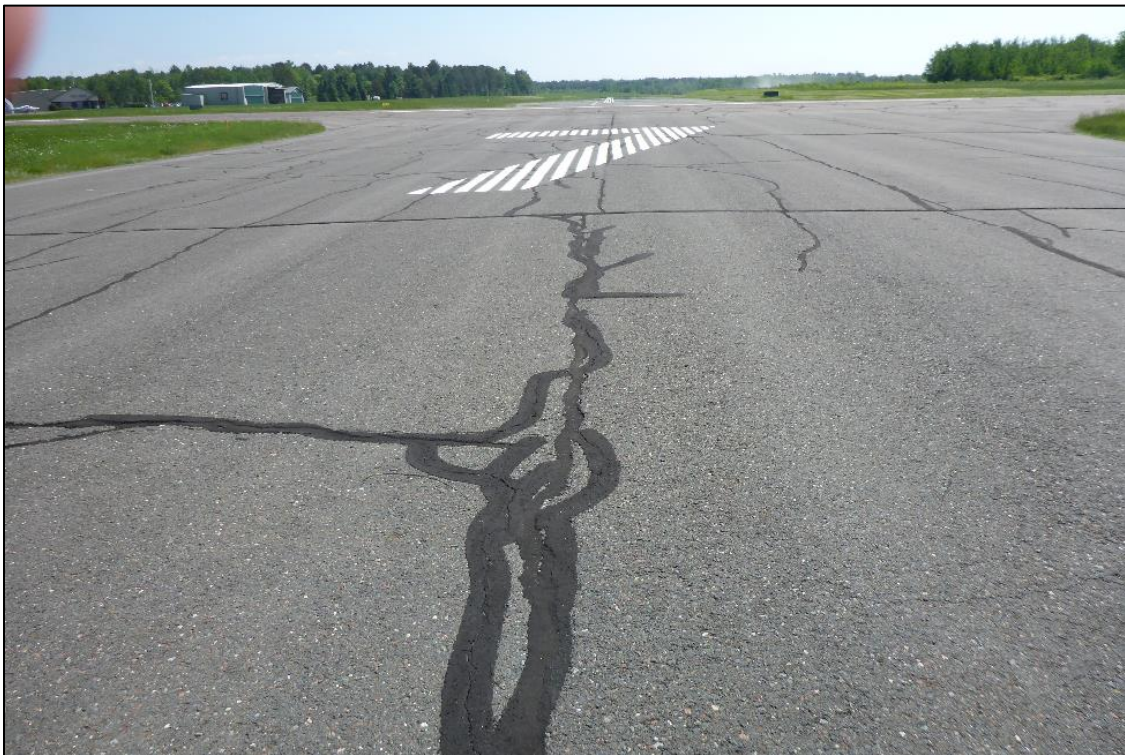
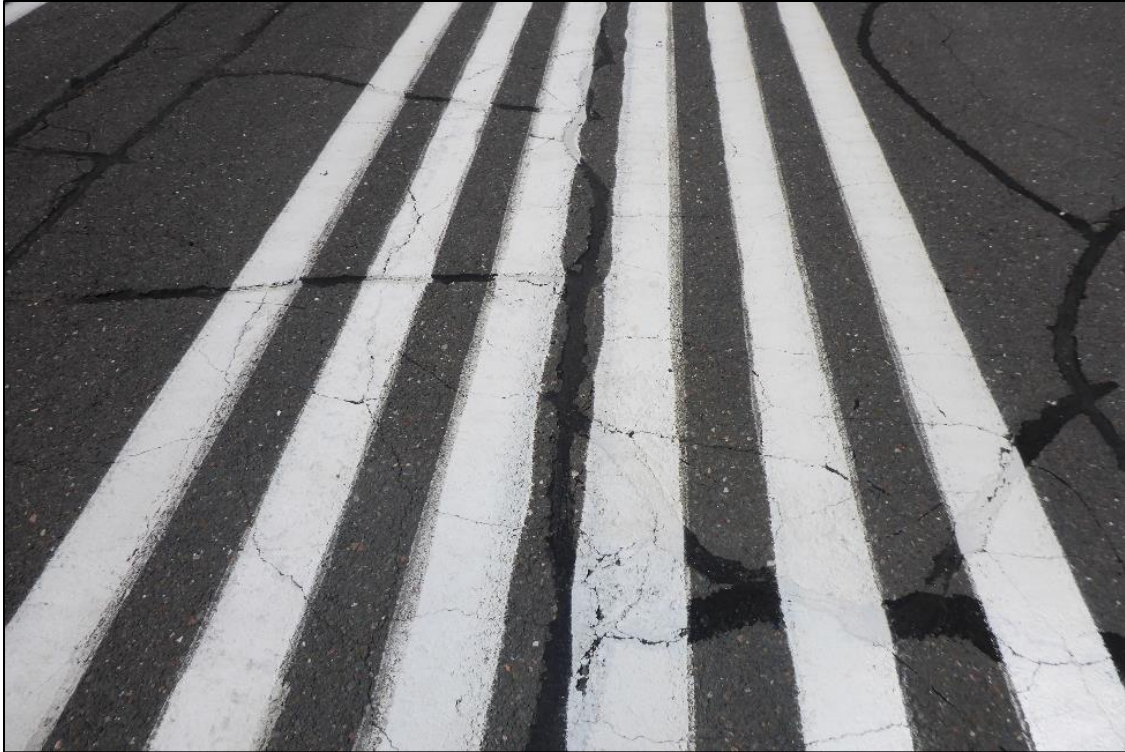
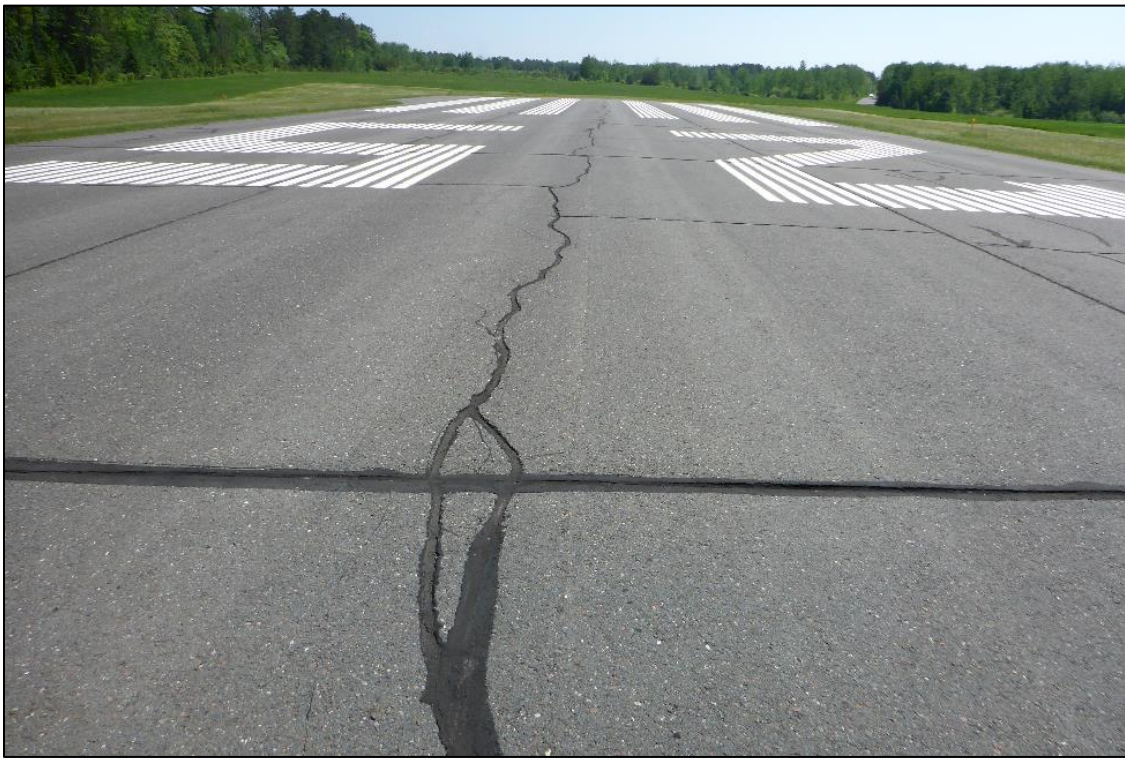
COQ RY725 001 (PCI = 54)

Network:	COQ	Name:	CLOQUET						
Branch:	RY725	Name:	RUNWAY 7-25	Use:	RUNWAY	Area:	231,200 SqFt		
Section:	001	of 1	From:	100	To:	161	Last Const.: 9/7/2000		
Surface:	AAC	Family:	MN2013 Asphalt Runways	Zone:	N	Category:	1	Rank:	S
Area:	231,200 SqFt	Length:	3,025 Ft	Width:	75 Ft				
Slabs:		Slab Length:	Ft	Slab Width:	Ft	Joint Length:	Ft		
Shoulder:		Street Type:		Grade:	0	Lanes:	0		
Section Comments:									
Last Insp. Date:	6/9/2017	TotalSamples:	62	Surveyed:	7				
Conditions:	PCI: 54								
Inspection Comments:									
Sample Number:	101	Type:	R	Area:	3750.00 SqFt	PCI:	38		
Sample Comments:									
48	L & T CR	M	30.00 Ft						
41	ALLIGATOR CR	M	180.00 SqFt						
57	WEATHERING	L	1700.00 SqFt						
48	L & T CR	L	833.00 Ft						
Sample Number:	112	Type:	R	Area:	3750.00 SqFt	PCI:	47		
Sample Comments:									
48	L & T CR	L	734.00 Ft						
48	L & T CR	M	63.00 Ft						
41	ALLIGATOR CR	M	20.00 SqFt						
53	RUTTING	L	45.00 SqFt

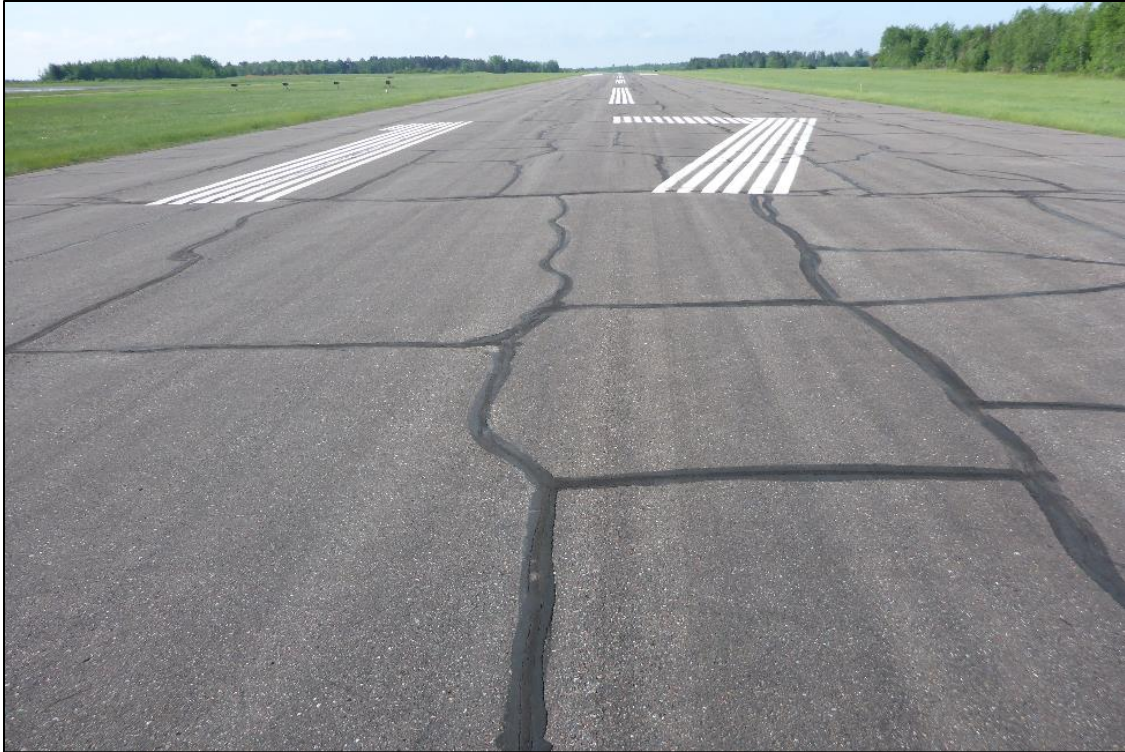
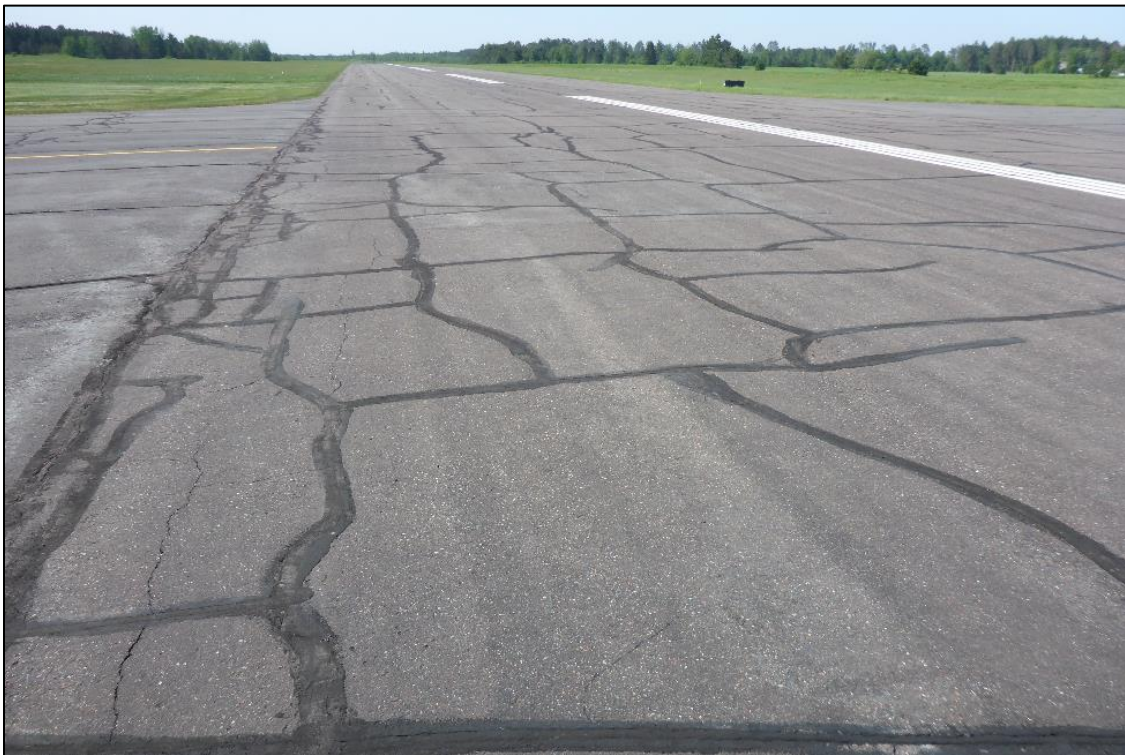
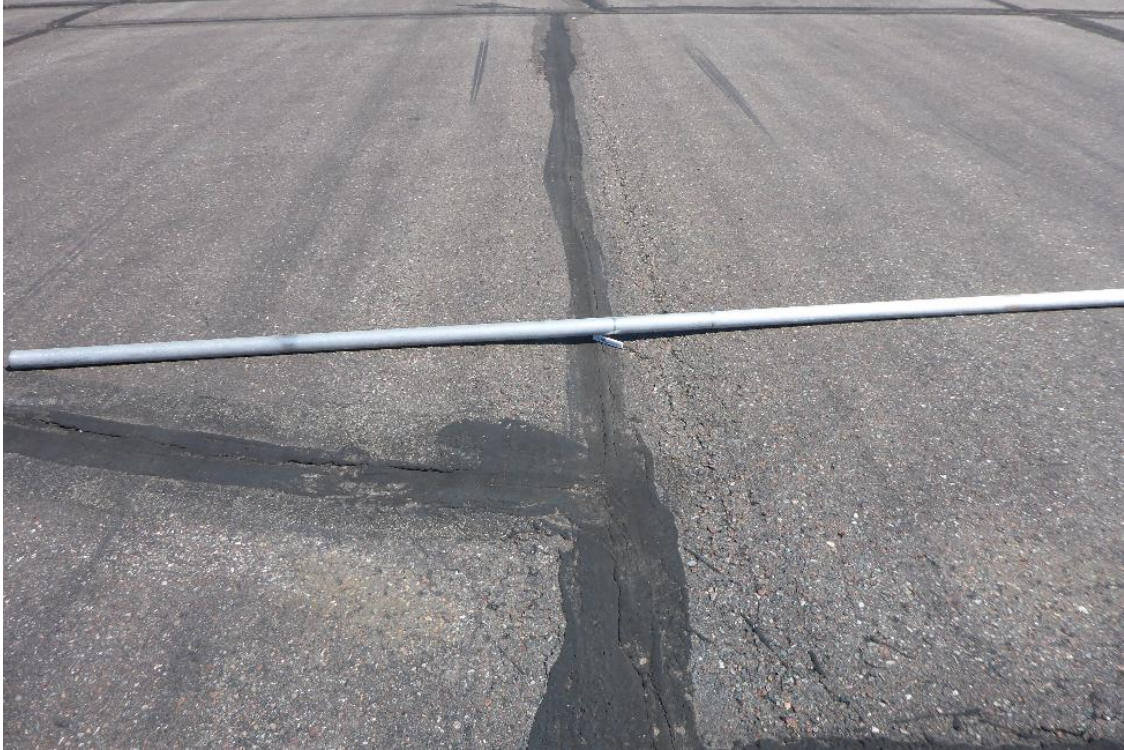
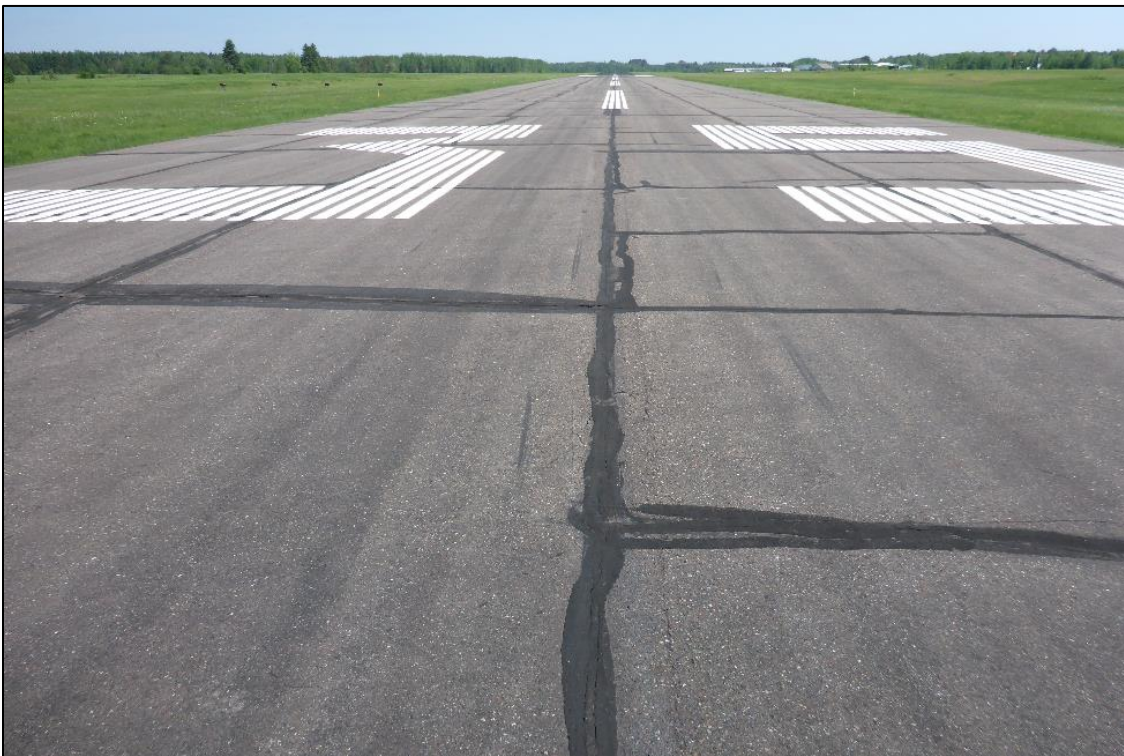
COQ RY1735 001 (PCI = 57)

Network:	COQ	Name:	CLOQUET						
Branch:	RY1735	Name:	RUNWAY 17-35	Use:	RUNWAY	Area:	300,250 SqFt		
Section:	001	of 1	From:	100	To:	105	Last Const.:	9/30/1989	
Surface:	AC	Family:	MN2013 Asphalt Runways	Zone:	N	Category:	1	Rank:	P
Area:	300,250 SqFt	Length:	4,003 Ft	Width:	75 Ft				
Slabs:	Slab Length:	Ft	Slab Width:	Ft	Joint Length:	Ft			
Shoulder:	Street Type:		Grade:	0	Lanes:	0			
Section Comments:	cracksealed since 08								
Last Insp. Date:	6/9/2017	TotalSamples:	80	Surveyed:	12				
Conditions:	PCI: 57								
Inspection Comments:									
Sample Number:	102	Type:	R	Area:	3750.00 SqFt	PCI:	59		
Sample Comments:									
48	L & T CR	L	660.00	Ft					
48	L & T CR	M	46.00	Ft					
45	DEPRESSION	M	30.00	SqFt					
Sample Number:	104	Type:	R	Area:	3750.00 SqFt	PCI:	52		
Sample Comments:									
48	L & T CR	L	644.00	Ft					
48	L & T CR	M	40.00	Ft					
57	WEATHERING	M	50.00	SqFt					
41	ALLIGATOR CR	L	18.00	SqFt

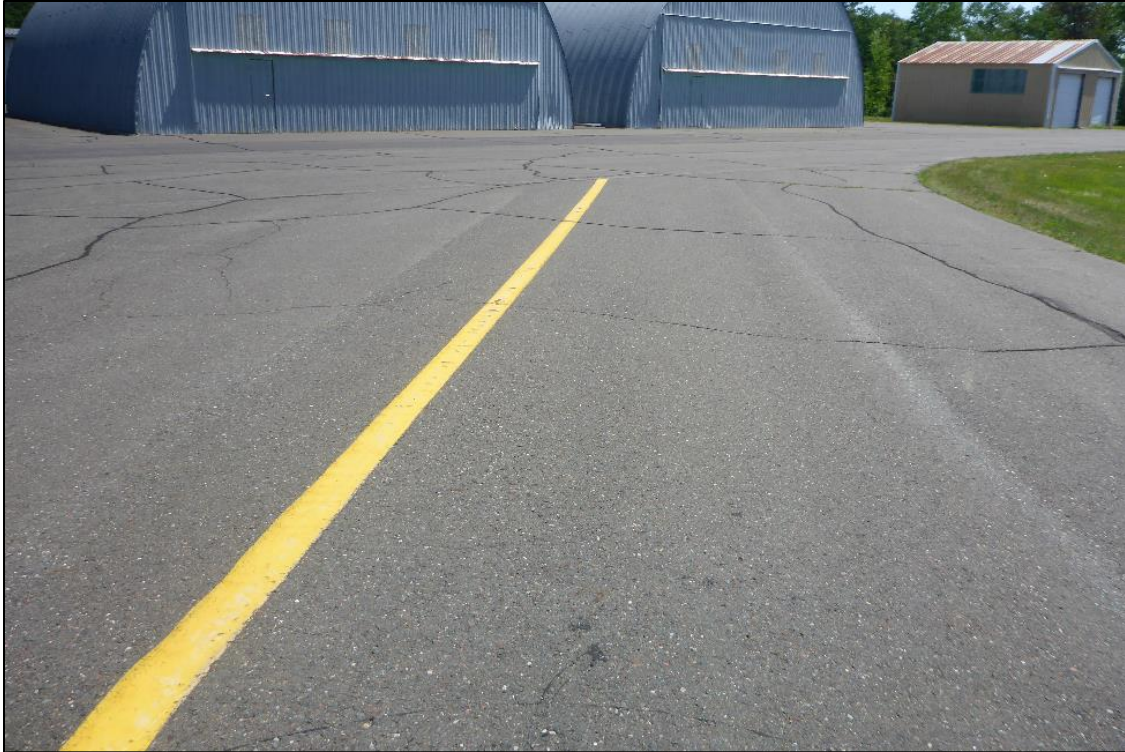
COQ TLA 001 (PCI = 61)

Network:	COQ	Name:	CLOQUET						
Branch:	TLA	Name:	TAXILANE A	Use:	TAXILANE	Area:	37,600 SqFt		
Section:	001	of 1	From:	100	To:	105	Last Const.:	9/7/1999	
Surface:	AC	Family:	MN2013 Asphalt Taxilanes	Zone:	N	Category:	1	Rank:	T
Area:	37,600 SqFt	Length:	206 Ft	Width:	146 Ft				
Slabs:		Slab Length:	Ft	Slab Width:	Ft	Joint Length:	Ft		
Shoulder:		Street Type:		Grade:	0	Lanes:	0		
Section Comments:									
Last Insp. Date:	6/9/2017	TotalSamples:	6	Surveyed:	3				
Conditions:	PCI: 61								
Inspection Comments:									
Sample Number:	100	Type:	R	Area:	4335.00 SqFt	PCI:	57		
Sample Comments:									
41	ALLIGATOR CR	M	8.00	SqFt					
57	WEATHERING	M	400.00	SqFt					
48	L & T CR	L	591.00	Ft					
48	L & T CR	M	38.00	Ft					
48	L & T CR	H	5.00	Ft					
Sample Number:	104	Type:	R	Area:	5650.00 SqFt	PCI:	62		
Sample Comments:									
48	L & T CR	L	803.00	Ft					
48	L & T CR	M	15.00	Ft					
57	WEATHERING	M	500.00	SqFt

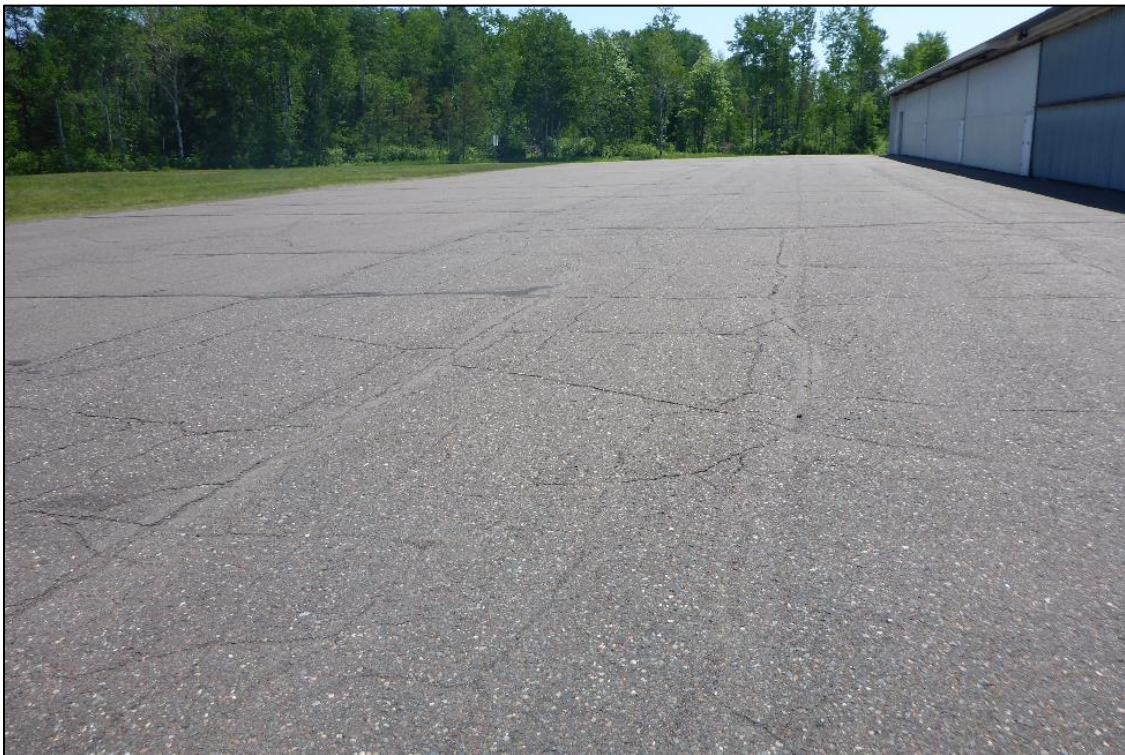
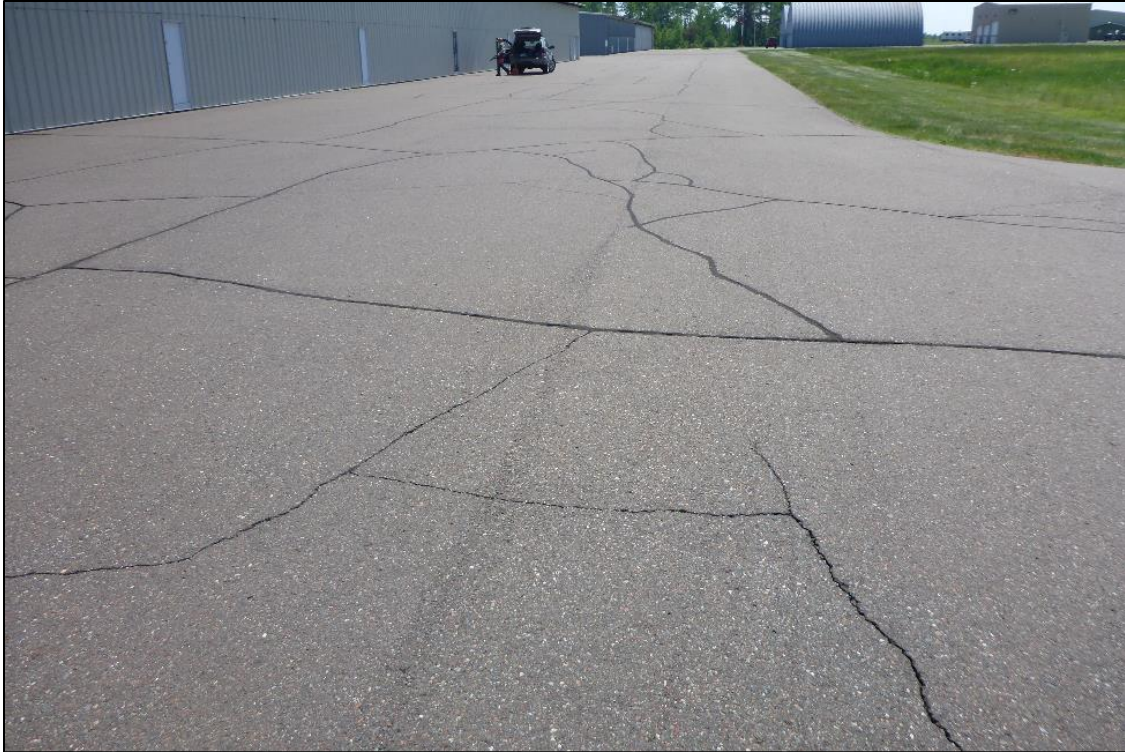
COQ TLB 001 (PCI = 23)

Network:	COQ	Name:	CLOQUET				
Branch:	TLB	Name:	TAXILANE B	Use:	TAXILANE	Area:	43,000 SqFt
Section:	001	of 1	From:	100	To:	108	Last Const.: 9/7/1982
Surface:	AC	Family:	MN2013 Asphalt Taxilanes	Zone:	N	Category:	1
Area:	43,000 SqFt	Length:	183 Ft	Width:	339 Ft	Joint Length:	Ft
Slabs:		Slab Length:	Ft	Slab Width:	Ft	Joint Length:	Ft
Shoulder:		Street Type:		Grade:	0	Lanes:	0
Section Comments:							
Last Insp. Date:	6/9/2017	TotalSamples:	9	Surveyed:	4		
Conditions:	PCI: 23	Inspection Comments:					
Sample Number:	100	Type:	R	Area:	5000.00 SqFt	PCI:	24
Sample Comments:							
57	WEATHERING	M	2000.00	SqFt			
43	BLOCK CR	L	3200.00	SqFt			
43	BLOCK CR	M	650.00	SqFt			
41	ALLIGATOR CR	M	445.00	SqFt			
45	DEPRESSION	L	45.00	SqFt			
48	L & T CR	L	58.00	Ft			
48	L & T CR	M	53.00	Ft			
Sample Number:	104	Type:	R	Area:	3700.00 SqFt	PCI:	43
Sample Comments:							
43	BLOCK CR	M	3600.00	SqFt			
57	WEATHERING	M	3700.00	SqFt
