Pavement Condition Report

Fairmont Municipal Airport (FRM)

December 2017

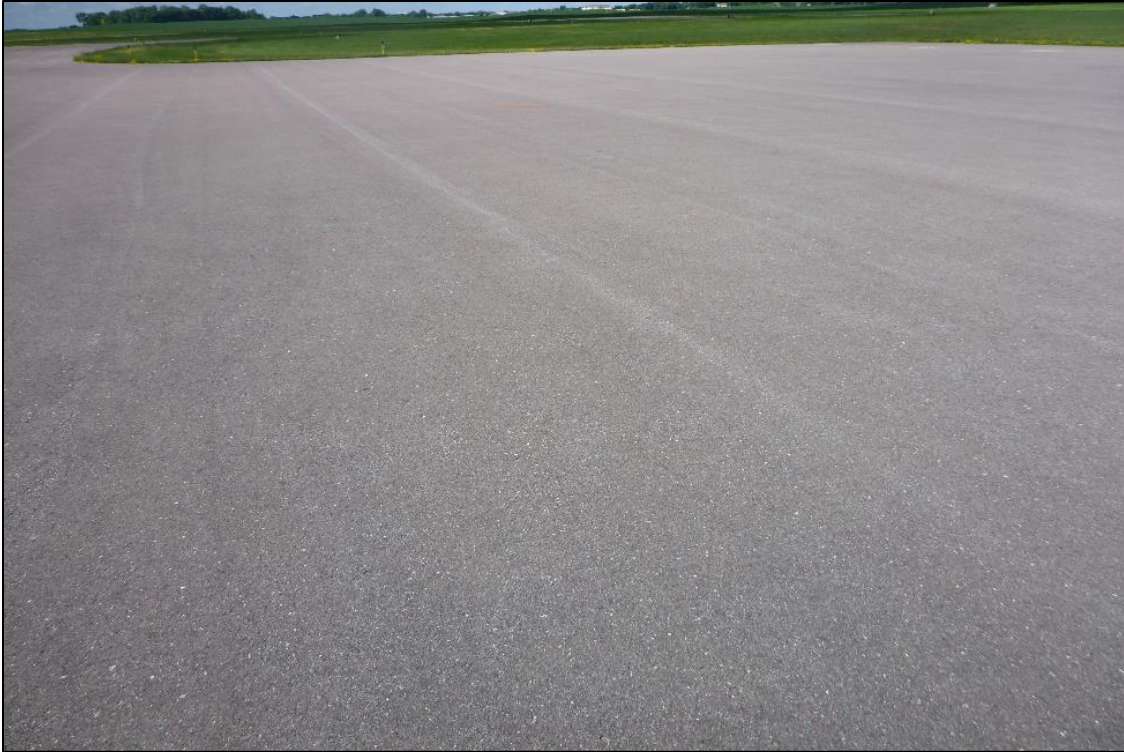
FRM APA 001 (PCI = 94)

Network:	FRM	Name:	FAIRMONT						
Branch:	APA	Name:	APRON A	Use:	APRON	Area:	142,300 SqFt		
Section:	001	of 3	From:	100	To:	400	Last Const.:	7/12/2013	
Surface:	AC	Family:	MN2013 Asphalt Aprons	Zone:	S	Category:	1	Rank:	S
Area:	60,900 SqFt	Length:	130 Ft	Width:	225 Ft				
Slabs:	Slab Length:	Ft	Slab Width:	Ft	Joint Length:	Ft			
Shoulder:	Street Type:		Grade:	0	Lanes:	0			
Section Comments:									
Last Insp. Date:	6/18/2017	TotalSamples:	13	Surveyed:	3				
Conditions:	PCI: 94								
Inspection Comments:									
Sample Number:	201	Type:	R	Area:	5000.00 SqFt	PCI:	89		
Sample Comments:									
48	L & T CR	M	15.00	Ft					
48	L & T CR	L	35.00	Ft					
Sample Number:	300	Type:	R	Area:	5000.00 SqFt	PCI:	100		
Sample Comments:									
<No Distress>									
Sample Number:	401	Type:	R	Area:	5000.00 SqFt	PCI:	94		
Sample Comments:									
48	L & T CR	L	82.00	Ft

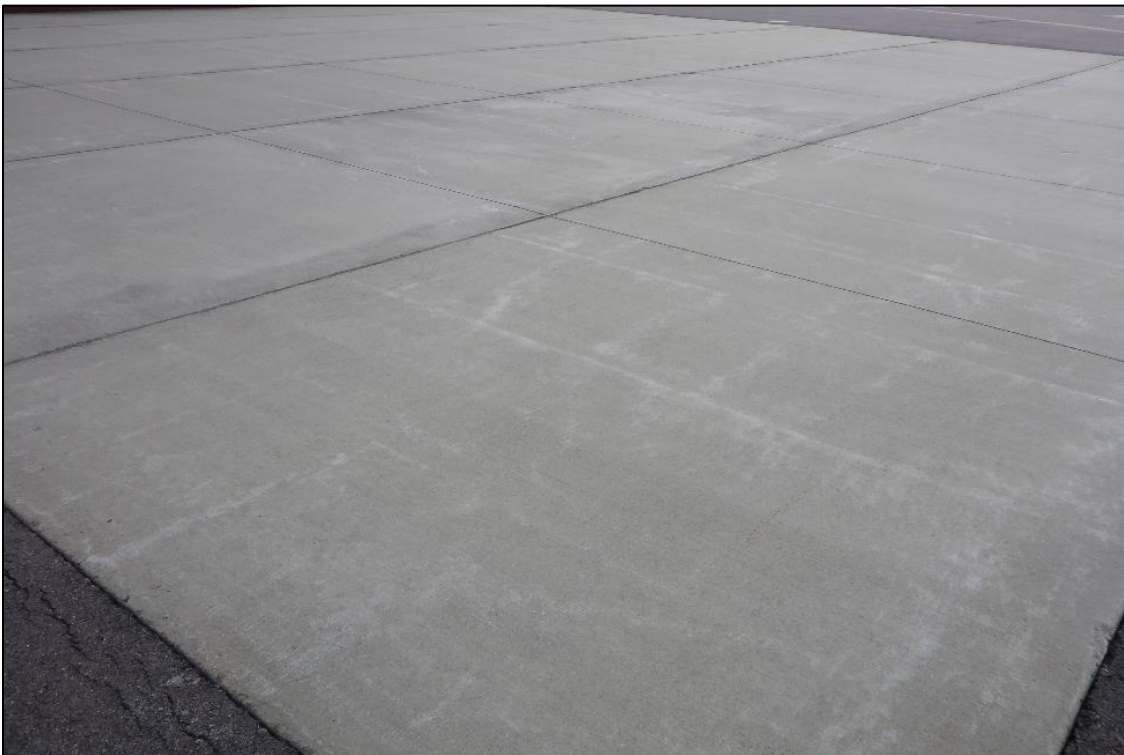
FRM APA 002 (PCI = 97)

Network:	FRM	Name:	FAIRMONT						
Branch:	APA	Name:	APRON A	Use:	APRON	Area:	142,300 SqFt		
Section:	002	of 3	From:	100	To:	100	Last Const.:	6/6/2013	
Surface:	PCC	Family:	MN2013 PCC	Zone:	S	Category:	1	Rank:	S
Area:	3,750 SqFt	Length:	62 Ft	Width:	60 Ft				
Slabs:	36	Slab Length:	10 Ft	Slab Width:	10 Ft	Joint Length:	610 Ft		
Shoulder:		Street Type:		Grade:	0	Lanes:	0		
Section Comments:									
Last Insp. Date:	6/18/2017	TotalSamples:	1	Surveyed:	1				
Conditions:	PCI: 97								
Inspection Comments:									
Sample Number:	100	Type:	R	Area:	36.00 Slabs	PCI:	97		
Sample Comments:									
65	JT SEAL DMG	L	36.00	Slabs					
74	JOINT SPALL	L	1.00	Slabs

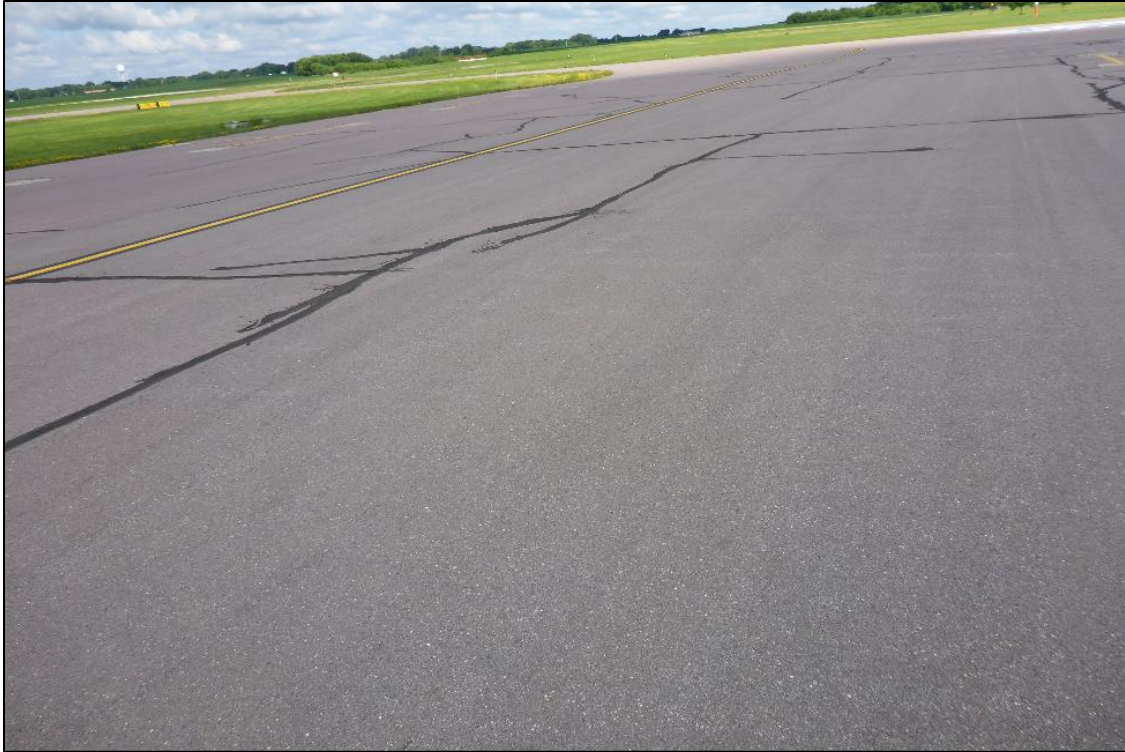
FRM APA 003 (PCI = 80)

Network:	FRM	Name:	FAIRMONT				
Branch:	APA	Name:	APRON A	Use:	APRON	Area:	142,300 SqFt
Section:	003	of 3	From:	103	To:	206	Last Const.: 7/7/2013
Surface:	AC	Family:	MN2013 Asphalt Aprons	Zone:	S	Category:	1
Area:	77,650 SqFt	Length:	400 Ft	Width:	100 Ft	Rank:	S
Slabs:	Slab Length:	Ft	Slab Width:	Ft	Joint Length:	Ft	
Shoulder:	Street Type:		Grade:	0	Lanes:	0	
Section Comments:							
Last Insp. Date:	6/18/2017	TotalSamples:	16	Surveyed:	4		
Conditions:	PCI: 80						
Inspection Comments:							
Sample Number:	104	Type:	R	Area:	5000.00 SqFt	PCI:	83
Sample Comments:							
48	L & T CR	M	42.00	Ft			
48	L & T CR	L	198.00	Ft			
Sample Number:	205	Type:	R	Area:	5000.00 SqFt	PCI:	77
Sample Comments:							
48	L & T CR	M	58.00	Ft			
48	L & T CR	L	322.00	Ft			
Sample Number:	304	Type:	R	Area:	5000.00 SqFt	PCI:	81
Sample Comments:							
48	L & T CR	L	193.00	Ft			
48	L & T CR	M	76.00	Ft			
Sample Number:	405	Type:	R	Area:	5000.00 SqFt	PCI:	81

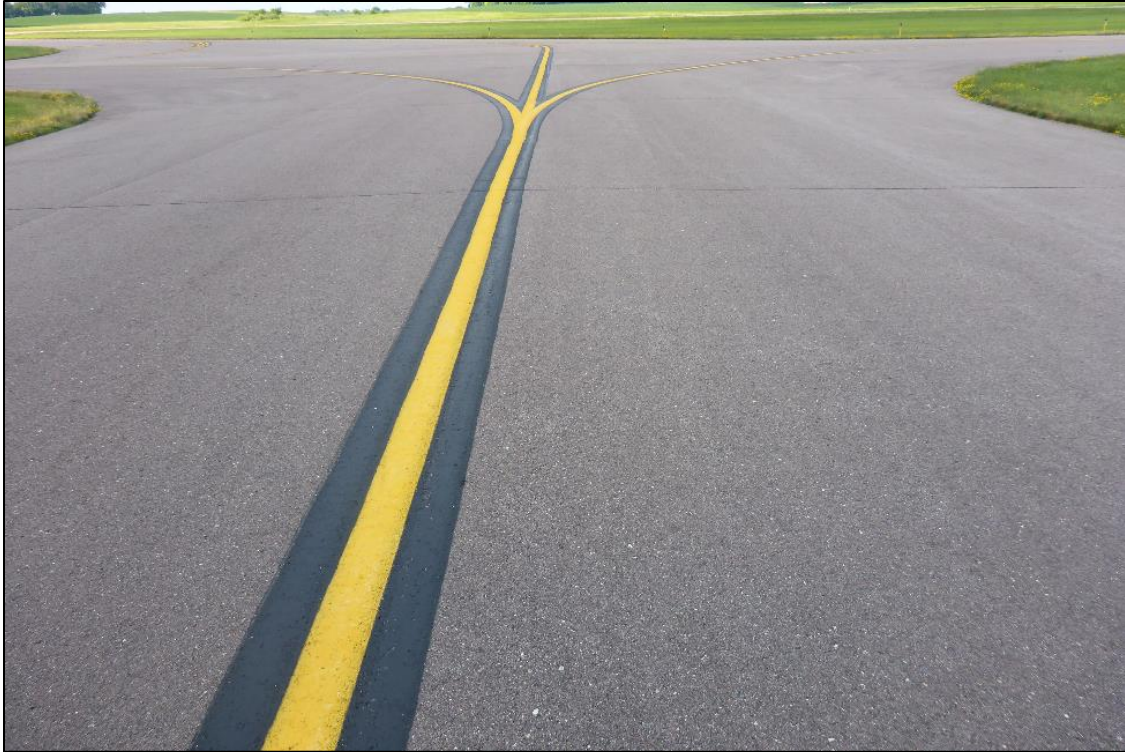
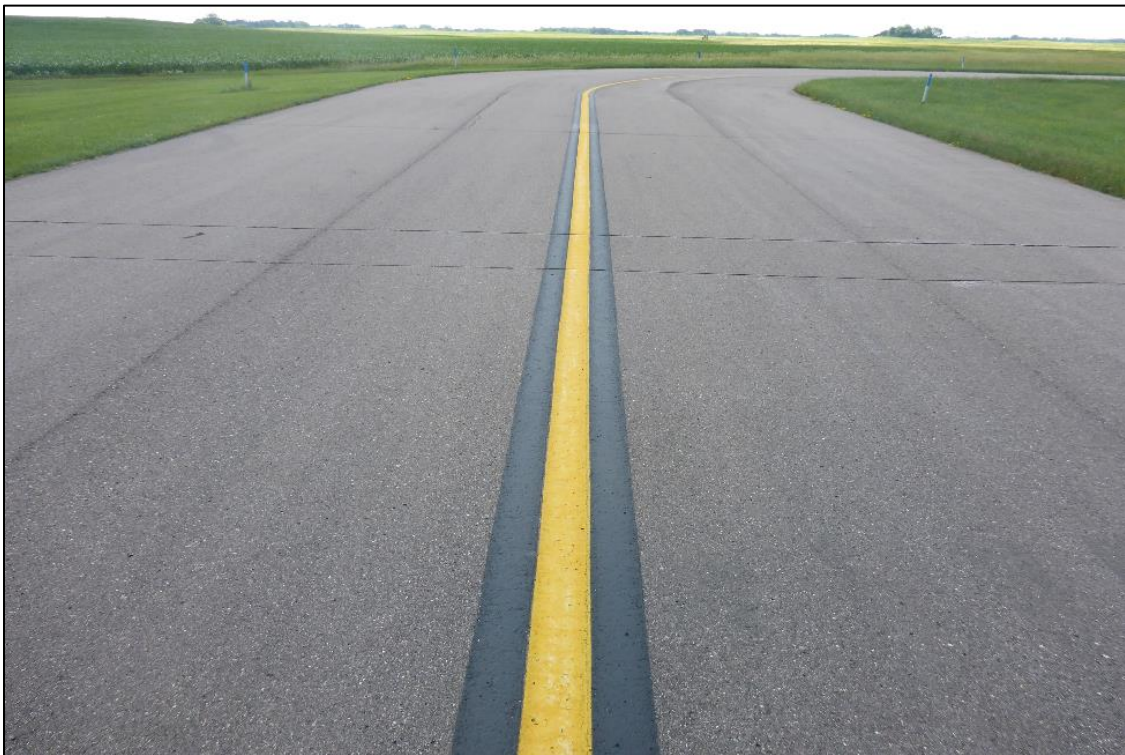
FRM CTBX 001 (PCI = 87)

Network:	FRM	Name:	FAIRMONT				
Branch:	CTBX	Name:	CONNECTING TAXIWAY B EXT.	Use:	TAXIWAY	Area:	11,450 SqFt
Section:	001	of 1	From:	205	To:	206	Last Const.: 7/13/2013
Surface:	AC	Family:	MN2013 Asphalt Taxiways	Zone:	S	Category:	1
Area:	11,450 SqFt	Length:	200 Ft	Width:	50 Ft		
Slabs:		Slab Length:	Ft	Slab Width:	Ft	Joint Length:	Ft
Shoulder:		Street Type:		Grade:	0	Lanes:	0
Section Comments:							
Last Insp. Date:	6/18/2017	TotalSamples:	2	Surveyed:	1		
Conditions:	PCI: 87						
Inspection Comments:							
Sample Number:	206	Type:	R	Area:	6050.00 SqFt	PCI:	87
Sample Comments:							
48	L & T CR	L	248.00	Ft

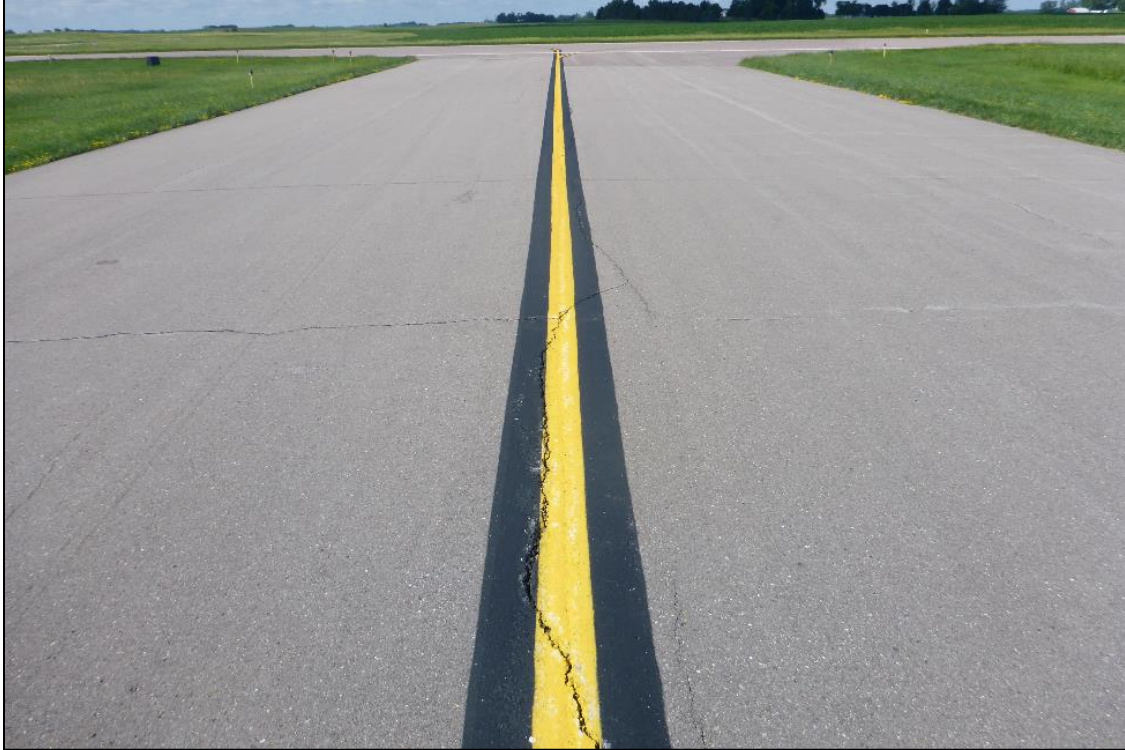
FRM CTE 001 (PCI = 85)

Network:	FRM	Name:	FAIRMONT				
Branch:	CTE	Name:	CONNECTING TAXIWAY E	Use:	TAXIWAY	Area:	19,400 SqFt
Section:	001	of 1	From:	300	To:	303	Last Const.: 7/7/2013
Surface:	AC	Family:	MN2013 Asphalt Taxiways	Zone:	S	Category:	1
Area:	19,400 SqFt	Length:	345 Ft	Width:	50 Ft	Joint Length:	Ft
Slabs:		Slab Length:	Ft	Slab Width:	Ft	Joint Length:	Ft
Shoulder:		Street Type:		Grade:	0	Lanes:	0
Section Comments:							
Last Insp. Date:	6/18/2017	TotalSamples:	3	Surveyed:	1		
Conditions:	PCI: 85						
Inspection Comments:							
Sample Number:	301	Type:	R	Area:	5000.00 SqFt	PCI:	85
Sample Comments:							
48	L & T CR	L	244.00	Ft

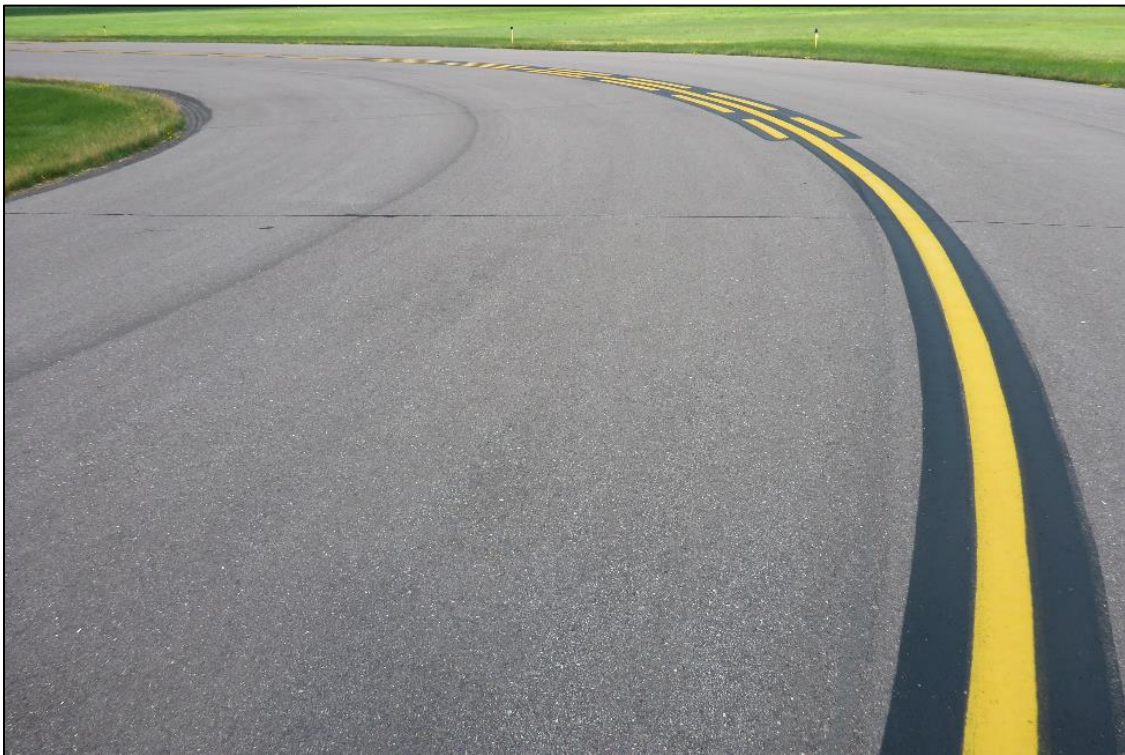
FRM PTA 001 (PCI = 92)

Network:	FRM	Name:	FAIRMONT						
Branch:	PTA	Name:	PARALLEL TAXIWAY A	Use:	TAXIWAY	Area:	316,250 SqFt		
Section:	001	of 2	From:	100	To:	108	Last Const.:	7/12/2013	
Surface:	AC	Family:	MN2013 Asphalt Taxiways	Zone:		Category:		Rank:	P
Area:	46,250 SqFt	Length:	855 Ft	Width:	50 Ft				
Slabs:		Slab Length:	Ft	Slab Width:	Ft	Joint Length:	Ft		
Shoulder:		Street Type:		Grade:	0	Lanes:	0		
Section Comments:									
Last Insp. Date:	6/18/2017	TotalSamples:	8	Surveyed:	3				
Conditions:	PCI: 92								
Inspection Comments:									
Sample Number:	100	Type:	R	Area:	5000.00 SqFt	PCI:	95		
Sample Comments:									
48	L & T CR		L		50.00 Ft				
Sample Number:	103	Type:	R	Area:	5000.00 SqFt	PCI:	89		
Sample Comments:									
48	L & T CR		L		160.00 Ft				
Sample Number:	105	Type:	R	Area:	5000.00 SqFt	PCI:	93		
Sample Comments:									
48	L & T CR		L		100.00 Ft

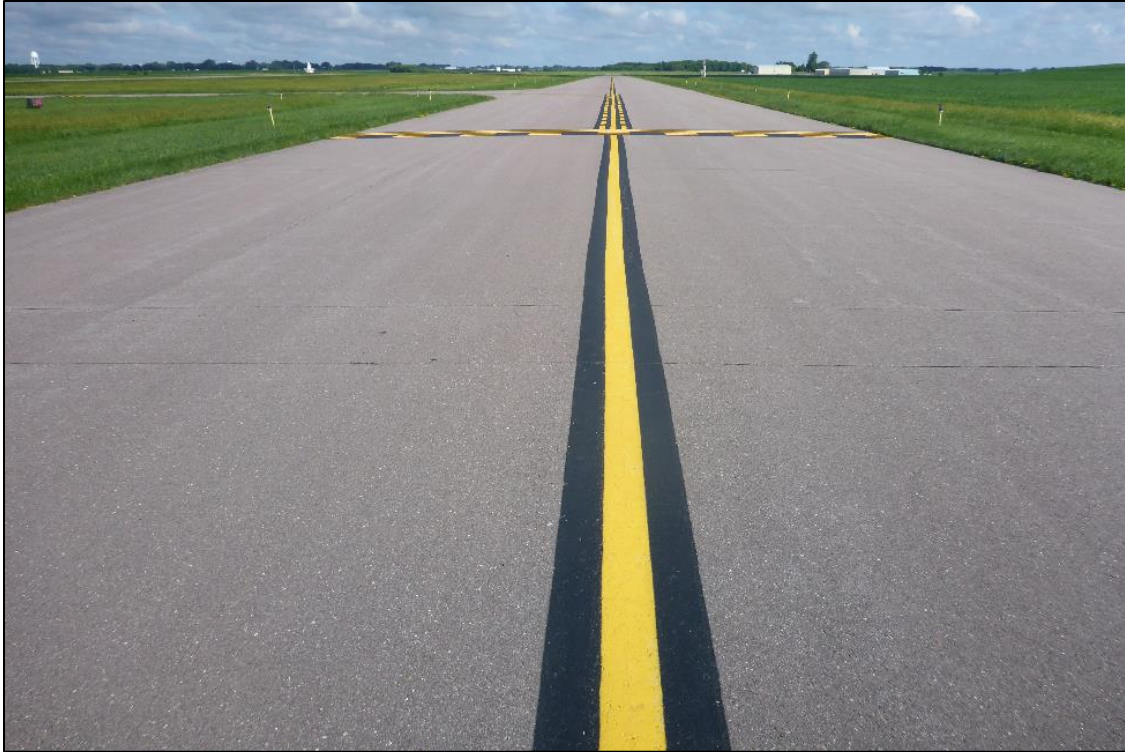
FRM PTA 002 (PCI = 91)

Network:	FRM	Name:	FAIRMONT				
Branch:	PTA	Name:	PARALLEL TAXIWAY A	Use:	TAXIWAY	Area:	316,250 SqFt
Section:	002	of 2	From:	108	To:	159	Last Const.: 7/7/2013
Surface:	AC	Family:	MN2013 Asphalt Taxiways	Zone:		Category:	Rank: P
Area:	270,000 SqFt	Length:	5,200 Ft	Width:	50 Ft		
Slabs:		Slab Length:	Ft	Slab Width:	Ft	Joint Length:	Ft
Shoulder:		Street Type:		Grade:	0	Lanes:	0
Section Comments:							
Last Insp. Date:	6/18/2017	TotalSamples:	52	Surveyed:	8		
Conditions:	PCI: 91	Inspection Comments:					
Sample Number:	110	Type:	R	Area:	5000.00 SqFt	PCI:	89
Sample Comments:							
48	L & T CR	L		162.00	Ft		
Sample Number:	114	Type:	R	Area:	5000.00 SqFt	PCI:	92
Sample Comments:							
48	L & T CR	L		110.00	Ft		
Sample Number:	124	Type:	R	Area:	5000.00 SqFt	PCI:	88
Sample Comments:							
48	L & T CR	M		11.00	Ft		
48	L & T CR	L		100.00	Ft		
Sample Number:	134	Type:	R	Area:	5000.00 SqFt	PCI:	93
Sample Comments:

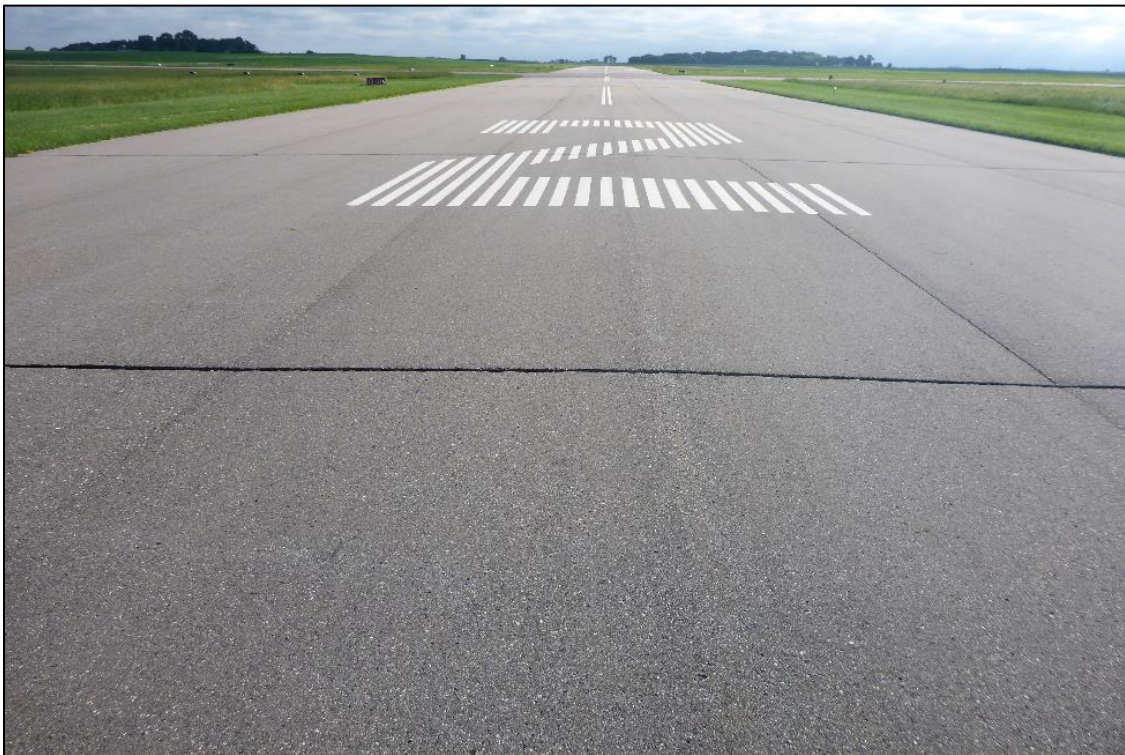
FRM RY220 001 (PCI = 85)

Network:	FRM	Name:	FAIRMONT				
Branch:	RY220	Name:	RUNWAY 2-20	Use:	RUNWAY	Area:	254,000 SqFt
Section:	001	of 3	From:	100	To:	111	Last Const.: 6/1/2011
Surface:	AC	Family:	MN2013 Asphalt Runways	Zone:	S	Category:	1
Area:	49,500 SqFt	Length:	630 Ft	Width:	75 Ft	Rank:	S
Slabs:	Slab Length:	Ft	Slab Width:	Ft	Joint Length:	Ft	
Shoulder:	Street Type:		Grade:	0	Lanes:	0	
Section Comments:							
Last Insp. Date:	6/18/2017	TotalSamples:	13	Surveyed:	3		
Conditions:	PCI: 85						
Inspection Comments:							
Sample Number:	101	Type:	R	Area:	3750.00 SqFt	PCI:	87
Sample Comments:							
48	L & T CR	L	150.00	Ft			
Sample Number:	105	Type:	R	Area:	3750.00 SqFt	PCI:	83
Sample Comments:							
48	L & T CR	L	85.00	Ft			
48	L & T CR	L	135.00	Ft			
Sample Number:	109	Type:	R	Area:	3750.00 SqFt	PCI:	84
Sample Comments:							
48	L & T CR	L	112.00	Ft			
48	L & T CR	M	17.00	Ft			
48	L & T CR	L	14.00	Ft

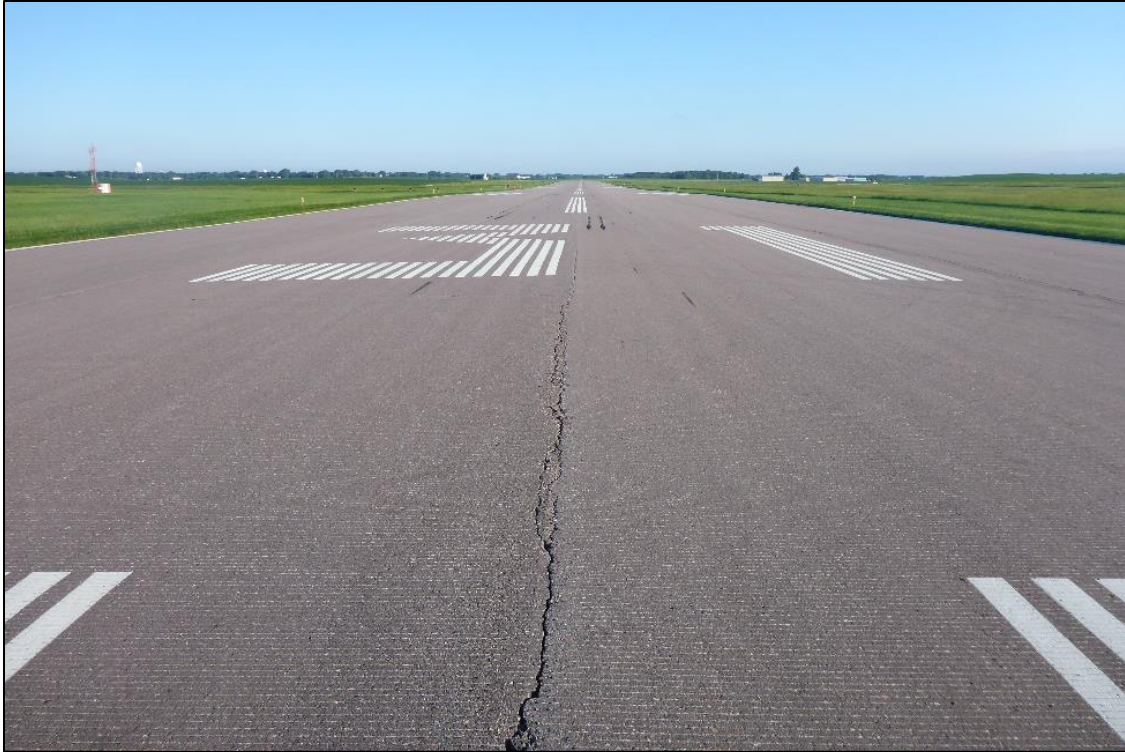
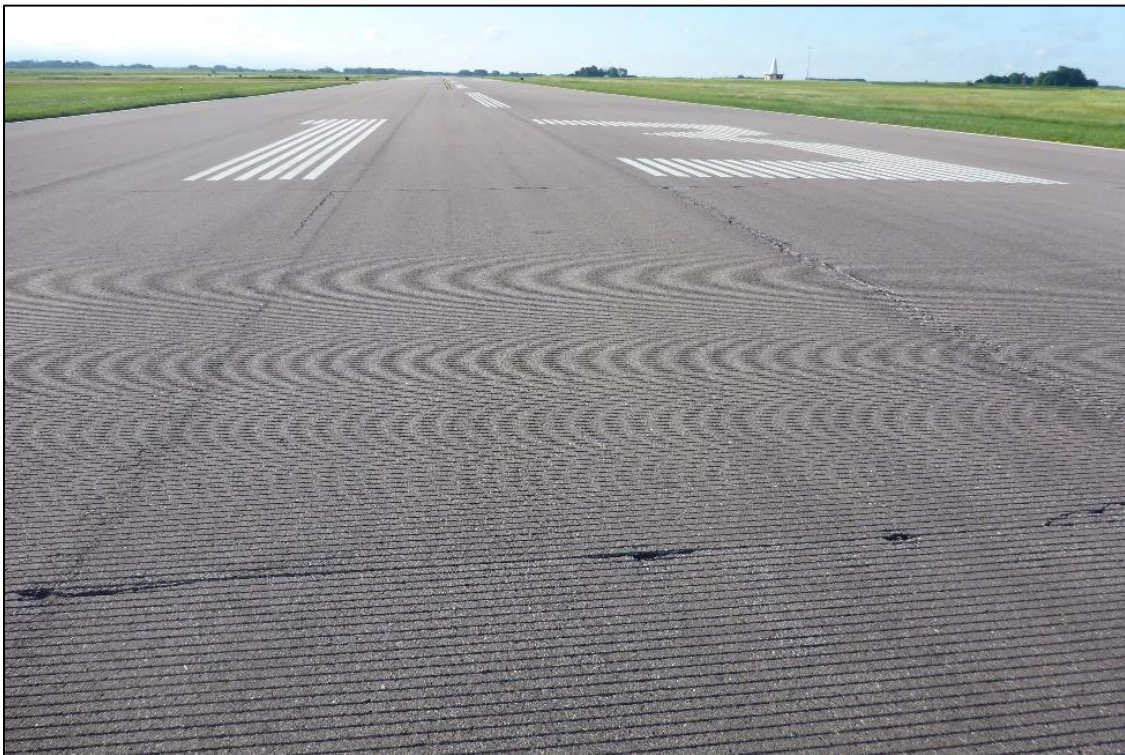
FRM RY1331 001 (PCI = 83)

Network:	FRM	Name:	FAIRMONT						
Branch:	RY1331	Name:	RUNWAY 13-31	Use:	RUNWAY	Area:	550,000 SqFt		
Section:	001	of 1	From:	100	To:	209	Last Const.: 7/6/2013		
Surface:	AC	Family:	MN2013 Asphalt Runways	Zone:	S	Category:	1	Rank:	P
Area:	550,000 SqFt	Length:	5,500 Ft	Width:	100 Ft				
Slabs:		Slab Length:	Ft	Slab Width:	Ft	Joint Length:	Ft		
Shoulder:		Street Type:		Grade:	0	Lanes:	0		
Section Comments:									
Last Insp. Date:	6/18/2017	TotalSamples:	110	Surveyed:	12				
Conditions:	PCI: 83								
Inspection Comments:									
Sample Number:	103	Type:	R	Area:	5000.00 SqFt	PCI:	78		
Sample Comments:									
48	L & T CR	L	73.00	Ft					
48	L & T CR	M	11.00	Ft					
48	L & T CR	L	73.00	Ft					
48	L & T CR	M	106.00	Ft					
Sample Number:	107	Type:	R	Area:	5000.00 SqFt	PCI:	82		
Sample Comments:									
48	L & T CR	M	34.00	Ft					
48	L & T CR	L	110.00	Ft					
48	L & T CR	L	99.00	Ft					
48	L & T CR	M	6.00	Ft
