Pavement Condition Report

Mankato Regional Airport (MKT)

December 2017

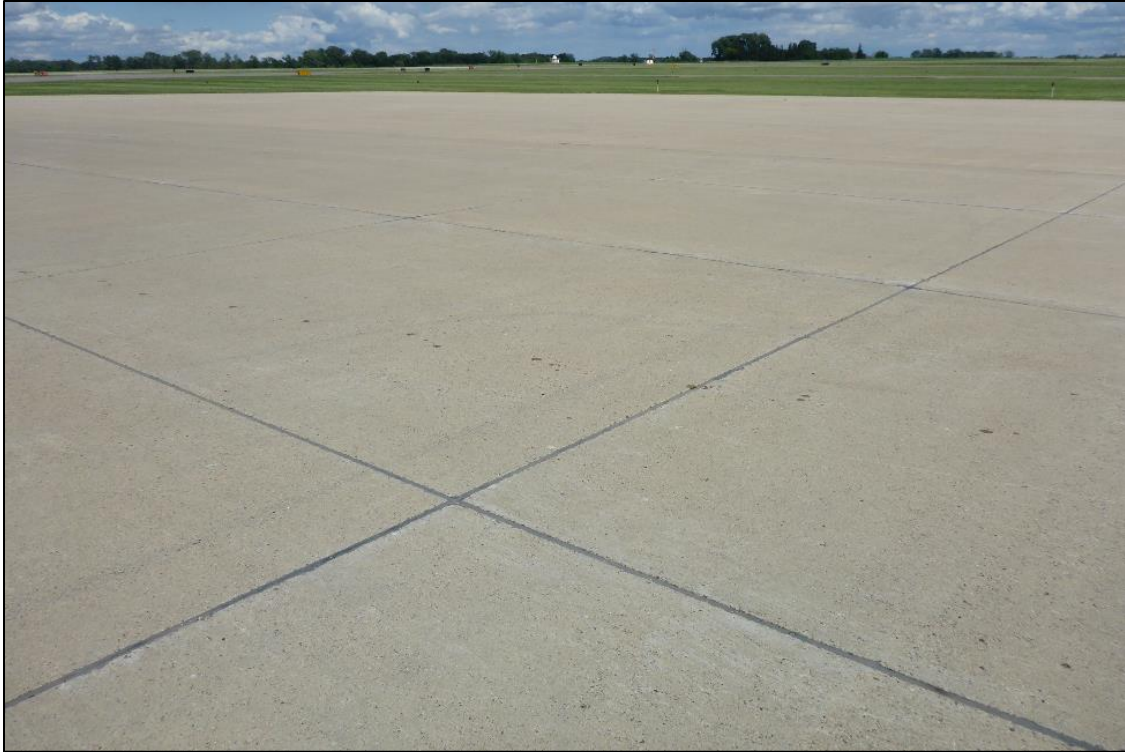
MKT APA 001 (PCI = 95)

Network:	MKT	Name:	MANKATO						
Branch:	APA	Name:	APRON A	Use:	APRON	Area:	143,000 SqFt		
Section:	001	of	1	From:	100	To:	407	Last Const.:	9/30/1996
Surface:	PCC	Family:	MN2013 PCC	Zone:	S	Category:	1	Rank:	S
Area:	143,000 SqFt	Length:	715 Ft	Width:	200 Ft				
Slabs:	763	Slab Length:	15 Ft	Slab Width:	13 Ft	Joint Length:	20,058 Ft		
Shoulder:		Street Type:		Grade:	0	Lanes:	0		
Section Comments:									
Last Insp. Date:	6/19/2017	TotalSamples:	32	Surveyed:	6				
Conditions:	PCI: 95								
Inspection Comments:									
Sample Number:	105	Type:	R	Area:	24.00 Slabs	PCI:	98		
Sample Comments:									
66	SMALL PATCH		L	1.00	Slabs				
74	JOINT SPALL		L	1.00	Slabs				
Sample Number:	107	Type:	R	Area:	24.00 Slabs	PCI:	82		
Sample Comments:									
63	LINEAR CR		L	1.00	Slabs				
63	LINEAR CR		L	1.00	Slabs				
63	LINEAR CR		L	1.00	Slabs				
74	JOINT SPALL		M	1.00	Slabs				
72	SHAT. SLAB		L	1.00	Slabs				
Sample Number:	201	Type:	R	Area:	24.00 Slabs	PCI:	100

Sample Comments:									
<No Distress>									
Sample Number:	204	Type:	R	Area:	24.00 Slabs	PCI:	97		
Sample Comments:									
66	SMALL PATCH		L	1.00	Slabs				
66	SMALL PATCH		L	1.00	Slabs				
75	CORNER SPALL		L	1.00	Slabs				
Sample Number:	206	Type:	R	Area:	24.00 Slabs	PCI:	96		
Sample Comments:									
66	SMALL PATCH		L	1.00	Slabs				
75	CORNER SPALL		M	1.00	Slabs				
Sample Number:	305	Type:	R	Area:	24.00 Slabs	PCI:	100		
Sample Comments:									
<No Distress>

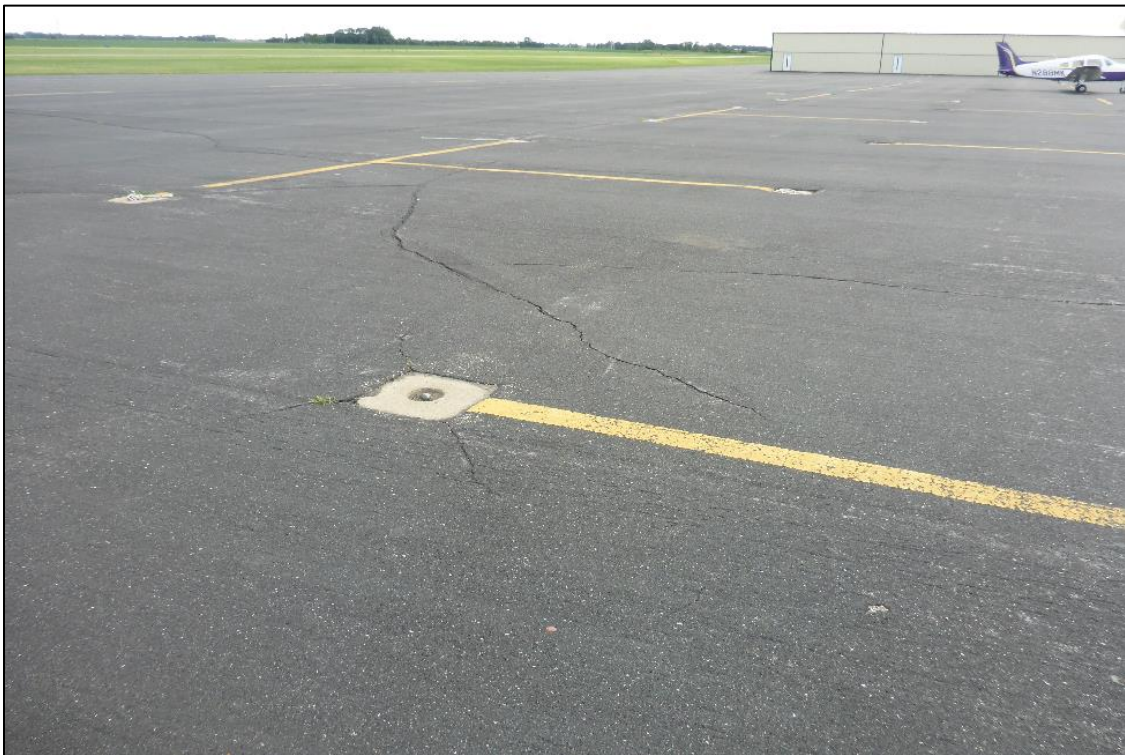
MKT APB 001 (PCI = 74)

Network:	MKT	Name:	MANKATO						
Branch:	APB	Name:	APRON B	Use:	APRON	Area:	99,000 SqFt		
Section:	001	of	1	From:	306	To:	710	Last Const.:	6/1/2002
Surface:	AAC	Family:	MN2013 Asphalt Aprons	Zone:	S	Category:	1	Rank:	S
Area:	99,000 SqFt	Length:	440 Ft	Width:	225 Ft				
Slabs:		Slab Length:	Ft	Slab Width:	Ft	Joint Length:	Ft		
Shoulder:		Street Type:		Grade:	0	Lanes:	0		
Section Comments:	estimated LCD								
Last Insp. Date:	6/19/2017	TotalSamples:	20	Surveyed:	4				
Conditions:	PCI: 74								
Inspection Comments:									
Sample Number:	201	Type:	R	Area:	5000.00 SqFt	PCI:	73		
Sample Comments:									
48	L & T CR	M	75.00	Ft					
48	L & T CR	L	458.00	Ft					
Sample Number:	302	Type:	R	Area:	5000.00 SqFt	PCI:	73		
Sample Comments:									
48	L & T CR	L	460.00	Ft					
48	L & T CR	M	75.00	Ft					
Sample Number:	401	Type:	R	Area:	5000.00 SqFt	PCI:	74		
Sample Comments:									
48	L & T CR	M	19.00	Ft					
48	L & T CR	L	420.00	Ft

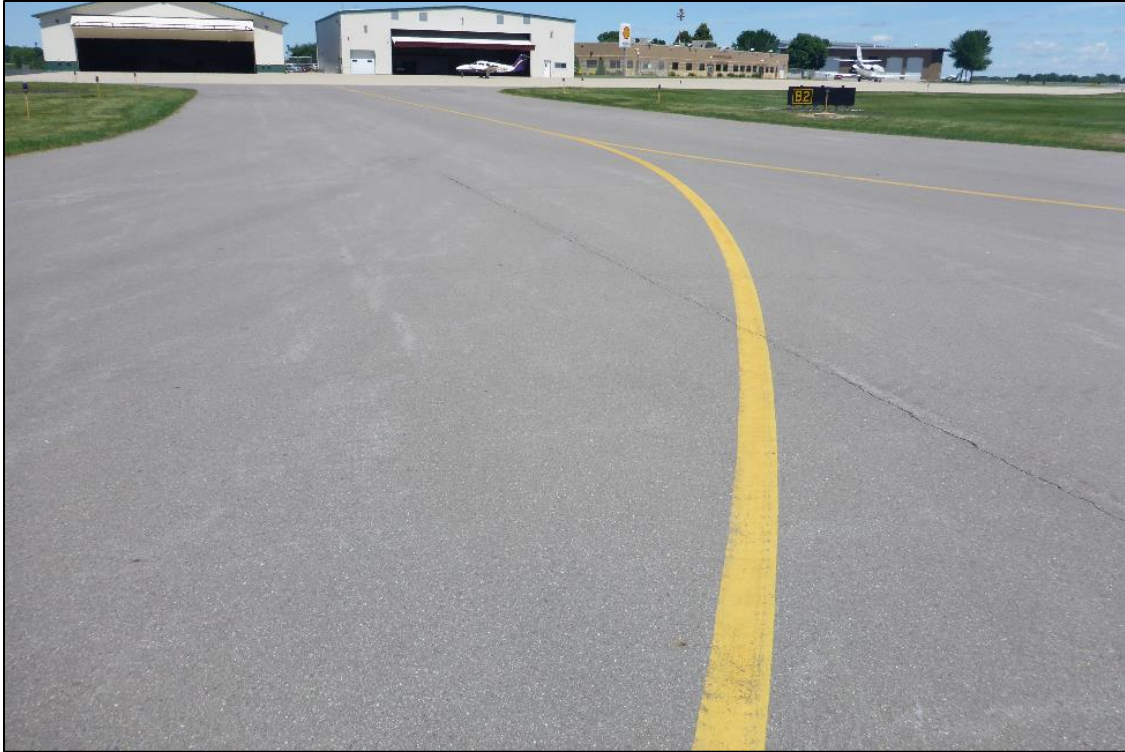
MKT CTB2 001 (PCI = 87)

Network:	MKT	Name:	MANKATO						
Branch:	CTB2	Name:	CONNECTING TAXIWAY B2	Use:	TAXIWAY	Area:	16,650 SqFt		
Section:	001	of	1	From:	300	To:	301	Last Const.:	1/1/2015
Surface:	AAC	Family:	MN2013 Asphalt Taxiways	Zone:	S	Category:	1	Rank:	S
Area:	16,650 SqFt	Length:	220 Ft	Width:	50 Ft				
Slabs:		Slab Length:	Ft	Slab Width:	Ft	Joint Length:	Ft		
Shoulder:		Street Type:		Grade:	0	Lanes:	0		
Section Comments:									
Last Insp. Date:	6/19/2017	TotalSamples:	4	Surveyed:	2				
Conditions:	PCI: 87								
Inspection Comments:									
Sample Number:	300	Type:	R	Area:	5000.00 SqFt	PCI:	86		
Sample Comments:									
48	L & T CR		L		225.00 Ft				
Sample Number:	301	Type:	R	Area:	5000.00 SqFt	PCI:	88		
Sample Comments:									
48	L & T CR		L		180.00 Ft

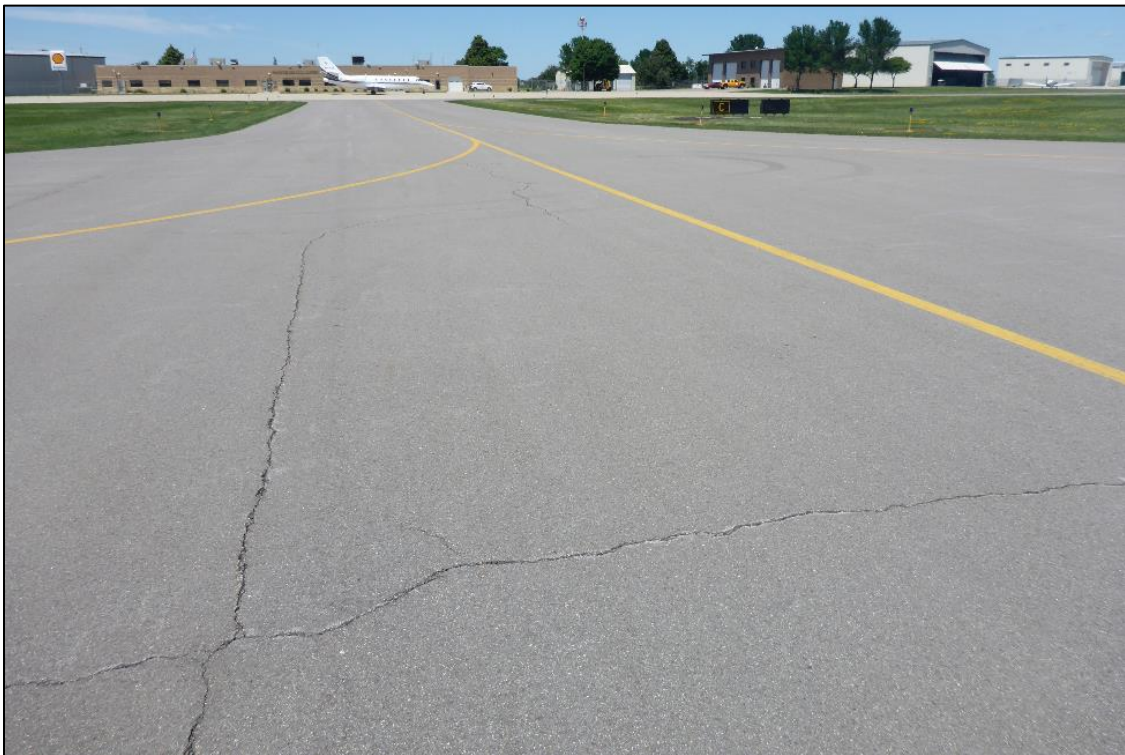
MKT CTC 001 (PCI = 85)

Network:	MKT	Name:	MANKATO						
Branch:	CTC	Name:	CONNECTING TAXIWAY C	Use:	TAXIWAY	Area:	40,500 SqFt		
Section:	001	of 1	From:	200	To:	203+50	Last Const.:	1/1/2015	
Surface:	AAC	Family:	MN2013 Asphalt Taxiways	Zone:	S	Category:	1	Rank:	P
Area:	40,500 SqFt	Length:	490 Ft	Width:	50 Ft				
Slabs:		Slab Length:	Ft	Slab Width:	Ft	Joint Length:	Ft		
Shoulder:		Street Type:		Grade:	0	Lanes:	0		
Section Comments:									
Last Insp. Date:	6/19/2017	TotalSamples:	9	Surveyed:	3				
Conditions:	PCI: 85								
Inspection Comments:									
Sample Number:	200	Type:	R	Area:	5500.00 SqFt	PCI:	86		
Sample Comments:									
48	L & T CR	L	244.00	Ft					
Sample Number:	202	Type:	R	Area:	5000.00 SqFt	PCI:	86		
Sample Comments:									
48	L & T CR	L	228.00	Ft					
Sample Number:	203	Type:	R	Area:	5000.00 SqFt	PCI:	83		
Sample Comments:									
48	L & T CR	L	298.00	Ft

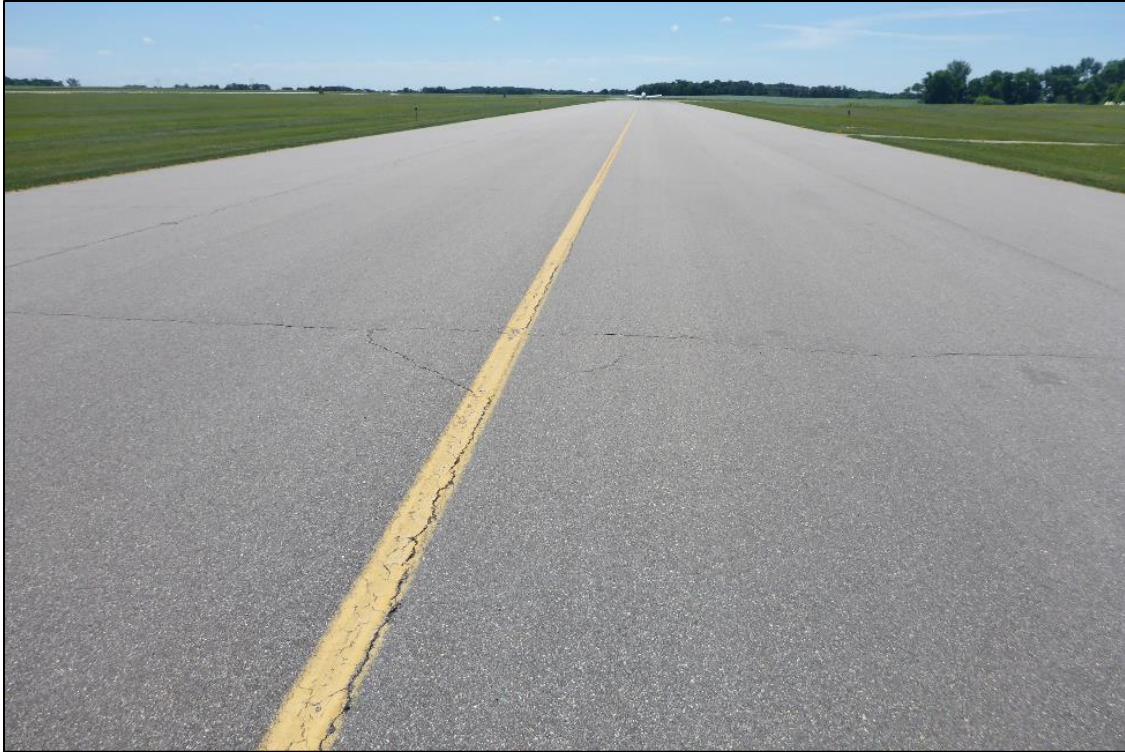
MKT PTA 001 (PCI = 77)

Branch ID	Section ID	Surface type ¹	Section area (SF)	LCD ²	2014 PCI	2017 PCI	Drop in PCI/Yr ³	% Deduct due to		Distress types
								Load ⁴	Climate ⁵	
APA	001	PCC	143,000	1996	96	95	0.2	59	-	Corner spall, joint spall, linear cr, shattered slab, small patch
APB	001	AAC	99,000	2002	75	74	1.7	-	100	L&T cr
CTA2	001	AC	19,700	2014	72	76	6.0 ⁷	-	100	L&T cr
CTA2X	001	AC	10,100	1997	74	65	1.7	-	100	L&T cr
CTA3	001	AAC	19,250	2007	79	72	2.7	-	100	L&T cr, weathering
CTB2	001	AAC	16,650	2015	77	87	4.3 ⁷	-	100	L&T cr
CTC	001	AAC	40,500	2015	75	85	5.0 ⁷	-	100	L&T cr
CTD	001	AC	14,550	2014	73	76	6.0 ⁷	-	100	L&T cr
CTD	002	AC	23,050	2014	72	77	5.9 ⁷	-	100	L&T cr
CTE	001	AC	38,100	1997	73	70	1.5	-	100	L&T cr
PPTD	001	AC	9,000	2015	69	77	7.7 ⁷	-	100	L&T cr
PPTD	002	AC	52,200	2002	70	70	1.9	-	100	L&T cr
PPTD	003	AAC	50,500	2002	75	68	2.1	-	100	L&T cr
PPTD	004	AAC	10,300	2009	82	72	3.3	-	100	L&T cr
PTA	001	AAC	256,250	2016	70	77	15.3 ⁷	-	100	L&T cr

⁷Low-severity L&T cracks are responsible for greater than expected drop in PCI since 2016 reconstruction

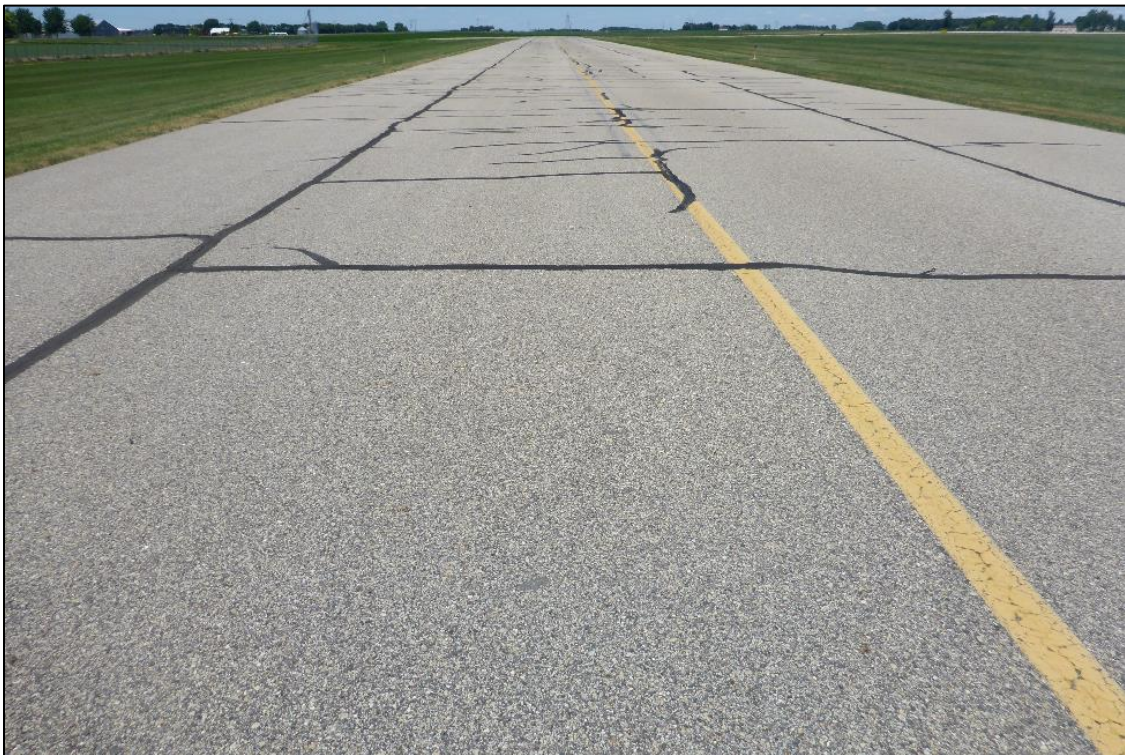
MKT PTA 002 (PCI = 66)

PTA	002	AC	95,700	2007	70	66	3.3	-	100	L&T cr, weathering
PTA	003	AC	21,700	2009	83	72	3.4	-	100	L&T cr, weathering
PTB	001	AC	18,000	2015	78	80	6.7 ⁷	-	100	L&T cr
PTB	002	AAC	60,000	2015	79	86	4.7 ⁷	-	100	L&T cr
PTB	003	AC	57,000	2015	78	89	3.7	-	100	L&T cr
PTB	004	AAC	47,150	2006	77	75	2.2	-	100	L&T cr
PTB	005	AAC	13,400	2009	85	84	1.9	-	100	L&T cr
RTA	001	AC	12,400	2006	82	76	2.1	-	100	L&T cr, weathering
RY1533	001	PCC	579,500	2007	89	86	1.4	80	6	Corner break, faulting, joint spall, joint seal dmg, linear cr, shattered slab

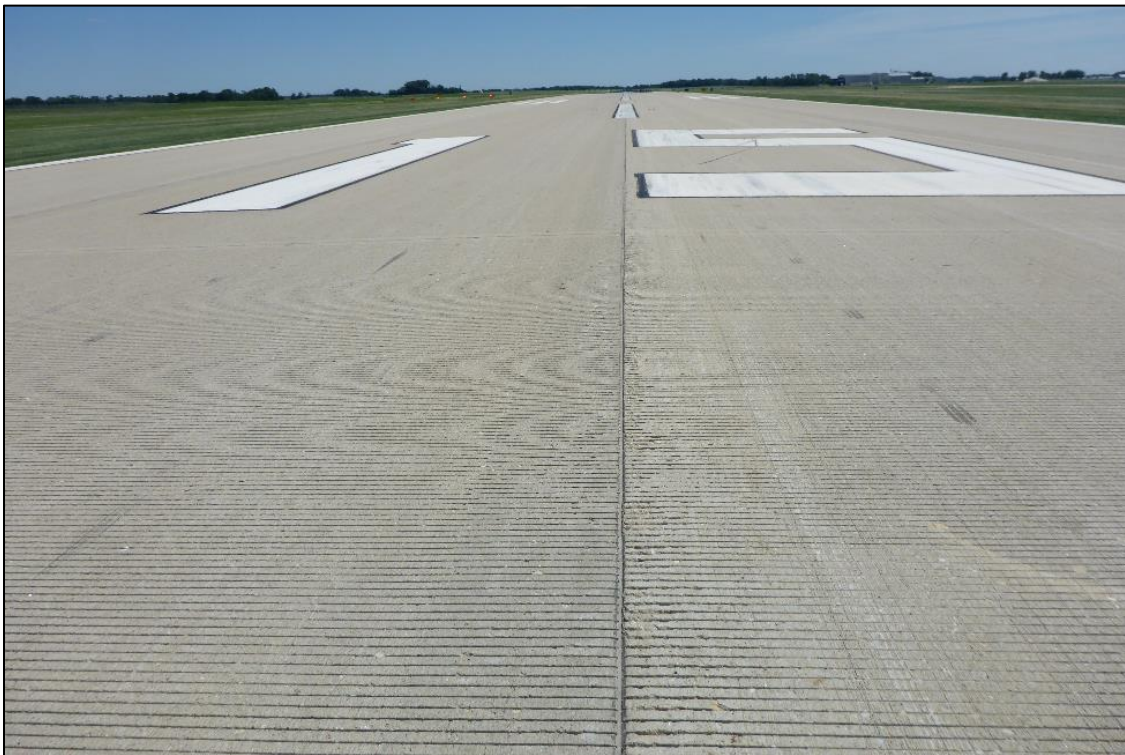
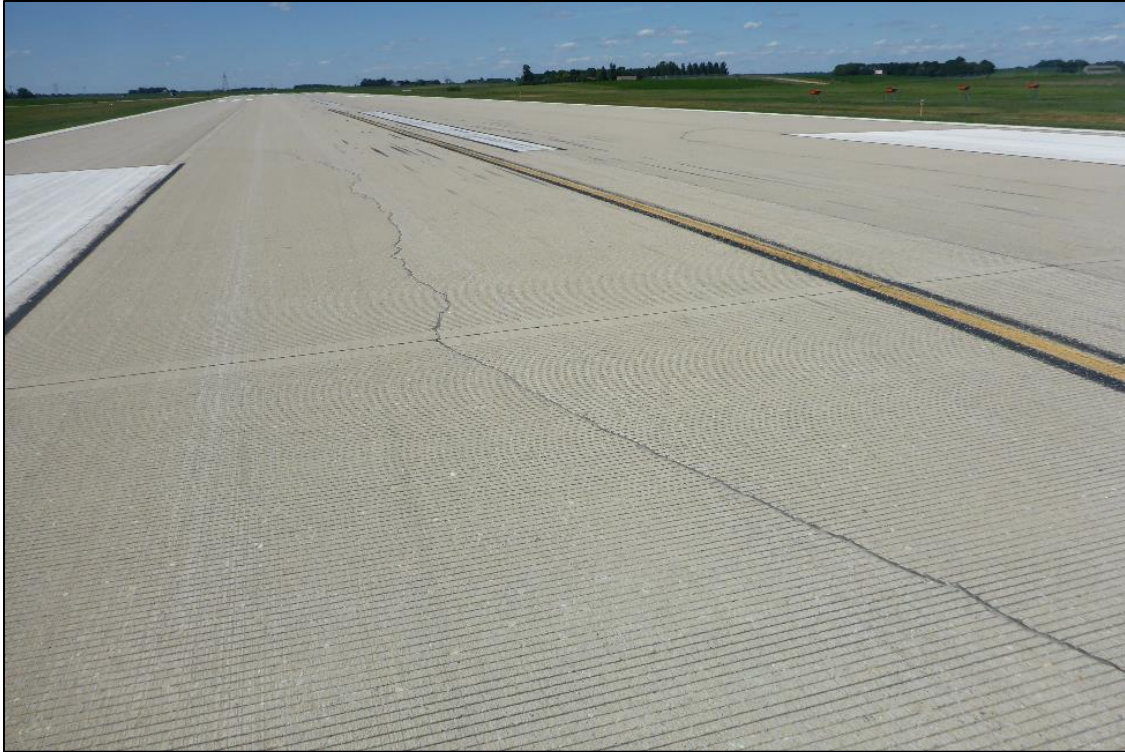
MKT RY1533 002 (PCI = 87)

Branch ID	Section ID	Surface type ¹	Section area (SF)	LCD ²	2014 PCI	2017 PCI	Drop in PCI/Yr ³	% Deduct due to		Distress types
								Load ⁴	Climate ⁵	
RY1533	002	PCC	123,700	2007	88	87	1.3	94	-	Corner break, corner spall, linear cr, shattered slab
RY422	001	AAC	199,900	2009	82	78	2.6	-	100	L&T cr
RY422	002	AAC	9,100	2009	78	77	2.7	-	100	L&T cr
RY422	003	AAC	21,700	2007	77	80 ⁶	2.0	-	100	L&T cr, weathering
RY422	004	AAC	57,750	2009	79	78	2.6	-	100	L&T cr
TLA	001	AC	115,000	1997	72	70	1.5	25	58	Alligator cr, L&T cr, swelling
TLB	001	AAC	16,650	1997	70	64	1.8	-	100	Block cr, L&T cr, raveling
TLC	001	AAC	29,700	2005	88	81	1.6	-	100	L&T cr
TLD	001	AC	78,000	1991	71	72	1.1	-	100	Block cr, L&T cr
TLE	001	AC	73,700	2007	69	66	3.3	31	69	Alligator cr, L&T cr
TLE	002	AC	10,500	2012	95	91	1.7	-	100	L&T cr
