# Pavement Condition Report

## Rochester International Airport (RST)

**December 2017**

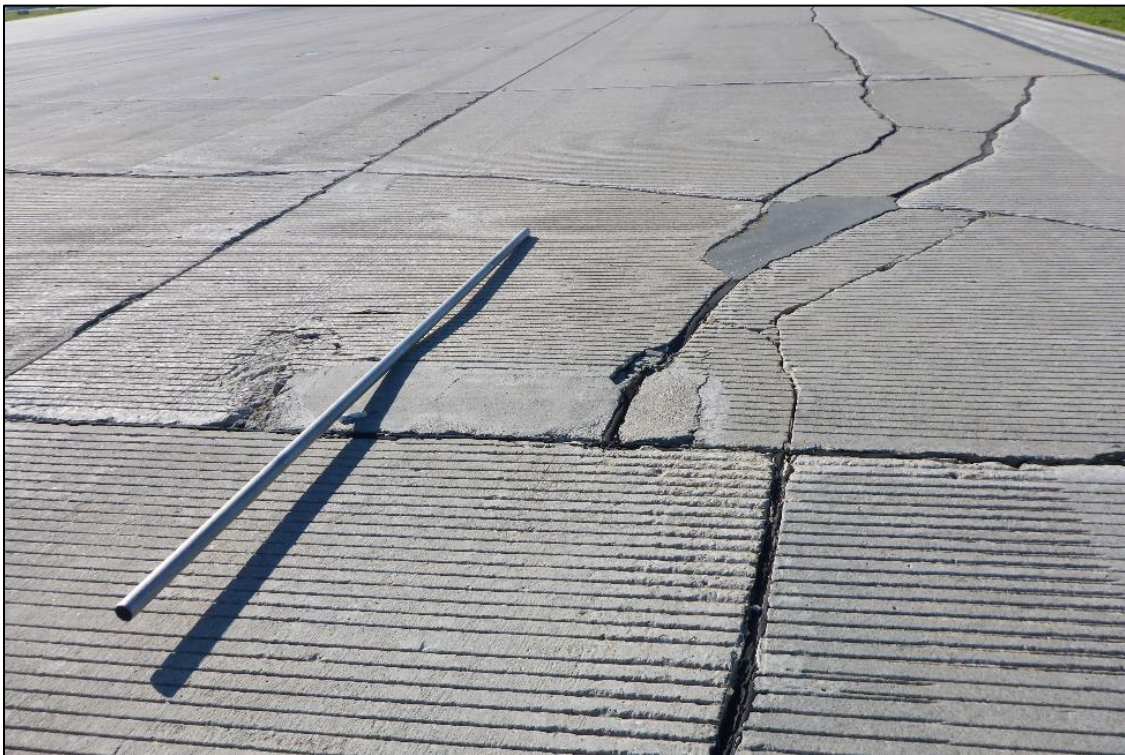
RST RY1331 01W BLOWUP (PCI = 46)
