Pavement Condition Report

Ortonville Municipal Airport-Martinson Field (VWV)

December 2017

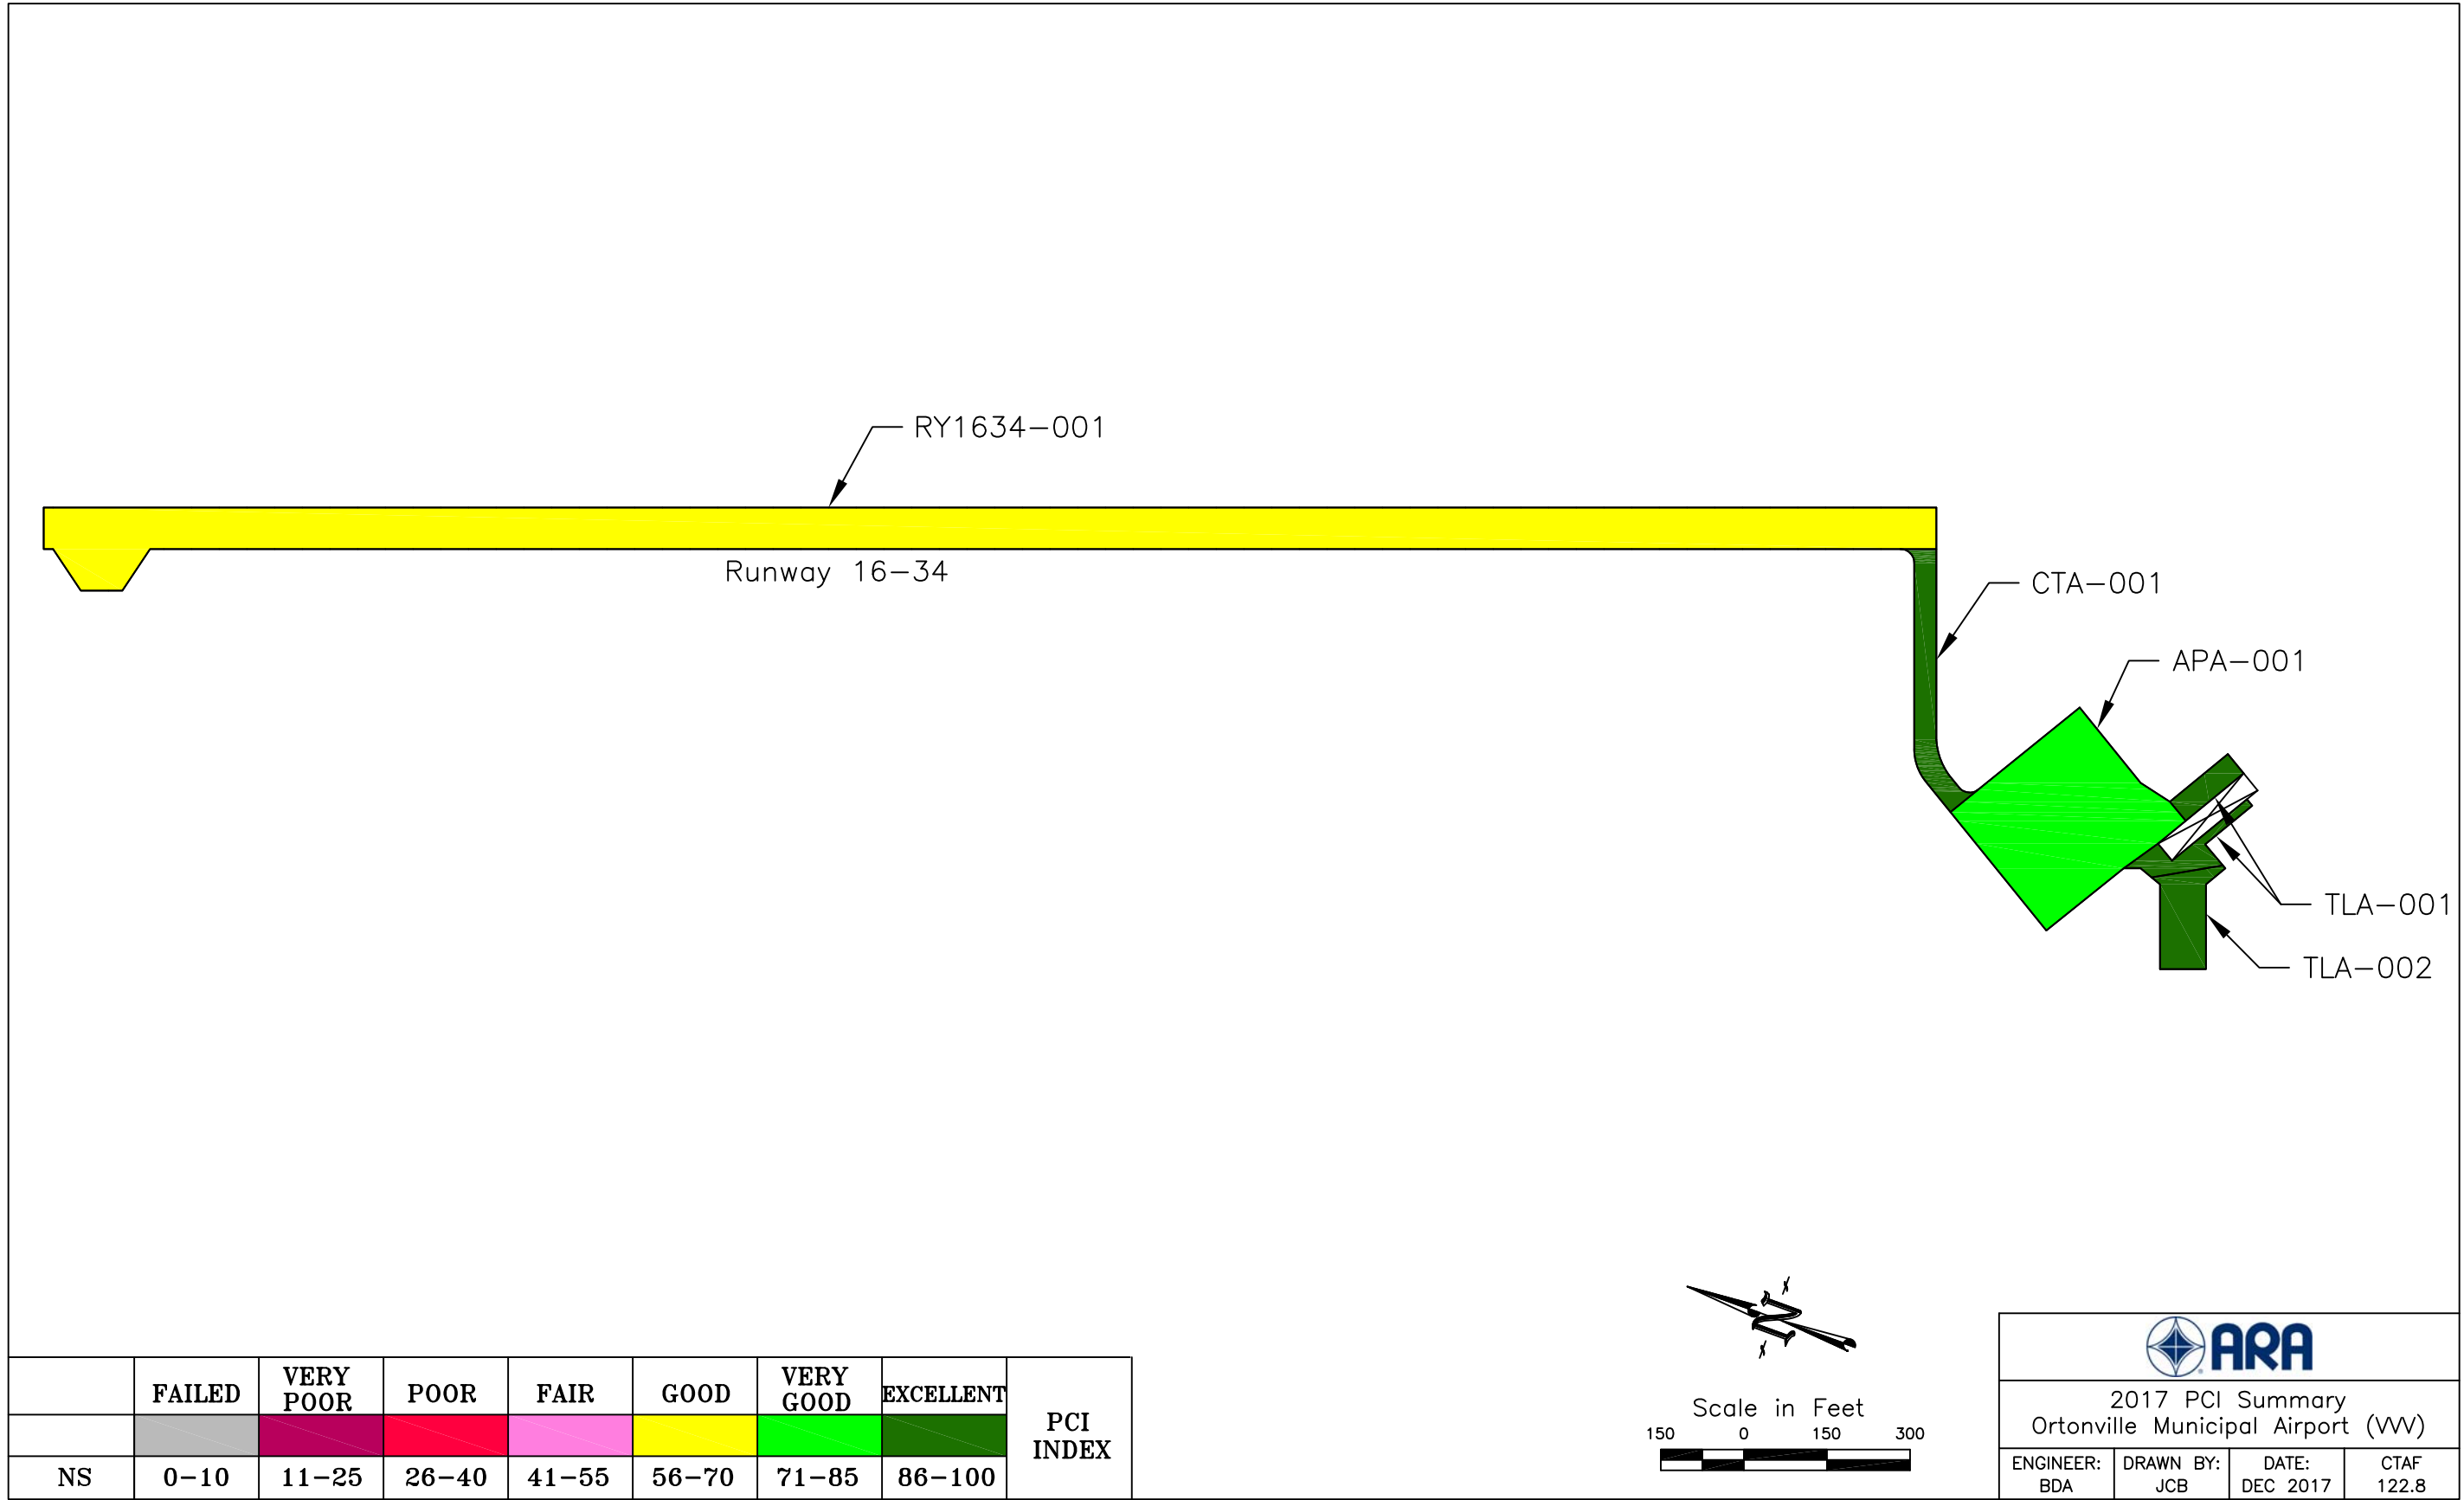
Figure 4. 2017 Pavement Condition Index Rating at Ortonville Municipal Airport (VW).

Figures 5 and 6 present the overall PCI for VVV by area distribution and pavement use, respectively. Table 3 presents the PCI summary for each section at VVV, including the drop in PCI per year. Generally, pavement sections will deteriorate between 1 and 3 PCI points per year. Sections deteriorating at higher rates may need maintenance above the normal application rates and should be closely monitored in case major repairs become necessary earlier than expected.
