Pavement Condition Report

Bemidji Regional Airport (BJI)

December 2018

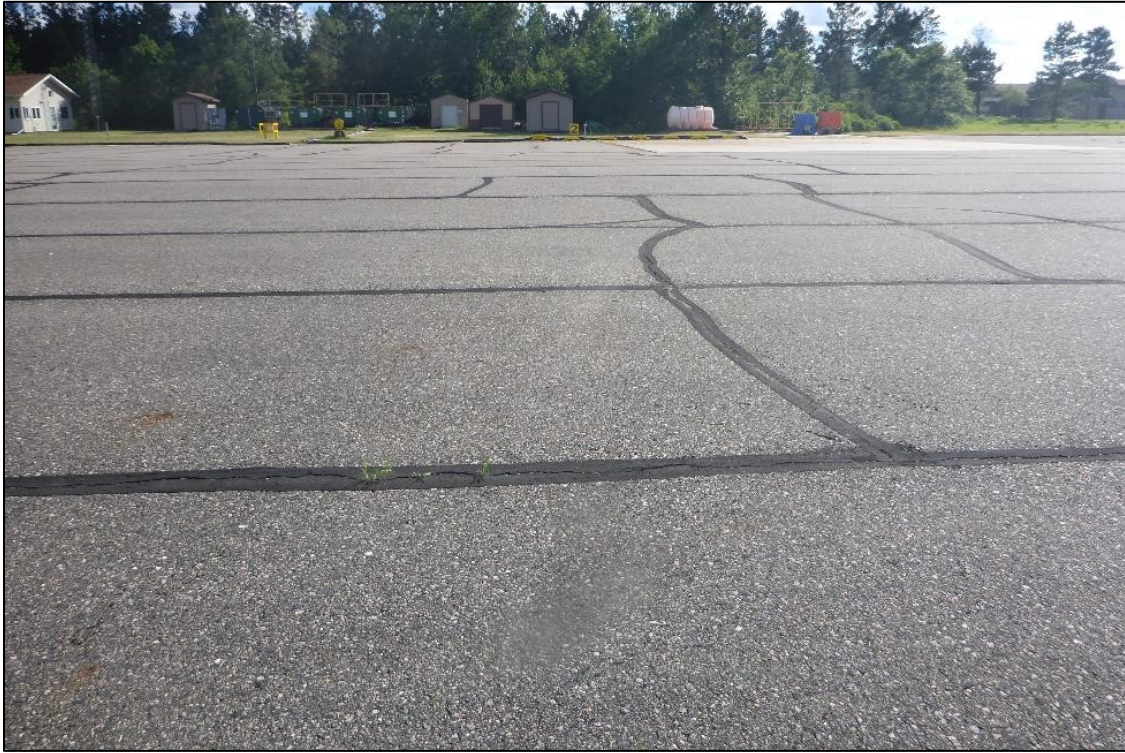
BJI ADNR 001 (PCI = 62)

Branch ID	Section ID	Surface type ¹	Section area (SF)	LCD ²	2015 PCI	2018 PCI	Drop in PCI/Yr ³	% Deduct due to		Distress types
								Load ⁴	Climate ⁵	
ADNR	001	AC	78,100	1995	70	63	1.6	-	100	L&T cr, Weathering
ADNR	002	PCC	8,000	1995	99	99	0.0	-	-	Shrinkage cr
APA	001	AAC	85,000	2002	84	86	0.9	-	82	L&T cr, Oil spillage
APB	001	PCC	72,650	1949	95	94	0.1	-	23	Jt seal damage, Large patch, Joint spall, Corner spall
APB	002	PCC	12,900	1974	83	70	0.7	47	-	Linear cr, Small patch, Large patch, Scaling, Corner spall
APB	003	PCC	93,245	1974	58	49	1.2	83	3	Corner break, Linear cr, Jt seal damage, Large patch, Faulting, Shat. slab, Shrinkage cr, Joint spall, Corner spall
APB	004	PCC	36,090	1989	91	81	0.7	-	30	Jt seal damage, Joint spall
CTC	001	AC	23,350	2008	91	91	0.9	-	100	L&T cr
CTD	001	AC	22,300	2008	93	82	1.8	-	100	L&T cr, Weathering
CTJ	001	AC	73,300	2018	-	100	0.0	-	-	-
PTA	001	AC	75,525	2008	98	93	0.7	-	100	L&T cr, Weathering

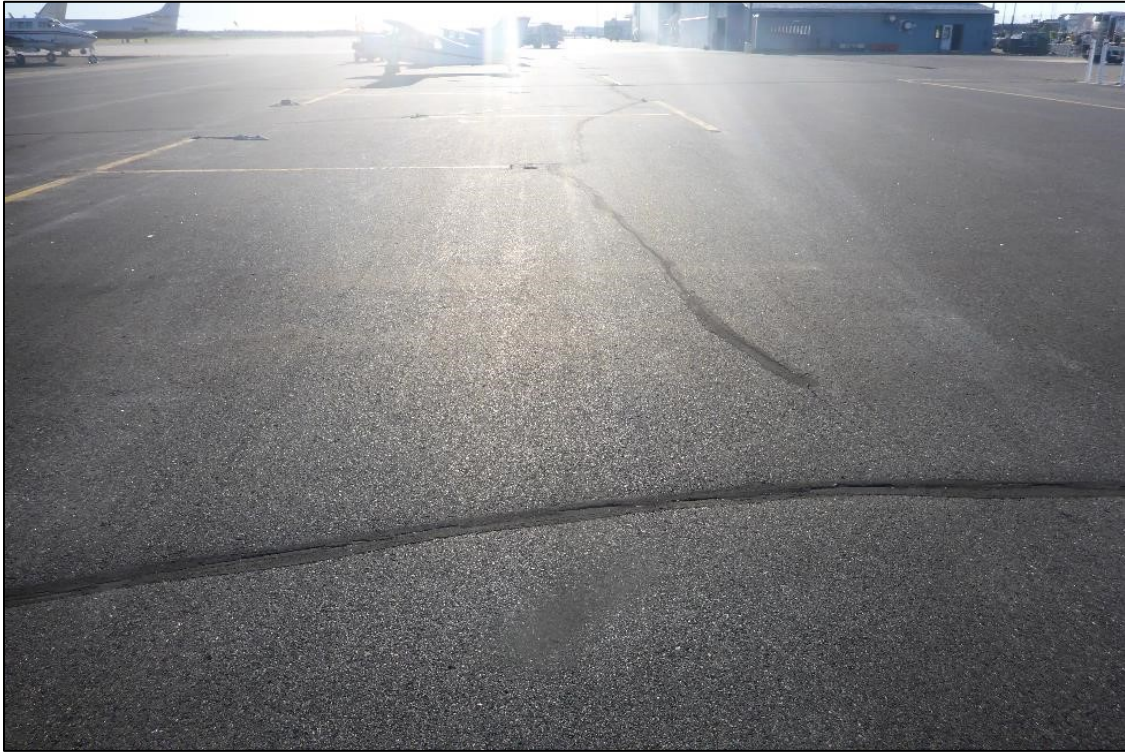
BJI APA 001 (PCI = 86)

Network:	BJI		Name:	BEMIDJI			
Branch:	APA	Name:	APRON A	Use:	APRON	Area:	85,000 SqFt
Section:	001	of 1	From:	100	To:	502	Last Const.: 9/26/2002
Surface:	AAC	Family:	MN2018 Asphalt Aprons	Zone:	N	Category:	2
Area:	85,000 SqFt	Length:	340 Ft	Width:	250 Ft	Rank:	S
Slabs:	Slab Length:	Ft	Slab Width:	Ft	Joint Length:	Ft	
Shoulder:	Street Type:		Grade:	0	Lanes:	0	
Last Insp. Date:	7/1/2018	Total Samples:	17	Surveyed:	3		
Conditions:	PCI:	86					
Sample Number:	202	Type:	R	Area:	5000.00 SqFt	PCI:	84
48	L & T CR	M	16.00 Ft				
48	L & T CR	L	173.00 Ft				
Sample Number:	301	Type:	R	Area:	4000.00 SqFt	PCI:	93
48	L & T CR	L	74.00 Ft				
Sample Number:	400	Type:	R	Area:	5000.00 SqFt	PCI:	82
48	L & T CR	M	14.00 Ft				
48	L & T CR	L	114.00 Ft				
49	OIL SPILLAGE	N	80.00 SqFt

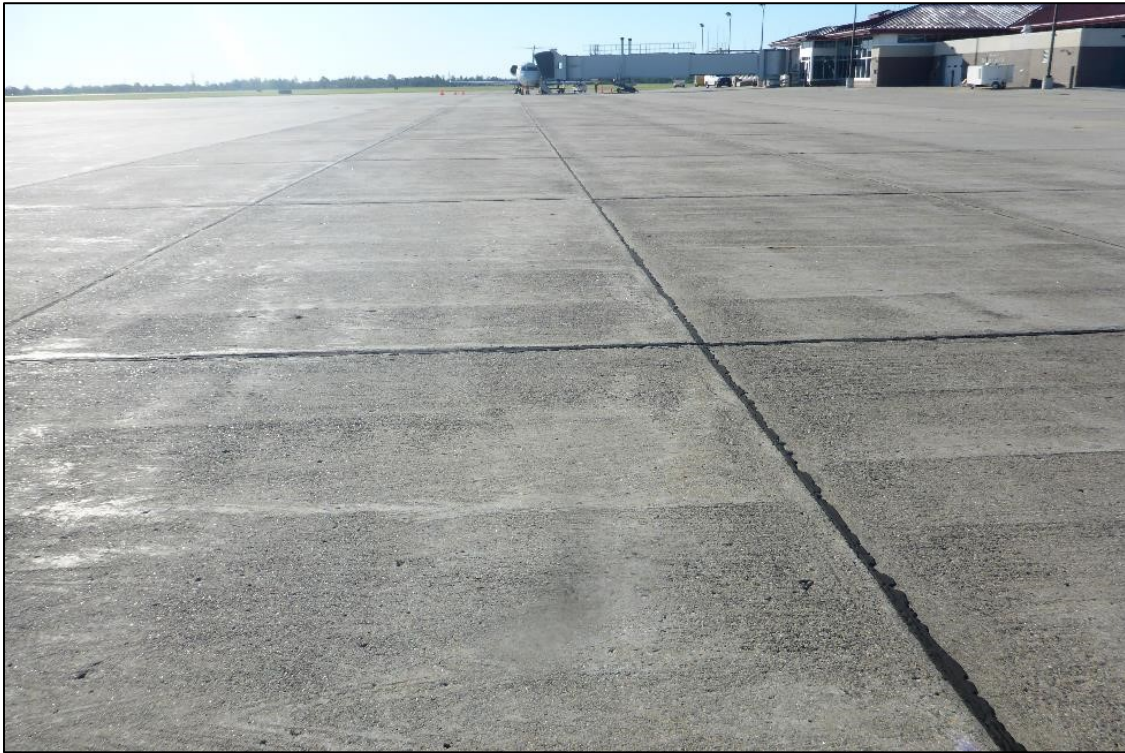
BJI APB 001 (PCI = 94)

Network:	BJI		Name:	BEMIDJI			
Branch:	APB	Name:	APRON B	Use:	APRON	Area:	214,885 SqFt
Section:	001	of 4	From:	200	To:	303	Last Const.: 9/30/1949
Surface:	PCC	Family:	MN2018 PCC	Zone:	N	Category:	2
Area:	72,650 SqFt	Length:	435 Ft	Width:	250 Ft	Rank:	P
Slabs:	291	Slab Length:	20 Ft	Slab Width:	13 Ft	Joint Length:	13,452 Ft
Shoulder:		Street Type:		Grade:	0	Lanes:	0
Last Insp. Date:	7/1/2018	Total Samples:	13	Surveyed:	4		
Conditions:	PCI: 94						
Sample Number:	202	Type:	R	Area:	16.00 Slabs	PCI:	81
65	JT SEAL DMG	L		16.00	Slabs		
74	JOINT SPALL	M		1.00	Slabs		
67	LARGE PATCH	L		4.00	Slabs		
Sample Number:	204	Type:	R	Area:	22.00 Slabs	PCI:	96
75	CORNER SPALL	M		1.00	Slabs		
Sample Number:	206	Type:	R	Area:	16.00 Slabs	PCI:	95
74	JOINT SPALL	M		1.00	Slabs		
Sample Number:	301	Type:	R	Area:	24.00 Slabs	PCI:	100

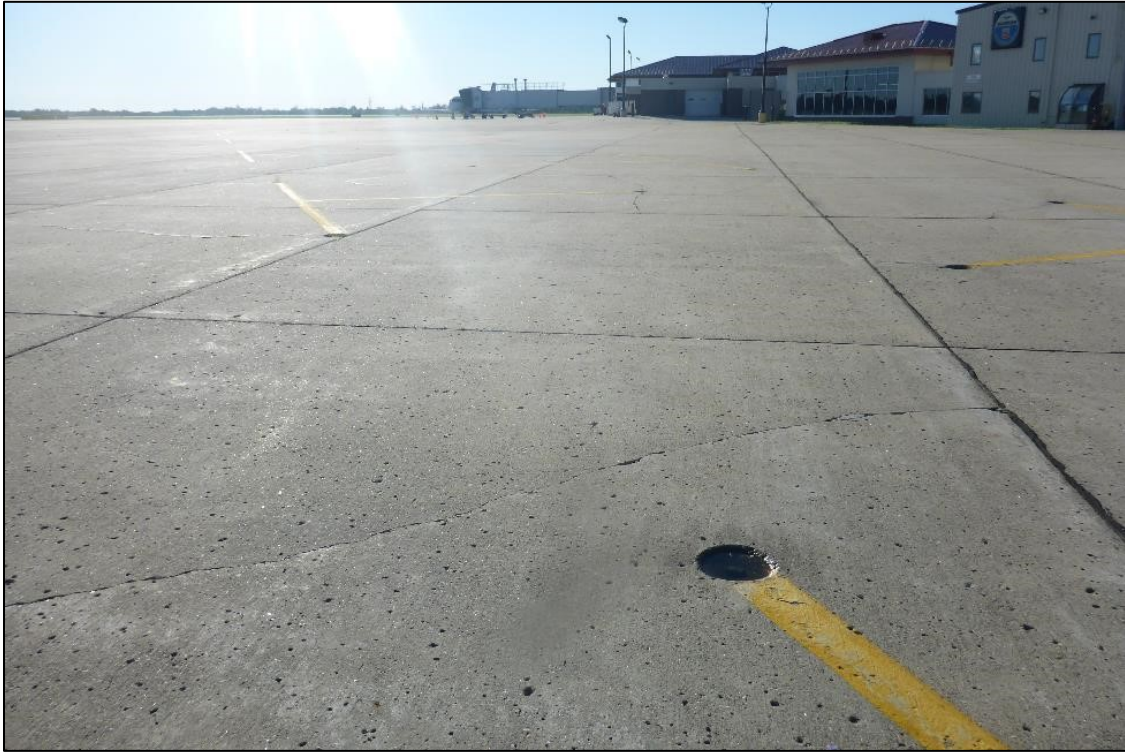
BJI APB 003 (PCI = 49)

Network:	BJI		Name:	BEMIDJI					
Branch:	APB	Name:	APRON B	Use:	APRON	Area:	214,885 SqFt		
Section:	003	of 4	From:	104	To:	116	Last Const.:	9/28/1974	
Surface:	PCC	Family:	MN2018 PCC	Zone:	N	Category:	2	Rank:	P
Area:	93,245 SqFt	Length:	357 Ft	Width:	242 Ft				
Slabs:	274	Slab Length:	20 Ft	Slab Width:	17 Ft	Joint Length:	8,803 Ft		
Shoulder:		Street Type:		Grade:	0	Lanes:	0		
Last Insp. Date:	7/1/2018	Total Samples:	13	Surveyed:	4				
Conditions:	PCI: 49								
Sample Number:	103	Type:	R	Area:	20.00 Slabs	PCI:	51		
67	LARGE PATCH	L		1.00	Slabs				
63	LINEAR CR	M		5.00	Slabs				
73	SHRINKAGE CR	N		1.00	Slabs				
63	LINEAR CR	L		1.00	Slabs				
62	CORNER BREAK	H		1.00	Slabs				
71	FAULTING	L		1.00	Slabs				
Sample Number:	104	Type:	R	Area:	20.00 Slabs	PCI:	55		
63	LINEAR CR	M		4.00	Slabs				
75	CORNER SPALL	H		1.00	Slabs				
63	LINEAR CR	L		3.00	Slabs				
71	FAULTING	L		3.00	Slabs				
73	SHRINKAGE CR	N		2.00	Slabs

Sample Number:	105	Type:	R	Area:	20.00 Slabs	PCI:	35		
63	LINEAR CR	M		13.00	Slabs				
65	JT SEAL DMG	L		20.00	Slabs				
73	SHRINKAGE CR	N		1.00	Slabs				
72	SHAT. SLAB	M		1.00	Slabs				
74	JOINT SPALL	M		1.00	Slabs				
Sample Number:	110	Type:	R	Area:	20.00 Slabs	PCI:	54		
73	SHRINKAGE CR	N		3.00	Slabs				
72	SHAT. SLAB	M		1.00	Slabs				
63	LINEAR CR	M		5.00	Slabs				
65	JT SEAL DMG	L		20.00	Slabs
