Pavement Condition Report

Norman County Ada-Twin Valley Airport (D00)

December 2018

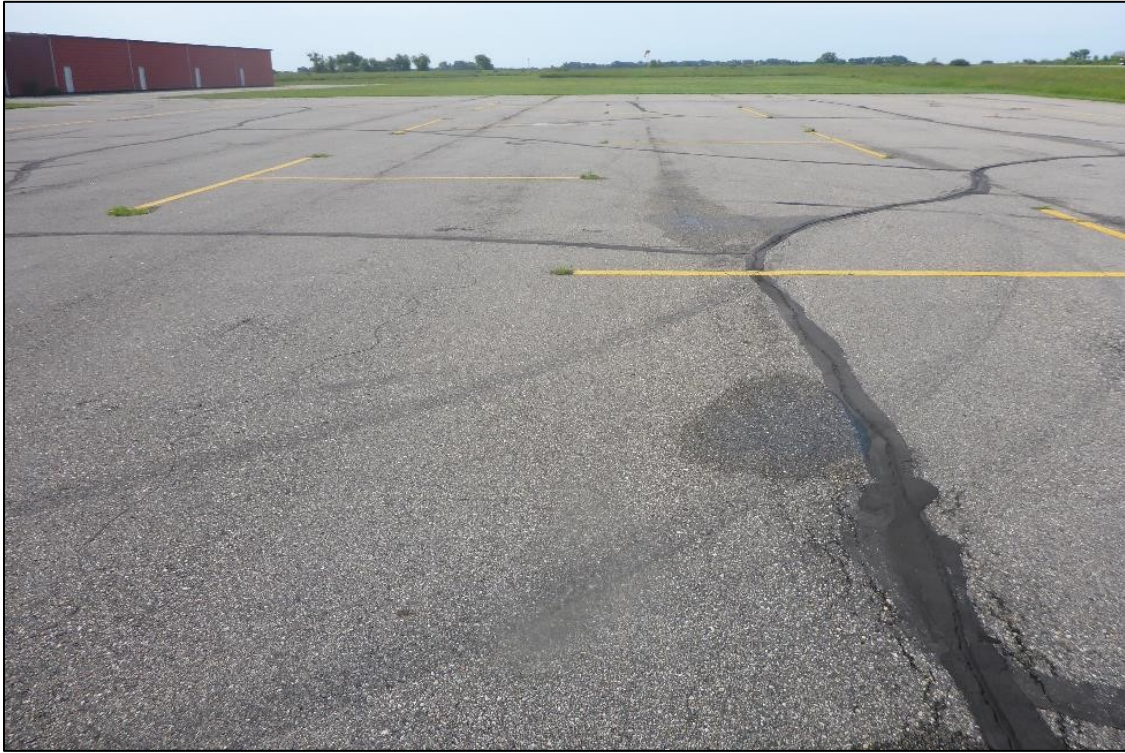
D00 APA 001 (PCI = 59)

Network: D00	Name: NORMAN CO. - ADA, TWIN VALLEY				
Branch: APA	Name: APRON A	Use: APRON	Area: 52,500 SqFt		
Section: 001	of 1	From: 100	To: 402	Last Const.: 6/30/2003	
Surface: AAC	Family: MN2018 Asphalt Aprons	Zone: W	Category: 2	Rank: S	
Area: 52,500 SqFt	Length: 300 Ft	Width: 170 Ft			
Slabs:	Slab Length: Ft	Slab Width: Ft	Joint Length: Ft		
Shoulder:	Street Type:	Grade: 0	Lanes: 0		
Last Insp. Date: 7/4/2018	Total Samples: 12	Surveyed: 3			
Conditions: PCI: 59					
Sample Number: 100	Type: R	Area: 5000.00 SqFt	PCI: 44		
41 ALLIGATOR CR	M	12.00 SqFt			
52 RAVELING	L	50.00 SqFt			
48 L & T CR	L	358.00 Ft			
57 WEATHERING	L	4900.00 SqFt			
56 SWELLING	H	8.00 SqFt			
56 SWELLING	L	70.00 SqFt			
48 L & T CR	M	75.00 Ft			
Sample Number: 201	Type: R	Area: 5000.00 SqFt	PCI: 66		
57 WEATHERING	L	4900.00 SqFt			
48 L & T CR	M	75.00 Ft			
56 SWELLING	L	40.00 SqFt			
48 L & T CR	L	302.00 Ft			
52 RAVELING	M	75.00 SqFt

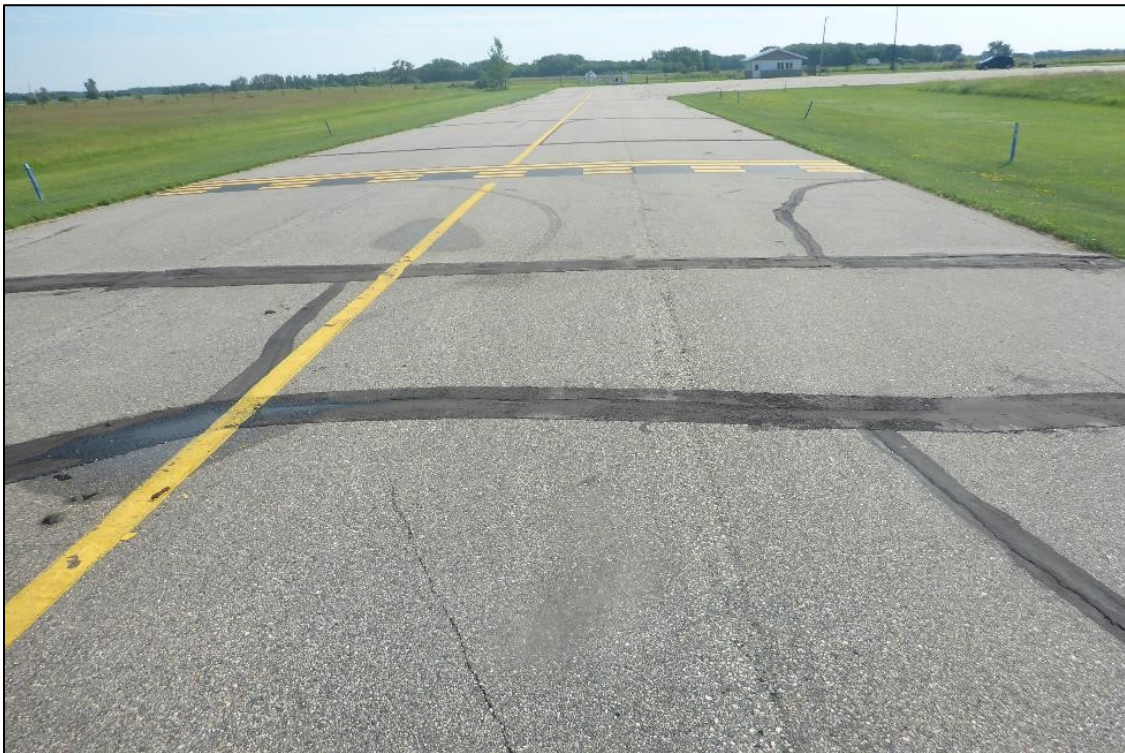
D00 CTA 001 (PCI = 80)

Network:	D00	Name:	NORMAN CO. - ADA, TWIN VALLEY						
Branch:	CTA	Name:	CONNECTING TAXIWAY A	Use:	TAXIWAY	Area:	13,600 SqFt		
Section:	001	of	1	From:	100	To:	102	Last Const.:	6/30/2003
Surface:	AAC	Family:	MN2018 Asphalt Runway- Taxiways	Zone:	W	Category:	2	Rank:	P
Area:	13,600 SqFt	Length:	320 Ft	Width:	40 Ft				
Slabs:		Slab Length:	Ft	Slab Width:	Ft	Joint Length:	Ft		
Shoulder:		Street Type:		Grade:	0	Lanes:	0		
Last Insp. Date:	7/4/2018	TotalSamples:	3	Surveyed:	1				
Conditions:	PCI: 80								
Sample Number:	101	Type:	R	Area:	4000.00 SqFt	PCI:	80		
57	WEATHERING		L	2000.00	SqFt				
48	L & T CR		L	181.00	Ft				
57	WEATHERING		M	50.00	SqFt

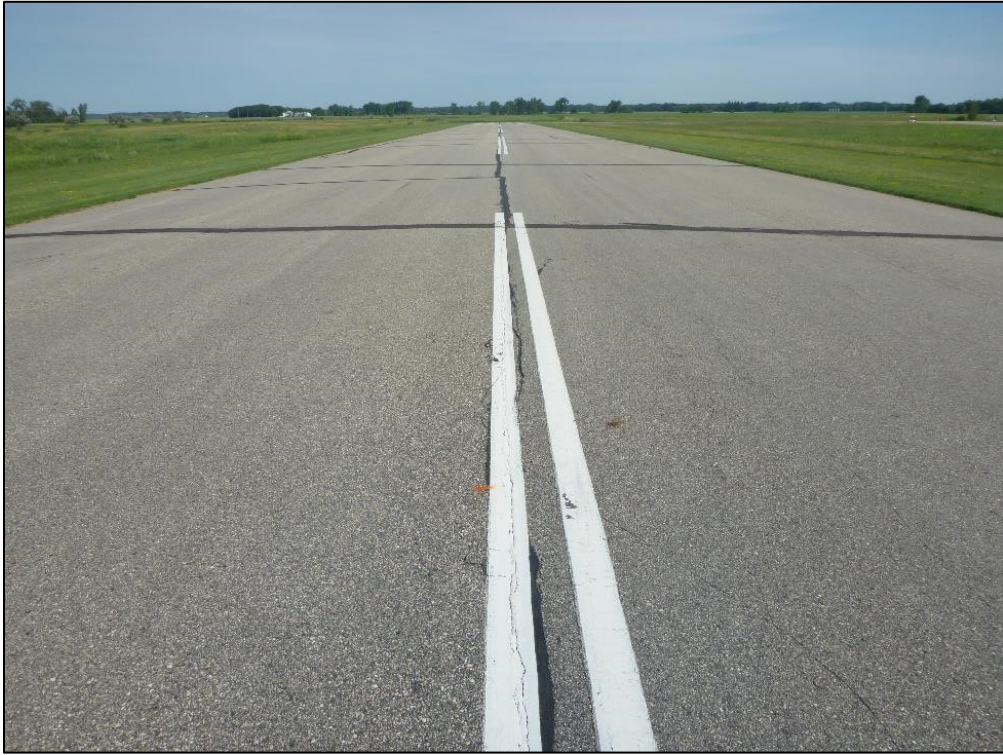
D00 RY1533 001 (PCI = 72)

Network:	D00		Name:	NORMAN CO. - ADA, TWIN VALLEY					
Branch:	RY1533	Name:	RUNWAY 15-33	Use:	RUNWAY	Area:	196,550 SqFt		
Section:	001	of 1	From:	100	To:	163	Last Const.:	6/30/2003	
Surface:	AAC	Family:	MN2018 Asphalt Runway- Taxiways	Zone:	W	Category:	2	Rank:	P
Area:	196,550 SqFt	Length:	3,266 Ft	Width:	60 Ft				
Slabs:		Slab Length:	Ft	Slab Width:	Ft	Joint Length:	Ft		
Shoulder:		Street Type:		Grade:	0	Lanes:	0		
Last Insp. Date:	7/4/2018	TotalSamples:	64	Surveyed:	6				
Conditions:	PCI: 72								
Sample Number:	109	Type:	R	Area:	3000.00 SqFt	PCI:	73		
57	WEATHERING	L		1000.00	SqFt				
48	L & T CR	M		13.00	Ft				
48	L & T CR	L		194.00	Ft				
Sample Number:	118	Type:	R	Area:	3000.00 SqFt	PCI:	79		
57	WEATHERING	L		1000.00	SqFt				
48	L & T CR	L		121.00	Ft				
48	L & T CR	M		17.00	Ft				
Sample Number:	127	Type:	R	Area:	3000.00 SqFt	PCI:	72		
57	WEATHERING	L		1000.00	SqFt				
48	L & T CR	L		226.00	Ft				
48	L & T CR	M		9.00	Ft

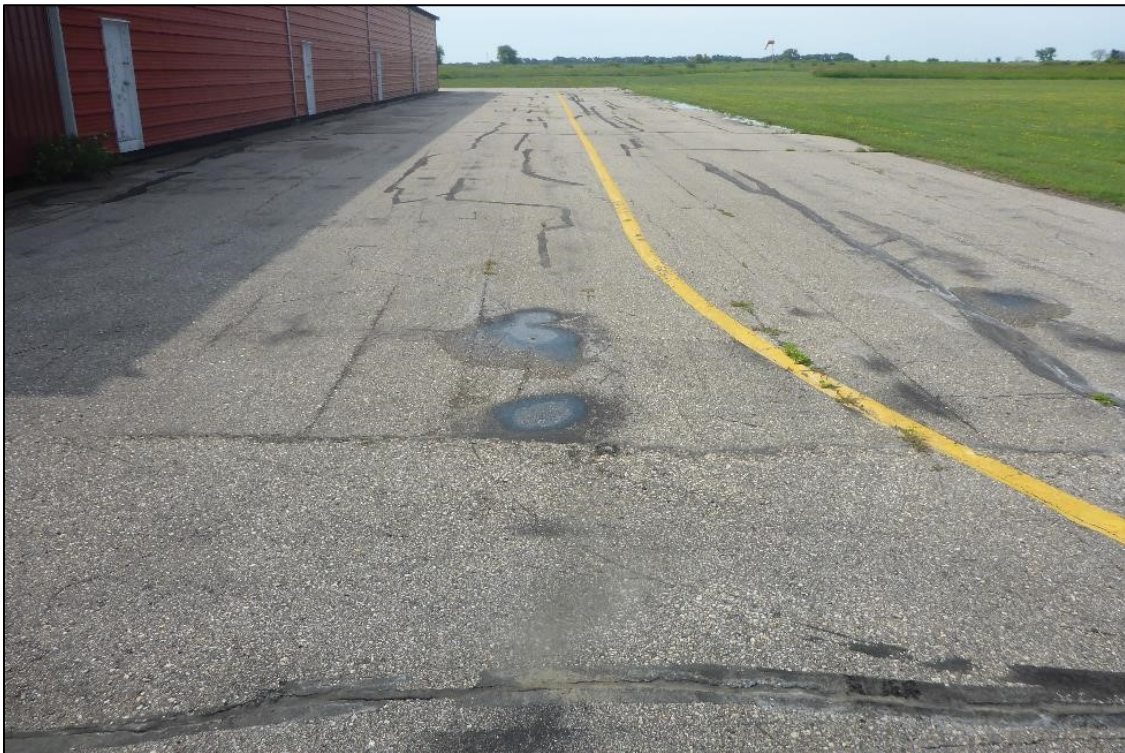
D00 TLA 001 (PCI = 39)

Network:	D00		Name:	NORMAN CO. - ADA, TWIN VALLEY					
Branch:	TLA	Name:	Taxilane A	Use:	TAXILANE	Area:	33,110 SqFt		
Section:	001	of 1	From:	100	To:	107	Last Const.:	6/1/1995	
Surface:	AC	Family:	MN2018 Asphalt Taxilanes	Zone:	W	Category:	2	Rank:	T
Area:	33,110 SqFt	Length:	670 Ft	Width:	50 Ft				
Slabs:	Slab Length:	Ft	Slab Width:	Ft	Joint Length:	Ft			
Shoulder:	Street Type:	Grade:	0	Lanes:	0				
Last Insp. Date:	7/4/2018	TotalSamples:	8	Surveyed:	3				
Conditions:	PCI: 39								
Sample Number:	101	Type:	R	Area:	4200.00 SqFt	PCI:	39		
41	ALLIGATOR CR	M		51.00	SqFt				
56	SWELLING	L		86.00	SqFt				
57	WEATHERING	L		2000.00	SqFt				
52	RAVELING	L		200.00	SqFt				
48	L & T CR	L		701.00	Ft				
45	DEPRESSION	L		80.00	SqFt				
48	L & T CR	M		28.00	Ft				
Sample Number:	102	Type:	R	Area:	3780.00 SqFt	PCI:	43		
56	SWELLING	L		180.00	SqFt				
57	WEATHERING	H		70.00	SqFt				
57	WEATHERING	L		2000.00	SqFt				
52	RAVELING	M		33.00	SqFt
