Pavement Condition Report

Fergus Falls Municipal Airport (FFM)

December 2018

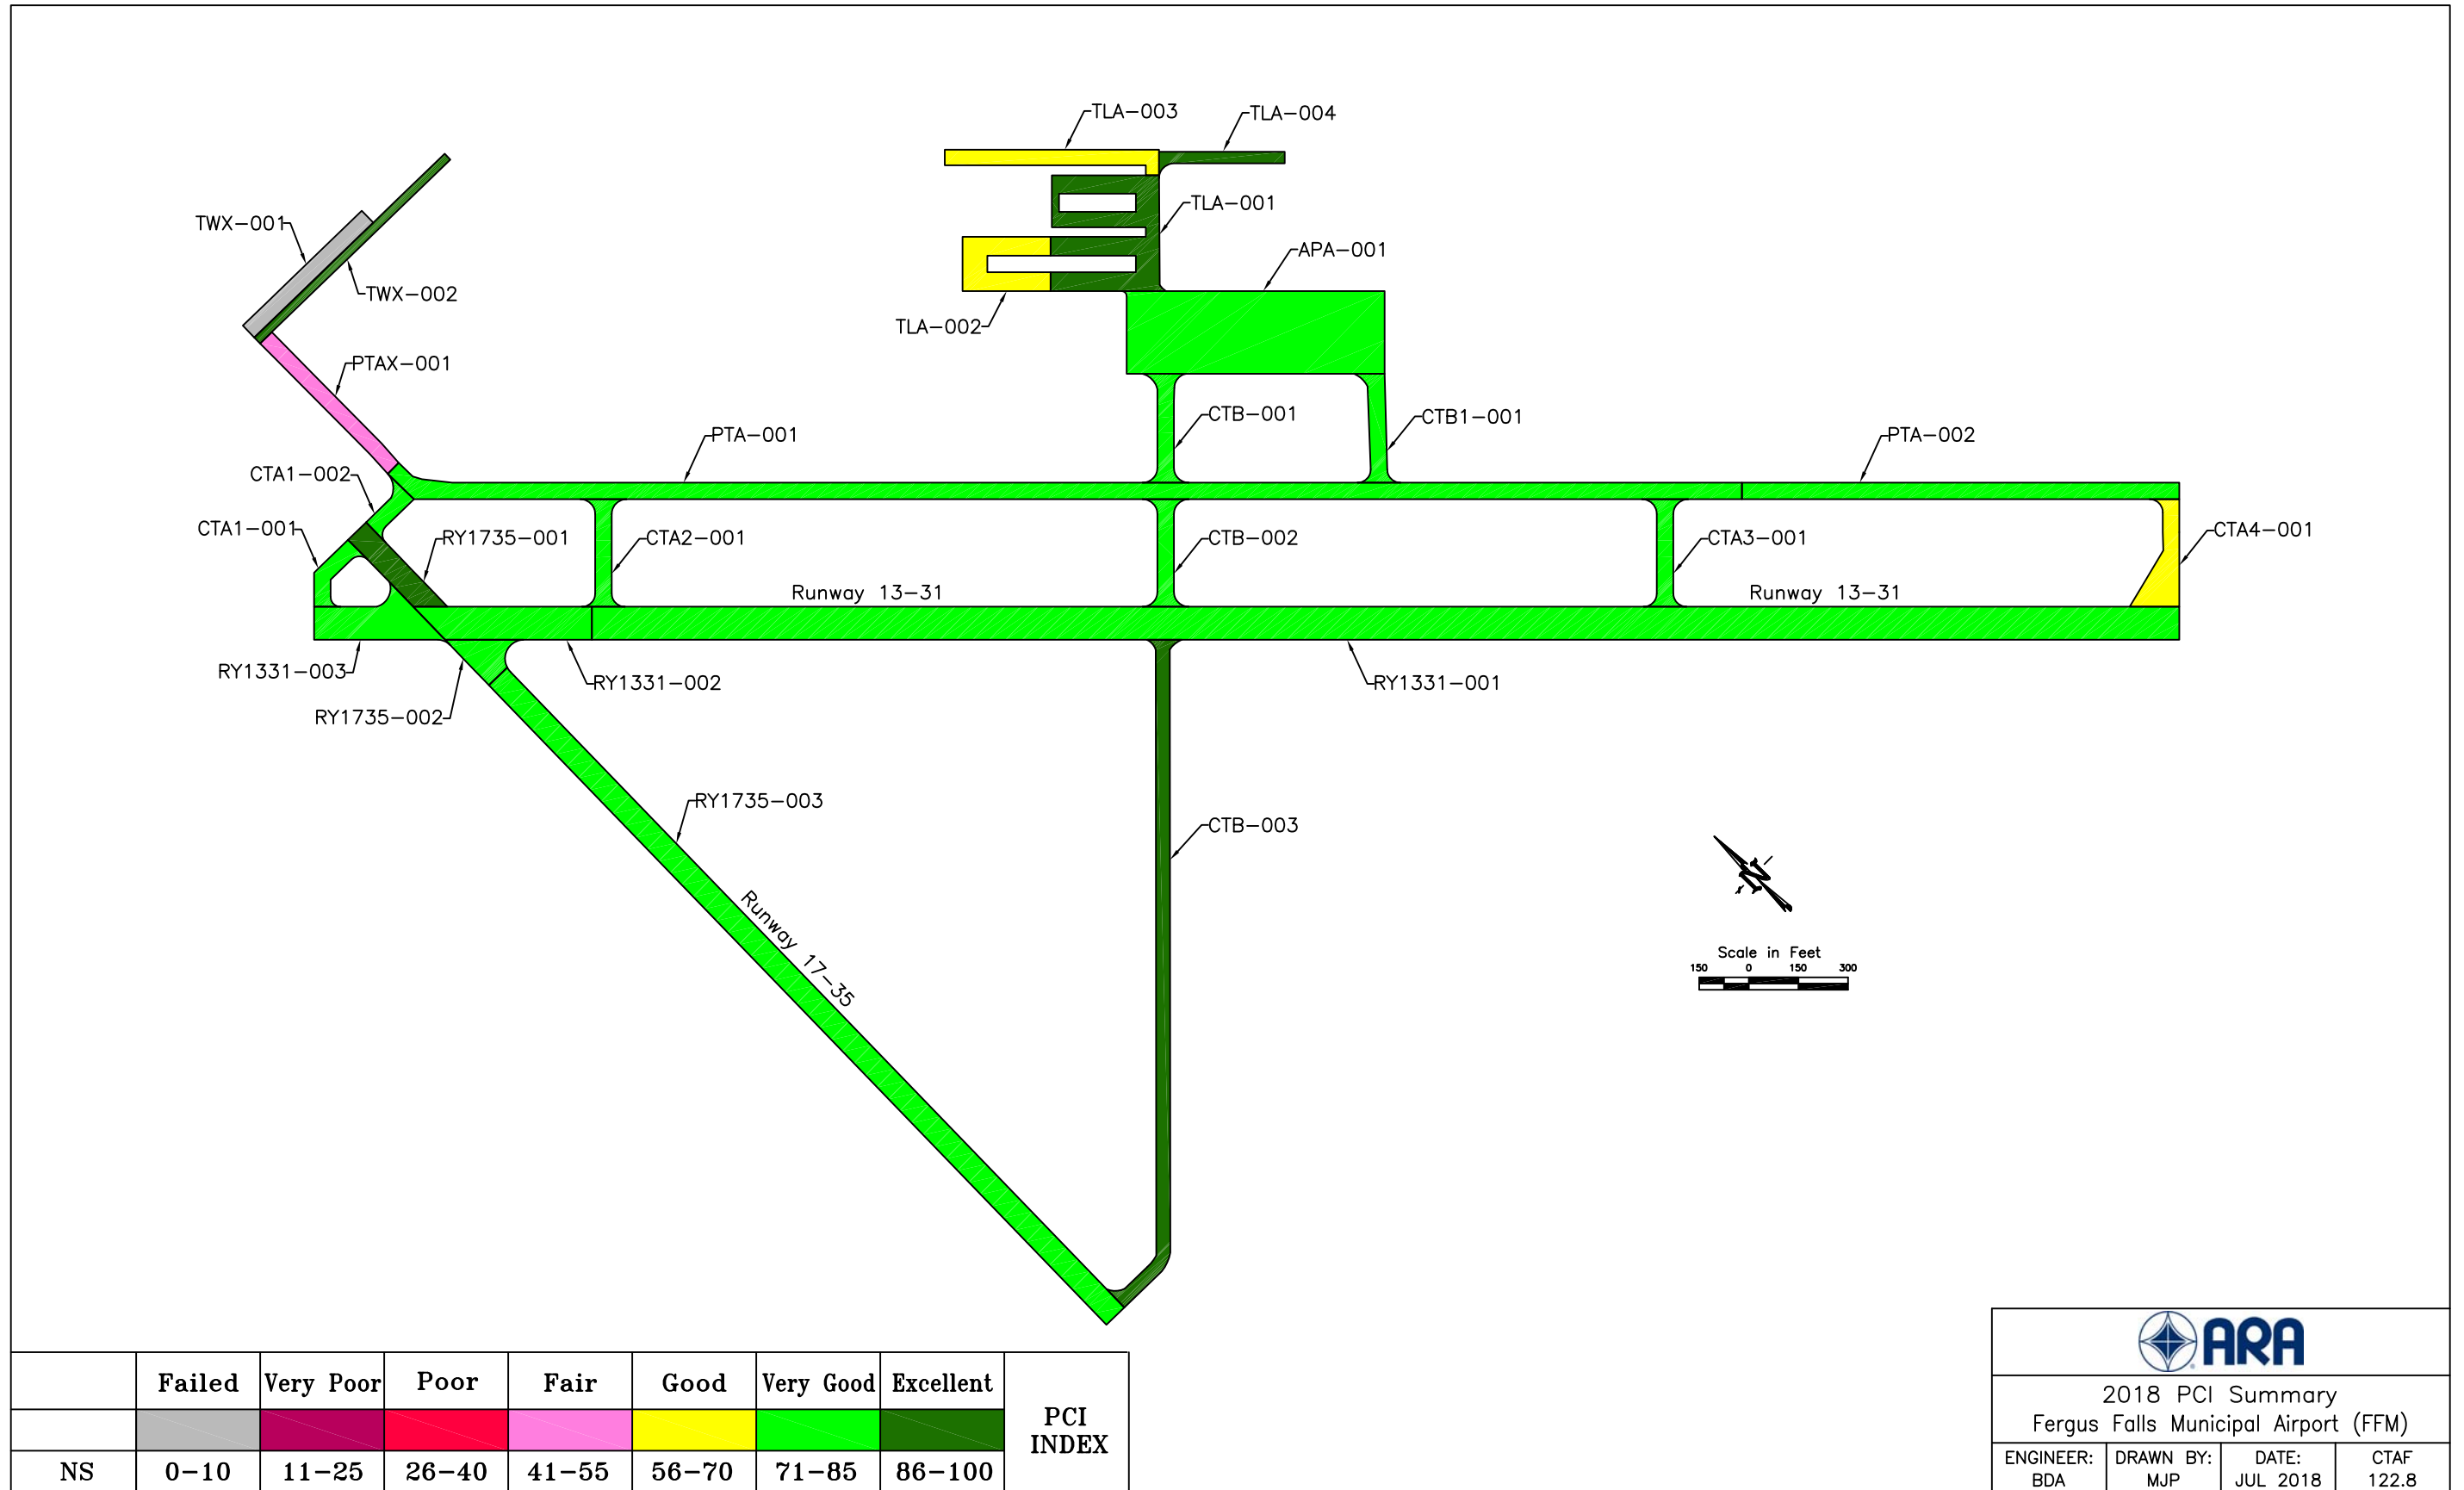
Figure 4. 2018 Pavement Condition Index Rating at Fergus Falls Municipal Airport (FFM).

Figures 5 and 6 present the overall PCI for FFM by area distribution and pavement use, respectively. Table 3 presents the PCI summary for each section at FFM, including the drop in PCI per year. Generally, pavement sections will deteriorate between 1 and 3 PCI points per year. Sections deteriorating at higher rates may need maintenance above the normal application rates and should be closely monitored in case major repairs become necessary earlier than expected.

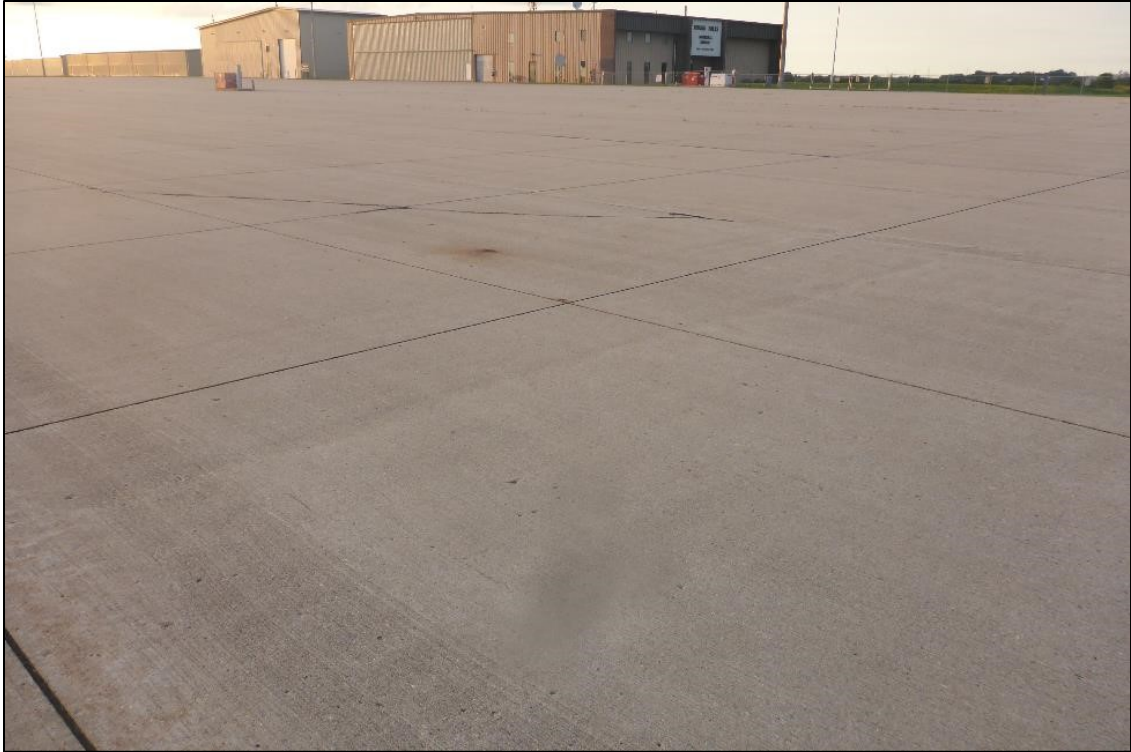
FFM APA 001 (PCI = 80)

65	JT SEAL DMG	M	20.00 Slabs
62	CORNER BREAK	M	1.00 Slabs
74	JOINT SPALL	M	1.00 Slabs
62	CORNER BREAK	L	1.00 Slabs
63	LINEAR CR	M	1.00 Slabs
71	FAULTING	L	3.00 Slabs

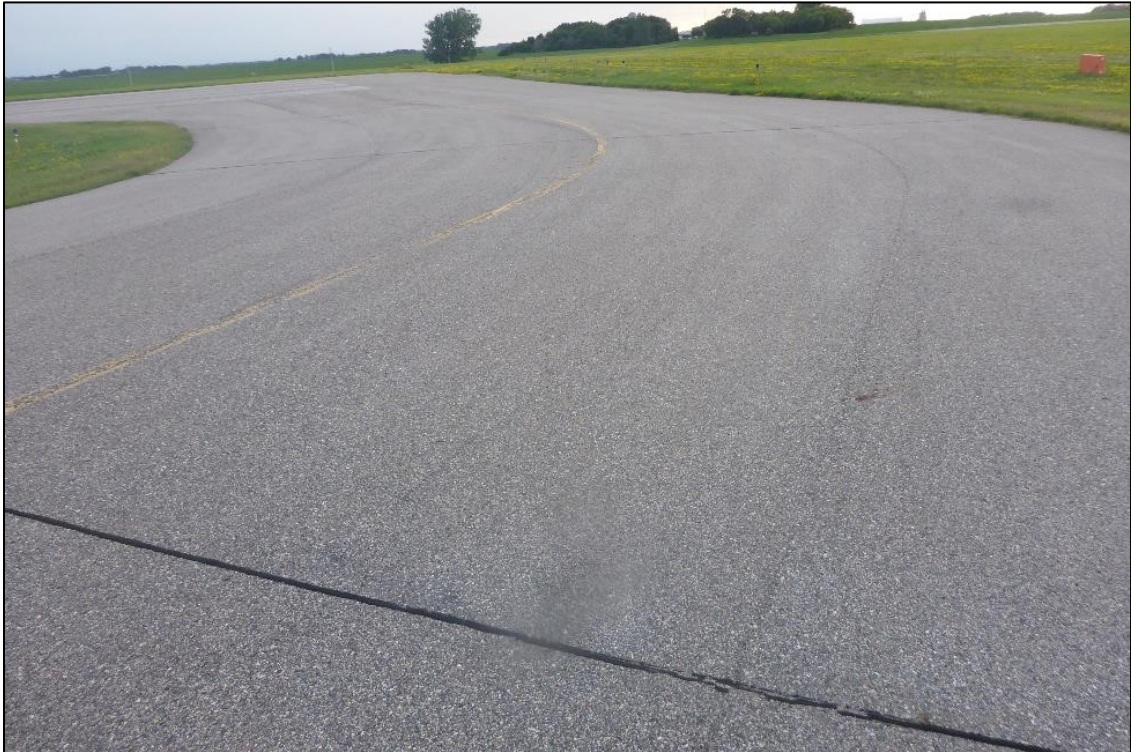
FFM CTA1 001 (PCI = 82)

Network:	FFM	Name:	FERGUS FALLS						
Branch:	CTA1	Name:	CONNECTING TAXIWAY A1	Use:	TAXIWAY	Area:	20,450 SqFt		
Section:	001	of 2	From:	100	To:	101	Last Const.:	12/15/2001	
Surface:	AC	Family:	MN2018 Asphalt Runway- Taxiways	Zone:	W	Category:	2	Rank:	P
Area:	11,700 SqFt	Length:	225 Ft	Width:	50 Ft				
Slabs:		Slab Length:	Ft	Slab Width:	Ft	Joint Length:	Ft		
Shoulder:		Street Type:		Grade:	0	Lanes:	0		
Section Comments:	PFC surface								
Last Insp. Date:	7/5/2018	TotalSamples:	2	Surveyed:	1				
Conditions:	PCI: 82								
Inspection Comments:									
Sample Number:	301	Type:	R	Area:	5000.00 SqFt	PCI:	82		
Sample Comments:									
48	L & T CR	L	111.00	Ft					
48	L & T CR	M	22.00	Ft					
57	WEATHERING	L	4900.00	SqFt

Network:	FFM	Name:	FERGUS FALLS						
Branch:	CTA1	Name:	CONNECTING TAXIWAY A1	Use:	TAXIWAY	Area:	20,450 SqFt		
Section:	002	of 2	From:	200	To:	200	Last Const.:	12/15/2001	
Surface:	AC	Family:	MN2018 Asphalt Runway- Taxiways	Zone:	W	Category:	2	Rank:	P
Area:	8,750 SqFt	Length:	137 Ft	Width:	50 Ft				
Slabs:		Slab Length:	Ft	Slab Width:	Ft	Joint Length:	Ft		
Shoulder:		Street Type:		Grade:	0	Lanes:	0		
Section Comments:									
Last Insp. Date:	7/5/2018	TotalSamples:	1	Surveyed:	1				
Conditions:	PCI: 81								
Inspection Comments:									
Sample Number:	400	Type:	R	Area:	8050.00 SqFt	PCI:	81		
Sample Comments:									
48	L & T CR	M	53.00	Ft					
48	L & T CR	L	220.00	Ft					
57	WEATHERING	L	4900.00	SqFt

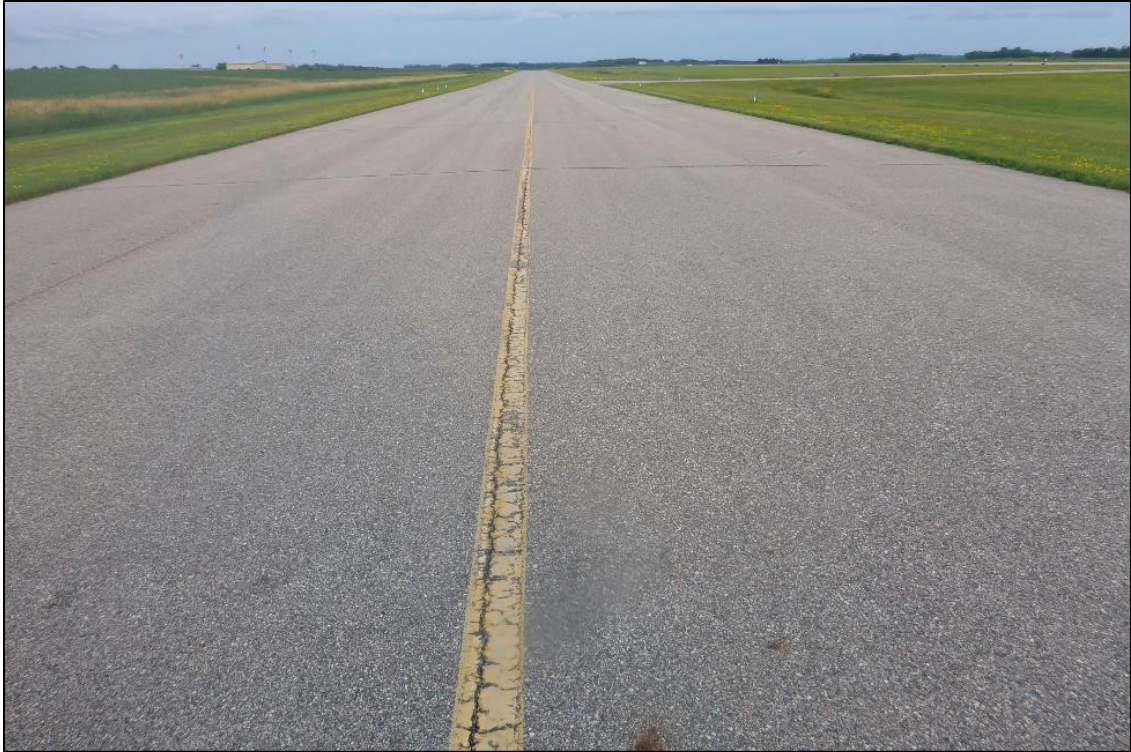
FFM PTA 001 (PCI = 73)

Network:	FFM	Name:	FERGUS FALLS						
Branch:	PTA	Name:	PARALLEL TAXIWAY A	Use:	TAXIWAY	Area:	271,825 SqFt		
Section:	001	of 2	From:	106	To:	145	Last Const.:	12/15/2001	
Surface:	AC	Family:	MN2018 Asphalt Runway- Taxiways	Zone:	W	Category:	2	Rank:	P
Area:	205,700 SqFt	Length:	4,000 Ft	Width:	50 Ft				
Slabs:		Slab Length:	Ft	Slab Width:	Ft	Joint Length:	Ft		
Shoulder:		Street Type:		Grade:	0	Lanes:	0		
Section Comments:									
Last Insp. Date:	7/5/2018	TotalSamples:	40	Surveyed:	4				
Conditions:	PCI: 73								
Inspection Comments:									
Sample Number:	110	Type:	R	Area:	5000.00 SqFt	PCI:	72		
Sample Comments:									
48	L & T CR	M	124.00	Ft					
57	WEATHERING	L	4500.00	SqFt					
48	L & T CR	L	123.00	Ft					
Sample Number:	120	Type:	R	Area:	5000.00 SqFt	PCI:	79		
Sample Comments:									
48	L & T CR	M	74.00	Ft					
48	L & T CR	L	30.00	Ft					
57	WEATHERING	L	4500.00	SqFt					
Sample Number:	130	Type:	R	Area:	5000.00 SqFt	PCI:	66

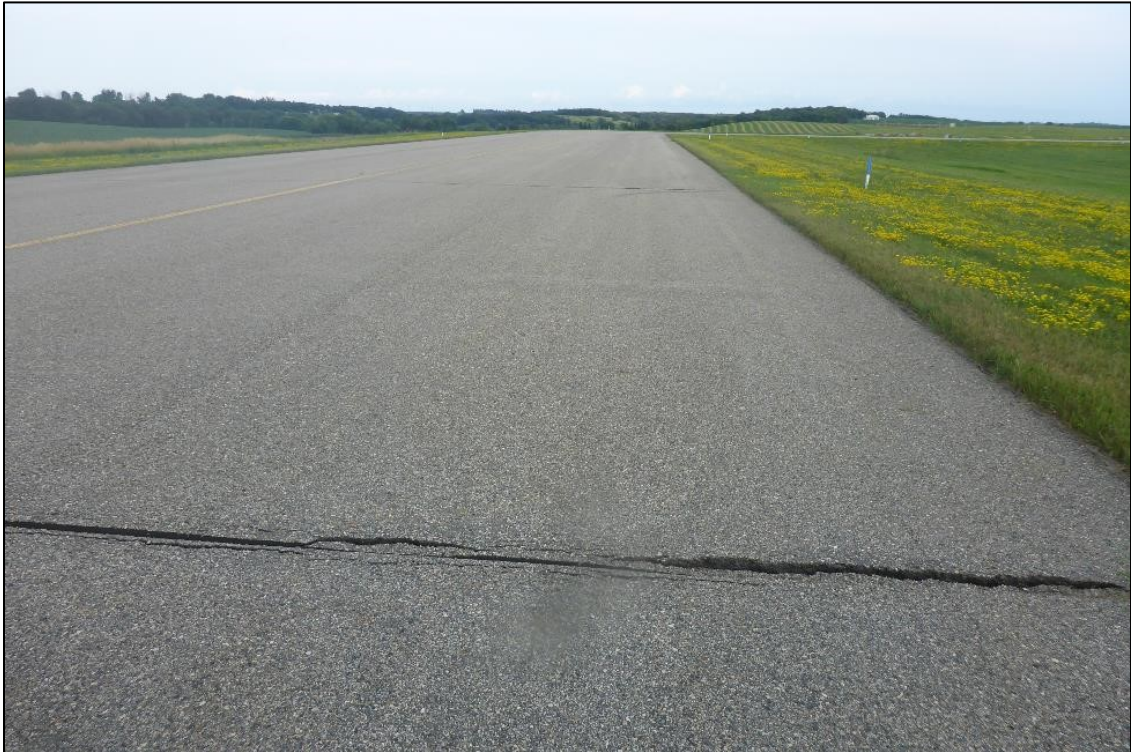
FFM PTA 002 (PCI = 71)

Network:	FFM	Name:	FERGUS FALLS						
Branch:	PTA	Name:	PARALLEL TAXIWAY A	Use:	TAXIWAY	Area:	271,825 SqFt		
Section:	002	of 2	From:	146	To:	159	Last Const.:	12/15/2001	
Surface:	AC	Family:	MN2018 Asphalt Runway- Taxiways	Zone:	W	Category:	2	Rank:	P
Area:	66,125 SqFt	Length:	1,420 Ft	Width:	50 Ft				
Slabs:		Slab Length:	Ft	Slab Width:	Ft	Joint Length:	Ft		
Shoulder:		Street Type:		Grade:	0	Lanes:	0		
Section Comments:									
Last Insp. Date:	7/5/2018	TotalSamples:	14	Surveyed:	3				
Conditions:	PCI: 71								
Inspection Comments:									
Sample Number:	149	Type:	R	Area:	5000.00 SqFt	PCI:	71		
Sample Comments:									
48	L & T CR	H	21.00 Ft						
57	WEATHERING	M	500.00 SqFt						
57	WEATHERING	L	4500.00 SqFt						
48	L & T CR	M	77.00 Ft						
Sample Number:	153	Type:	R	Area:	5000.00 SqFt	PCI:	71		
Sample Comments:									
48	L & T CR	H	17.00 Ft						
48	L & T CR	M	83.00 Ft						
57	WEATHERING	M	500.00 SqFt

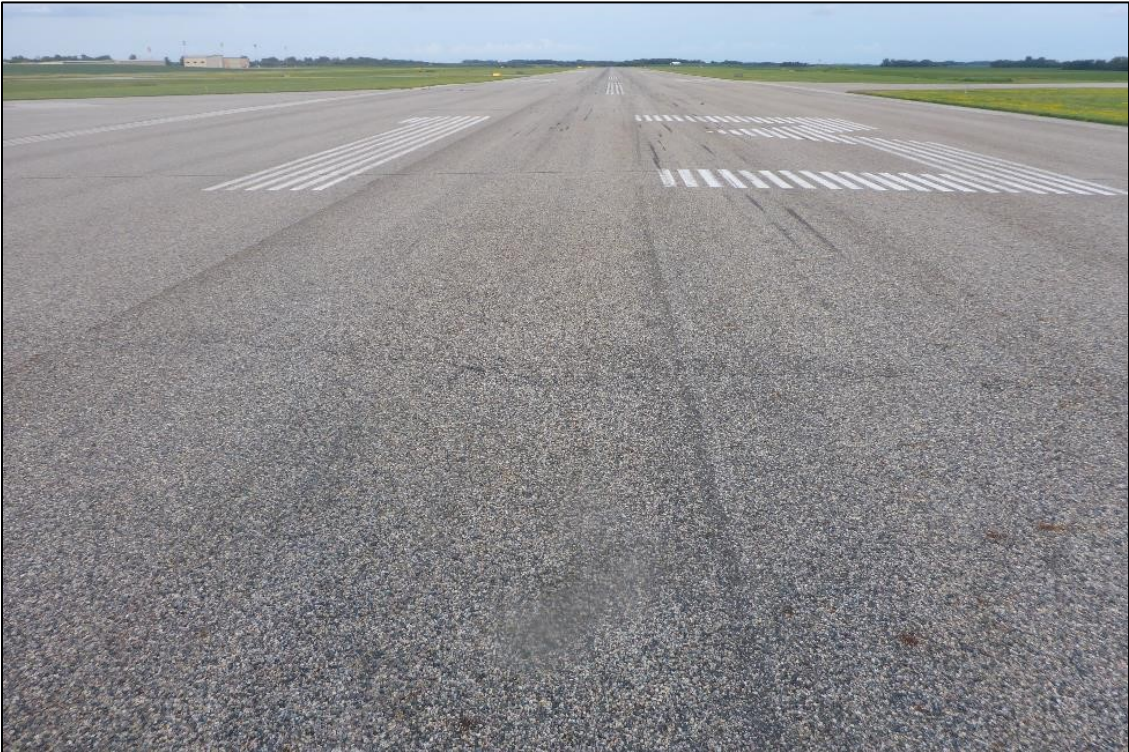
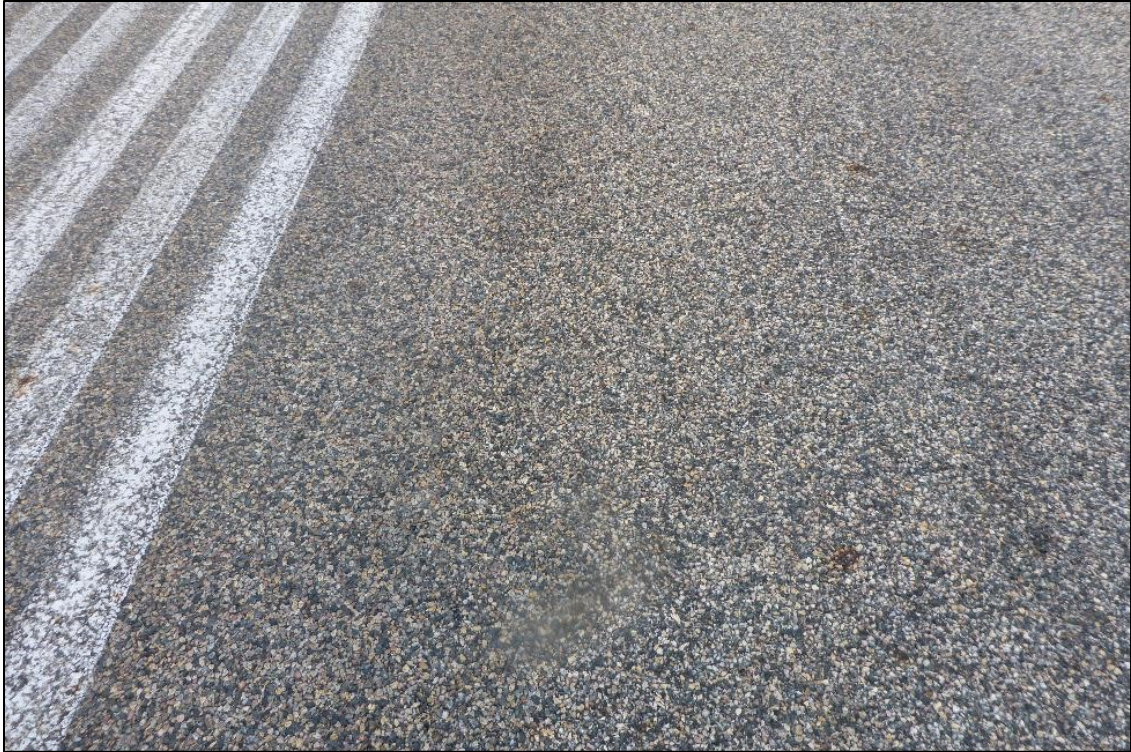
FFM RY1331 003 (PCI = 76)

Network:	FFM	Name:	FERGUS FALLS						
Branch:	RY1331	Name:	RUNWAY 13-31	Use:	RUNWAY	Area:	567,150 SqFt		
Section:	003	of 3	From:	206	To:	212	Last Const.:	12/15/2001	
Surface:	AC	Family:	MN2018 Asphalt Runway- Taxiways	Zone:	W	Category:	2	Rank:	P
Area:	37,950 SqFt	Length:	350 Ft	Width:	100 Ft				
Slabs:		Slab Length:	Ft	Slab Width:	Ft	Joint Length:	Ft		
Shoulder:		Street Type:		Grade:	0	Lanes:	0		
Section Comments:	PFC surface								
Last Insp. Date:	7/5/2018	TotalSamples:	7	Surveyed:	3				
Conditions:	PCI: 76								
Inspection Comments:									
Sample Number:	208	Type:	R	Area:	5000.00 SqFt	PCI:	78		
Sample Comments:									
52	RAVELING	L	1650.00	SqFt					
48	L & T CR	L	100.00	Ft					
Sample Number:	209	Type:	R	Area:	5000.00 SqFt	PCI:	73		
Sample Comments:									
48	L & T CR	H	1.00	Ft					
48	L & T CR	L	40.00	Ft					
52	RAVELING	L	1650.00	SqFt					
48	L & T CR	M	59.00	Ft					
Sample Number:	211	Type:	R	Area:	5000.00 SqFt	PCI:	78
