Pavement Condition Report

Fosston Municipal Airport (FSE)

December 2018

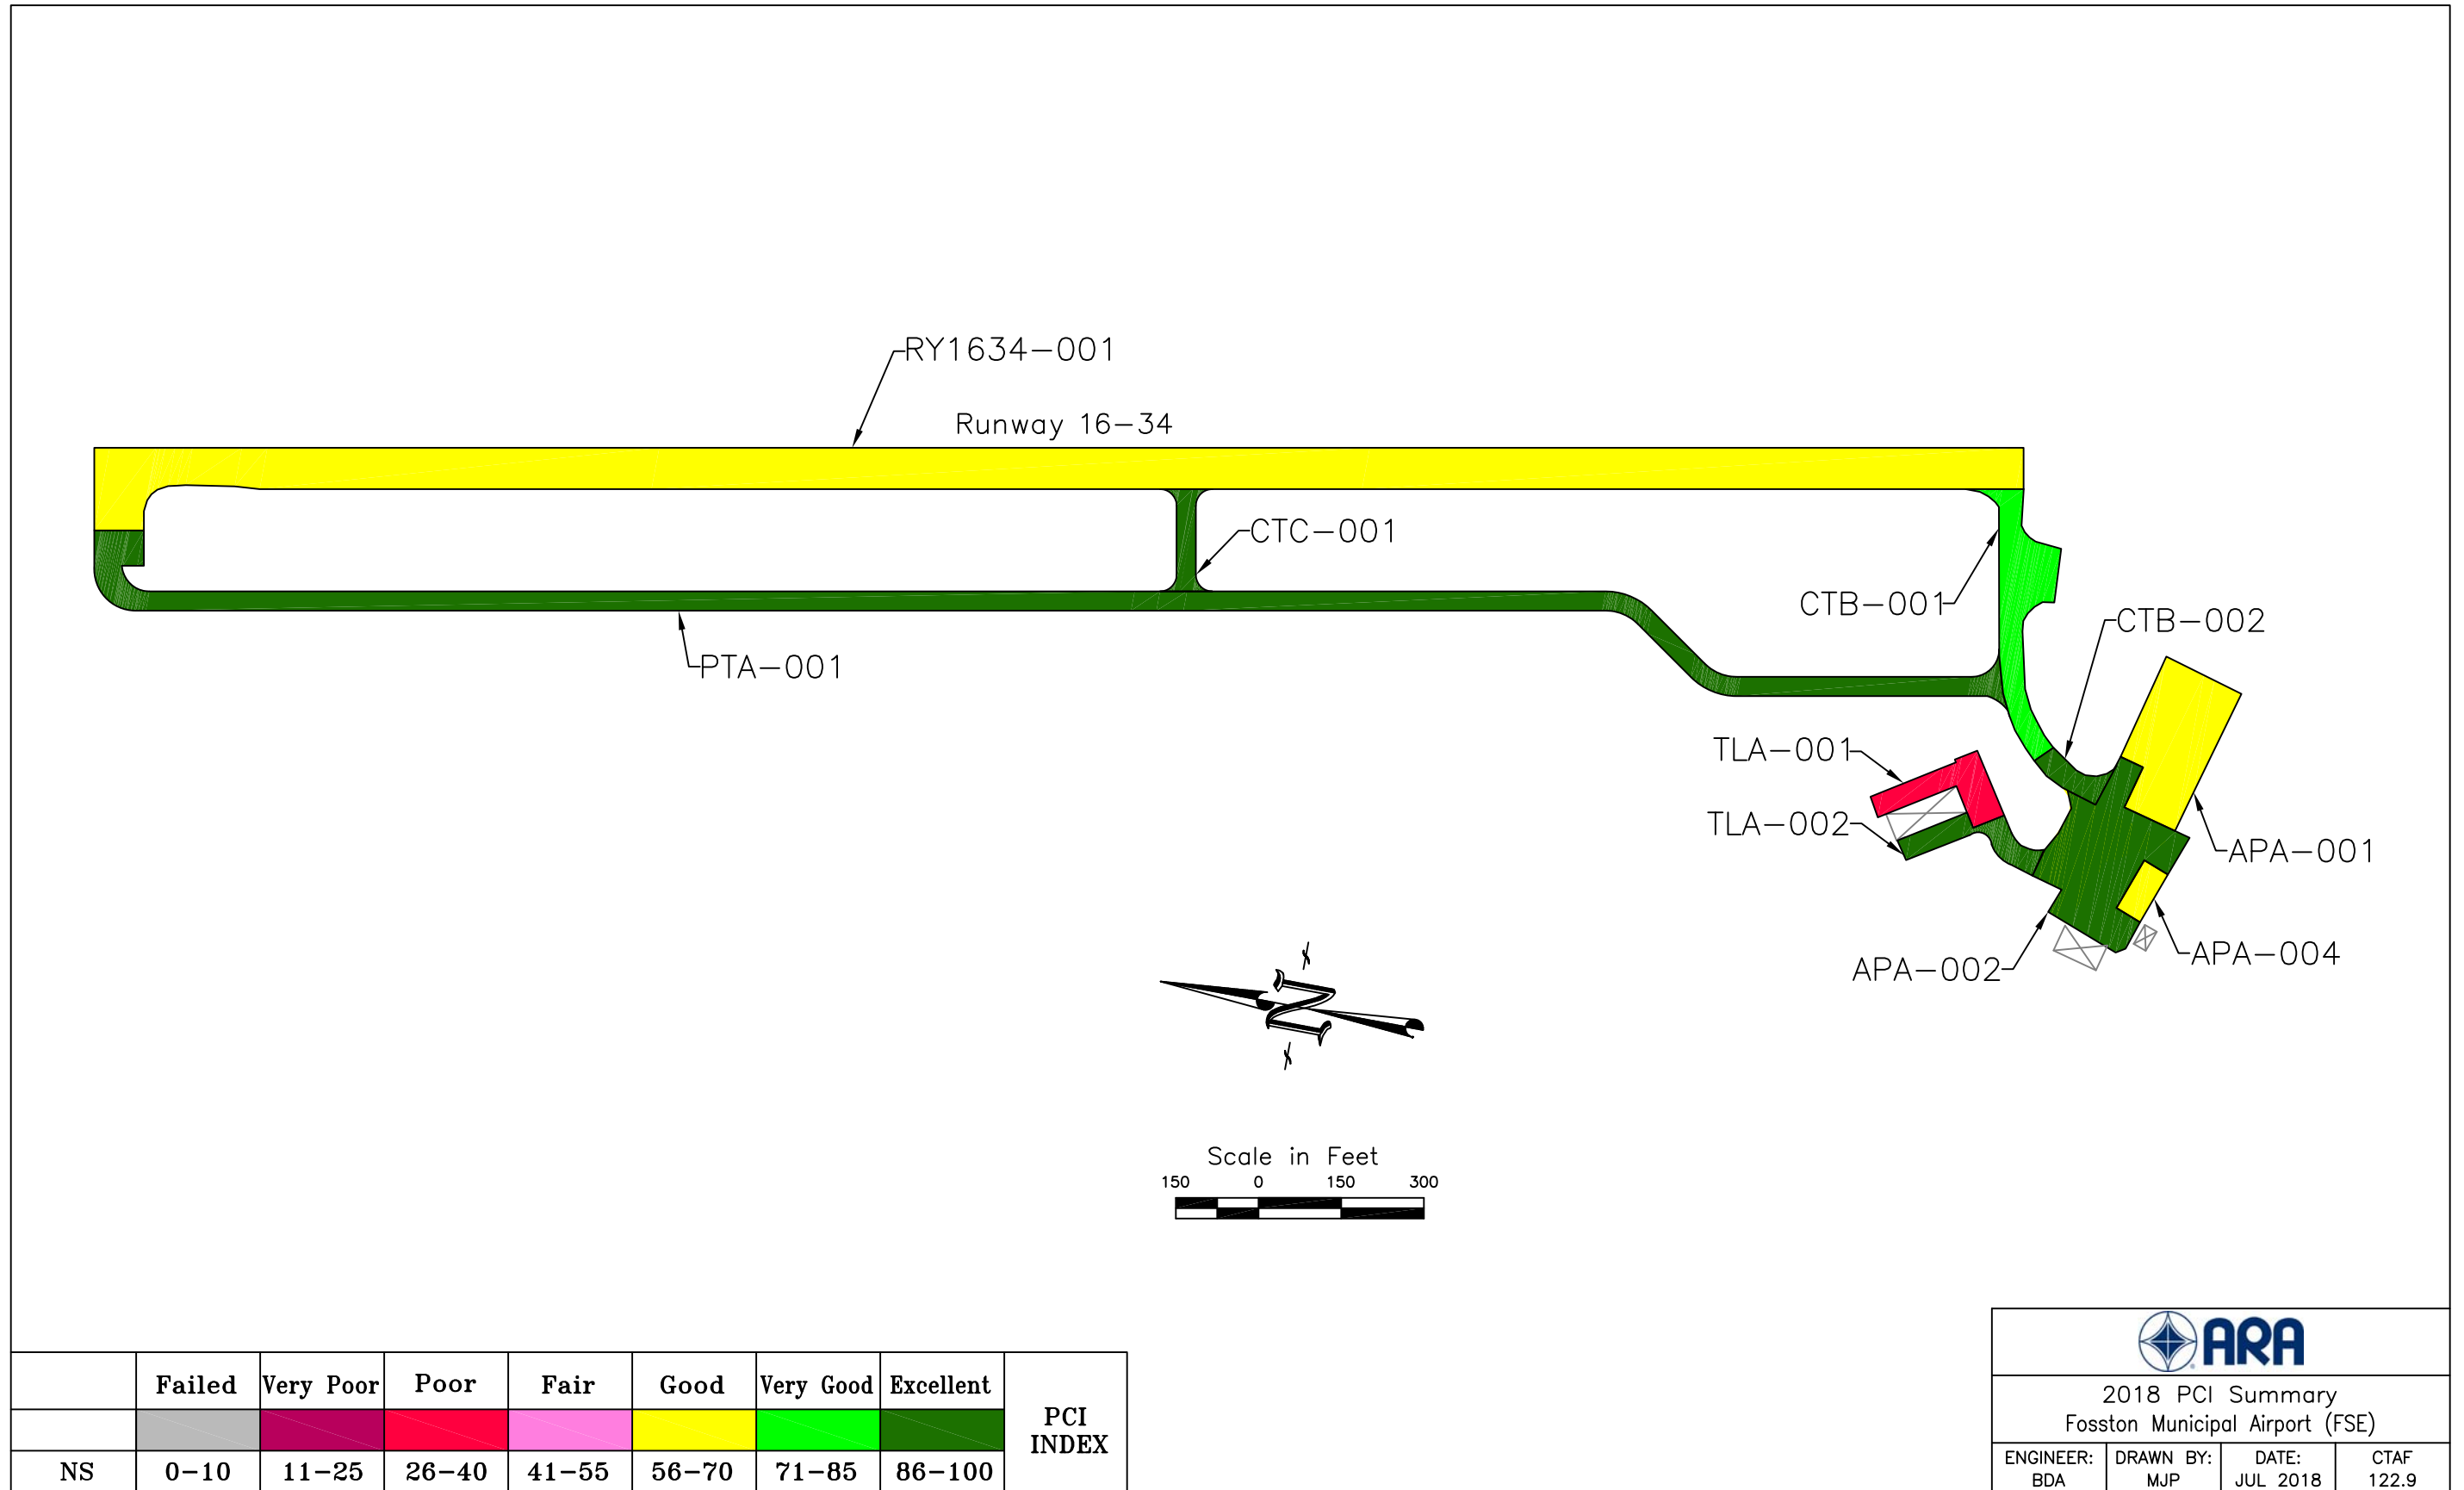
Figure 4. 2018 Pavement Condition Index Rating at Fosston Municipal Airport (FSE).

⁶Higher than expected deterioration rate of 4.3 PCI/year due to the development of low and medium alligator cracking in significant quantities.

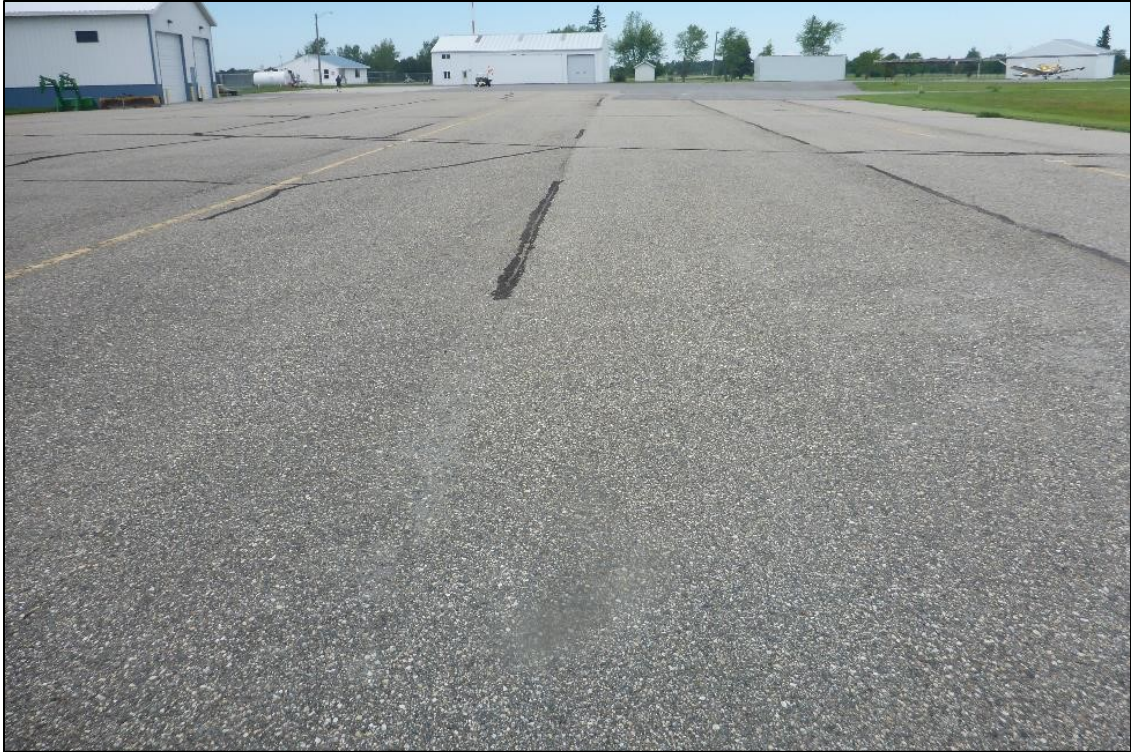
FSE APA 001 (PCI = 65)

Section Comments: Maint. R&E (crack seal)

Conditions: PCI: 65

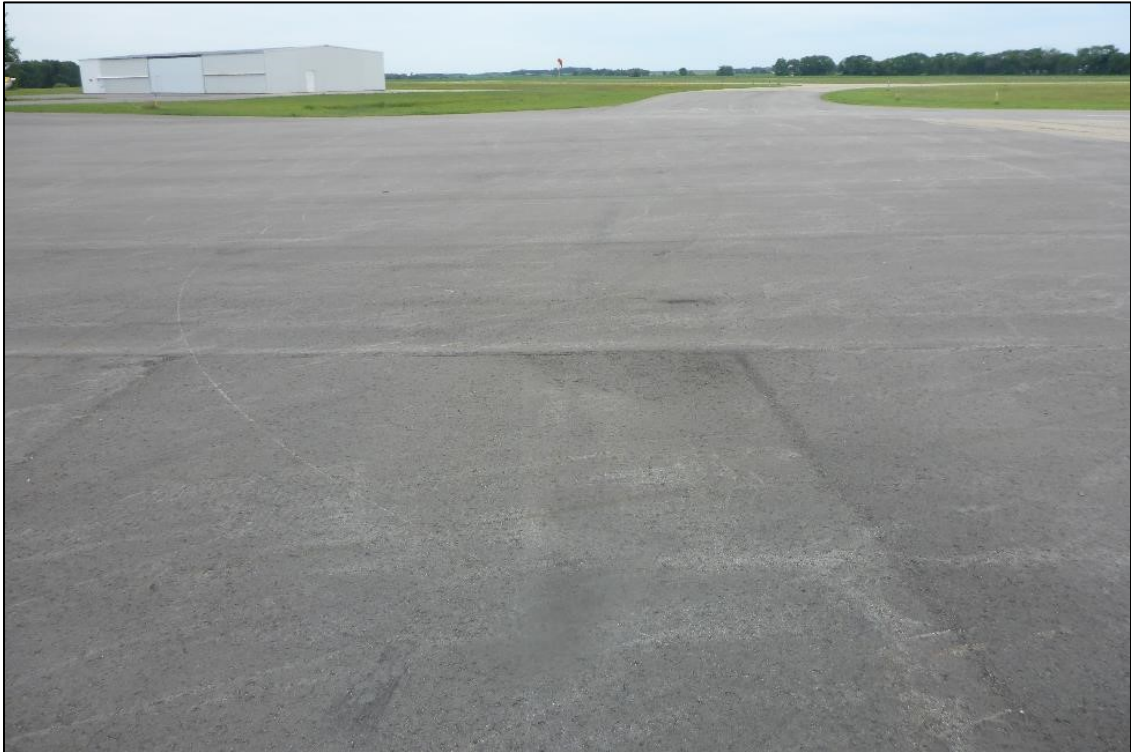
FSE APA 002 (PCI = 100)

Network:	FSE	Name:	FOSSTON						
Branch:	APA	Name:	APRON A	Use:	APRON	Area:	88,850 SqFt		
Section:	002	of 3	From:	93	To:	303	Last Const.:	1/15/2017	
Surface:	AAC	Family:	MN2018 Asphalt Aprons	Zone:	N	Category:	2	Rank:	S
Area:	46,000 SqFt	Length:	220 Ft	Width:	100 Ft				
Slabs:	Slab Length:	Ft	Slab Width:	Ft	Joint Length:	Ft			
Shoulder:	Street Type:		Grade:	0	Lanes:	0			
Section Comments:	Maint. R&E (crack seal)								
Last Insp. Date:	7/1/2018	TotalSamples:	8	Surveyed:	4				
Conditions:	PCI: 100								
Inspection Comments:									
Sample Number:	093	Type:	R	Area:	5000.00 SqFt	PCI:	100		
Sample Comments:	<No Distress>								
Sample Number:	103	Type:	R	Area:	5000.00 SqFt	PCI:	100		
Sample Comments:	<No Distress>								
Sample Number:	203	Type:	R	Area:	5000.00 SqFt	PCI:	100		
Sample Comments:	<No Distress>								
Sample Number:	204	Type:	R	Area:	5000.00 SqFt	PCI:	100		
Sample Comments:	<No Distress>

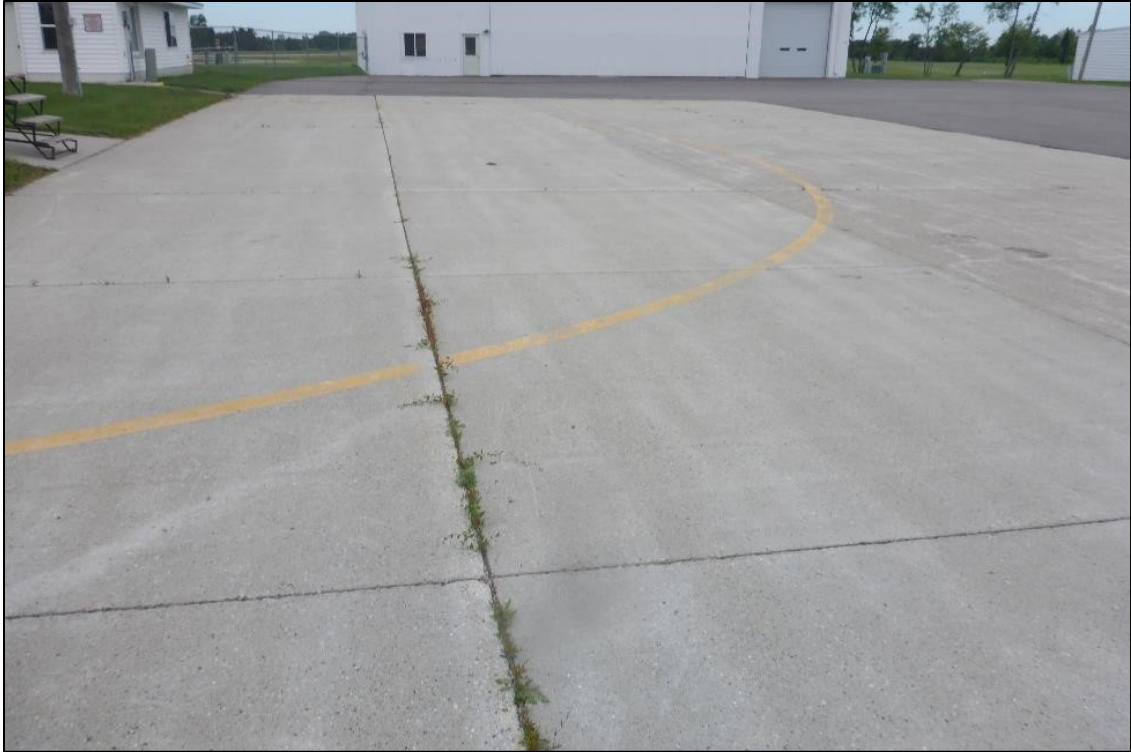
FSE APA 004 (PCI = 59)

Network:	FSE	Name:	FOSSTON						
Branch:	APA	Name:	APRON A	Use:	APRON	Area:	88,850 SqFt		
Section:	004	of 3	From:	403	To:	404	Last Const.:	6/1/2002	
Surface:	PCC	Family:	MN2018 PCC	Zone:	N	Category:	2	Rank:	S
Area:	5,000 SqFt	Length:	150 Ft	Width:	50 Ft				
Slabs:	32	Slab Length:	13 Ft	Slab Width:	13 Ft	Joint Length:	1,000 Ft		
Shoulder:		Street Type:		Grade:	0	Lanes:	0		
Section Comments:									
Last Insp. Date:	7/1/2018	TotalSamples:	2	Surveyed:	2				
Conditions:	PCI: 59								
Inspection Comments:									
Sample Number:	403	Type:	R	Area:	16.00 Slabs	PCI:	82		
Sample Comments:									
75	CORNER SPALL	L	1.00	Slabs					
62	CORNER BREAK	L	2.00	Slabs					
63	LINEAR CR	L	1.00	Slabs					
Sample Number:	404	Type:	R	Area:	16.00 Slabs	PCI:	35		
Sample Comments:									
72	SHAT. SLAB	H	1.00	Slabs					
62	CORNER BREAK	M	2.00	Slabs					
72	SHAT. SLAB	M	1.00	Slabs					
63	LINEAR CR	L	4.00	Slabs					
63	LINEAR CR	M	1.00	Slabs

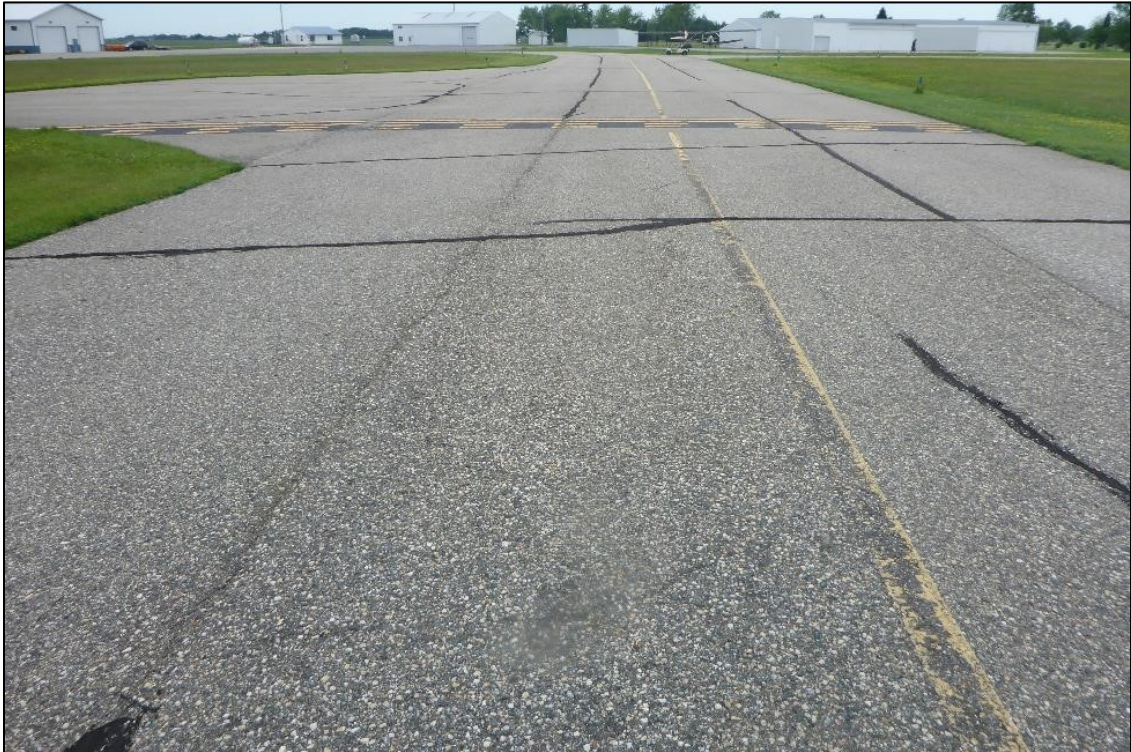
FSE CTB 001 (PCI = 72)

Network:	FSE	Name:	FOSSTON				
Branch:	CTB	Name:	CONNECTING TAXIWAY B	Use:	TAXIWAY	Area:	34,950 SqFt
Section:	001	of 2	From:	100	To:	107	Last Const.: 6/1/2002
Surface:	AC	Family:	MN2018 Asphalt Runway- Taxiways	Zone:	N	Category:	2
Area:	29,150 SqFt	Length:	770 Ft	Width:	40 Ft	Joint Length:	Ft
Slabs:		Slab Length:	Ft	Slab Width:	Ft	Joint Length:	Ft
Shoulder:		Street Type:		Grade:	0	Lanes:	0
Section Comments:	Maint. R&E (crack seal)						
Last Insp. Date:	7/1/2018	TotalSamples:	7	Surveyed:	2		
Conditions:	PCI: 72						
Inspection Comments:							
Sample Number:	101	Type:	R	Area:	4000.00 SqFt	PCI:	72
Sample Comments:							
57	WEATHERING	L	800.00	SqFt			
48	L & T CR	L	212.00	Ft			
57	WEATHERING	H	15.00	SqFt			
57	WEATHERING	M	2000.00	SqFt			
Sample Number:	104	Type:	R	Area:	3800.00 SqFt	PCI:	72
Sample Comments:							
48	L & T CR	L	253.00	Ft			
57	WEATHERING	L	2100.00	SqFt			
57	WEATHERING	M	1500.00	SqFt

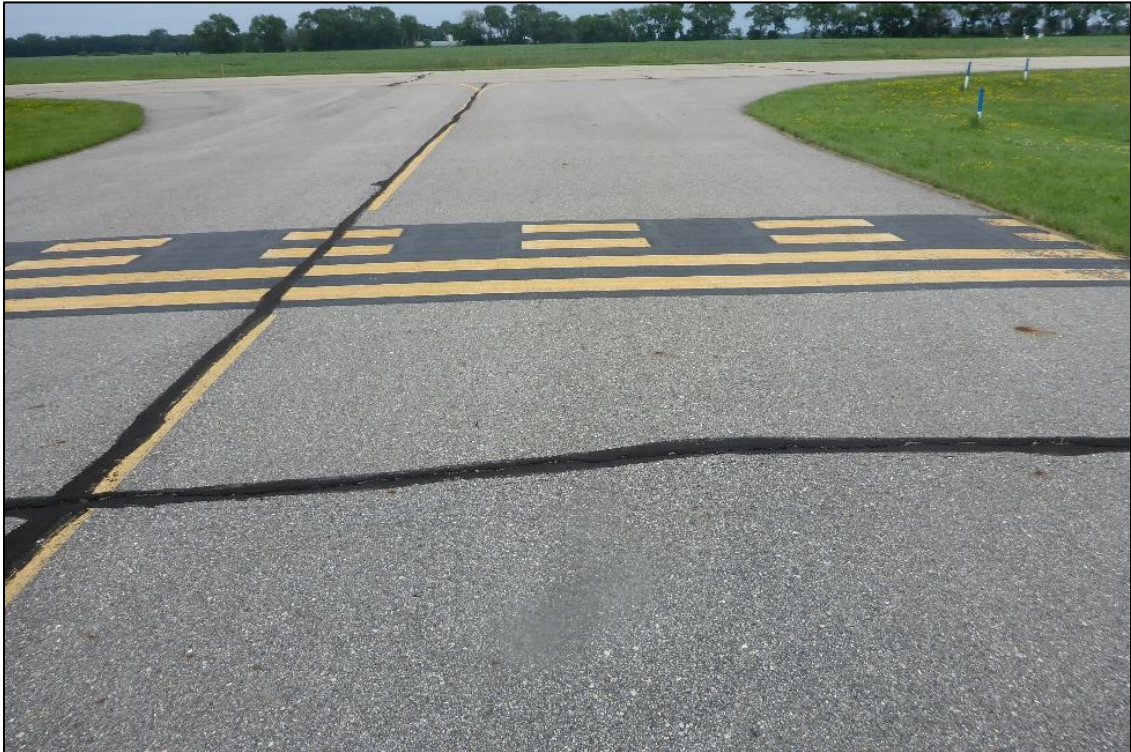
FSE CTC 001 (PCI = 87)

Network:	FSE	Name:	FOSSTON						
Branch:	CTC	Name:	Connecting Taxiway C	Use:	TAXIWAY	Area:	7,270 SqFt		
Section:	001	of 1	From:	100	To:	101	Last Const.:	9/1/2012	
Surface:	AC	Family:	MN2018 Asphalt Runway- Taxiways	Zone:		Category:		Rank:	S
Area:	7,270 SqFt	Length:	186 Ft	Width:	35 Ft				
Slabs:		Slab Length:	Ft	Slab Width:	Ft	Joint Length:	Ft		
Shoulder:		Street Type:		Grade:	0	Lanes:	0		
Section Comments:									
Last Insp. Date:	7/1/2018	TotalSamples:	2	Surveyed:	2				
Conditions:	PCI: 87								
Inspection Comments:									
Sample Number:	100	Type:	R	Area:	3500.00 SqFt	PCI:	84		
Sample Comments:									
48	L & T CR	L	100.00	Ft					
48	L & T CR	M	35.00	Ft					
Sample Number:	101	Type:	R	Area:	3500.00 SqFt	PCI:	89		
Sample Comments:									
48	L & T CR	L	112.00	Ft

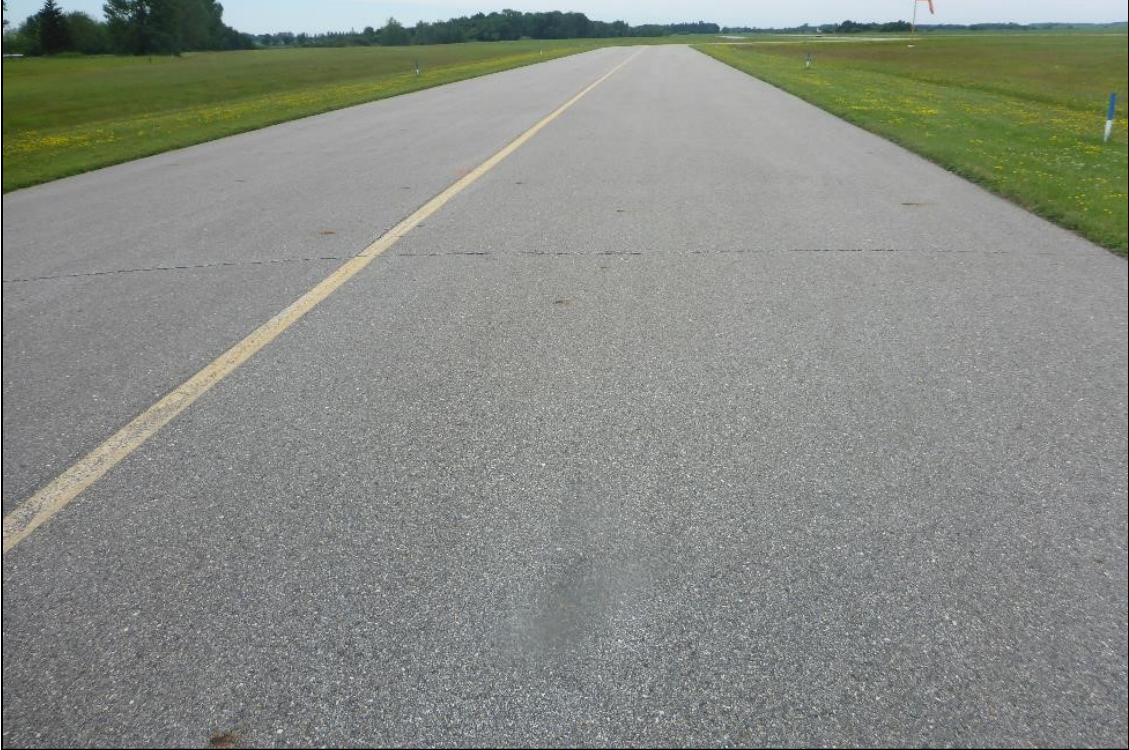
FSE PTA 001 (PCI = 92)

Network:	FSE	Name:	FOSSTON						
Branch:	PTA	Name:	Parallel Taxiway A	Use:	TAXIWAY	Area:	131,450 SqFt		
Section:	001	of	1	From:	100	To:	135	Last Const.:	9/1/2012
Surface:	AC	Family:	MN2018 Asphalt Runway- Taxiways		Zone:	Category:	Rank:	P	
Area:	131,450 SqFt	Length:	3,540 Ft	Width:	35 Ft				
Slabs:	Slab Length:	Ft	Slab Width:	Ft	Joint Length:	Ft			
Shoulder:	Street Type:	Grade:	0		Lanes:	0			
Section Comments:									
Last Insp. Date:	7/1/2018		TotalSamples:	36		Surveyed:	6		
Conditions:	PCI: 92								
Inspection Comments:									
Sample Number:	104	Type:	R	Area:	3500.00 SqFt		PCI:	89	
Sample Comments:									
48	L & T CR	M	7.00 Ft						
48	L & T CR	L	47.00 Ft						
Sample Number:	110	Type:	R	Area:	3500.00 SqFt		PCI:	100	
Sample Comments:									
<No Distress>									
Sample Number:	116	Type:	R	Area:	3500.00 SqFt		PCI:	97	
Sample Comments:									
48	L & T CR	L	6.00 Ft						
Sample Number:	122	Type:	R	Area:	3500.00 SqFt		PCI:	100

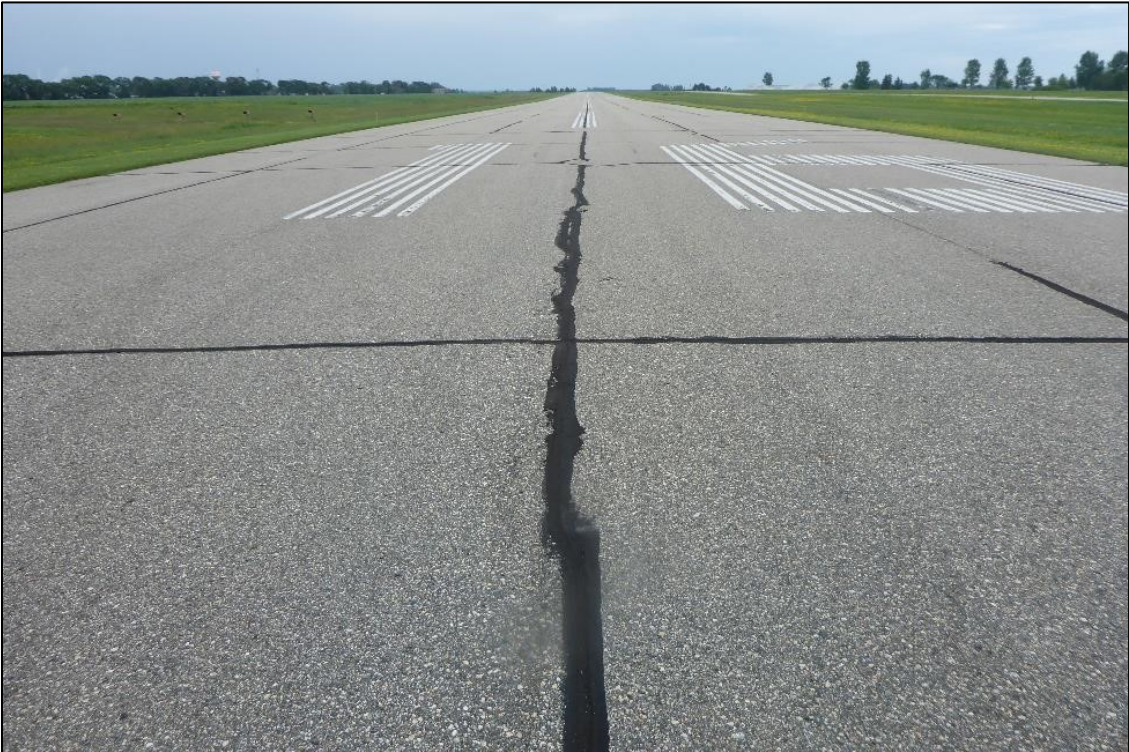
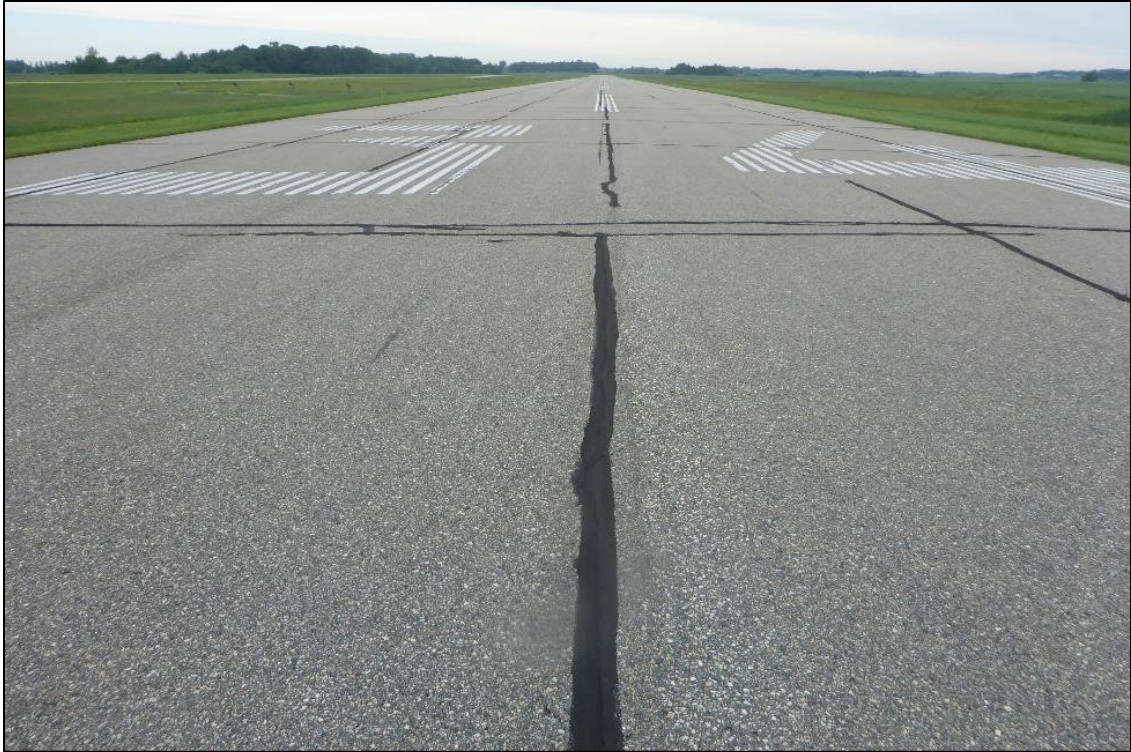
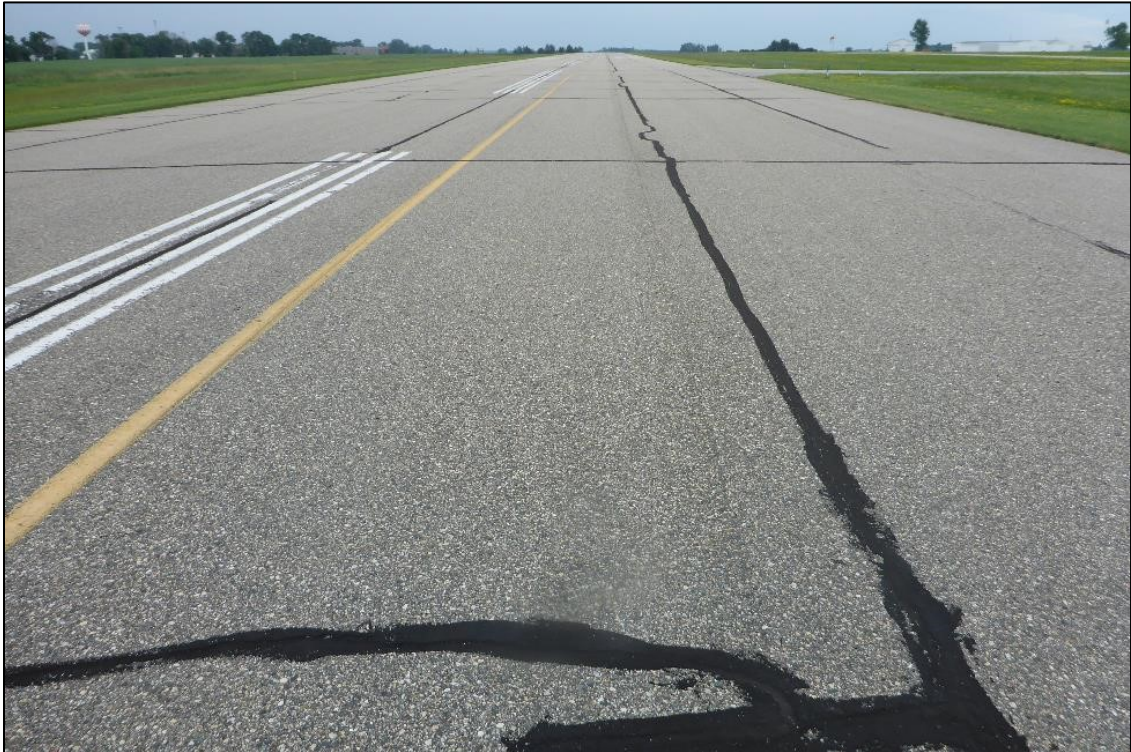
FSE RY1634 001 (PCI = 70)

Network:	FSE	Name:	FOSSTON						
Branch:	RY1634	Name:	RUNWAY 16-34	Use:	RUNWAY	Area:	268,700 SqFt		
Section:	001	of	1	From:	100	To:	169+(268,269)	Last Const.:	6/1/2002
Surface:	AC	Family:	MN2018 Asphalt Runway- Taxiways	Zone:	N	Category:	2	Rank:	P
Area:	268,700 SqFt	Length:	3,600 Ft	Width:	75 Ft				
Slabs:		Slab Length:	Ft	Slab Width:	Ft	Joint Length:	Ft		
Shoulder:		Street Type:		Grade:	0	Lanes:	0		
Section Comments:	Maint. R&E (crack seal)								
Last Insp. Date:	7/1/2018	TotalSamples:	72	Surveyed:	8				
Conditions:	PCI: 70								
Inspection Comments:	new cs								
Sample Number:	104	Type:	R	Area:	3750.00 SqFt	PCI:	65		
Sample Comments:									
48	L & T CR	M	16.00	Ft					
48	L & T CR	H	5.00	Ft					
57	WEATHERING	L	3700.00	SqFt					
48	L & T CR	L	375.00	Ft					
57	WEATHERING	M	50.00	SqFt					
Sample Number:	108	Type:	R	Area:	3750.00 SqFt	PCI:	74		
Sample Comments:									
48	L & T CR	L	304.00	Ft					
57	WEATHERING	M	3700.00	SqFt

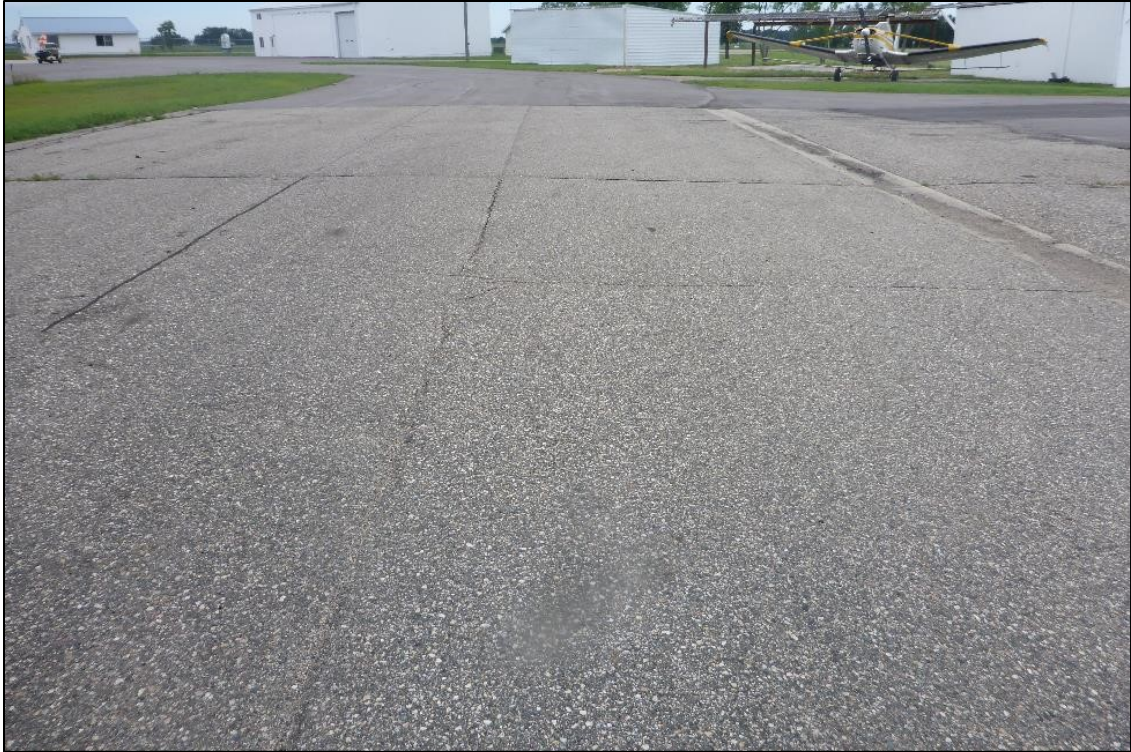
FSE TLA 001 (PCI = 31)

Conditions: PCI: 31
