# Pavement Condition Report

## Montevideo-Chippewa County Airport (MVE)

**December 2018**

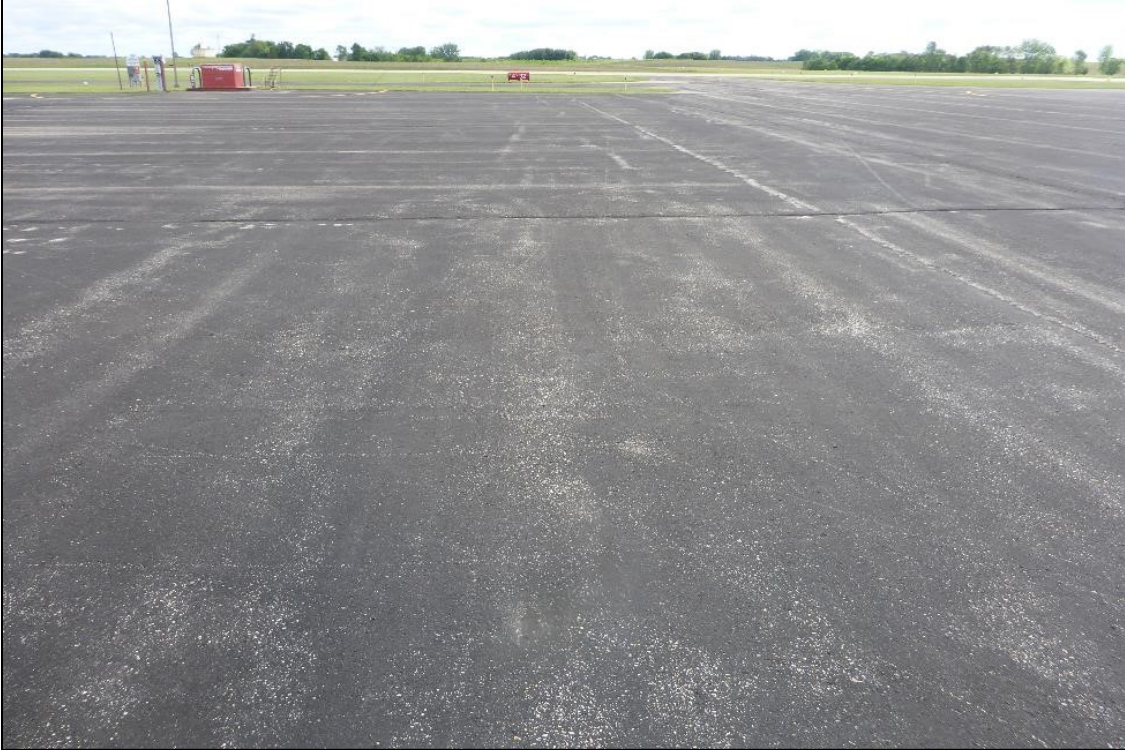
MVE APA 001 (PCI = 80)

**Section Comments:** maint. R&E (crack seal)

**Conditions:** PCI: 80

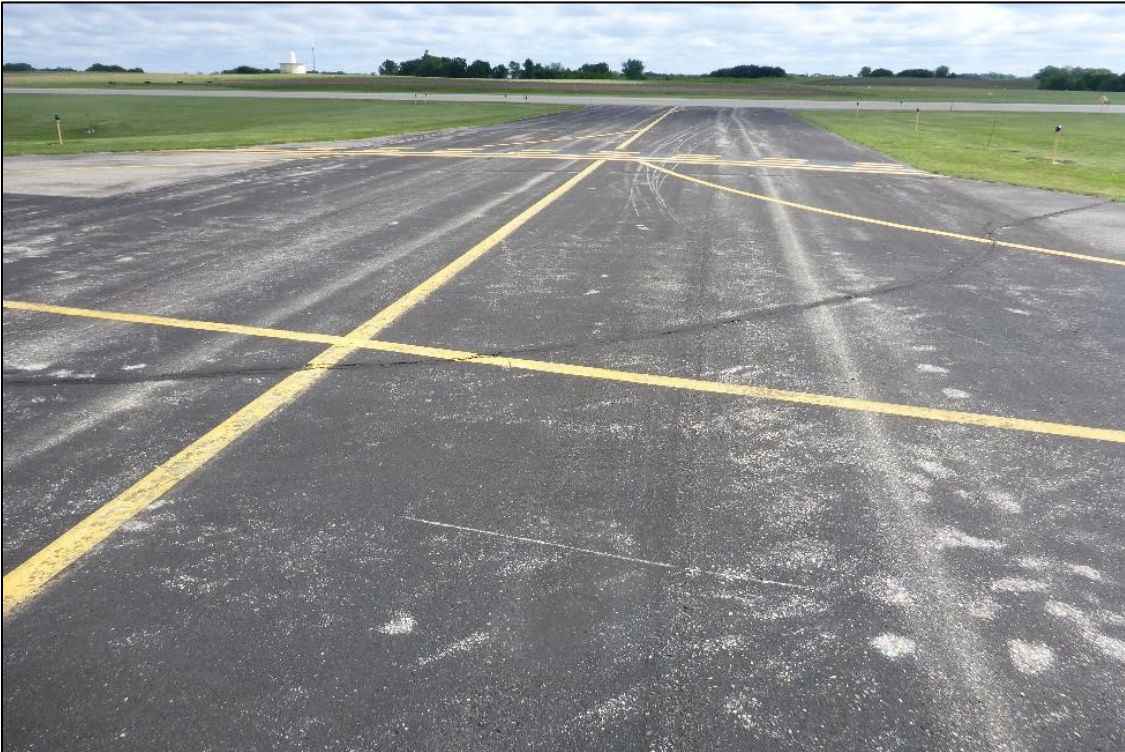
MVE CTA 001 (PCI = 79)

**Section Comments:** maint. R&E (crack seal)

**Conditions:** PCI: 79
