Pavement Condition Report

Piney-Pinecreek Border Airport (48Y)

December 2019

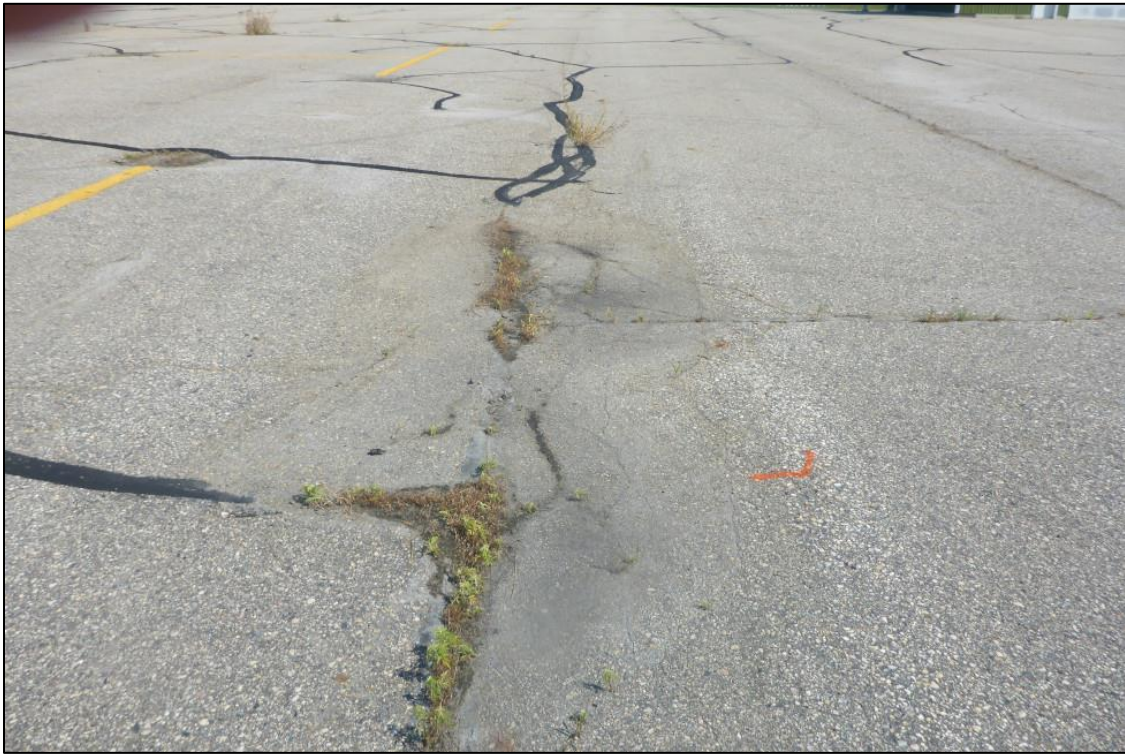
48Y APA 001 (PCI = 62)

Conditions: PCI: 62

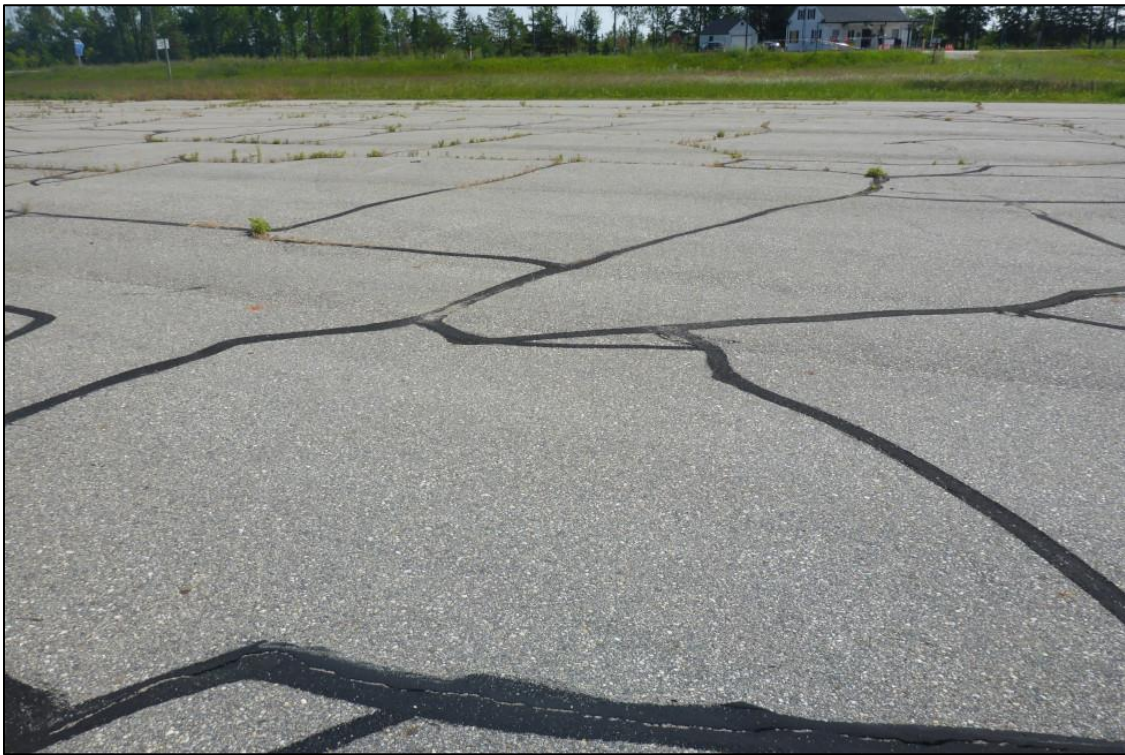
48Y APB 001 (PCI = 51)

Conditions: PCI: 51

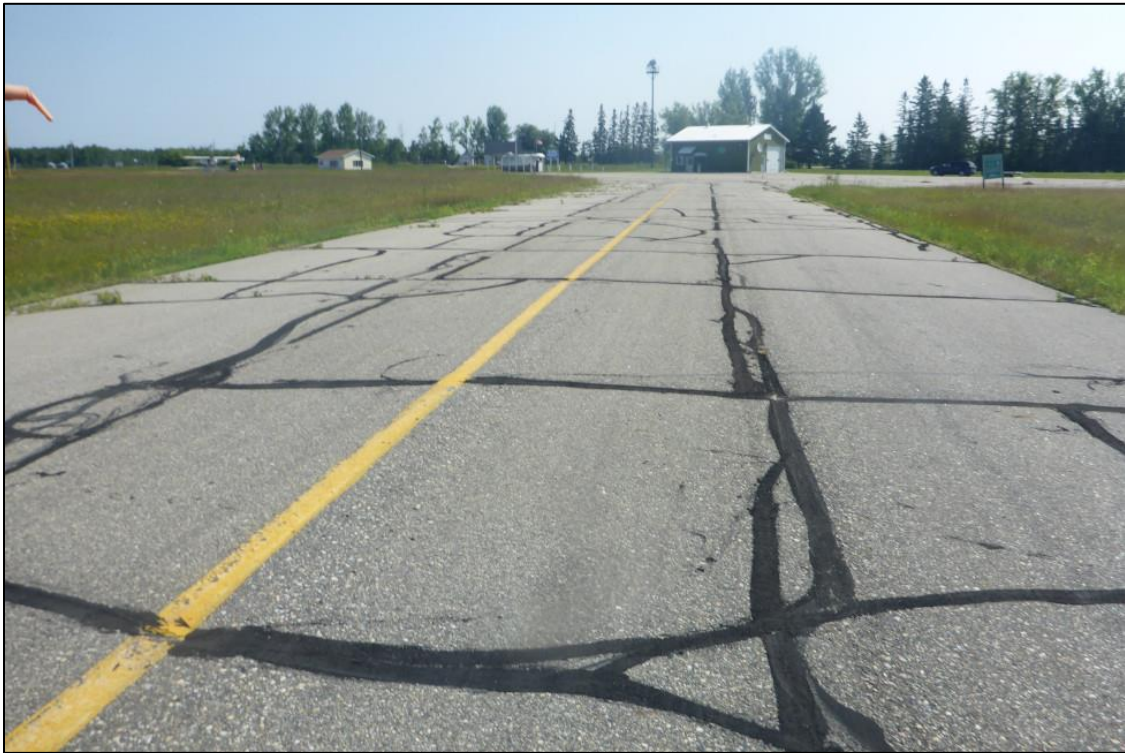
48Y CTA 001 (PCI = 61)

Conditions: PCI: 61

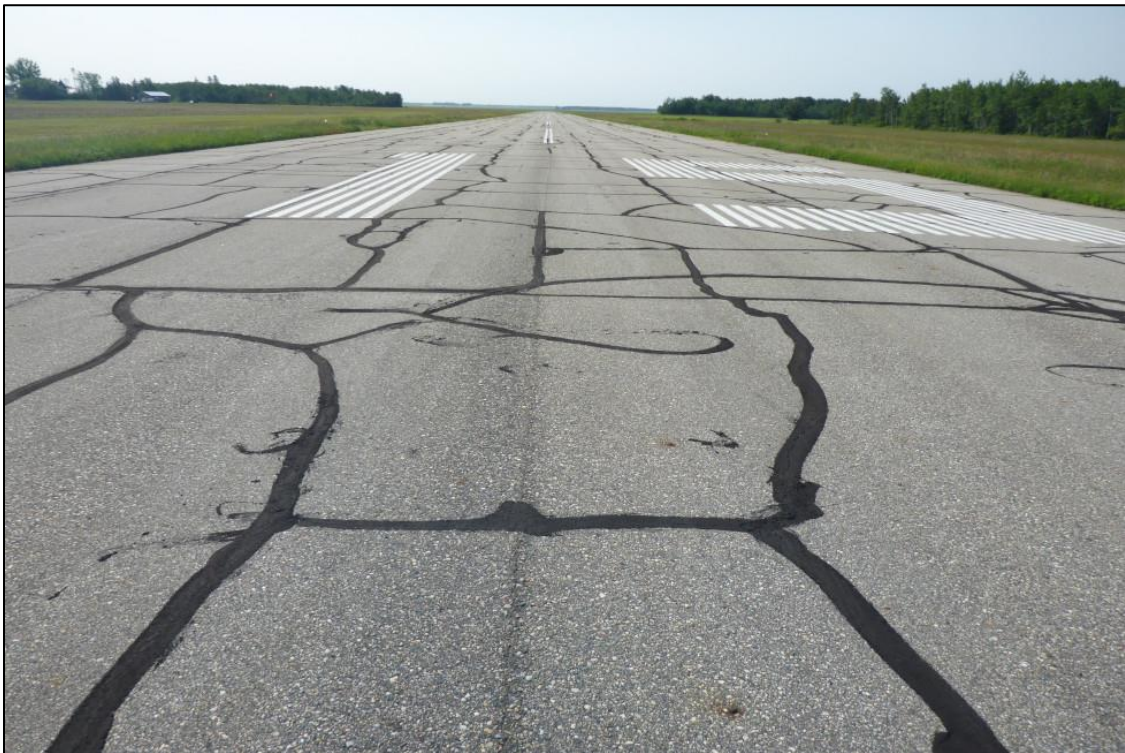
48Y RY1533 001 (PCI = 60)

Network:	48Y	Name:	PINEY-PINECREEK						
Branch:	RY1533	Name:	RUNWAY 15-33	Use:	RUNWAY	Area:	257,350 SqFt		
Section:	001	of 1	From:	100	To:	165	Last Const.: 6/1/2009		
Surface:	AC	Family:	MN2018 Asphalt Runway- Taxiways	Zone:	N	Category:	3	Rank:	P
Area:	257,350 SqFt	Length:	3,298 Ft	Width:	75 Ft				
Slabs:		Slab Length:	Ft	Slab Width:	Ft	Joint Length:	Ft		
Shoulder:		Street Type:		Grade:	0	Lanes:	0		
Section Comments:	maint. (R&E) CS								
Last Insp. Date:	7/16/2019	TotalSamples:	68	Surveyed:	8				
Conditions:	PCI: 60								
Inspection Comments:									
Sample Number:	106	Type:	R	Area:	3750.00 SqFt	PCI:	61		
Sample Comments:	pic 663 cs since last								
48	L & T CR	L	802.00	Ft					
48	L & T CR	M	16.00	Ft					
Sample Number:	115	Type:	R	Area:	3750.00 SqFt	PCI:	62		
Sample Comments:									
48	L & T CR	L	711.00	Ft					
48	L & T CR	M	35.00	Ft					
57	WEATHERING	L	200.00	SqFt					
Sample Number:	124	Type:	R	Area:	3750.00 SqFt	PCI:	59
