# Pavement Condition Report

## Red Lake Falls Municipal Airport (D81)

**December 2019**

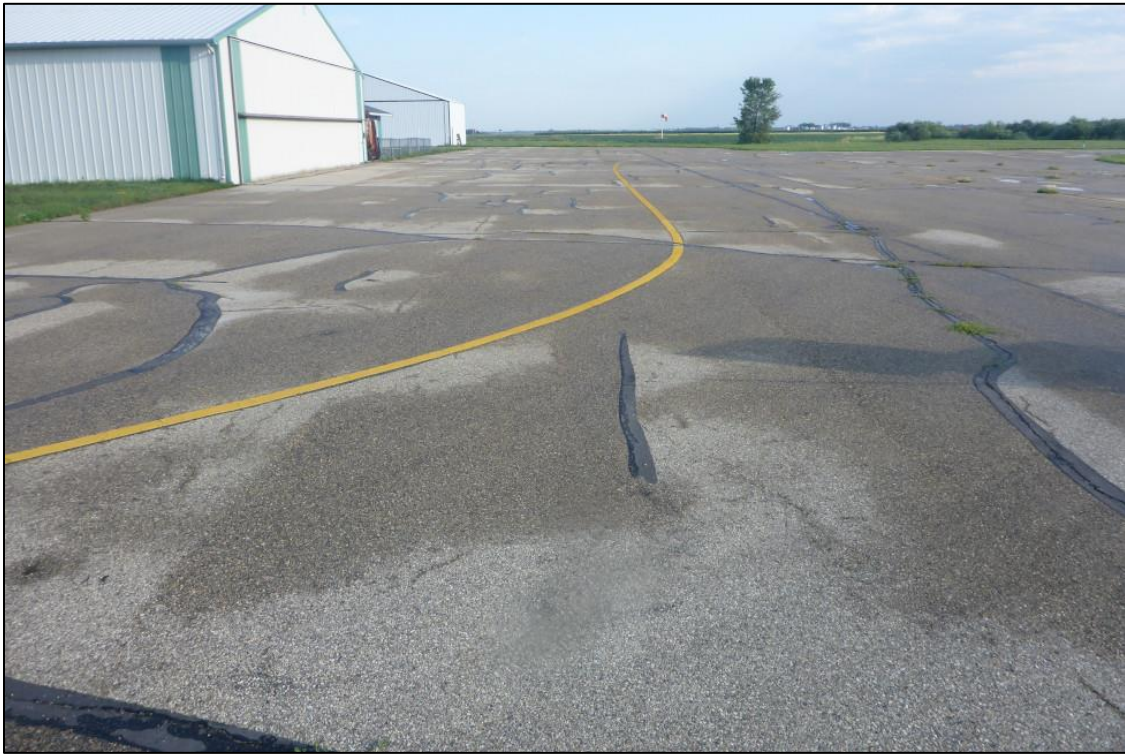
D81 APA 001 (PCI = 64)

**Conditions:** PCI: 64

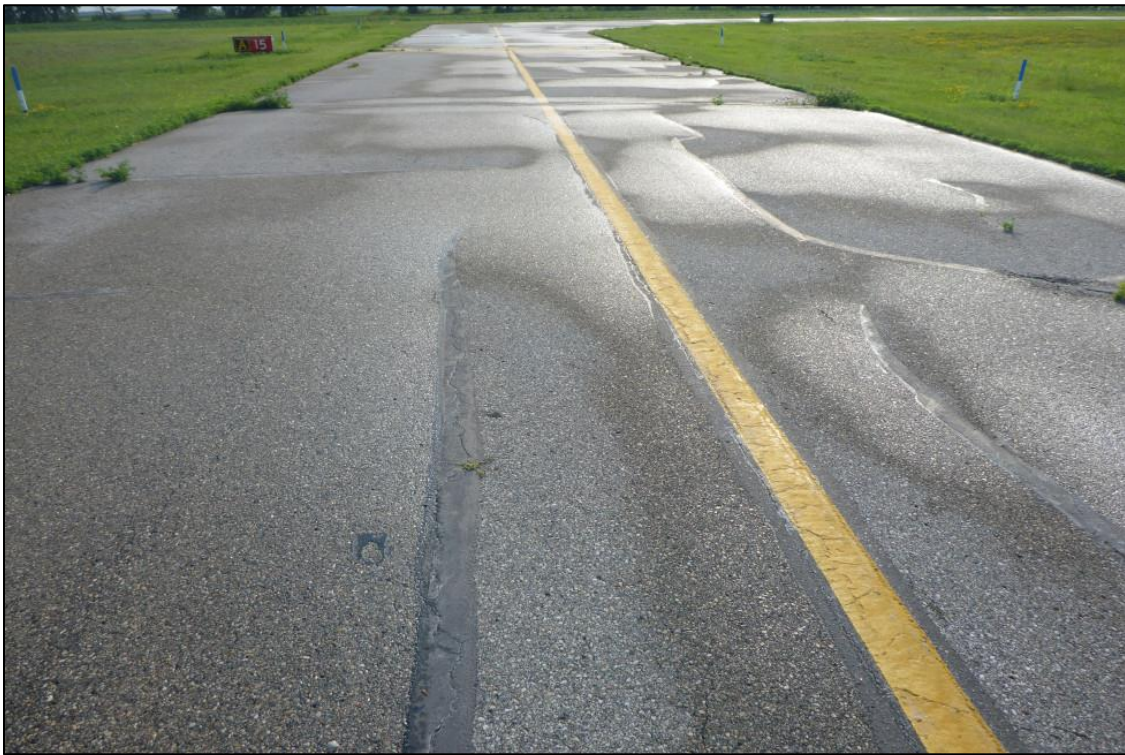
D81 CTA 001 (PCI = 58)

**Conditions:** PCI: 58

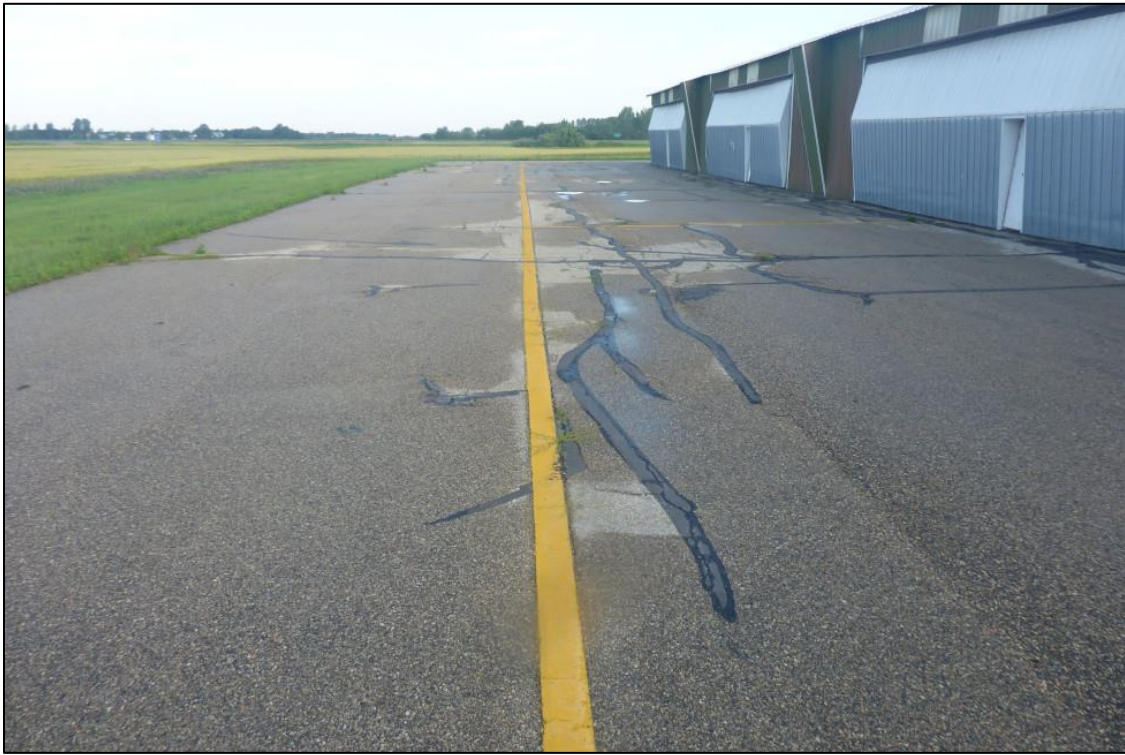
D81 TLA 001 (PCI = 56)

**Conditions:** PCI: 56
