Pavement Condition Report

Grand Rapids - Itasca County Airport (GPZ)

December 2019

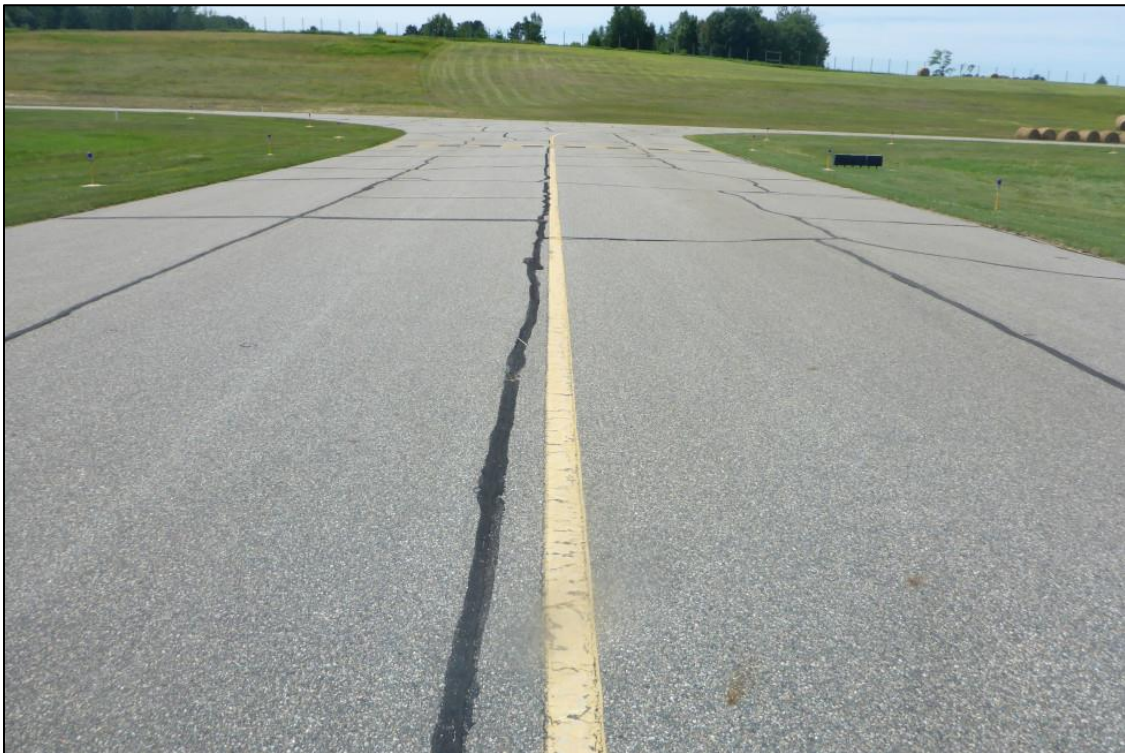
GPZ CTA2 001 (PCI = 66)

Network:	GPZ	Name:	GRAND RAPIDS						
Branch:	CTA2	Name:	CONNECTING TAXIWAY A2	Use:	TAXIWAY	Area:	21,875 SqFt		
Section:	001	of 2	From:	201	To:	202	Last Const.: 8/30/2005		
Surface:	AC	Family:	MN2018 Asphalt Runway- Taxiways	Zone:	E	Category:	3	Rank:	S
Area:	12,675 SqFt	Length:	240 Ft	Width:	50 Ft				
Slabs:		Slab Length:	Ft	Slab Width:	Ft	Joint Length:	Ft		
Shoulder:		Street Type:		Grade:	0	Lanes:	0		
Section Comments:									
Last Insp. Date:	7/16/2019	TotalSamples:	2	Surveyed:	1				
Conditions:	PCI: 66								
Inspection Comments:									
Sample Number:	201	Type:	R	Area:	5000.00 SqFt	PCI:	66		
Sample Comments: p127									
48	L & T CR	L	522.00	Ft					
48	L & T CR	M	29.00	Ft					
57	WEATHERING	L	5000.00	SqFt

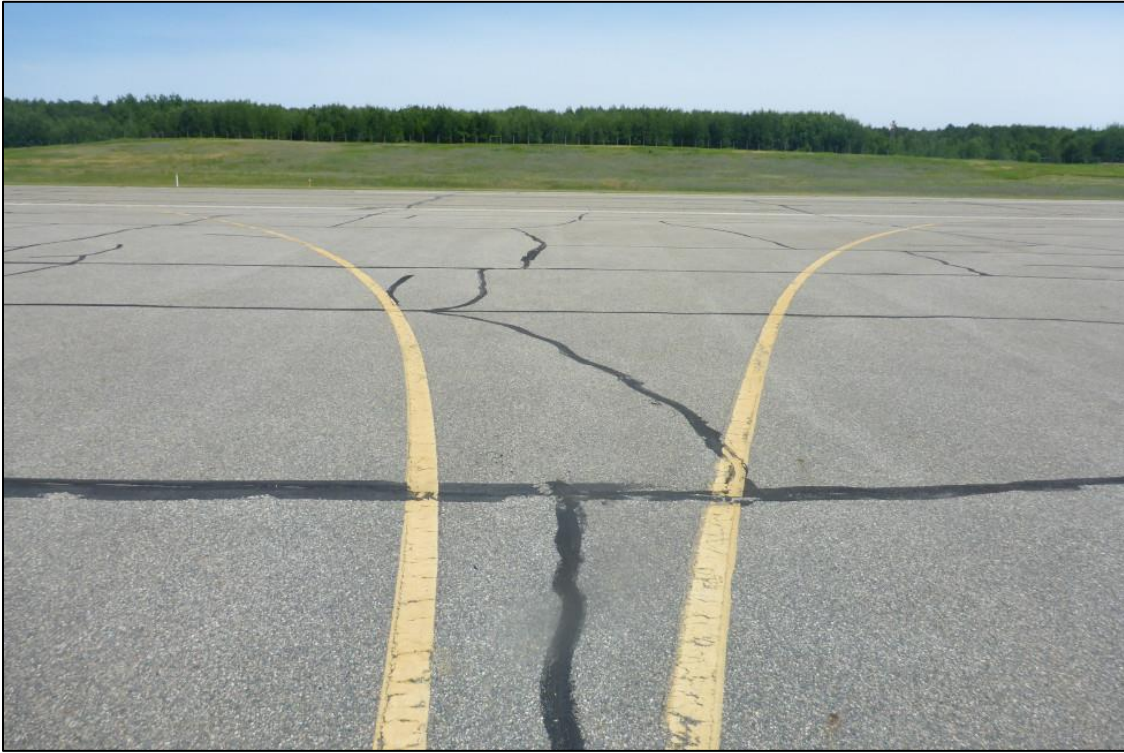
GPZ CTA2 002 (PCI = 64)

Network:	GPZ	Name:	GRAND RAPIDS						
Branch:	CTA2	Name:	CONNECTING TAXIWAY A2	Use:	TAXIWAY	Area:	21,875 SqFt		
Section:	002	of 2	From:	200	To:	300	Last Const.:	8/30/2005	
Surface:	AC	Family:	MN2018 Asphalt Runway- Taxiways	Zone:	E	Category:	3	Rank:	S
Area:	9,200 SqFt	Length:	100 Ft	Width:	50 Ft				
Slabs:		Slab Length:	Ft	Slab Width:	Ft	Joint Length:	Ft		
Shoulder:		Street Type:		Grade:	0	Lanes:	0		
Section Comments:									
Last Insp. Date:	7/16/2019	TotalSamples:	2	Surveyed:	1				
Conditions:	PCI: 64								
Inspection Comments:									
Sample Number:	200	Type:	R	Area:	5000.00 SqFt	PCI:	64		
Sample Comments: p126									
48	L & T CR	L	612.00	Ft					
48	L & T CR	M	44.00	Ft					
57	WEATHERING	L	5000.00	SqFt

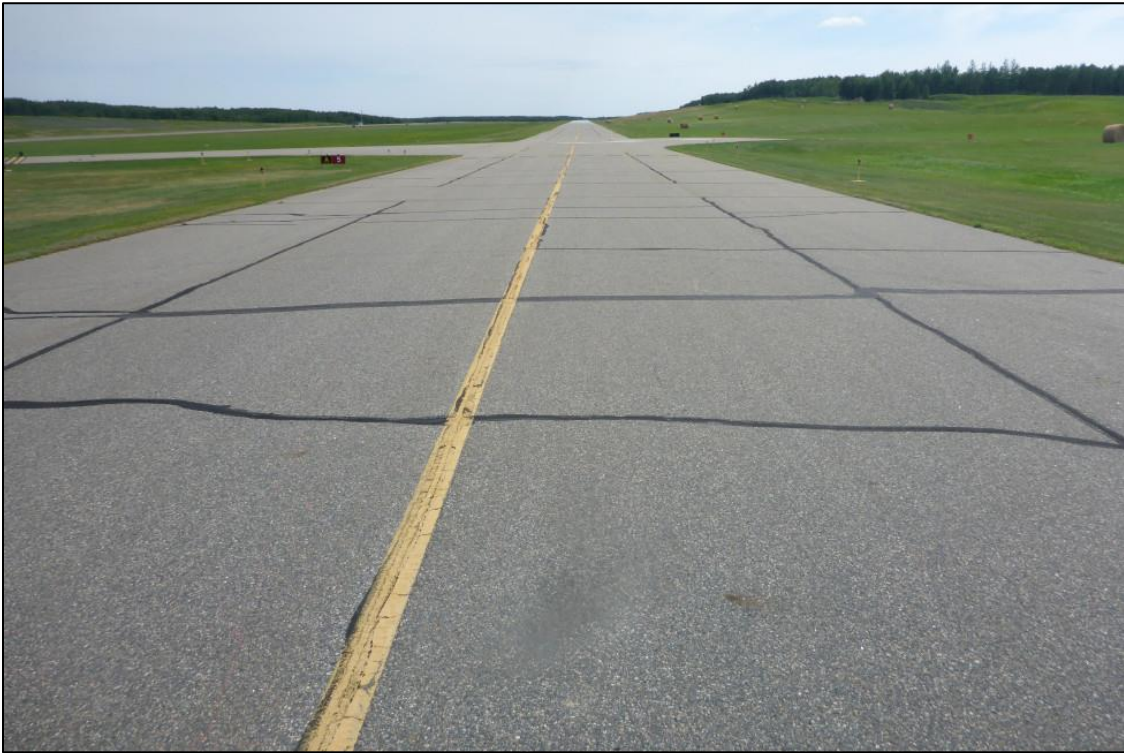
GPZ PTA 001 (PCI = 62)

Network:	GPZ	Name:	GRAND RAPIDS						
Branch:	PTA	Name:	PARALLEL TAXIWAY A	Use:	TAXIWAY	Area:	312,350 SqFt		
Section:	001	of 5	From:	100	To:	103	Last Const.:	8/30/2005	
Surface:	AC	Family:	MN2018 Asphalt Runway- Taxiways	Zone:	E	Category:	3	Rank:	P
Area:	23,250 SqFt	Length:	465 Ft	Width:	50 Ft				
Slabs:		Slab Length:	Ft	Slab Width:	Ft	Joint Length:	Ft		
Shoulder:		Street Type:		Grade:	0	Lanes:	0		
Section Comments:									
Last Insp. Date:	7/16/2019	TotalSamples:	4	Surveyed:	1				
Conditions:	PCI: 62								
Inspection Comments:									
Sample Number:	102	Type:	R	Area:	5000.00 SqFt	PCI:	62		
Sample Comments: p133									
48	L & T CR	L	682.00	Ft					
48	L & T CR	M	36.00	Ft					
57	WEATHERING	M	5000.00	SqFt

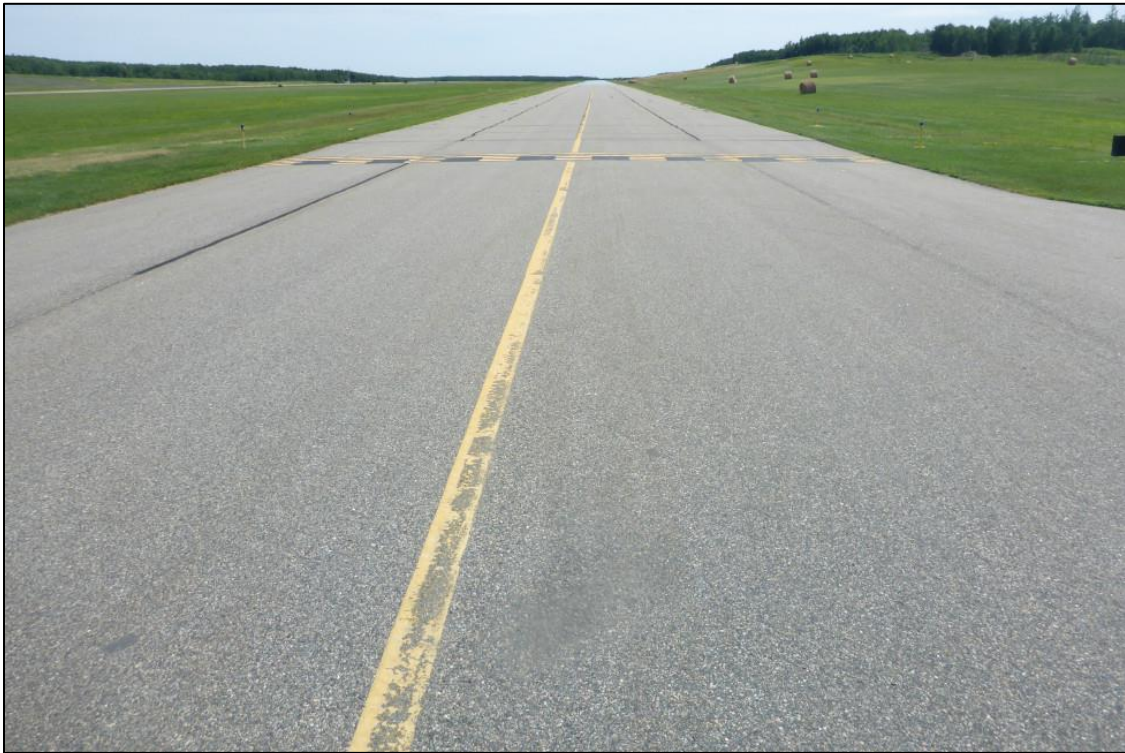
GPZ PTA 002 (PCI = 94)

Network:	GPZ	Name:	GRAND RAPIDS						
Branch:	PTA	Name:	PARALLEL TAXIWAY A	Use:	TAXIWAY	Area:	312,350 SqFt		
Section:	002	of 5	From:	104	To:	106	Last Const.:	10/1/2008	
Surface:	AC	Family:	MN2018 Asphalt Runway- Taxiways	Zone:	E	Category:	3	Rank:	P
Area:	10,350 SqFt	Length:	207 Ft	Width:	50 Ft				
Slabs:		Slab Length:	Ft	Slab Width:	Ft	Joint Length:	Ft		
Shoulder:		Street Type:		Grade:	0	Lanes:	0		
Section Comments:									
Last Insp. Date:	7/16/2019	TotalSamples:	2	Surveyed:	1				
Conditions:	PCI: 94								
Inspection Comments:									
Sample Number:	106	Type:	R	Area:	5000.00 SqFt	PCI:	94		
Sample Comments:	p132								
48	L & T CR	L	82.00	Ft

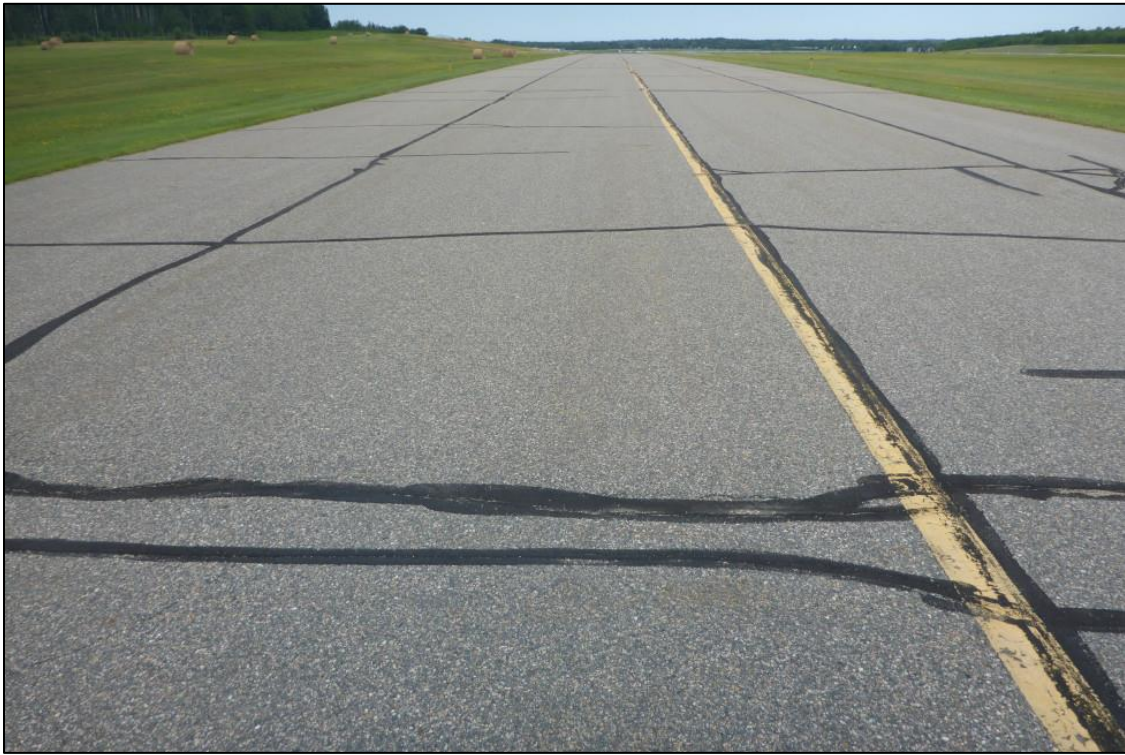
GPZ PTA 004 (PCI = 62)

Network:	GPZ	Name:	GRAND RAPIDS						
Branch:	PTA	Name:	PARALLEL TAXIWAY A	Use:	TAXIWAY	Area:	312,350 SqFt		
Section:	004	of 5	From:	123	To:	152	Last Const.:	8/30/2005	
Surface:	AAC	Family:	MN2018 Asphalt Runway- Taxiways	Zone:	E	Category:	3	Rank:	P
Area:	161,400 SqFt	Length:	2,900 Ft	Width:	50 Ft				
Slabs:		Slab Length:	Ft	Slab Width:	Ft	Joint Length:	Ft		
Shoulder:		Street Type:		Grade:	0	Lanes:	0		
Section Comments:									
Last Insp. Date:	7/16/2019	TotalSamples:	34	Surveyed:	4				
Conditions:	PCI: 62								
Inspection Comments:									
Sample Number:	126	Type:	R	Area:	5000.00 SqFt	PCI:	61		
Sample Comments: p596									
48	L & T CR	L	774.00	Ft					
48	L & T CR	M	34.00	Ft					
57	WEATHERING	L	5000.00	SqFt					
Sample Number:	133	Type:	R	Area:	5000.00 SqFt	PCI:	65		
Sample Comments:									
48	L & T CR	L	557.00	Ft					
48	L & T CR	M	47.00	Ft					
57	WEATHERING	M	5000.00	SqFt					
Sample Number:	140	Type:	R	Area:	5000.00 SqFt	PCI:	62

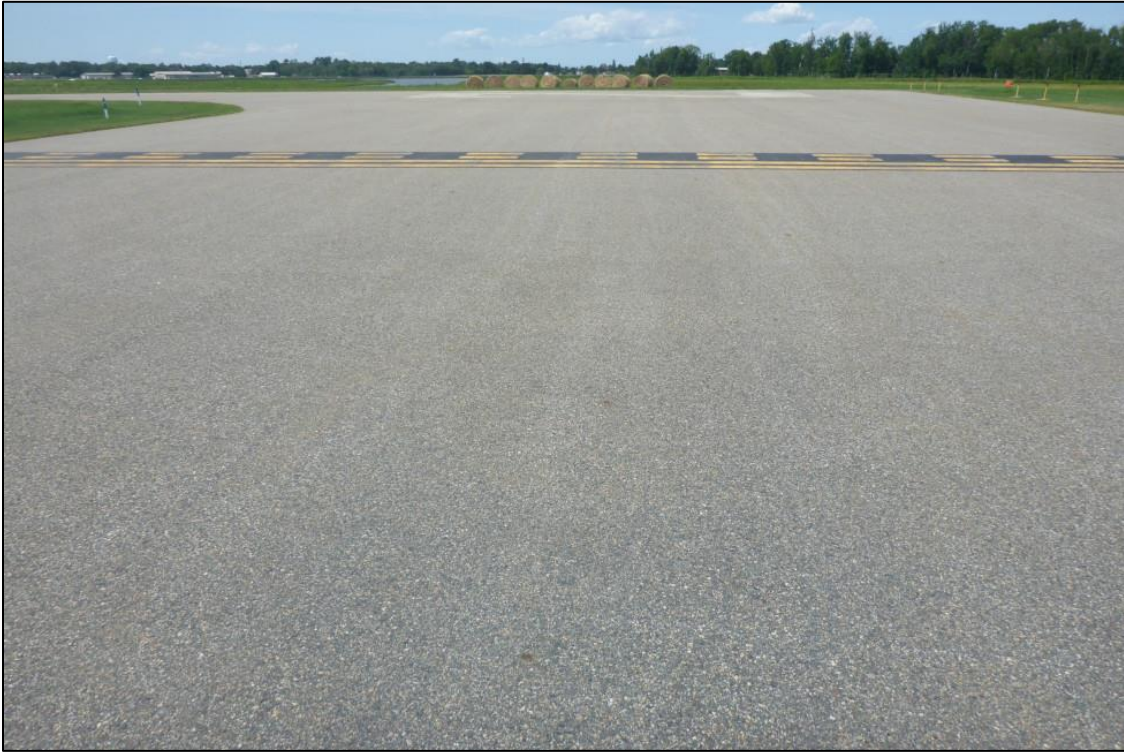
GPZ RTA23 001 (PCI = 95)

Network:	GPZ	Name:	GRAND RAPIDS						
Branch:	RTA23	Name:	Runway 23 Turn Around	Use:	TAXIWAY	Area:	12,850 SqFt		
Section:	001	of 1	From:	100	To:	102	Last Const.:	10/1/2008	
Surface:	AC	Family:	MN2018 Asphalt Runway- Taxiways	Zone:	E	Category:	3	Rank:	S
Area:	12,850 SqFt	Length:	145 Ft	Width:	85 Ft				
Slabs:		Slab Length:	Ft	Slab Width:	Ft	Joint Length:	Ft		
Shoulder:		Street Type:		Grade:	0	Lanes:	0		
Section Comments:									
Last Insp. Date:	7/16/2019	TotalSamples:	3	Surveyed:	1				
Conditions:	PCI: 95								
Inspection Comments:									
Sample Number:	101	Type:	R	Area:	4250.00 SqFt	PCI:	95		
Sample Comments:	pic 600								
57	WEATHERING	L	2200.00	SqFt

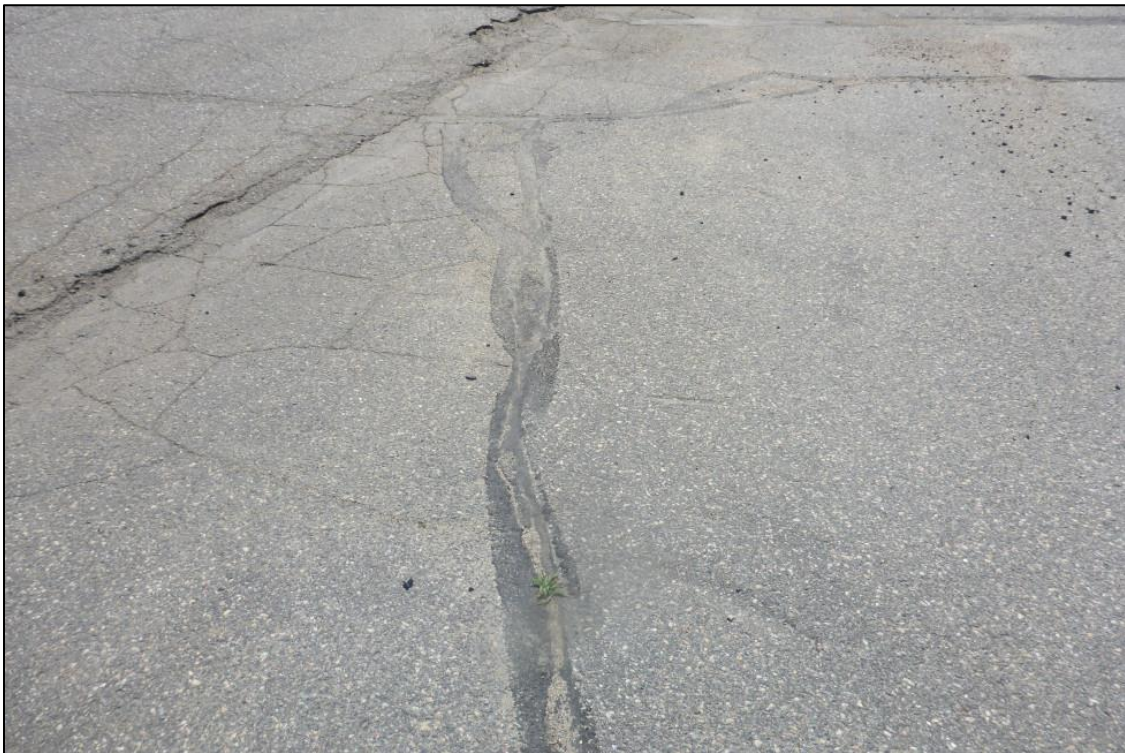
GPZ TLF 001 (PCI = 55)

⁶Higher than expected 3-year drop in PCI between inspections for TLF-001 is due to the development of medium-severity Alligator cracking and Weathering in significant quantities.
