# Pavement Condition Report

## Little Falls - Morrison County Airport (LXL)

**December 2019**

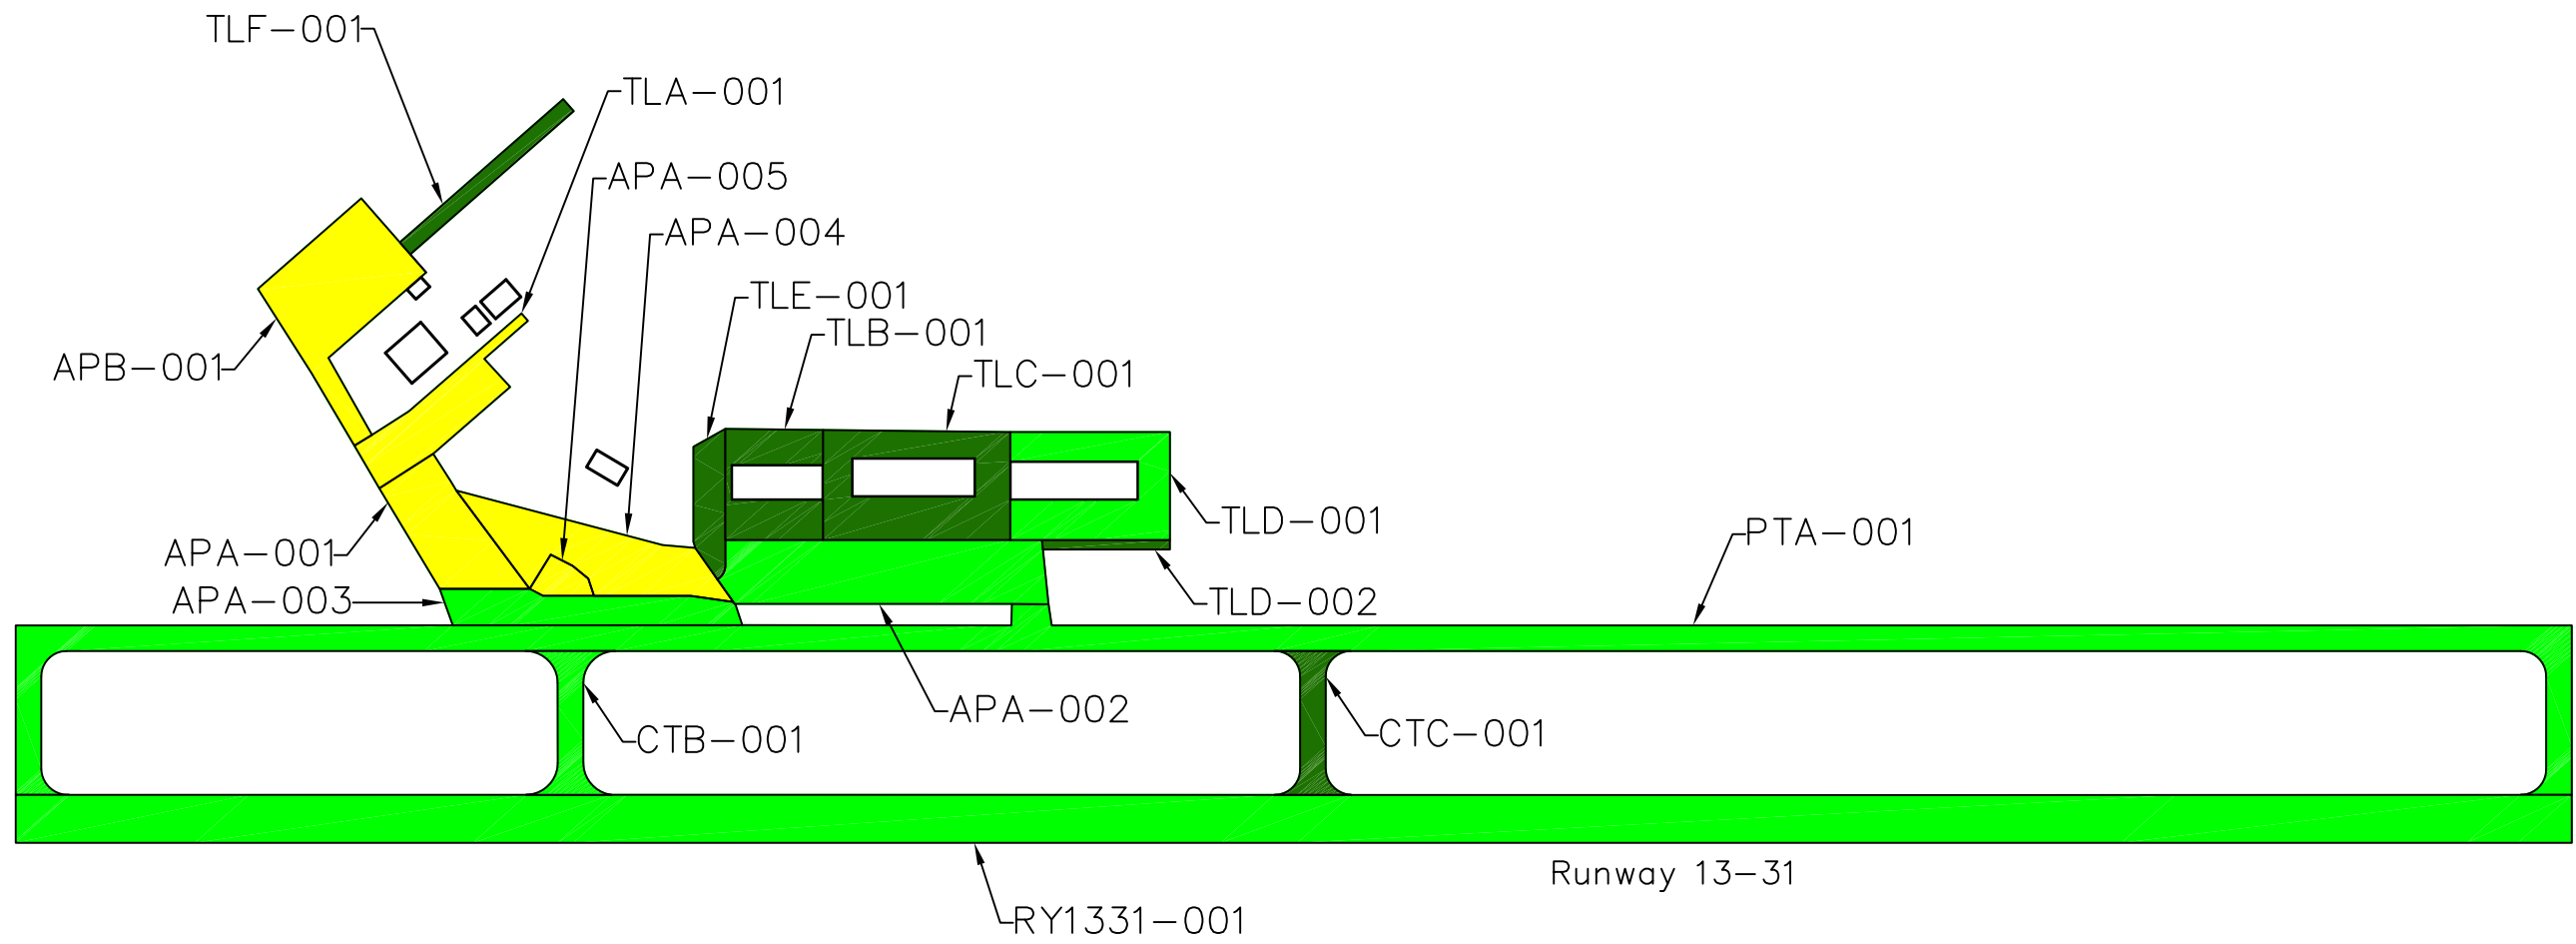
Figure 4. 2019 Pavement Condition Index Rating at Little Falls-Morrison County Airport (LXL).

<sup>8</sup>Higher than expected deterioration rate of 23.0 PCI/year due to reflective cracking through the asphalt overlay.

<sup>9</sup>Higher than expected deterioration rate due to the development of low and medium-severity L&T cracking in significant quantities.

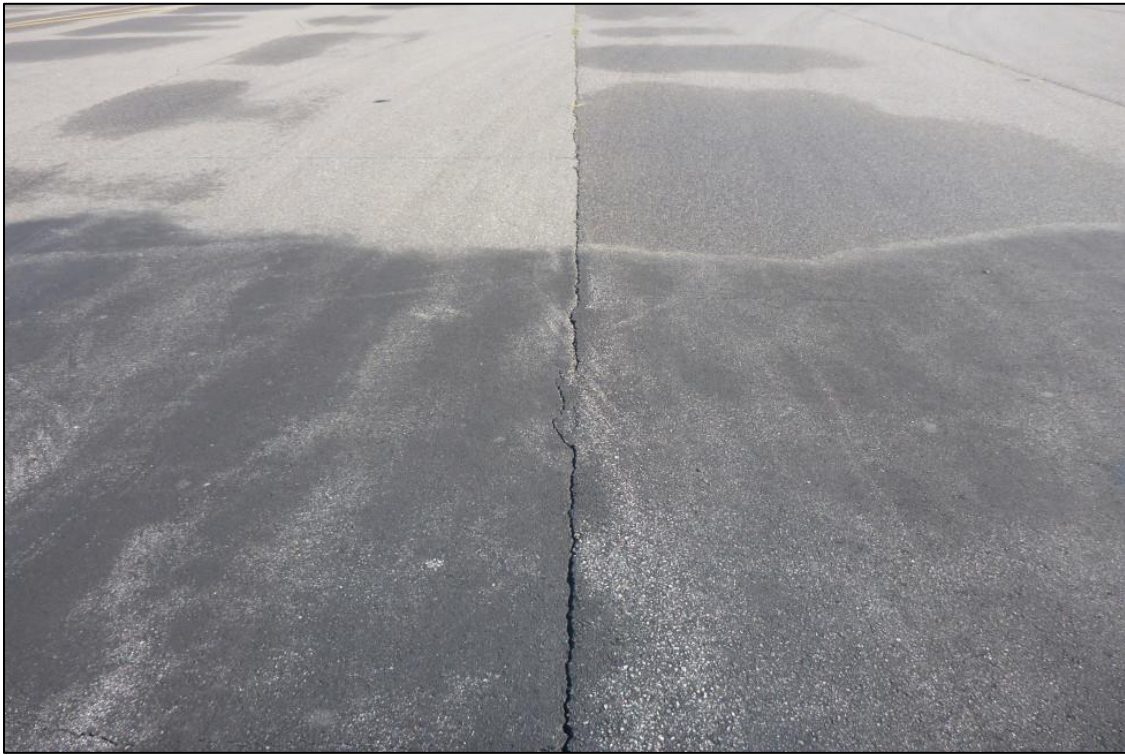
LXL APA 001 (PCI = 70)

**Conditions:** PCI: 70

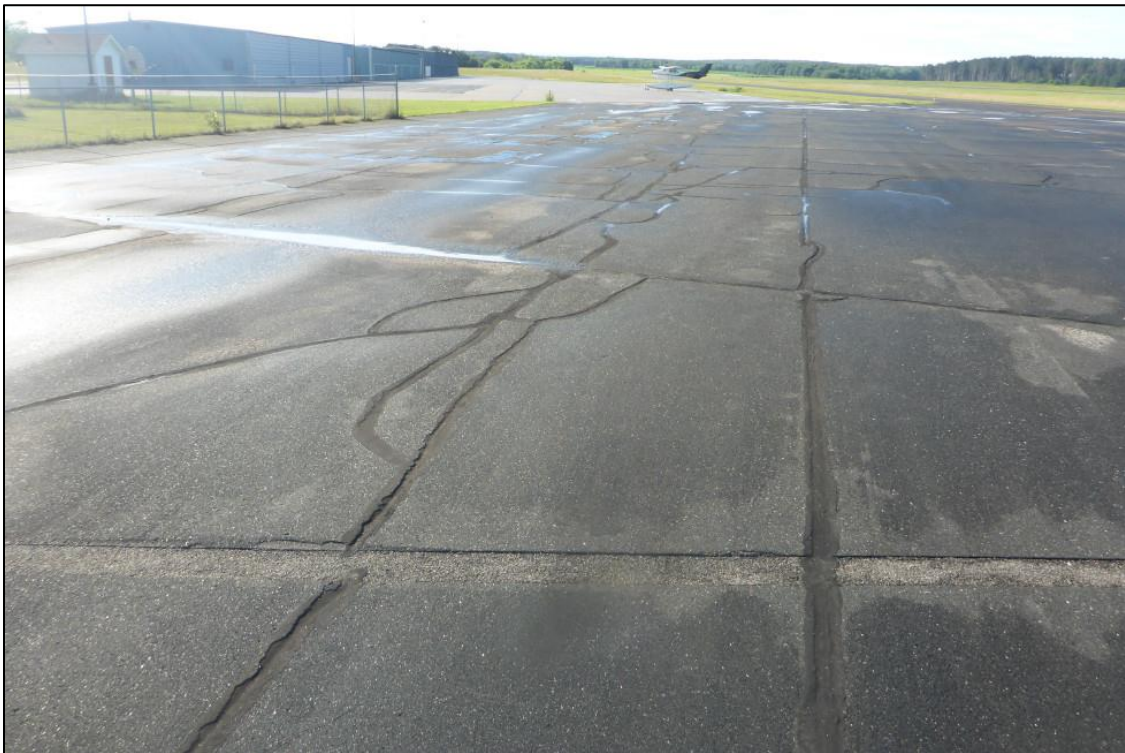
LXL APA 004 (PCI = 56)

**Conditions:** PCI: 56

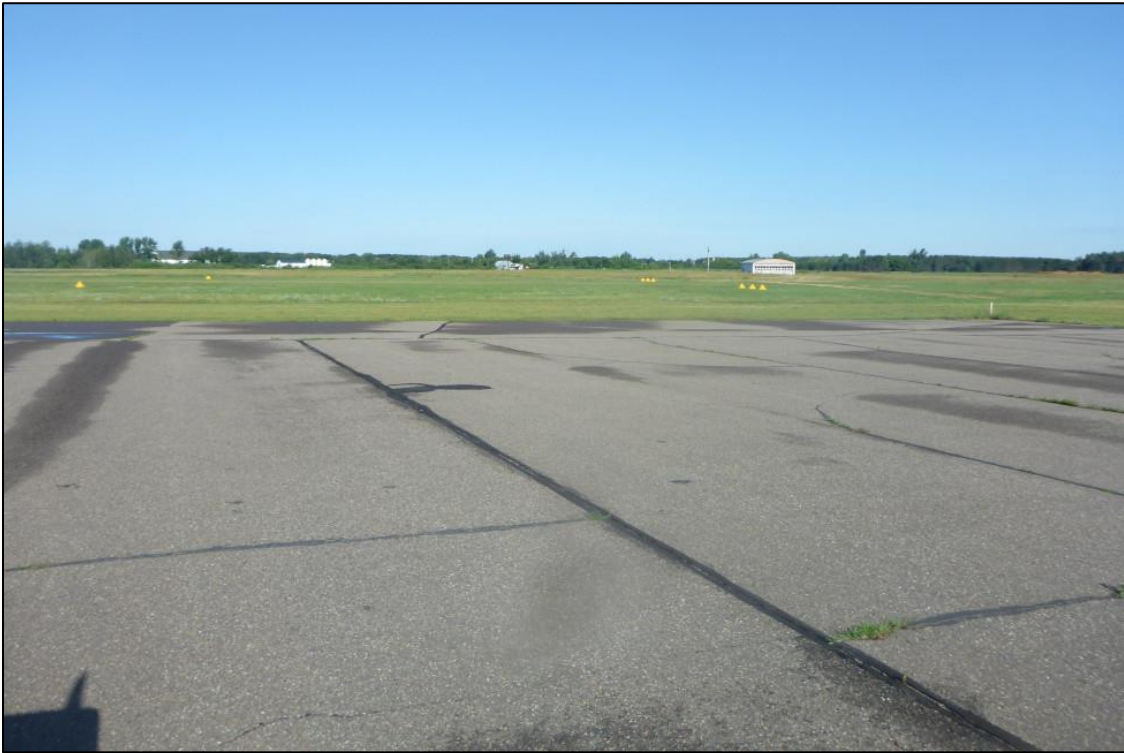
LXL APB 001 (PCI = 63)

**Conditions:** PCI: 63
