Pavement Condition Report

Thief River Falls Regional Airport (TVF)

December 2019

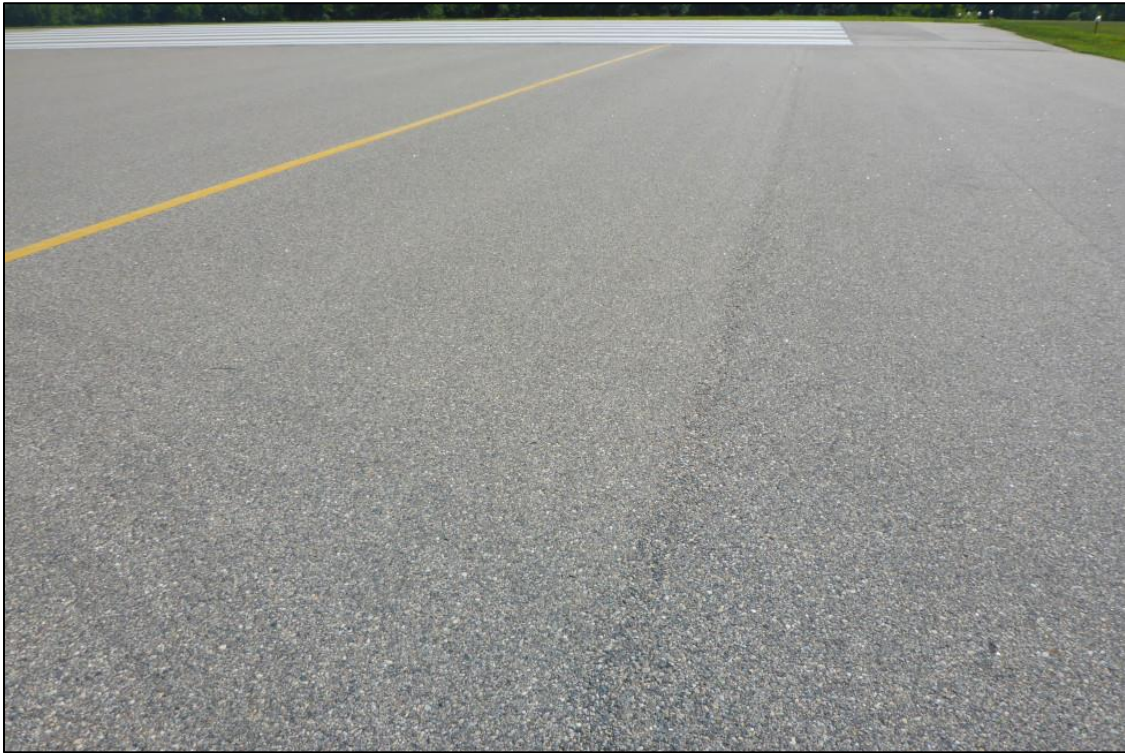
TVF CTA 001 (PCI = 98)

Network:	TVF		Name:	THIEF RIVER FALLS					
Branch:	CTA	Name:	CONNECTING TAXIWAY A	Use:	TAXIWAY	Area:	24,820 SqFt		
Section:	001	of 2	From:	100	To:	102+25	Last Const.:	10/1/2011	
Surface:	AC	Family:	MN2018 Asphalt Runway- Taxiways	Zone:	N	Category:	3	Rank:	P
Area:	11,475 SqFt	Length:	125 Ft	Width:	75 Ft				
Slabs:		Slab Length:	Ft	Slab Width:	Ft	Joint Length:	Ft		
Shoulder:		Street Type:		Grade:	0	Lanes:	0		
Section Comments:									
Last Insp. Date:	7/16/2019		TotalSamples:	2		Surveyed:	1		
Conditions:	PCI:	98							
Inspection Comments:									
Sample Number:	101	Type:	R	Area:	4250.00 SqFt	PCI:	98		
Sample Comments:	pic 703								
57	WEATHERING	L		350.00	SqFt

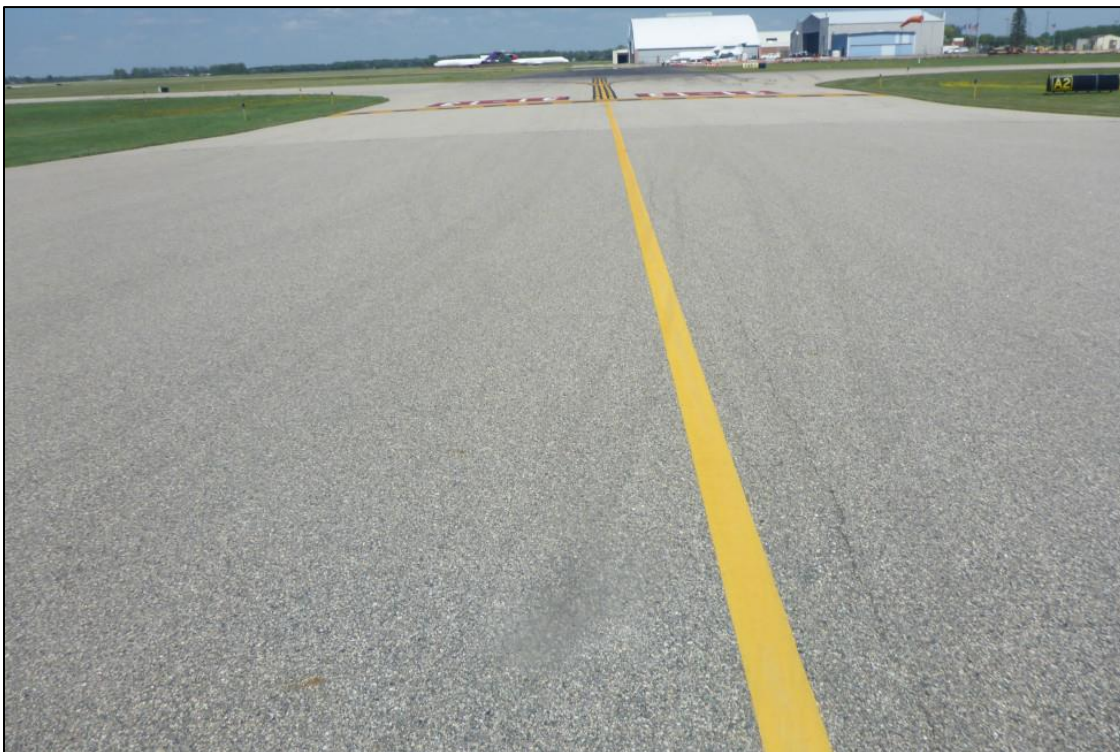
TVF CTA2 001 (PCI = 94)

Network:	TVF		Name:	THIEF RIVER FALLS			
Branch:	CTA2	Name:	CONNECTING TAXIWAY A2	Use:	TAXIWAY	Area:	32,325 SqFt
Section:	001	of 2	From:	400	To:	402	Last Const.: 10/1/2011
Surface:	AC	Family:	MN2018 Asphalt Runway- Taxiways	Zone:	N	Category:	3
Area:	18,825 SqFt	Length:	125 Ft	Width:	75 Ft		
Slabs:		Slab Length:	Ft	Slab Width:	Ft	Joint Length:	Ft
Shoulder:		Street Type:		Grade:	0	Lanes:	0
Section Comments:							
Last Insp. Date:	7/16/2019	TotalSamples:	5	Surveyed:	1		
Conditions:	PCI: 94						
Inspection Comments:							
Sample Number:	401	Type:	R	Area:	3750.00 SqFt	PCI:	94
Sample Comments:	p210						
48	L & T CR	L	50.00	Ft

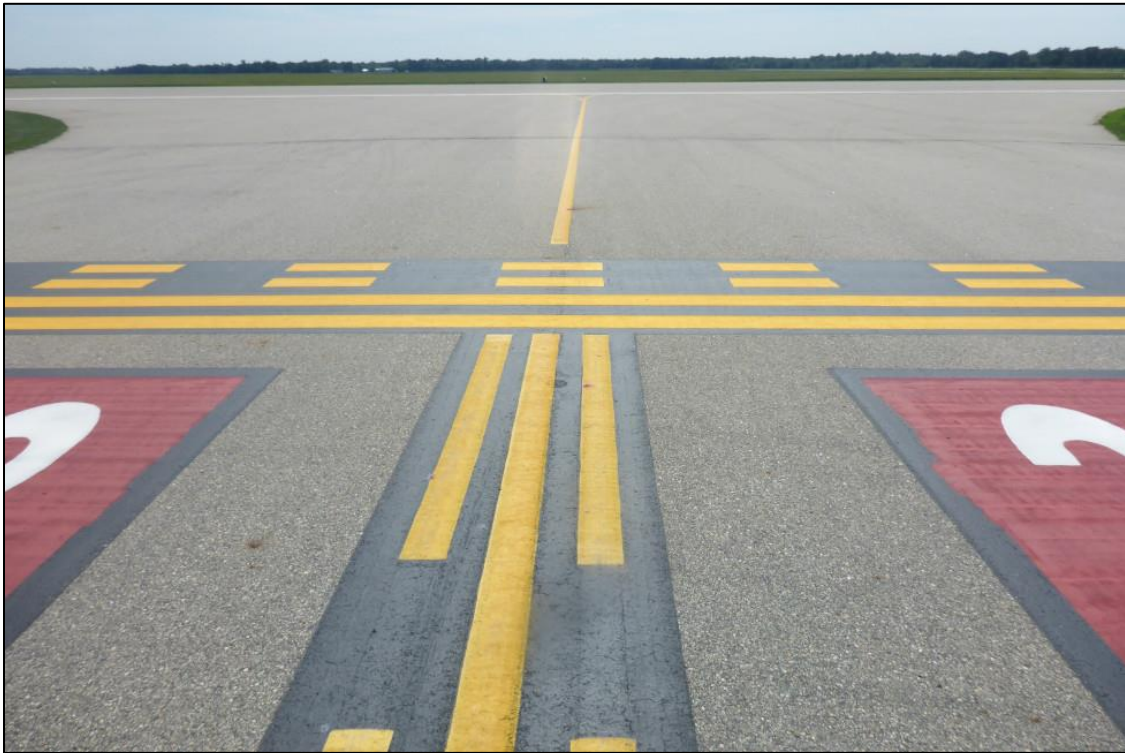
TVF CTA2 002 (PCI = 98)

Network:	TVF		Name:	THIEF RIVER FALLS					
Branch:	CTA2	Name:	CONNECTING TAXIWAY A2	Use:	TAXIWAY	Area:	32,325 SqFt		
Section:	002	of 2	From:	403	To:	405	Last Const.:	7/1/2013	
Surface:	AC	Family:	MN2018 Asphalt Runway- Taxiways	Zone:	N	Category:	3	Rank:	P
Area:	13,500 SqFt	Length:	160 Ft	Width:	75 Ft				
Slabs:		Slab Length:	Ft	Slab Width:	Ft	Joint Length:	Ft		
Shoulder:		Street Type:		Grade:	0	Lanes:	0		
Section Comments:									
Last Insp. Date:	7/16/2019	TotalSamples:	8	Surveyed:	1				
Conditions:	PCI: 98								
Inspection Comments:									
Sample Number:	403	Type:	R	Area:	3750.00 SqFt	PCI:	98		
Sample Comments:	p211								
57	WEATHERING	L		500.00	SqFt

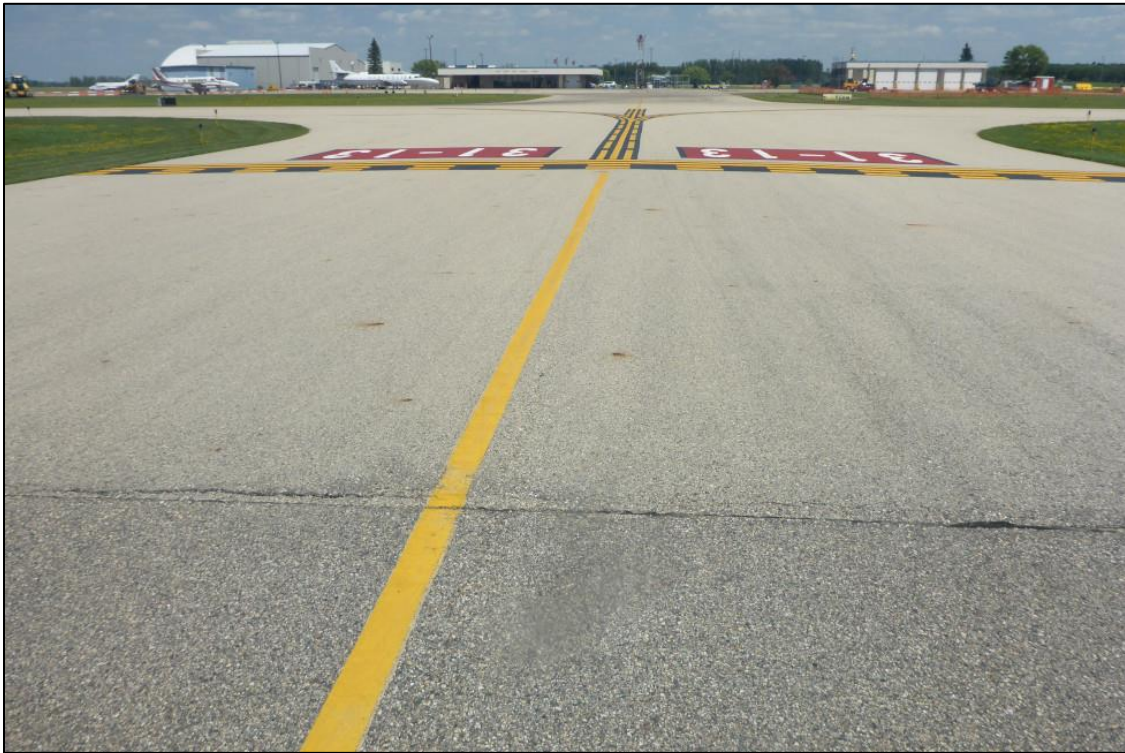
TVF CTA3 002 (PCI = 94)

Network:	TVF		Name:	THIEF RIVER FALLS					
Branch:	CTA3	Name:	CONNECTING TAXIWAY A3	Use:	TAXIWAY	Area:	32,325 SqFt		
Section:	002	of 2	From:	500	To:	507	Last Const.:	7/1/2013	
Surface:	AC	Family:	MN2018 Asphalt Runway- Taxiways	Zone:	N	Category:	3	Rank:	P
Area:	13,500 SqFt	Length:	160 Ft	Width:	75 Ft				
Slabs:		Slab Length:	Ft	Slab Width:	Ft	Joint Length:	Ft		
Shoulder:		Street Type:		Grade:	0	Lanes:	0		
Section Comments:									
Last Insp. Date:	7/16/2019		TotalSamples:	8		Surveyed:	1		
Conditions:	PCI: 94								
Inspection Comments:									
Sample Number:	504	Type:	R	Area:	3750.00 SqFt	PCI:	94		
Sample Comments:									
48	L & T CR		L	50.00 Ft

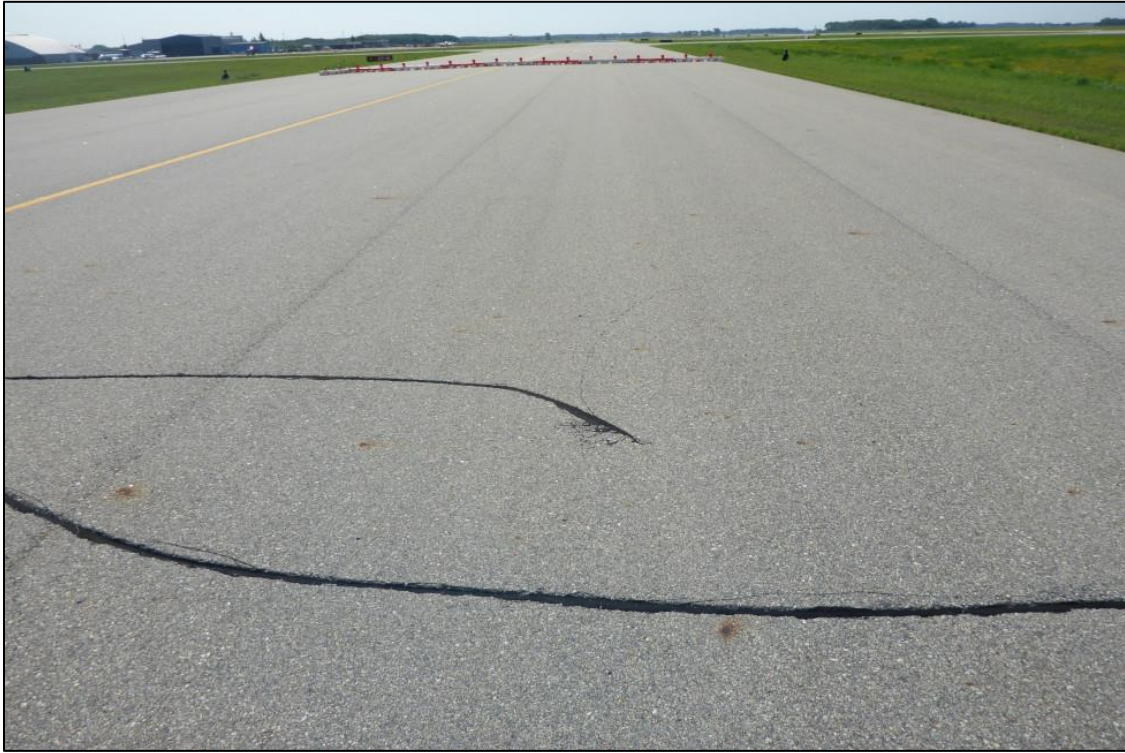
TVF PTA 002 (PCI = 89)

Network:	TVF	Name:	THIEF RIVER FALLS						
Branch:	PTA	Name:	PARALLEL TAXIWAY A	Use:	TAXIWAY	Area:	494,755 SqFt		
Section:	002	of 6	From:	104	To:	139	Last Const.:	7/1/2013	
Surface:	AC	Family:	MN2018 Asphalt Runway- Taxiways	Zone:	N	Category:	3	Rank:	P
Area:	135,000 SqFt	Length:	1,800 Ft	Width:	75 Ft				
Slabs:		Slab Length:	Ft	Slab Width:	Ft	Joint Length:	Ft		
Shoulder:		Street Type:		Grade:	0	Lanes:	0		
Section Comments:									
Last Insp. Date:	7/16/2019	TotalSamples:	40	Surveyed:	6				
Conditions:	PCI: 89								
Inspection Comments:									
Sample Number:	112	Type:	R	Area:	3750.00 SqFt	PCI:	93		
Sample Comments:	pic 682 su 107								
48	L & T CR	L	75.00	Ft					
Sample Number:	121	Type:	R	Area:	3750.00 SqFt	PCI:	93		
Sample Comments:									
48	L & T CR	L	75.00	Ft					
Sample Number:	122	Type:	R	Area:	3750.00 SqFt	PCI:	96		
Sample Comments:									
48	L & T CR	L	19.00	Ft					
Sample Number:	132	Type:	R	Area:	3750.00 SqFt	PCI:	95

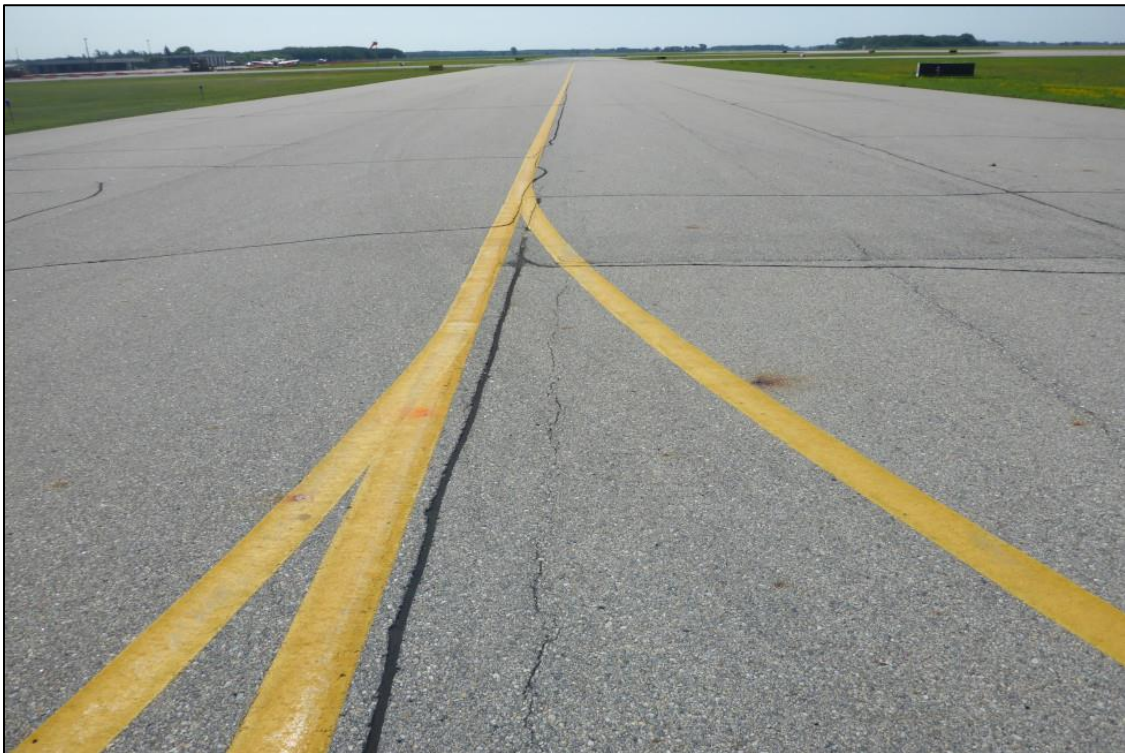
TVF PTA 003 (PCI = 80)

Network:	TVF		Name:	THIEF RIVER FALLS		
Branch:	PTA	Name:	PARALLEL TAXIWAY A	Use:	TAXIWAY	Area: 494,755 SqFt
Section:	003	of 6	From: 140	To: 157	Last Const.: 7/1/2013	
Surface:	AAC	Family:	MN2018 Asphalt Runway- Taxiways	Zone: N	Category: 3	Rank: P
Area:	50,250 SqFt	Length:	900 Ft	Width:	75 Ft	
Slabs:		Slab Length:	Ft	Slab Width:	Ft	Joint Length: Ft
Shoulder:		Street Type:		Grade: 0	Lanes: 0	
Section Comments:						
Last Insp. Date:	7/16/2019		TotalSamples:	13	Surveyed:	2
Conditions:	PCI:	80				
Inspection Comments:						
Sample Number:	152	Type:	R	Area:	3750.00 SqFt	PCI: 74
Sample Comments:	pic 684					
48	L & T CR	L	446.00 Ft			
Sample Number:	156	Type:	R	Area:	3750.00 SqFt	PCI: 85
Sample Comments:						
48	L & T CR	L	184.00 Ft

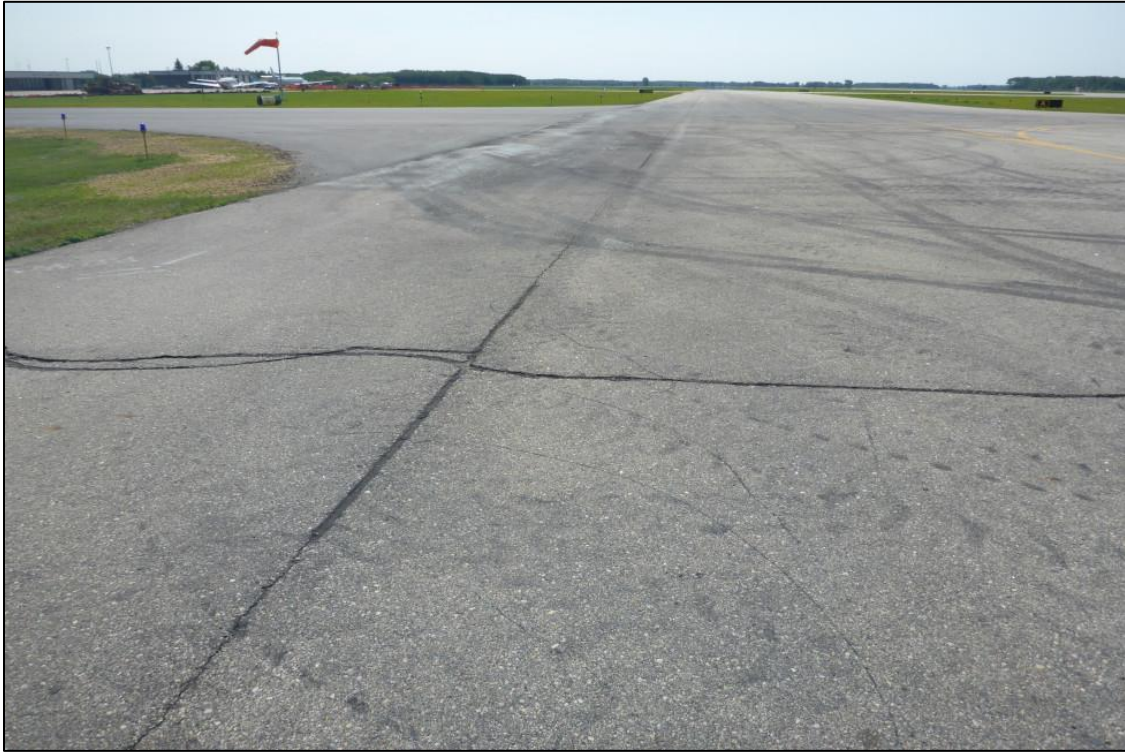
TVF PTA 004 (PCI = 91)

Network:	TVF		Name:	THIEF RIVER FALLS					
Branch:	PTA	Name:	PARALLEL TAXIWAY A	Use:	TAXIWAY	Area:	494,755 SqFt		
Section:	004	of 6	From:	158	To:	228	Last Const.: 7/1/2013		
Surface:	AC	Family:	MN2018 Asphalt Runway- Taxiways	Zone:	N	Category:	3	Rank:	P
Area:	270,000 SqFt	Length:	3,600 Ft	Width:	75 Ft				
Slabs:		Slab Length:	Ft	Slab Width:	Ft	Joint Length:	Ft		
Shoulder:		Street Type:		Grade:	0	Lanes:	0		
Section Comments:									
Last Insp. Date:	7/16/2019		TotalSamples:	71		Surveyed:	9		
Conditions:	PCI:	91							
Inspection Comments:									
Sample Number:	162	Type:	R	Area:	3750.00 SqFt	PCI:	85		
Sample Comments:	pic 685								
48	L & T CR	L	118.00	Ft					
48	L & T CR	M	9.00	Ft					
Sample Number:	172	Type:	R	Area:	3750.00 SqFt	PCI:	86		
Sample Comments:									
48	L & T CR	L	173.00	Ft					
Sample Number:	182	Type:	R	Area:	3750.00 SqFt	PCI:	88		
Sample Comments:									
48	L & T CR	L	135.00	Ft					
Sample Number:	192	Type:	R	Area:	3750.00 SqFt	PCI:	97
