## **INSPIRATION POINT WAYSIDE REST**

### **Condition Assessment**

TH 16 near junction with CSAH 21  
Carrolton Township, Fillmore County, MN

**November 2013**

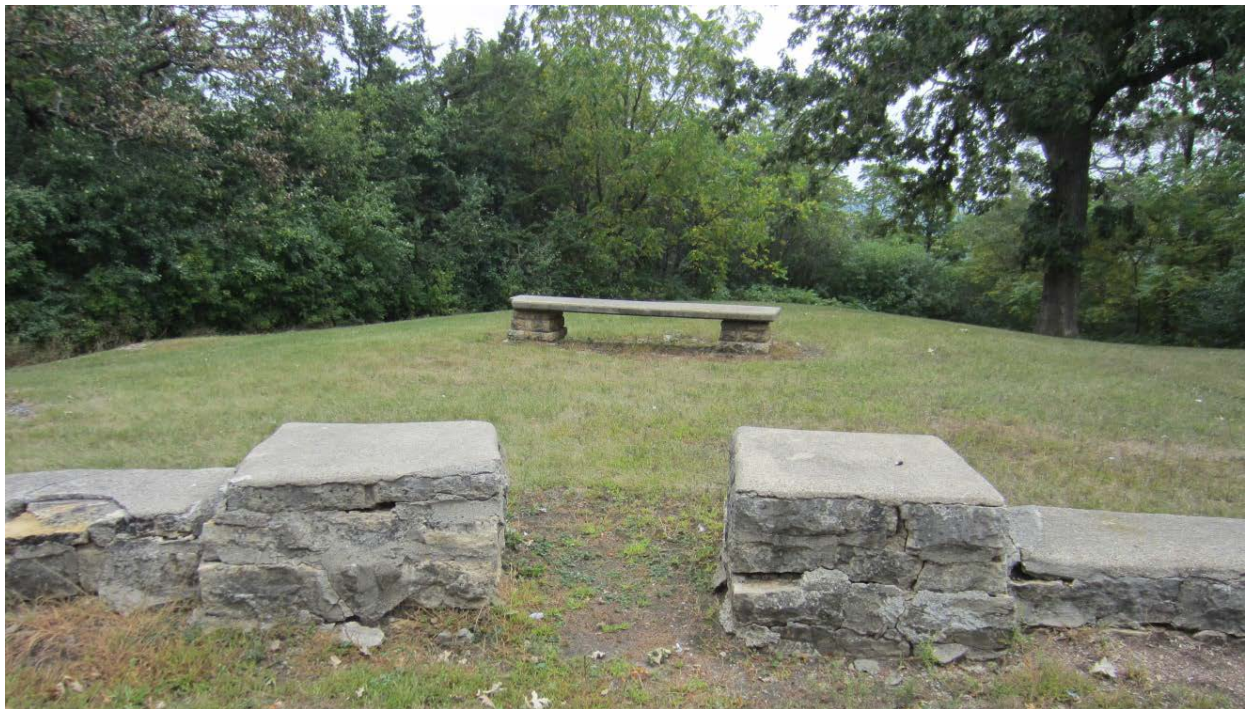
The View today blocked by buckthorn and other invasive species

- Recommendation:
    - Remove all buckthorn and other invasive woody species within the project limits using an established and effective method for eliminating these invasive species.

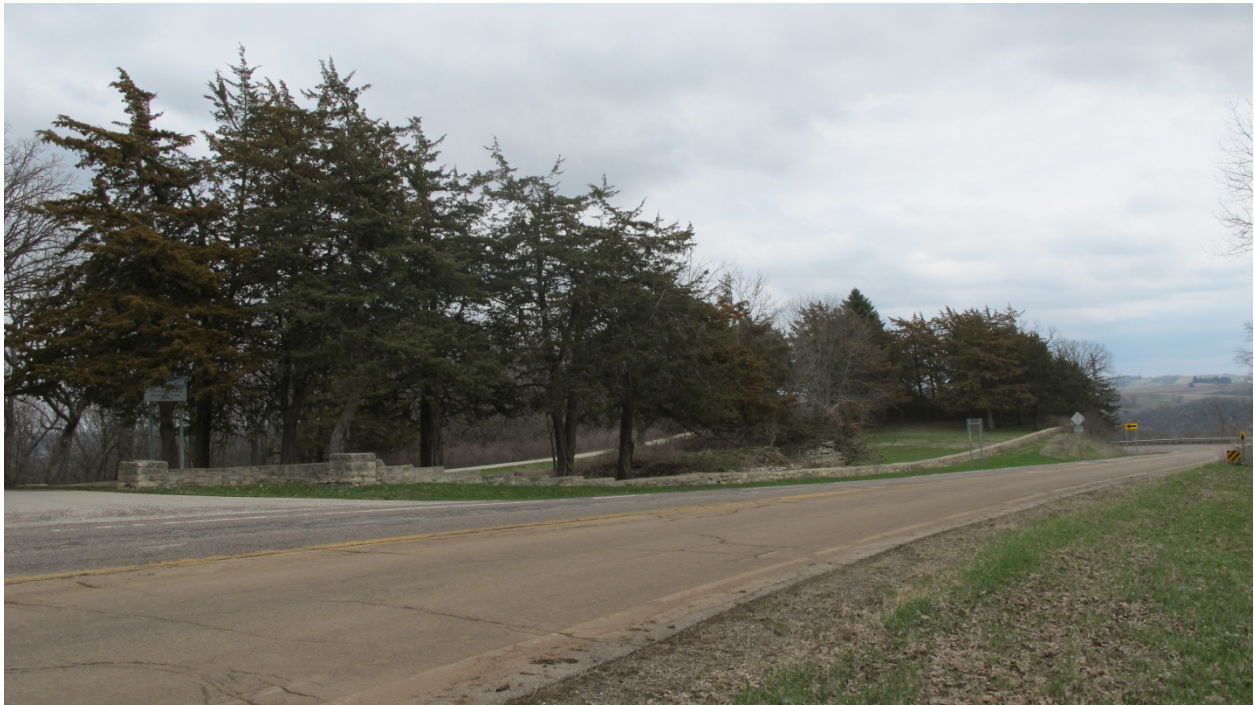
Original entrance, and south wall today.

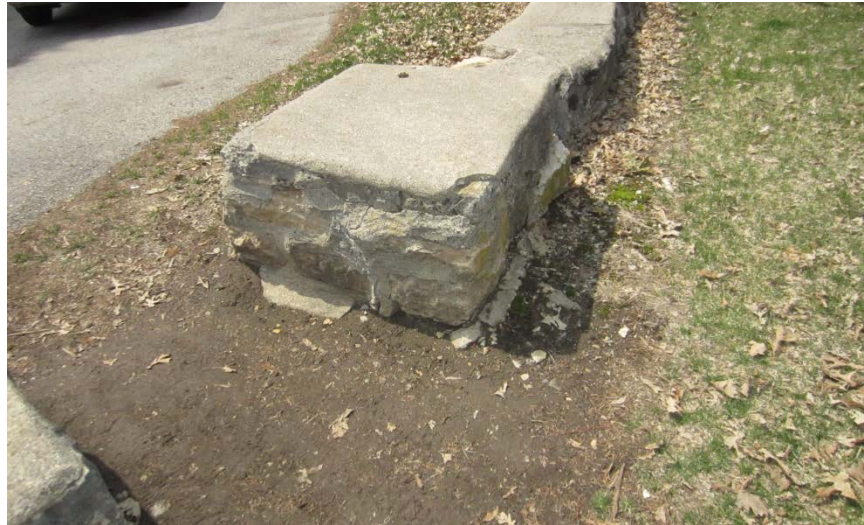
Unpaved opening through East Overlook wall

- When fully restored, at least one of the two picnic areas should be accessible. The East Table currently has only one bench that remains, the table and other bench is missing. Reconstruct the missing table and bench to be wheelchair accessible, but sympathetic with the historic design using materials and details that are modified to accommodate a wheelchair. Add an accessible gravel path from East Overlook Parking Area, through the opening in the overlook wall, and East Picnic Table.

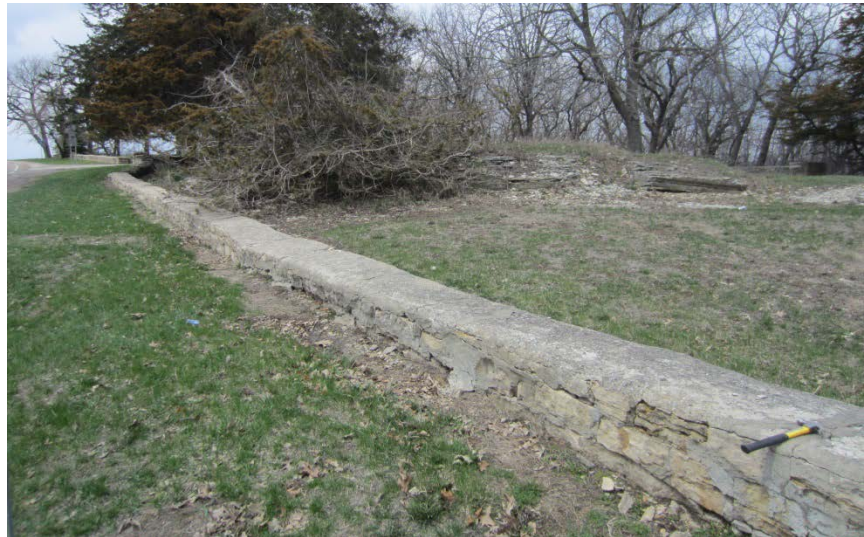
The South Entrance Walls are in poor condition. The original plans noted these walls to be dry laid masonry construction. From the assessment, it does appear these walls were an attempt at this specific type of construction, however, the craftsmanship or dry laid masonry techniques were lacking. Poor construction techniques have resulted in the structural failure of the wall which impacts the historic and aesthetic integrity of the wall. There are many sections of the wall that have shifted out of place or settled differently than adjacent sections of wall, indicating a failure of the base. To repair these conditions a concrete cap and crudely applied surface mortar was installed. Initially intended to stabilize the walls, these repairs are inappropriate for this type of wall construction and have resulted in the ongoing and accelerated deterioration of the walls. This deterioration is causing the stone to spall and break, altering many beyond the ability for salvage and reinstallation.

- The piers appear to have always been mortared, but because of their failing condition must be dismantled and reconstructed. Exact reconstruction, placing the stones in their historic configuration, must be followed. Photographically document the location of the current stone to aid in the reconstruction process.

- The original construction documents state that the walls were built on an 8" sand foundation; however this foundation has failed and must be removed. Install new reinforced concrete foundation with a proper frost footing to serve as the base for the reconstructed stone wall. The new foundation must not extend above grade.

- Reconstruct the walls using original stone, supplementing with replacement stones when necessary where stones have deteriorated and to provide the need for additional stone following proper dry laid stone construction. The new stones must match the existing stones in size, color, surface texture, and tooling.

- Part of the original Nichols detail included setting the top 6" of stone in a mortar bed, essentially capping the wall as a solid mass. This is not a typical detail for a dry laid stone wall; however, if this mortared cap was placed upon a properly constructed wall, it will aid in the durability of the wall and is recommended to be replicated.

- Reset curb stones. Use dismantling means and methods that do not damage adjacent, sound masonry. Salvage original stones, clean stones to remove mortar, dirt, and moss growth, and prepare for reuse. Reinstall curb stones in their original locations on a new compacted Class 5 base, mortaring the vertical joints. Mortar must match existing, historic mortar in strength, texture, appearance, and tooling. Reconstructed mortar joints will be flush with the outside face of adjacent stones. There have been several other sites that have installed a concrete 'footing' under the curb stone to help the stone resist overturning. The documents do not show this type of construction, but digging test holes at the back of the curb will assist in this determination. If this curb footing is found, include a similar detail in the reconstruction of the curb.

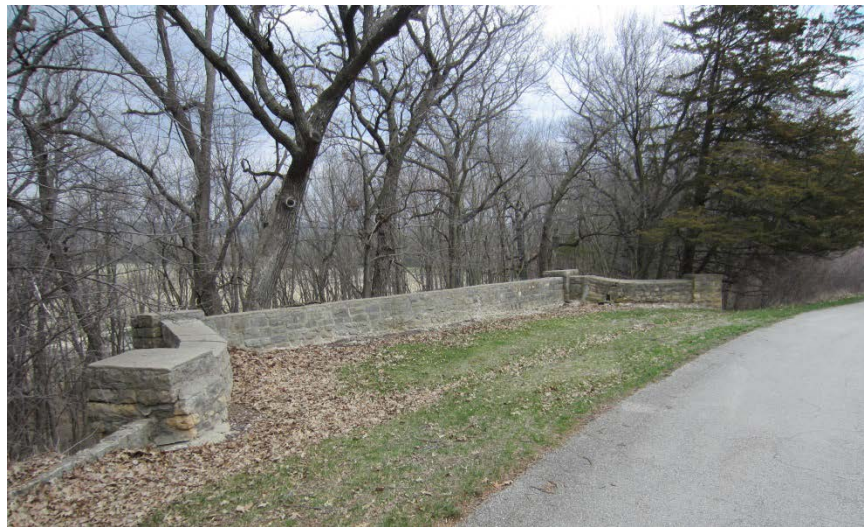
North Overlook and Parking Area

The wall is in failing condition. The last conditions assessment in 2005 reported that the central, straight portion of the wall was out of plumb 9" on the west end and 10" on the east end. The same section of the wall is currently 9 ¼" out of plumb on the west end and 10 ¾" out of plumb on the east end. The wall is continuing to shift and immediate action should be taken to avoid structural failure of the wall.

There are several possible reasons why the wall is out of plumb. The weight of vehicles parked next to the wall may have compacted and pushed soil against the foundation of the retaining wall. The

historic foundation was likely not designed to support the weight of modern vehicles. In our experience with other retaining walls from that era, we have found that the foundations were often insufficient.

Another reason for the failure is likely due to improper storm water drainage from the retained soil. The gravel surface of the parking area has eroded and the surface of the adjacent road has been changed from gravel to bituminous that slopes towards the wall. The storm water that is draining off the bituminous roadway onto the parking area is draining towards the retaining wall, possibly with enough pressure to displace the wall.

The central, straight portion of the wall has poorly crafted mortar joints. The joints are not well packed and there are frequent voids in the joints. This has contributed to the deterioration of the wall. Masonry walls constructed with mortared joints are designed to act monolithically; however with missing mortar, the wall is significantly weakened. The pillars on either side of the central, straight portion of the wall have more skillfully installed joints and appear to be in sound condition but are leaning out of plumb because of the adjacent wall. Several of the stones in this section of wall are cracked and broken. There is significant dirt and moss growth on the wall; particularly at the base where it was very wet indicating that water from the parking area above is draining through the wall.

Both the west and the east sections of quarter circle walls have large cracks that extend from the top of the wall to the bottom and run through the entire thickness of the wall. There are several stones adjacent to the cracks that have shifted and now project from the face of the wall. Successive mortar repairs have been applied to the large cracks and adjacent stones in an attempt to repair those cracks. Unfortunately, this repair was not successful. The cracks are once again open and the repair mortar has likely caused additional damage trapping water in the walls and cracking the adjacent stone. The pillar on the west end of the wall (terminating the west semi-circular portion of the wall) is in poor condition. The concrete cap is cracked and a section of it is missing. The top two courses of stones are shifted several inches further north than the rest of the pillar below. There are many joints without mortar and large sections of the pillar have mortar smeared on the face of the stones.

- Dismantle and reconstruct the entire retaining wall. Photograph the wall to document the historic stone pattern and configuration. Measure all details of the wall to ensure that the reconstructed wall is true to the original wall design as built. Use dismantling means and methods that do not damage adjacent, sound masonry. Salvage original stones, clean stones to remove mortar, dirt and moss growth, and prepare for reuse.

- Demolish the historic foundation, if one exists. Install new reinforced concrete foundation and soil retaining system designed by a structural engineer. Install drainage system to protect retaining wall from future water damage.

- Reconstruct wall with original stone, using replacement stones only when necessary to replace broken or deteriorated stones. Any replacement stones must match the removed stones in size, color, surface texture, and tooling. Install in fully filled bed, head, and collar

- Reconstruct curb stones to accommodate modified site drainage, see Section 4.1. Use dismantling means and methods that do not damage adjacent, sound masonry. Salvage original stones, clean stones to remove mortar and biological growth, and prepare for reuse. Reinstall curb stones in their original locations on a new compacted Class 5 base, mortaring the vertical joints. Mortar must match existing, historic mortar in strength, texture, appearance, and tooling. Reconstructed mortar joints will be flush with the outside face of adjacent stones. There have been several other sites that have installed a concrete 'footing' under the curb stone to help the stone resist overturning. The documents do not show this type of construction, but digging test holes at the back of the curb will assist in this determination. If this curb footing is found, include a similar detail in the reconstruction of the curb.

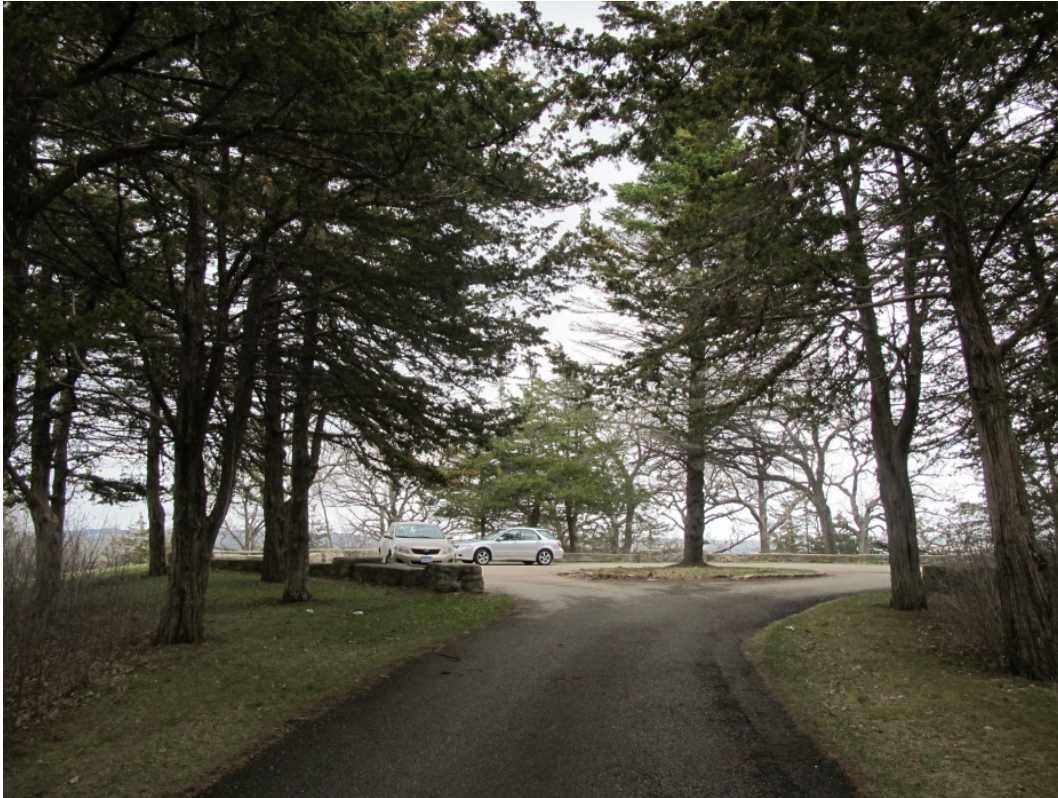
Looking east towards East Overlook and Parking Area

The curb is in good condition, although the grade and bituminous have now made them flush instead of raised above grade.

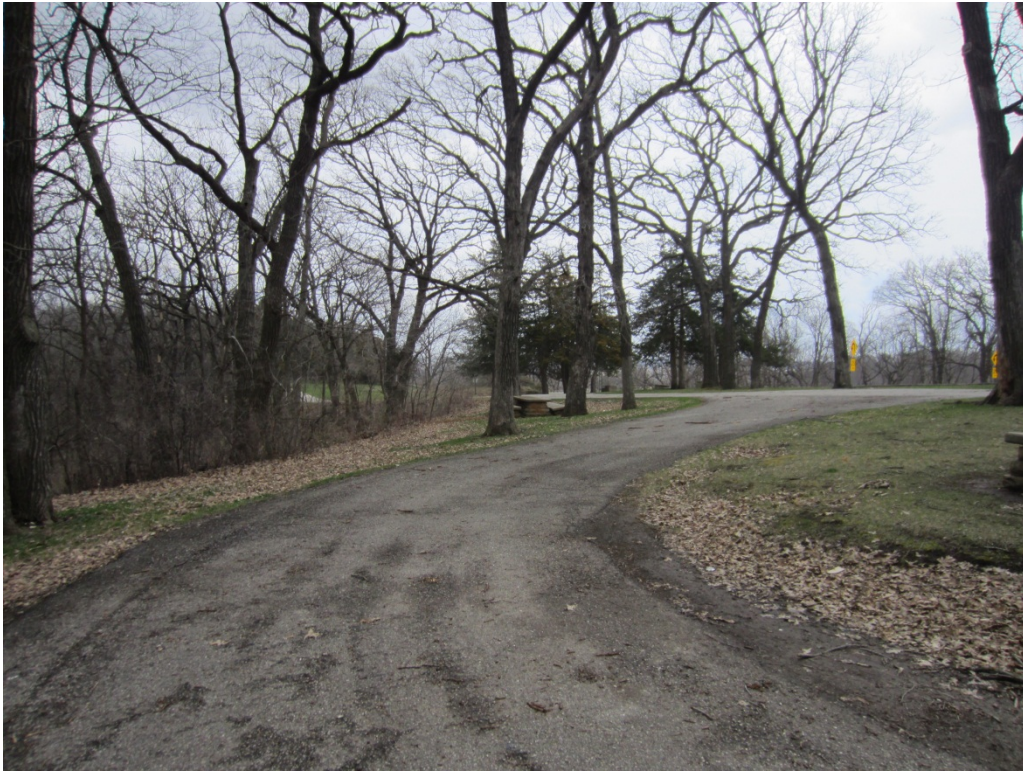
4.2 – West Drive with deteriorated and cracking bituminous

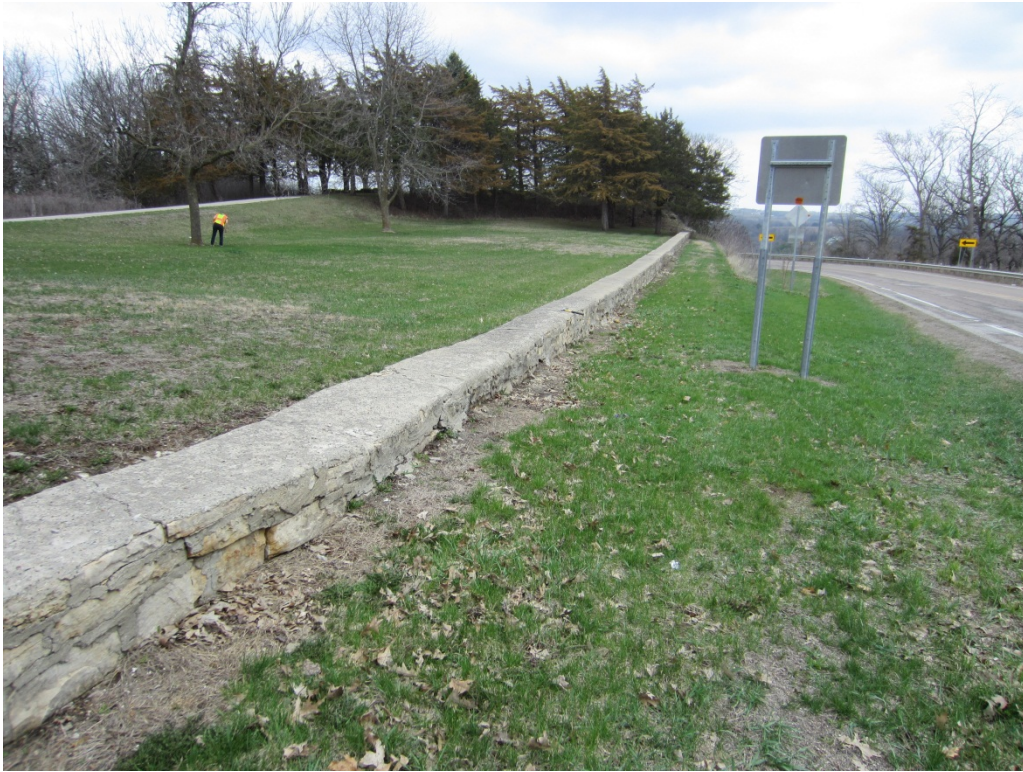
4.5 – Shifted sections of East Entrance Walls

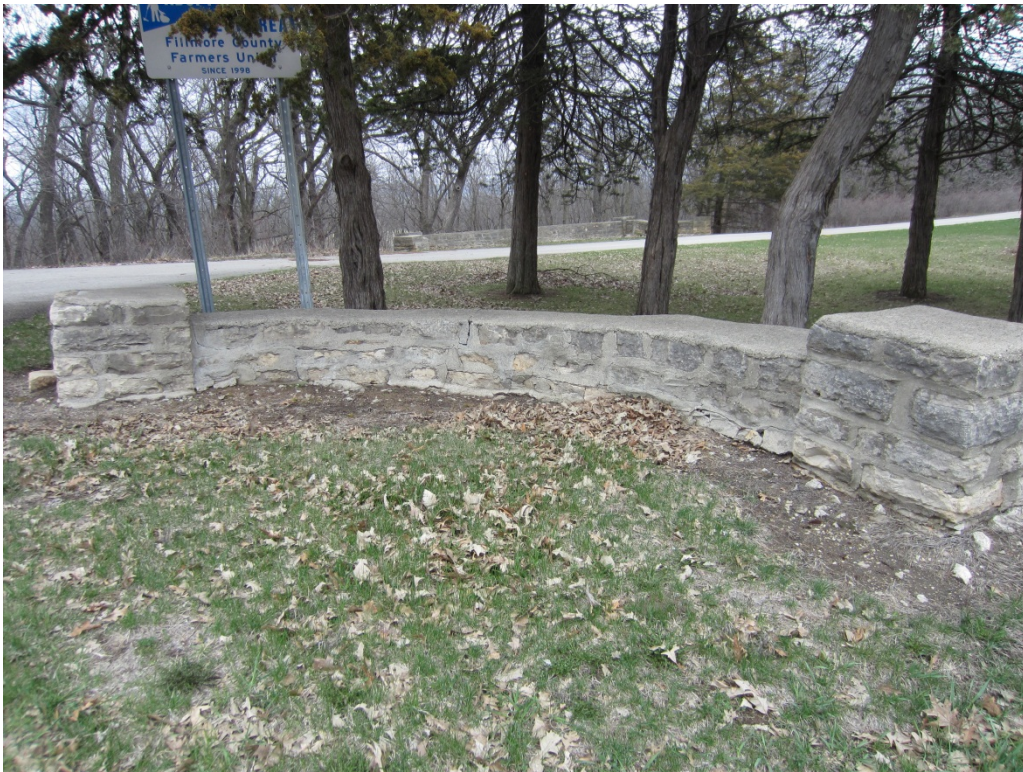
4.5 – Mortar cap and mortared joints of curved walls at Historic Entrance

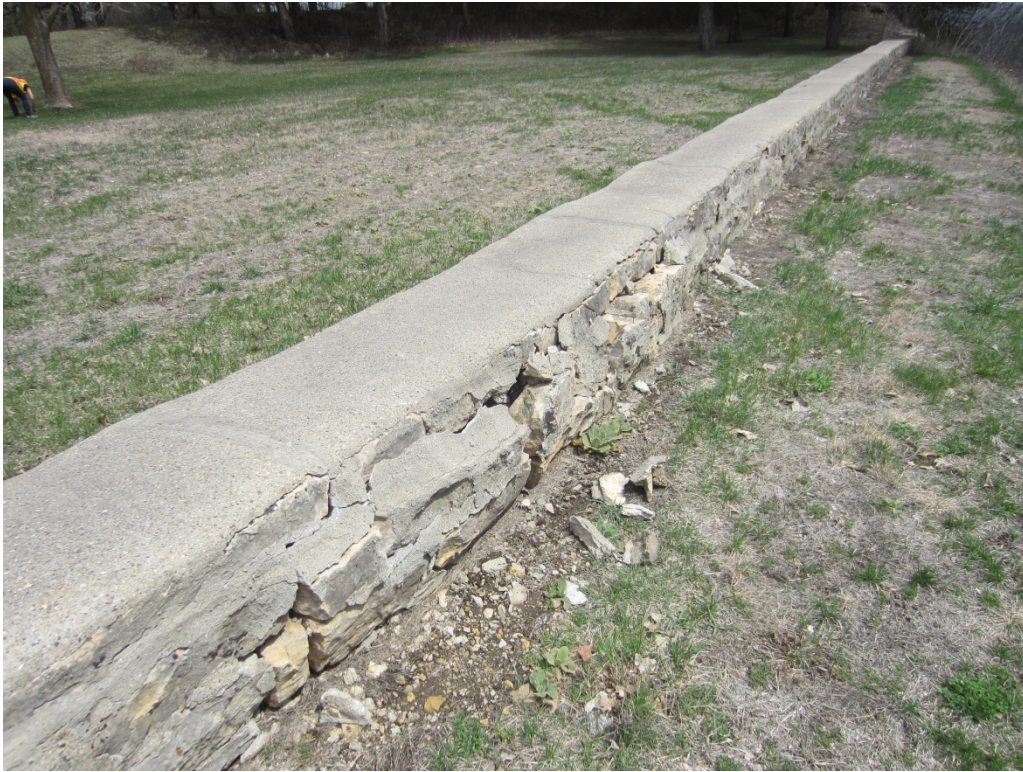
4.5 – Significant deterioration at South Entrance Walls

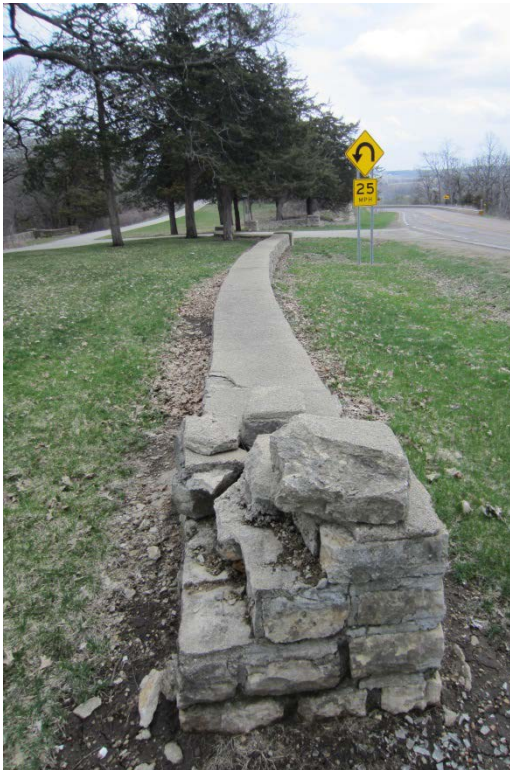
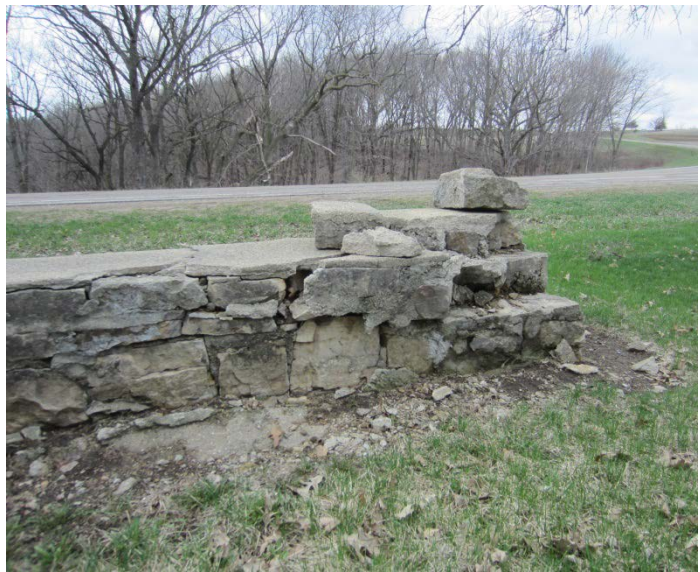
4.5 – Vehicle impact at west end of South Entrance Walls

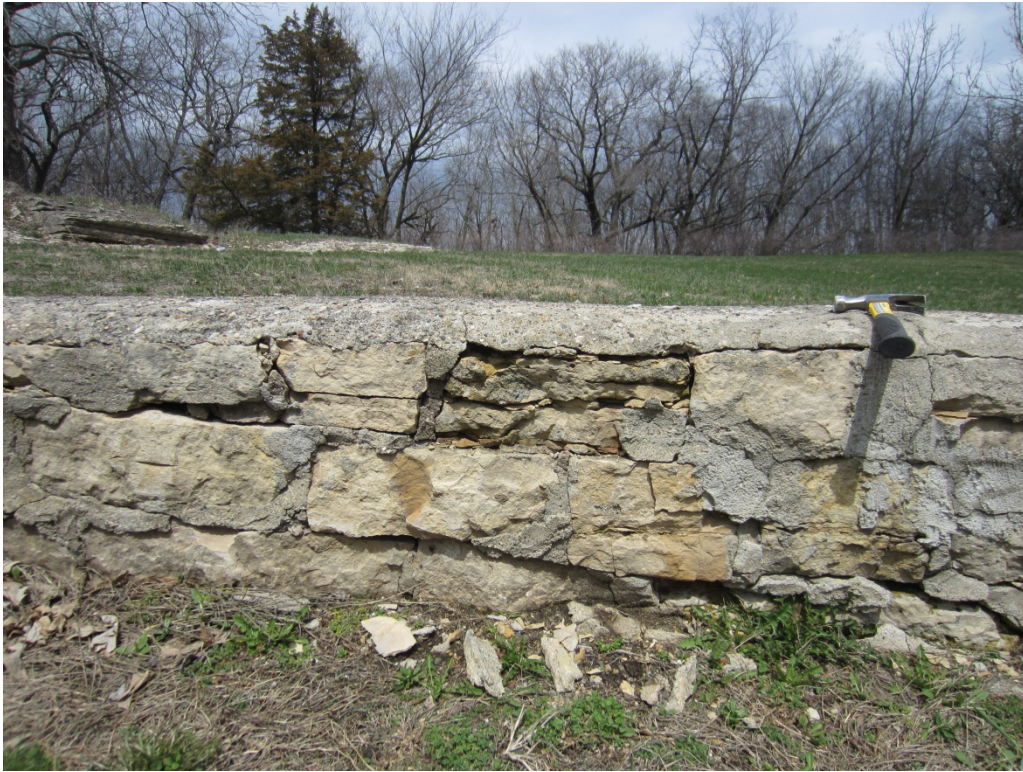
4.5 – Dry laid freestanding masonry of South Entrance walls showing mortar cap, mortared joints, and stone deterioration

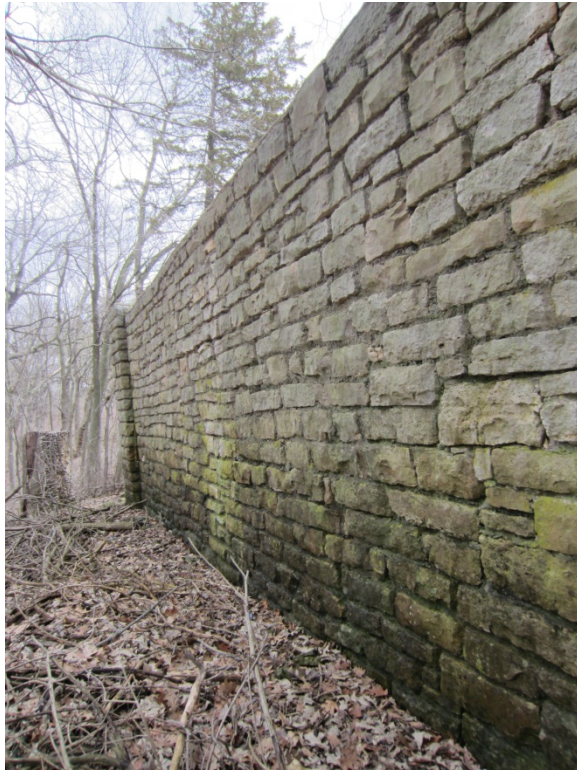
4.6 – North Overlook Retaining Wall – note tilting of the wall from plumb

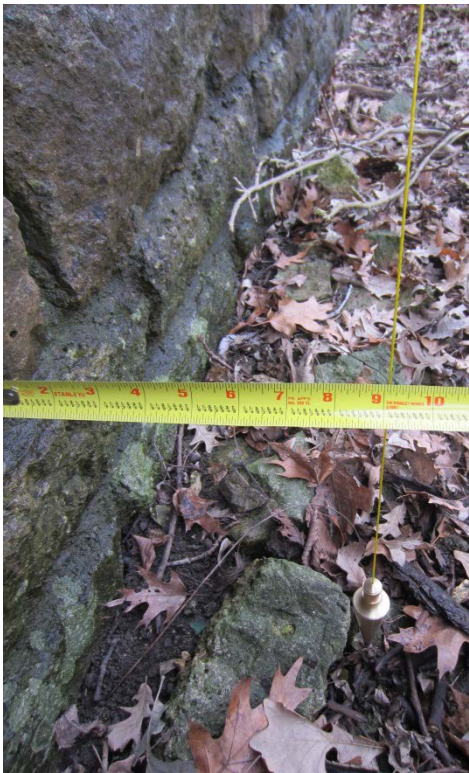
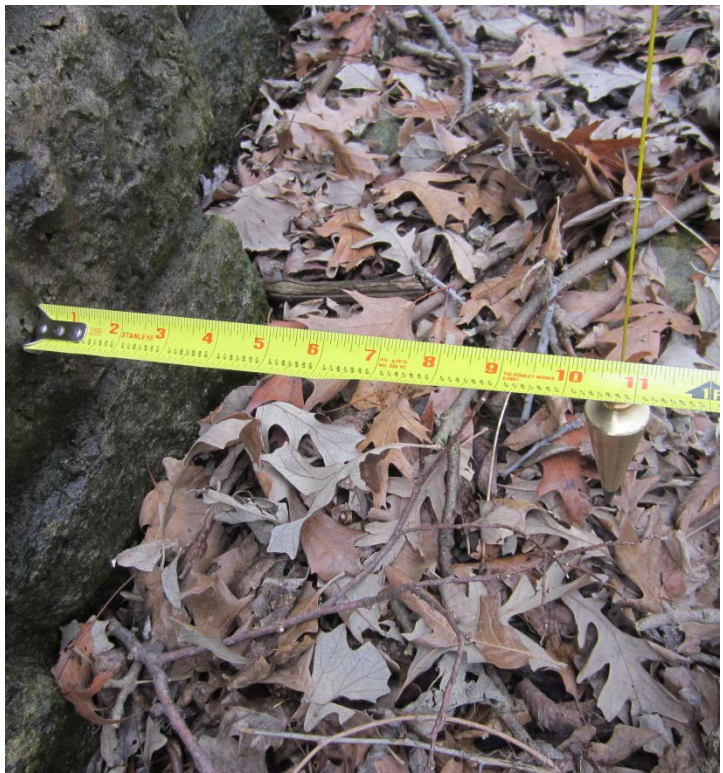
4.6 – West end of North Overlook Wall is out of plumb by 9-1/4" (above left) at the west pier is and the east pier is out of plumb by 10-3/4" (above right)

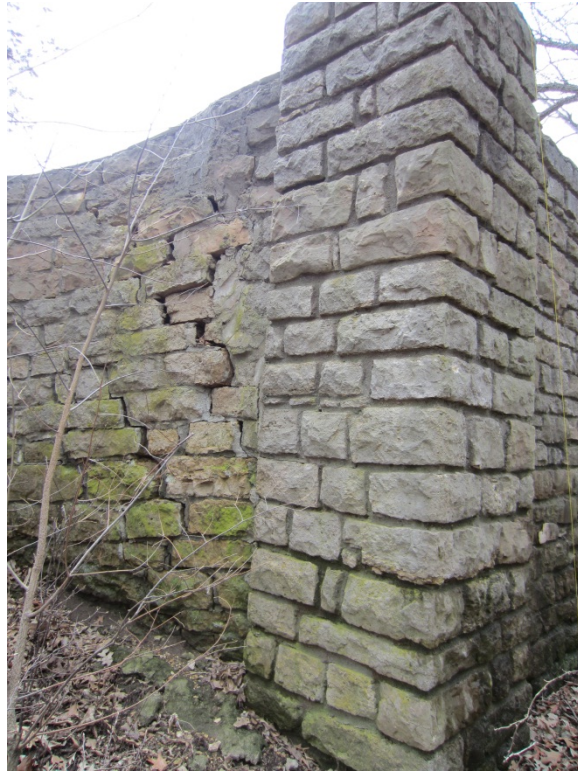
4.6 – Cracks indicating movement of the wall

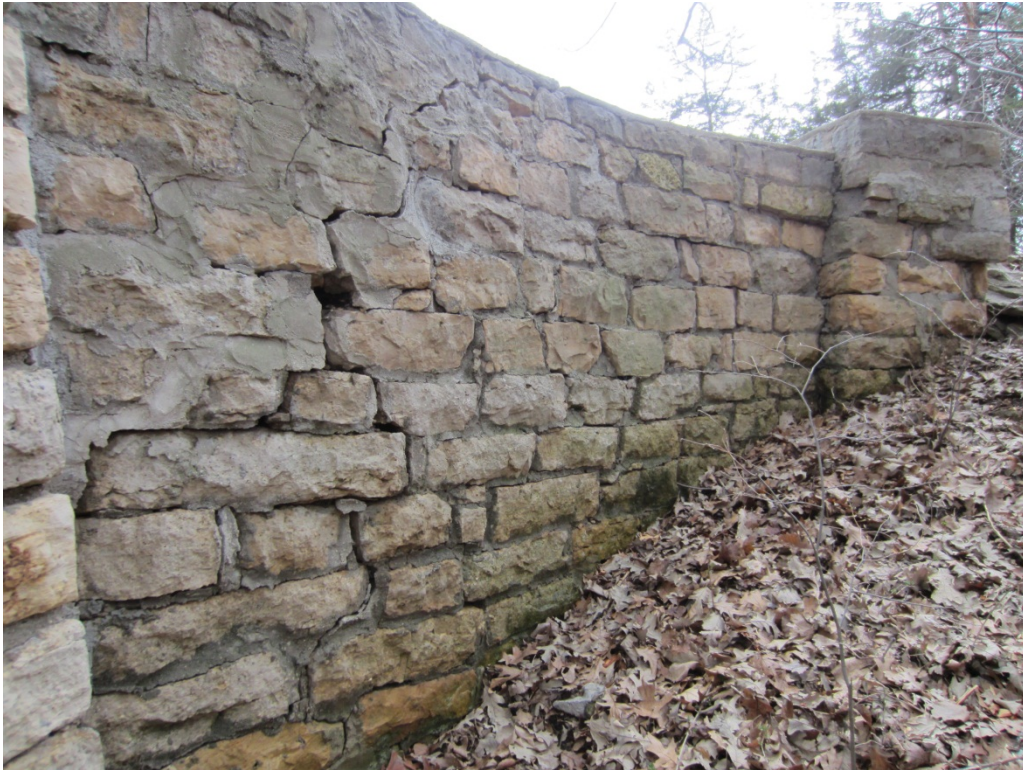
4.6 – Cracks indicating movement of the wall

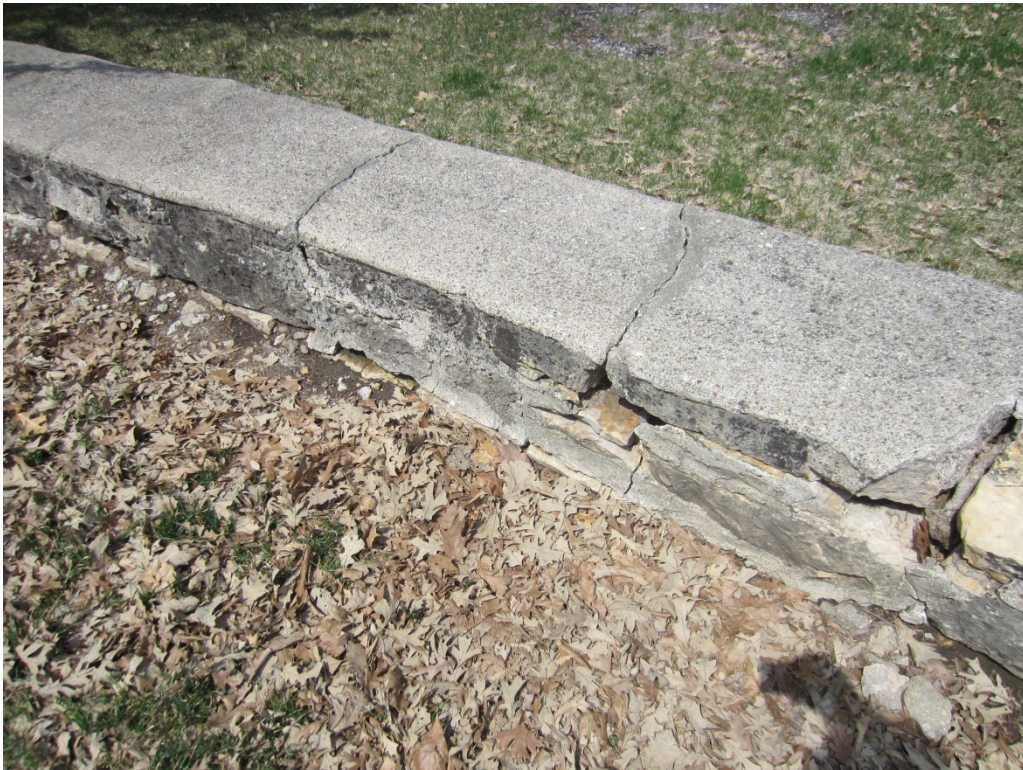
4.7 – Mortared cap, joints, and stone deterioration at East Overlook Wall

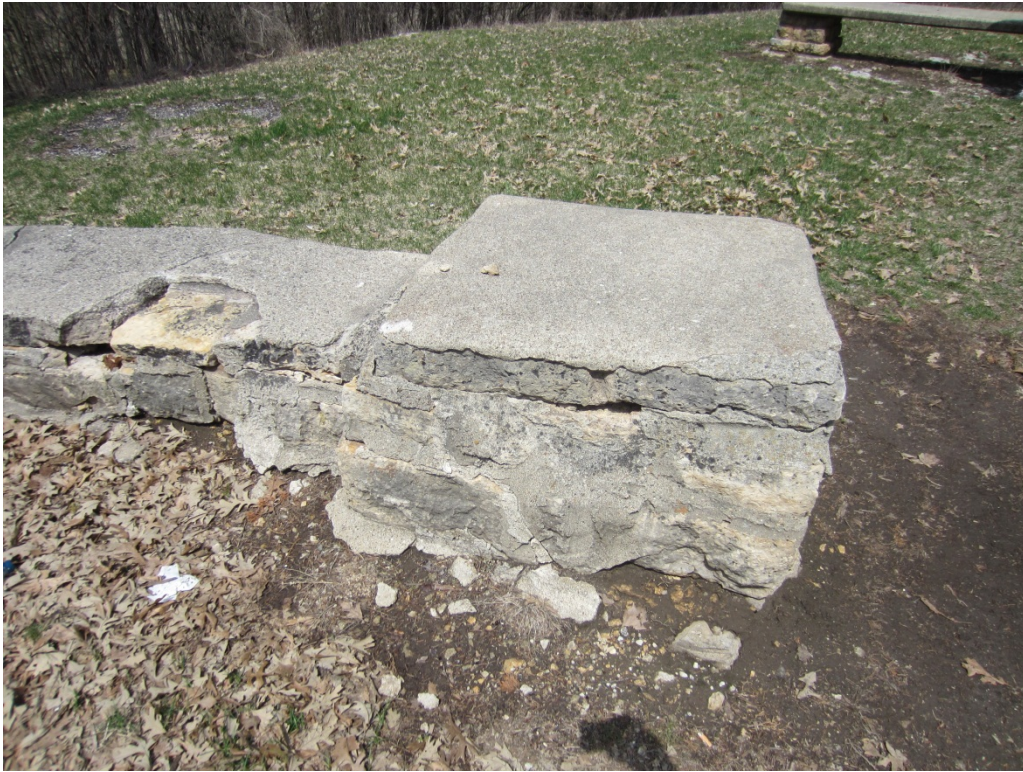
4.7 – Significant deterioration at wall and pier of East Overlook Wall

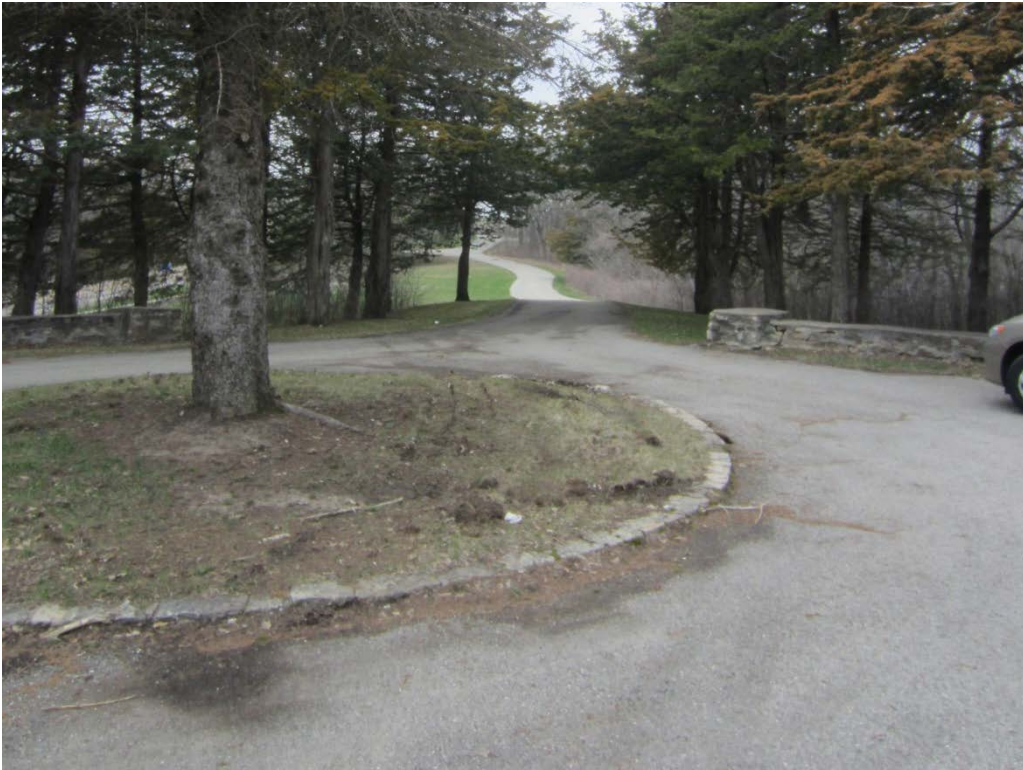
4.7 – Flush curbstones and tree at the island of the East Overlook Wall and Parking Area

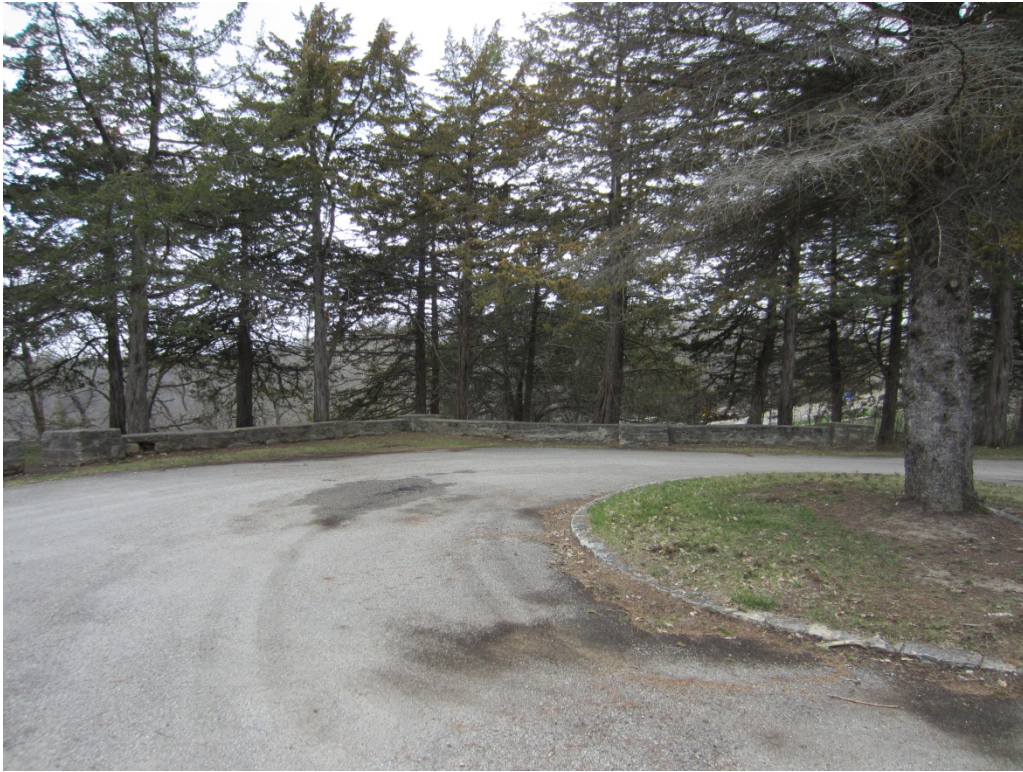
4.7 – Bituminous deterioration

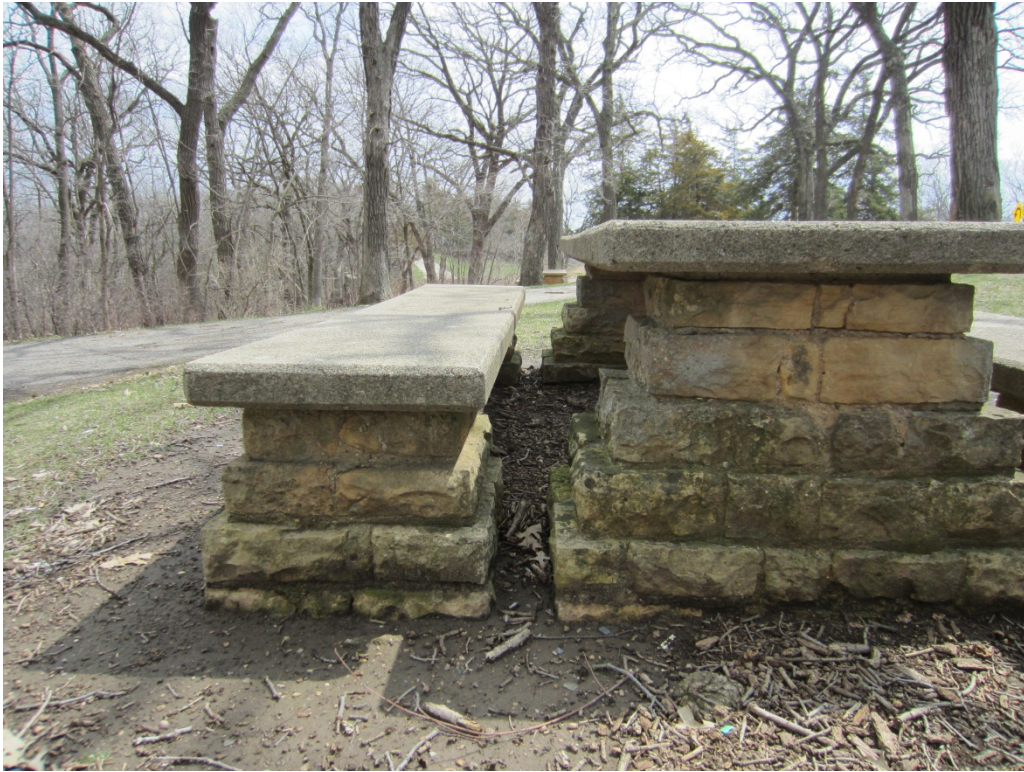
4.8 – Dirt and moss on West Table

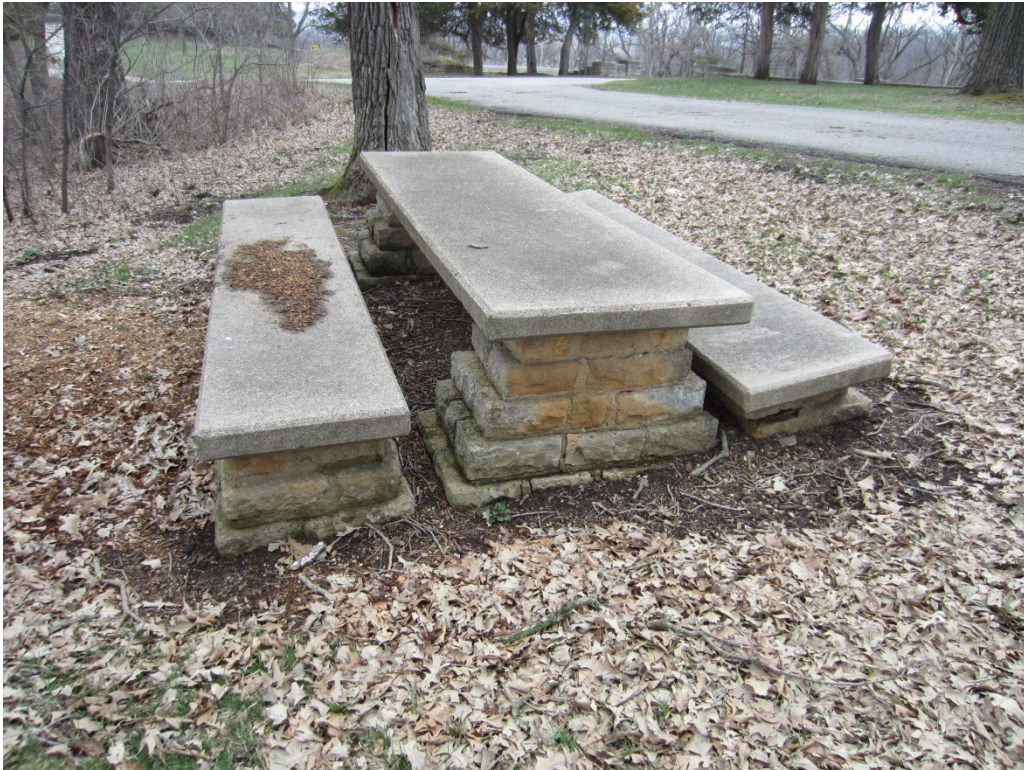
4.8 – Center Table with undermined bench

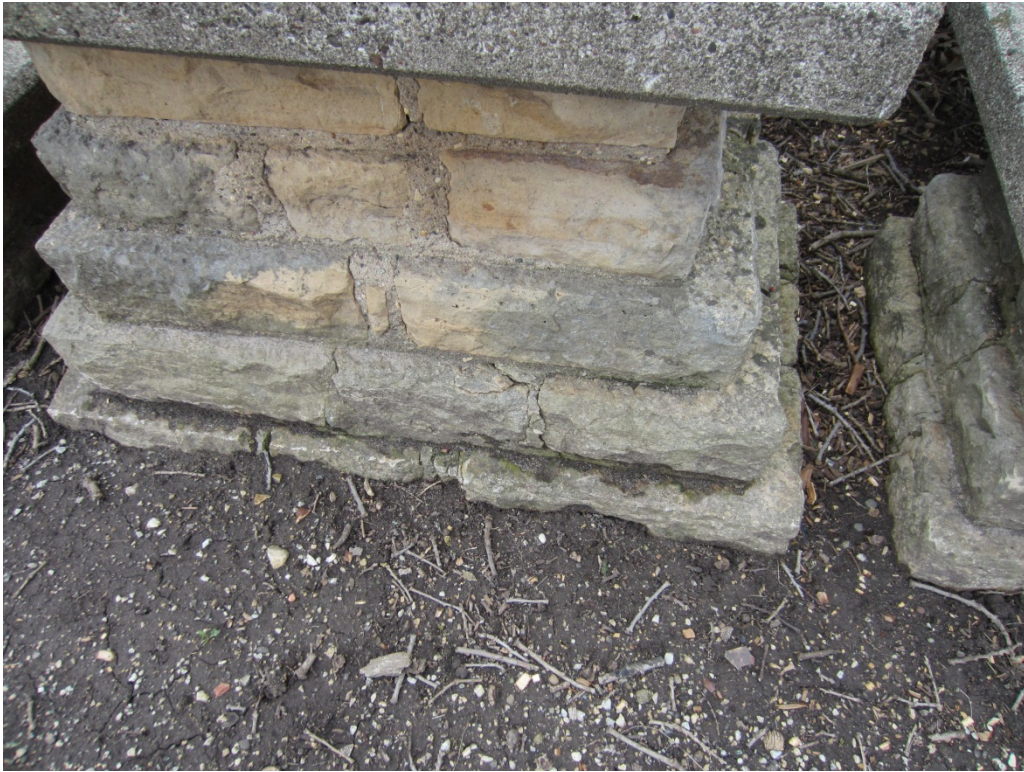
4.8 – Center Table with stone deterioration
