Pavement Condition Report

Cloquet/Carlton County Airport (COQ)

December 2017

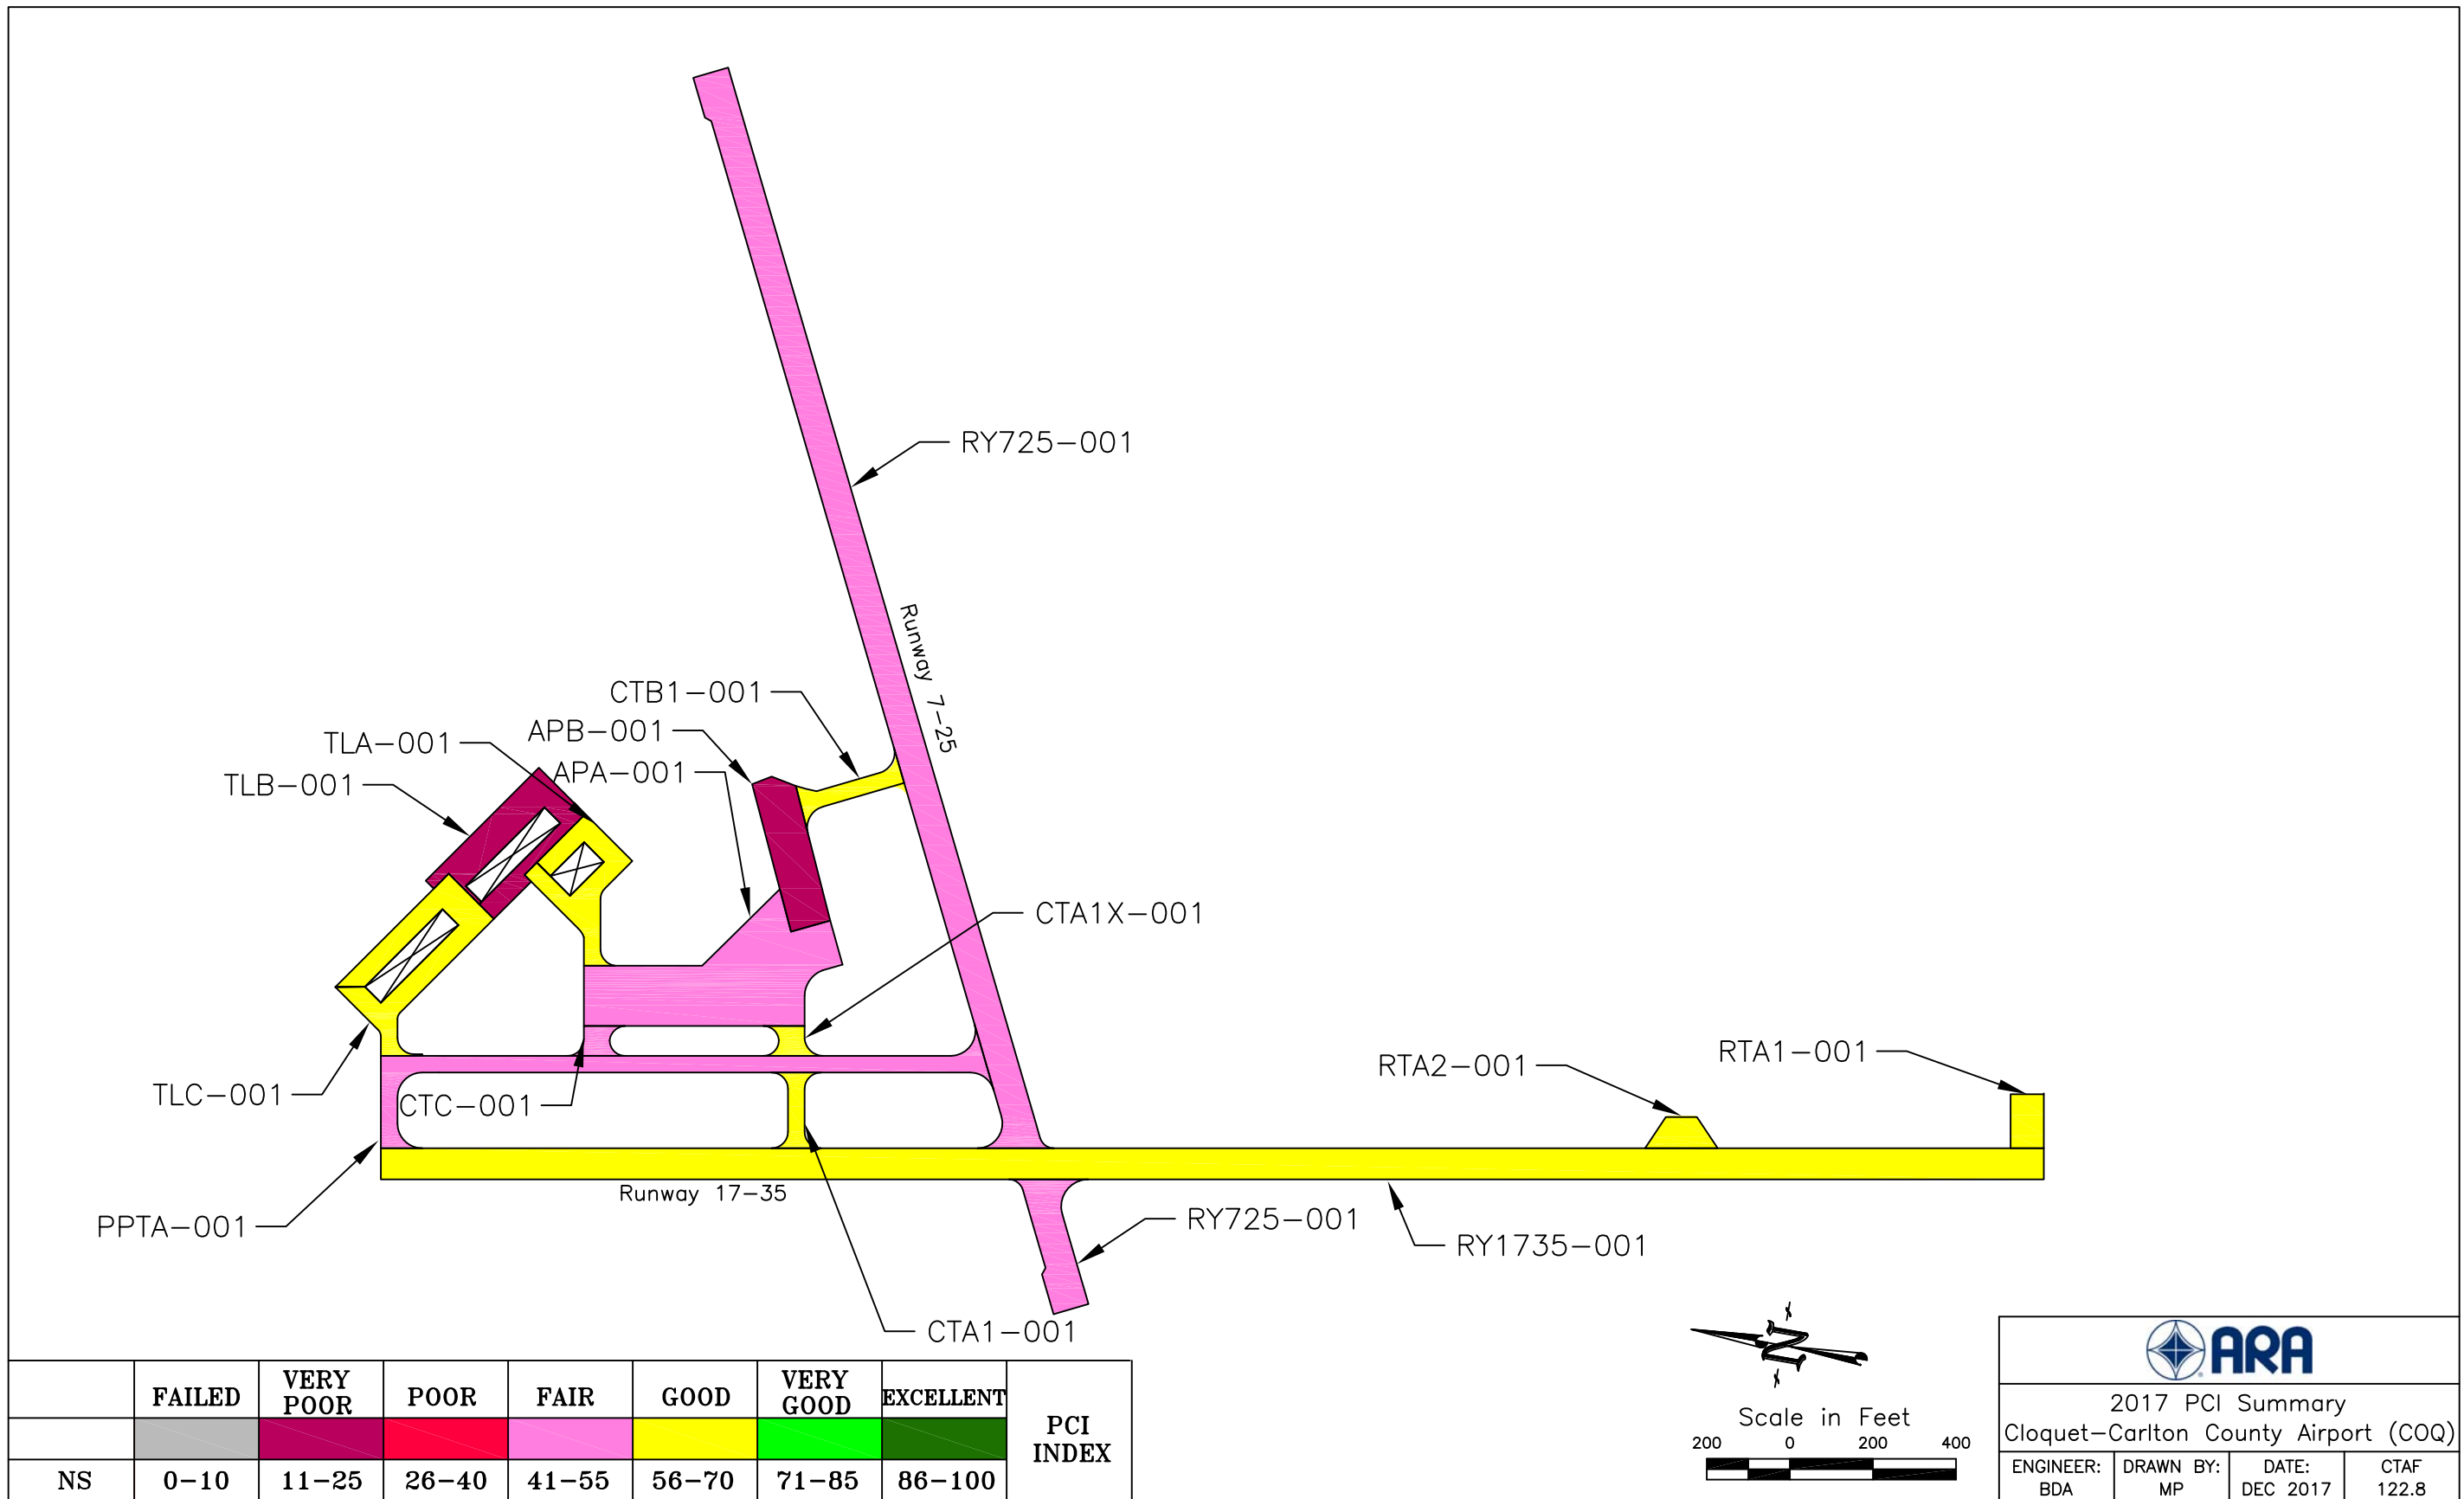
Figure 4. 2017 Pavement Condition Index Rating at Cloquet-Carlton County Airport (COQ).

The results of the 2017 PCI inspection are presented in figure 4. The overall area-weighted, inspected PCI for COQ is 52. When summarizing PCI values, an area-weighted calculation is used instead of a straight mathematical average because the area-weighted calculations eliminate the skewing of the PCI due to the disparity of the section sizes.

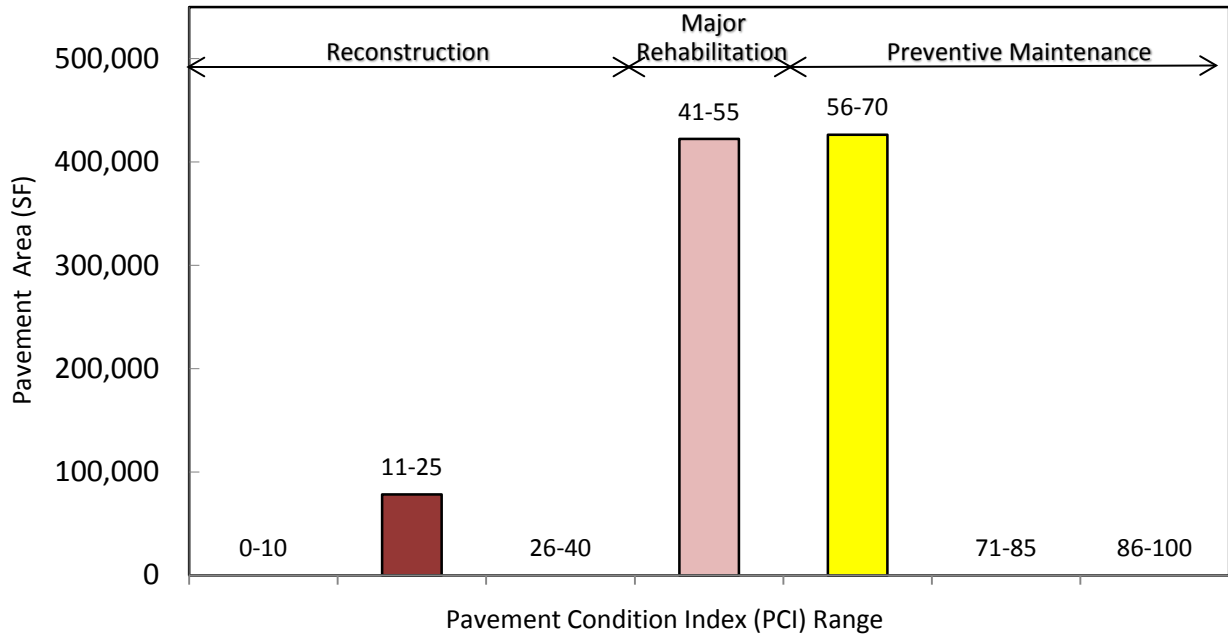
Figure 5. Condition distribution.

Figures 5 and 6 present the overall PCI for COQ by area distribution and pavement use, respectively. Table 3 presents the PCI summary for each section at COQ, including the drop in PCI per year. Generally, pavement sections will deteriorate between 1 and 3 PCI points per year. Sections deteriorating at higher rates may need maintenance above the normal application rates and should be closely monitored in case major repairs become necessary earlier than expected.

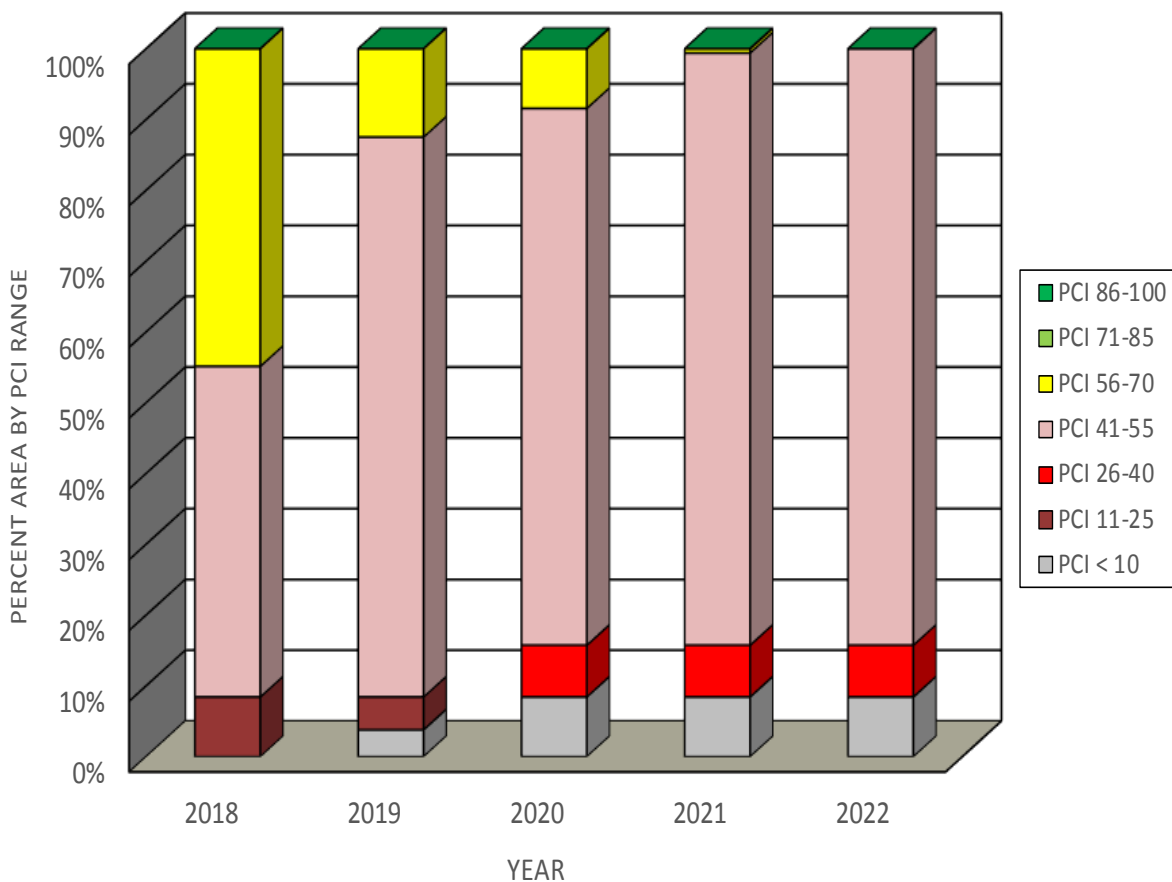
Figure 7. Projected PCI by percent area.

Figure 7 shows the projected PCI at COQ by percent area for the next 5 years assuming no major repairs (overlays, reconstruction, etc.) are performed during that period. It shows how quickly a pavement network can deteriorate when no capital improvements are made.
