Pavement Condition Report

Mankato Regional Airport (MKT)

December 2017

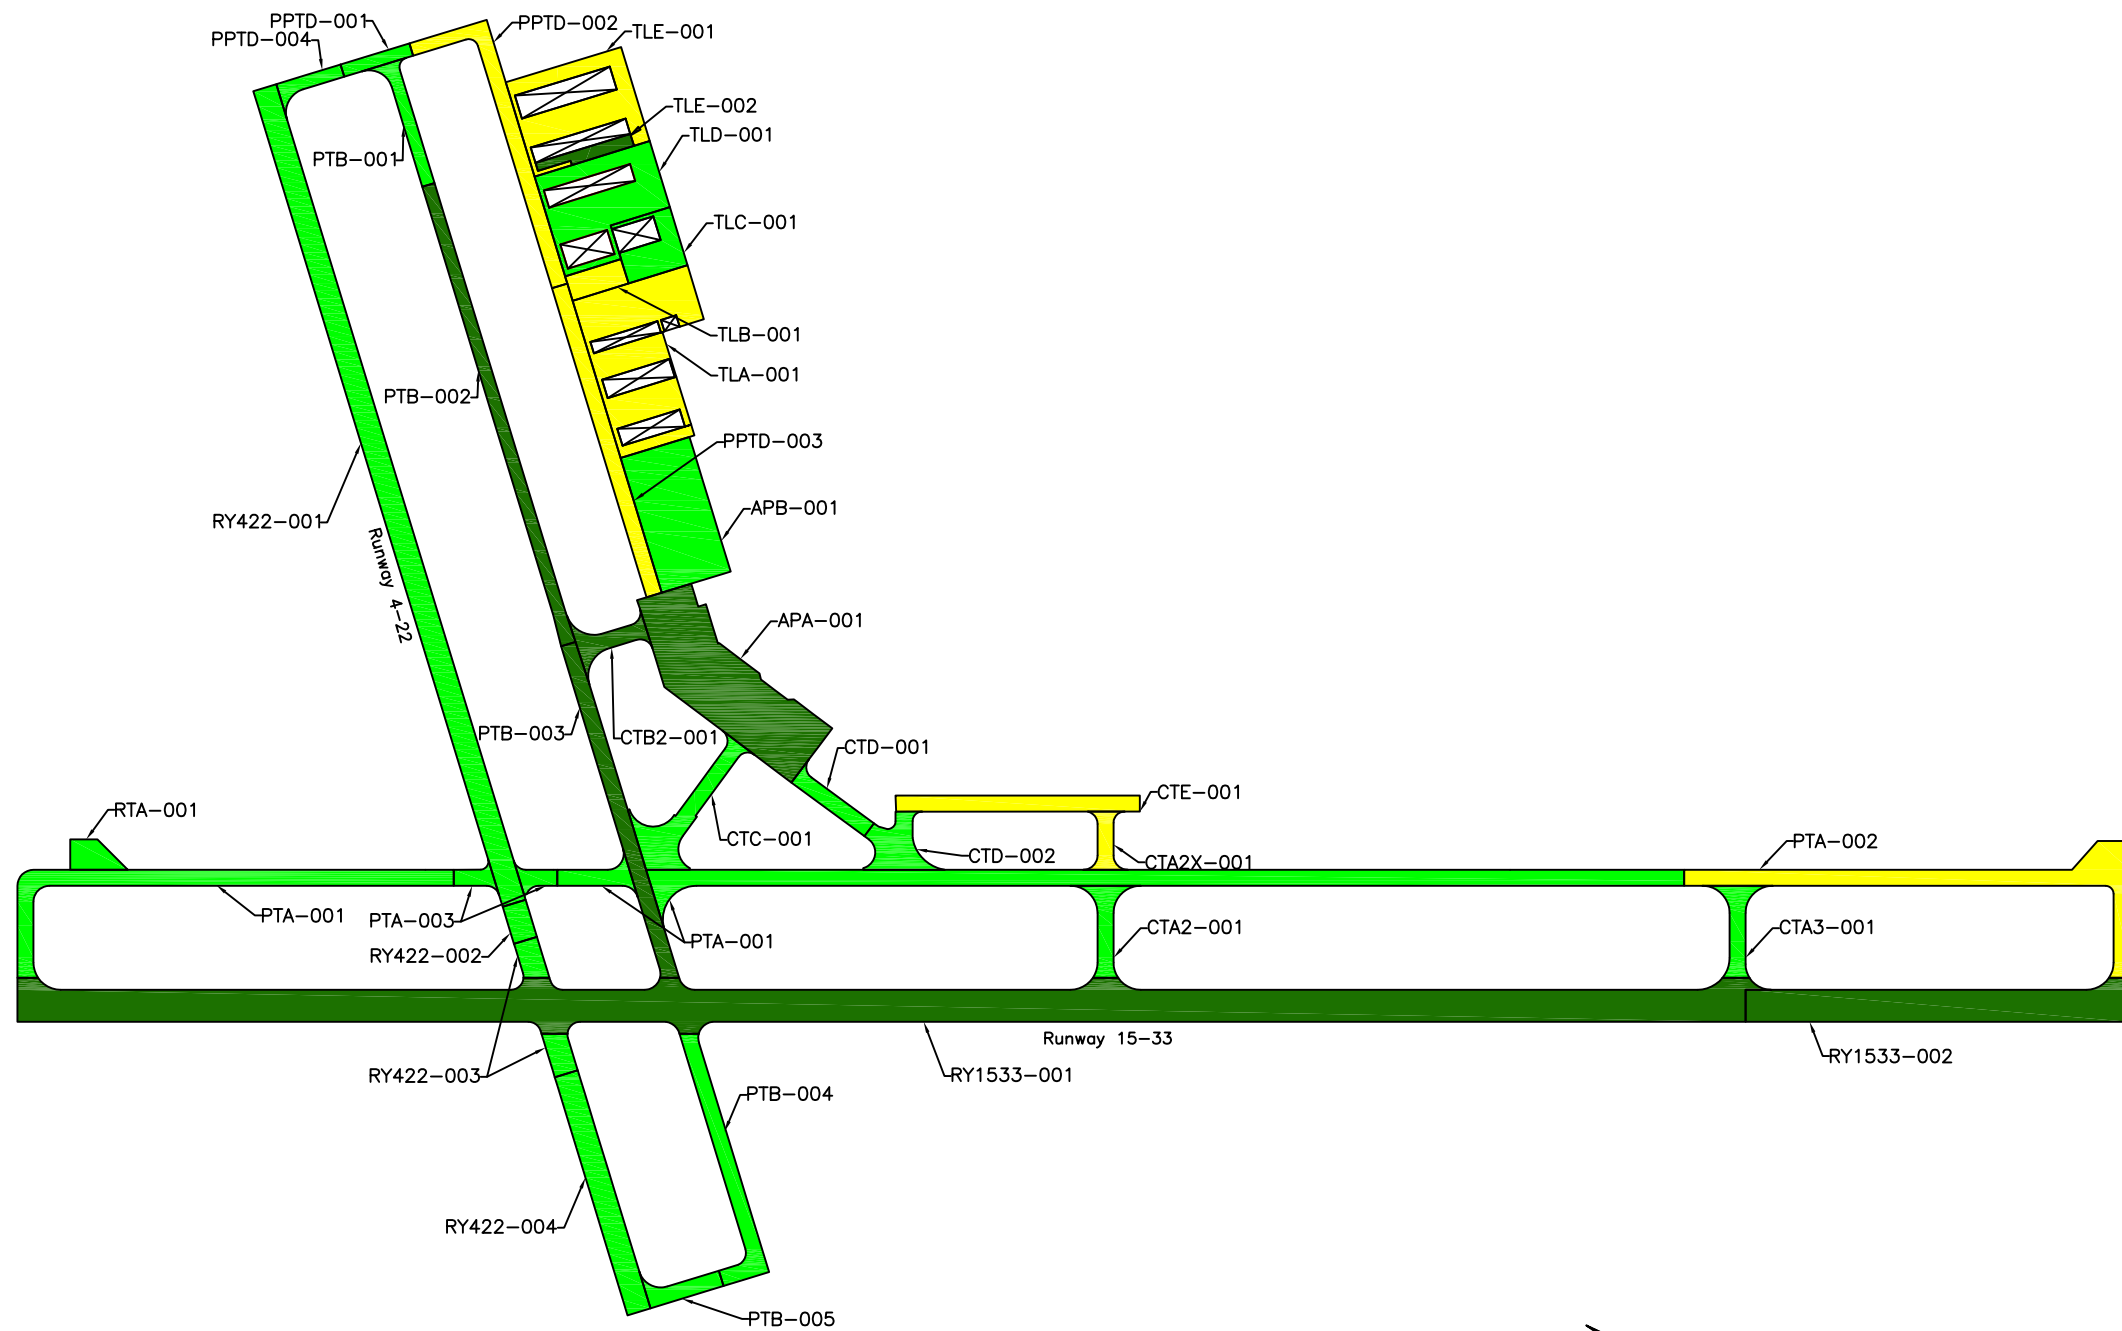
Figure 4. 2017 Pavement Condition Index Rating at Mankato Regional Airport (MKT).

The results of the 2017 PCI inspection are presented in figure 4. The overall area-weighted, inspected PCI for MKT is 80. When summarizing PCI values, an area-weighted calculation is used instead of a straight mathematical average because the area-weighted calculations eliminate the skewing of the PCI due to the disparity of the section sizes.

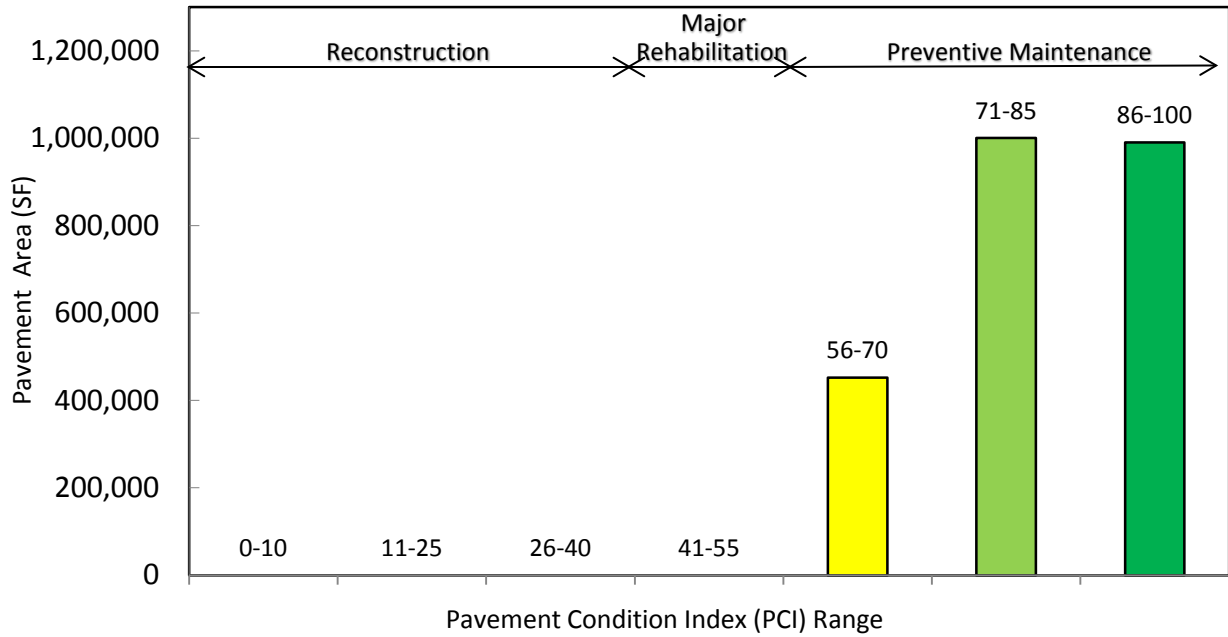
Figure 5. Condition distribution.

Figures 5 and 6 present the overall PCI for MKT by area distribution and pavement use, respectively. Table 3 presents the PCI summary for each section at MKT, including the drop in PCI per year. Generally, pavement sections will deteriorate between 1 and 3 PCI points per year. Sections deteriorating at higher rates may need maintenance above the normal application rates and should be closely monitored in case major repairs become necessary earlier than expected.

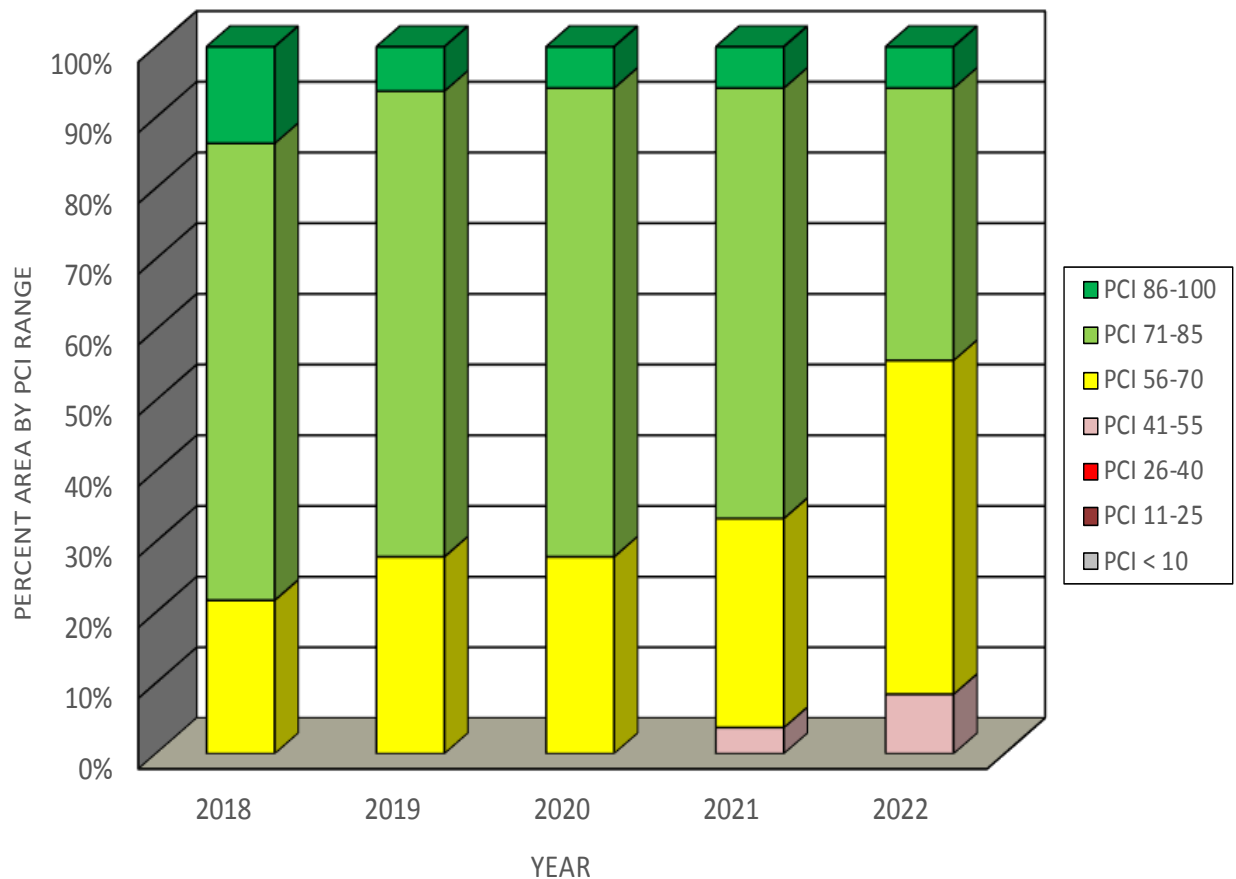
Figure 7. Projected PCI by percent area.

Figure 7 shows the projected PCI at MKT by percent area for the next 5 years assuming no major repairs (overlays, reconstruction, etc.) are performed during that period. It shows how quickly a pavement network can deteriorate when no capital improvements are made.

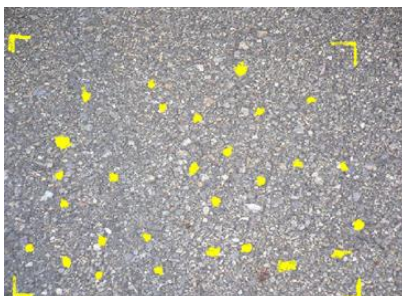
Raveling – At low severity, the number of missing coarse aggregates (> 3/8 inch) is between 5-20 missing/yd², medium severity (pictured below where the missing coarse aggregates have been dotted with yellow paint) is 21-40 missing/yd², and high severity is > 40 missing/yd².

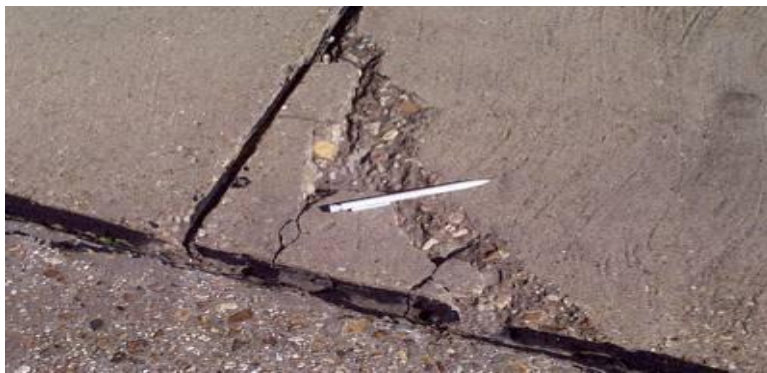
Example of Joint and Corner Spalling

Spalls at slab joints and corners are caused by excessive internal stress in the pavement. Spalls occur when these stresses exceed the shear strength of the concrete. Spalling usually results from thermal expansion during warm or hot weather. As slabs expand, they push against one another at joints. If the joints are filled with incompressibles, such as sand, or if adjacent slabs offset slightly, stresses can become severe, causing spalls. Spalling can be reduced significantly by conscientious maintenance of joint sealant.

Spall repair requires patching. The extent and severity of spalling on a pavement surface suggests appropriate action. For example, at low severity, spalled concrete remains securely in place in the slab. A low-severity spall should be monitored closely for further deterioration and should be patched when
