# Pavement Condition Report

## Montevideo-Chippewa County Airport (MVE)

**December 2018**

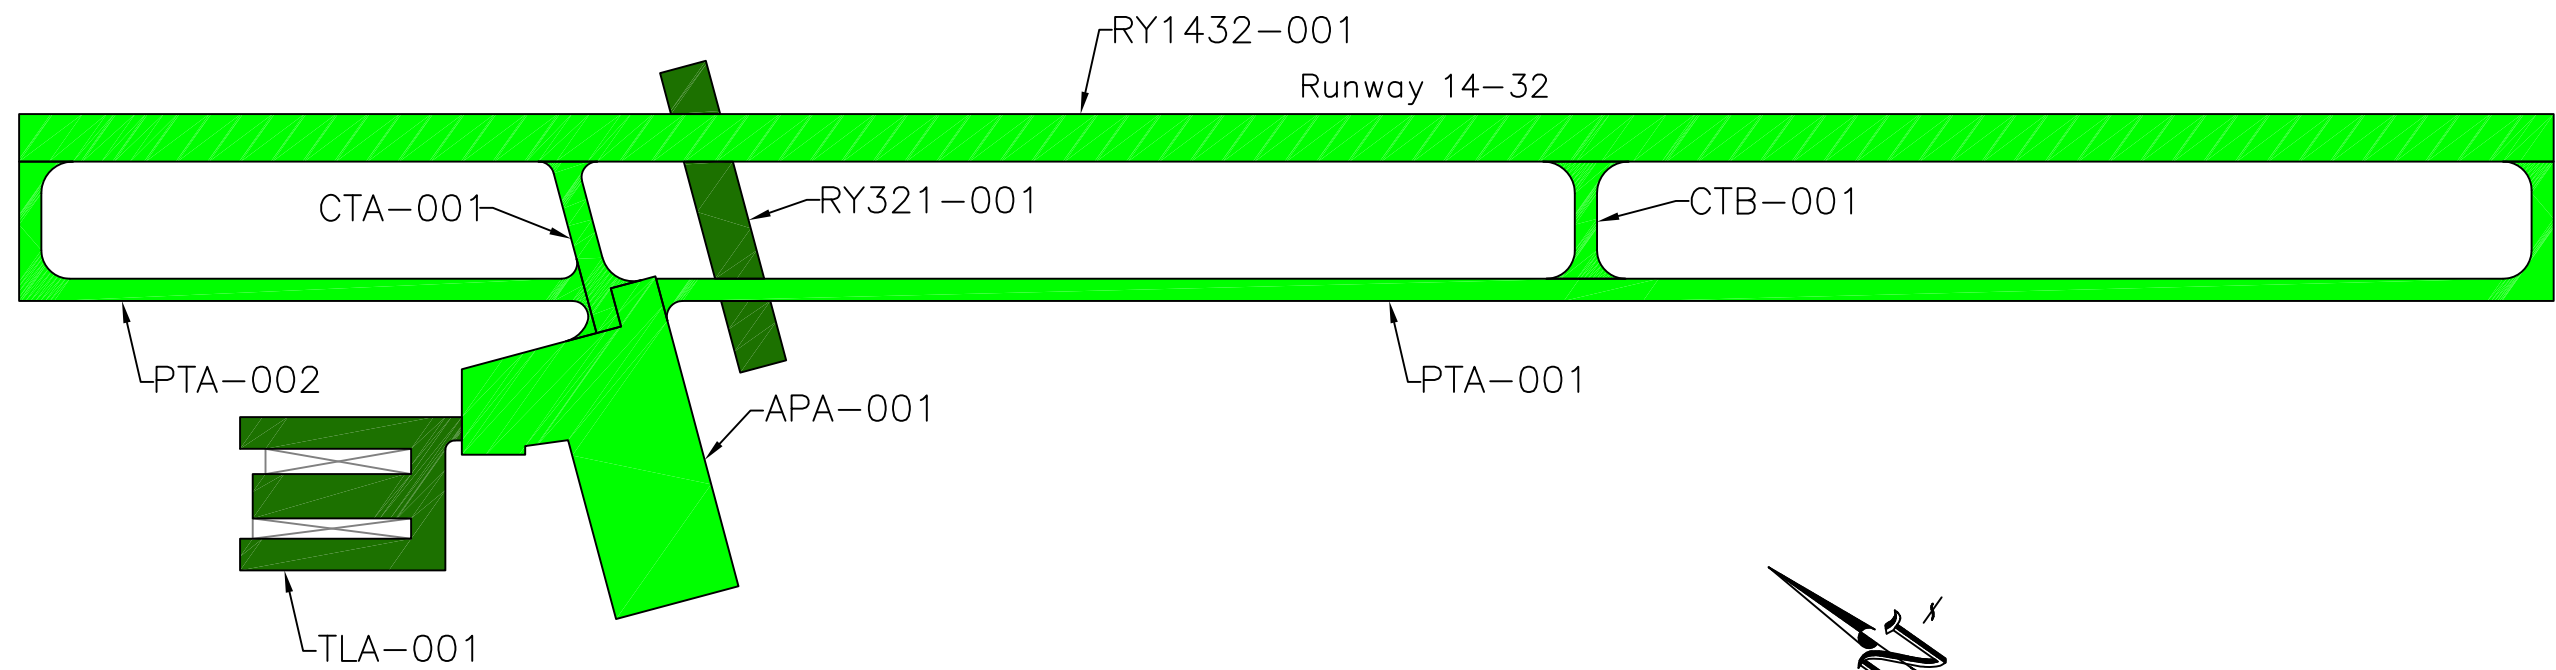
Figure 4. 2018 Pavement Condition Index Rating at Montevideo-Chippewa Co. Airport (MVE).

The results of the 2018 PCI inspection are presented in figure 4. The overall area-weighted, inspected PCI for MVE is 82. When summarizing PCI values, an area-weighted calculation is used instead of a straight mathematical average because the area-weighted calculations eliminate the skewing of the PCI due to the disparity of the section sizes.

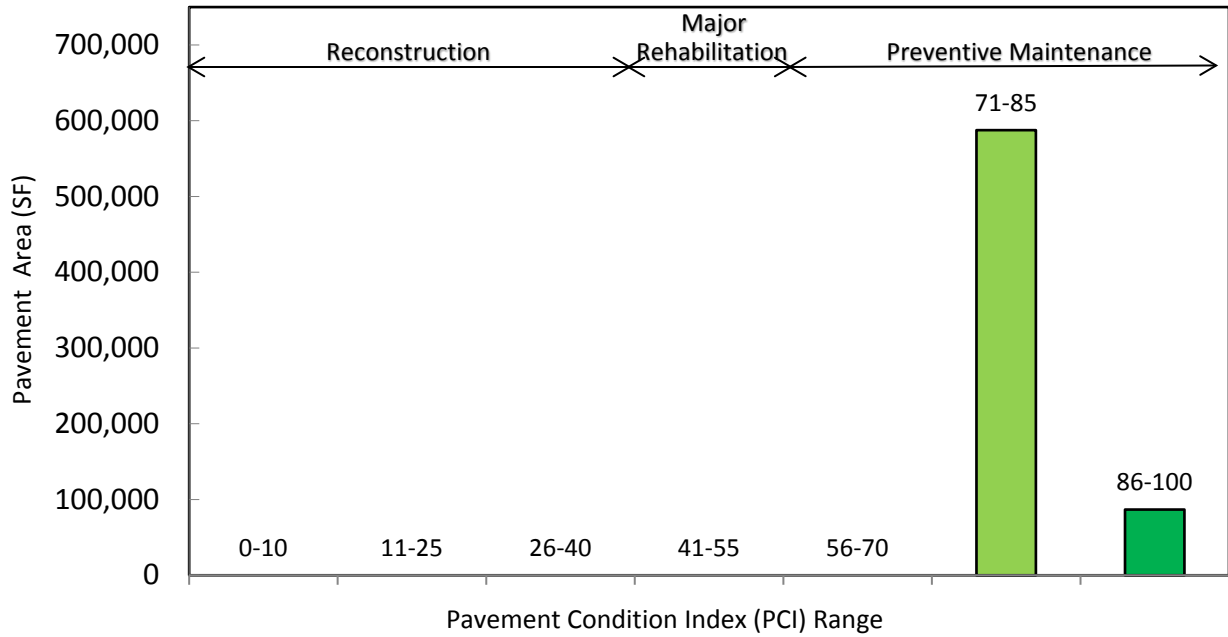
Figure 5. Condition distribution.

Figures 5 and 6 present the overall PCI for MVE by area distribution and pavement use, respectively. Table 3 presents the PCI summary for each section at MVE, including the drop in PCI per year. Generally, pavement sections will deteriorate between 1 and 3 PCI points per year. Sections deteriorating at higher rates may need maintenance above the normal application rates and should be closely monitored in case major repairs become necessary earlier than expected.

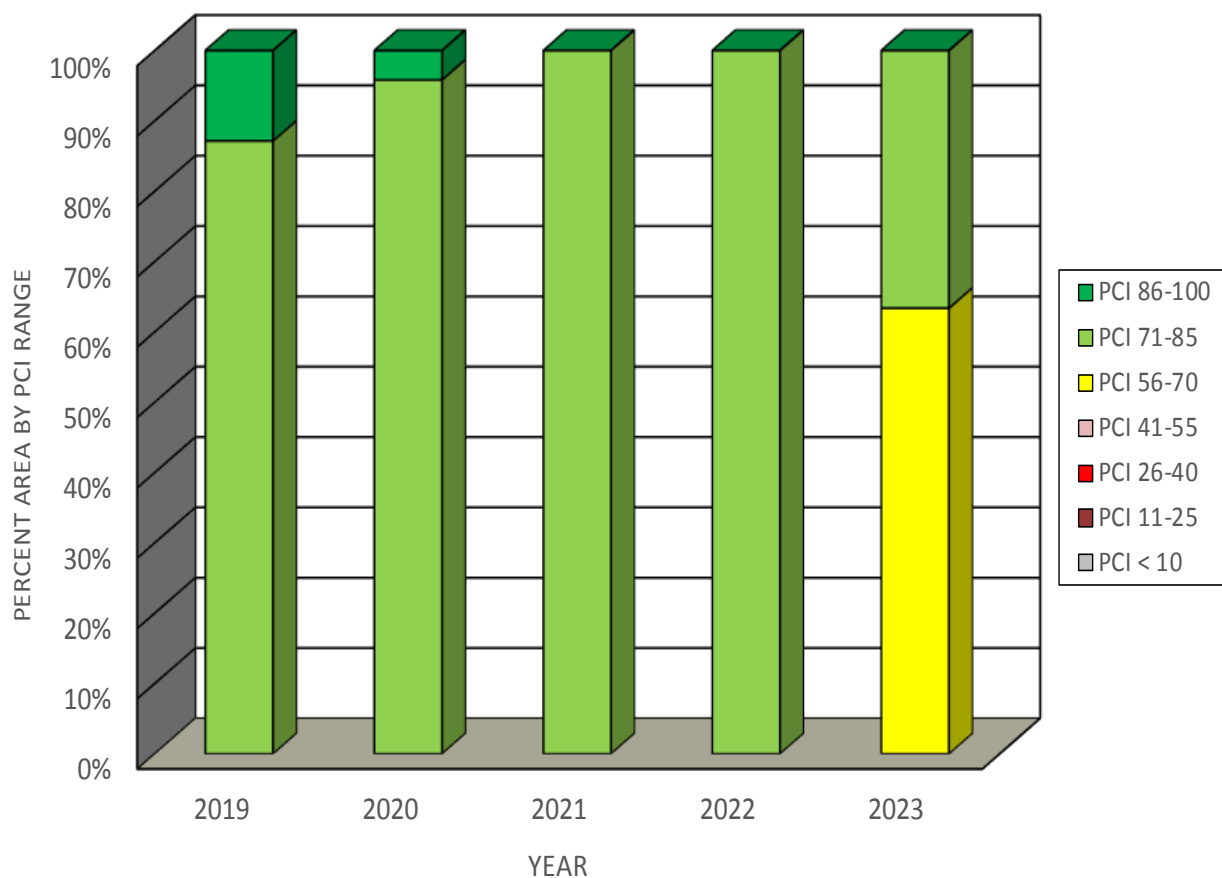
Figure 7. Projected PCI by percent area.

Figure 7 shows the projected PCI at MVE by percent area for the next 5 years assuming no major repairs (overlays, reconstruction, etc.) are performed during that period. It shows how quickly a pavement network can deteriorate when no capital improvements are made.
