Pavement Condition Report

Piney-Pinecreek Border Airport (48Y)

December 2019

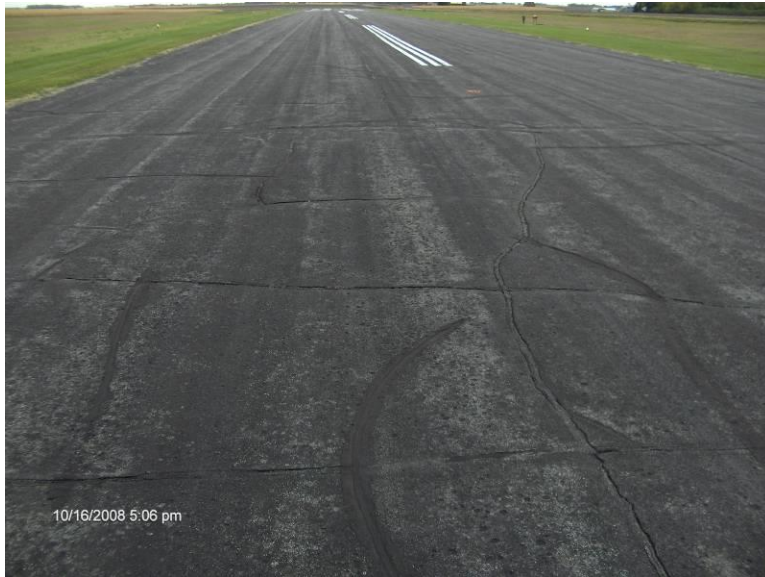
Example of Block Cracking

Block cracking is longitudinal and transverse cracking that has established a pattern of blocks ranging in size from 1ft x 1ft to 10ft x 10ft. This distress typically happens in older asphalt pavements and is an indication that the bituminous binder has lost most of its flexibility. The severity determination is basically determined by the crack width criteria defined for longitudinal and transverse cracking. Crack sealing typically is used to repair block cracking; however, the amount of required sealant can be extensive due to the high density of cracks.

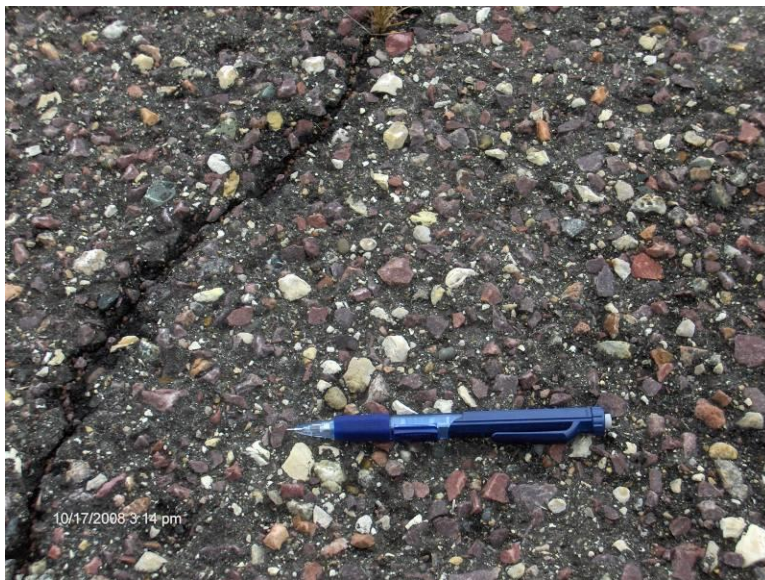
Example of Raveling/Weathering

Raveling and weathering are the wearing away of the pavement surface. Raveling is the condition where the mid- to large size aggregates are becoming dislodged; weathering is when the fine aggregate wears away exposing the edges of the larger aggregate. These distresses are usually evident over large areas and may occur together (pictured above) or separately. Raveling and weathering may indicate that the asphalt binder has hardened significantly.
