# Pavement Condition Report

## Little Falls - Morrison County Airport (LXL)

**December 2019**

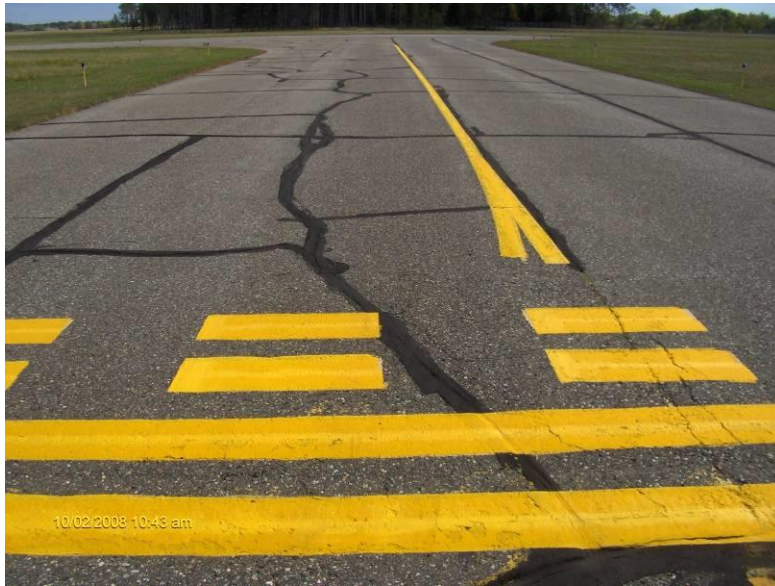
### ***Example of Longitudinal and Transverse Cracking (L&T cracking)***

Longitudinal and transverse cracks are caused by pavement aging, by construction, and by subsurface movement. Aging occurs as pavement loses some of its components to the atmosphere and becomes more brittle. Consistent application of pavement sealcoats can help to prevent the occurrence of age related cracks. Cracks will also develop along poorly constructed paving lane joints. Ensuring that joints are made when both sides are still hot, and near the same temperature, is one of the best ways to mitigate this potential problem. Seasonal movement caused by changes in moisture content or temperature differences can also cause pavement cracks. Asphalt pavement placed over a PCC pavement or cement stabilized base course may evidence reflective cracking from the underlying material. Longitudinal and transverse cracks are not caused by wheel loads, although traffic may worsen their condition.

Low severity longitudinal and transverse cracks are less than  $\frac{1}{4}$  inch wide, or if sealed with suitable filler material in satisfactory condition can be any width, less than 3 inches, if they are not spalled. Maintenance usually is not indicated for low-severity cracking. Moderately spalled cracks and cracks wider than  $\frac{1}{4}$  inch which are not satisfactorily sealed are at medium severity. Medium-severity cracks should be sealed with a high-quality crack filling material. Severely spalled cracks and cracks wider than 3 inches are at high severity. High-severity L&T cracks normally require patching.

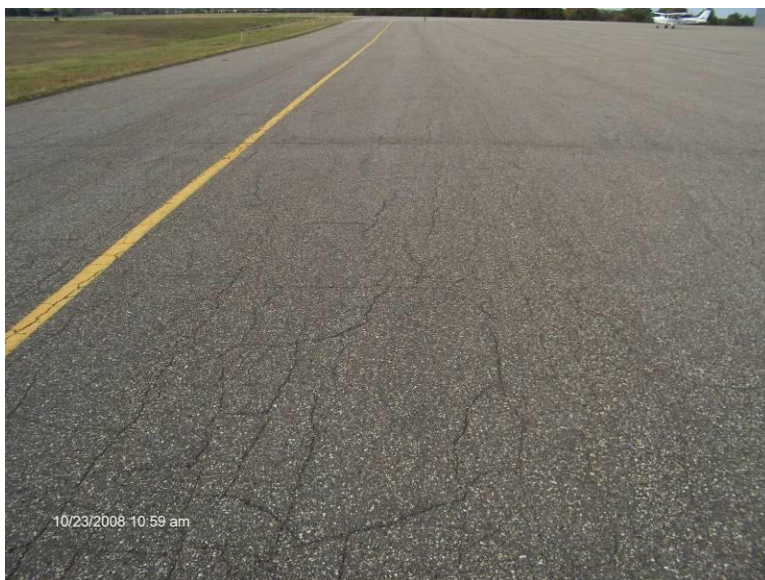
### ***Example of Alligator Cracking***

Alligator (or fatigue) cracks are a series of interconnected load-related cracks caused by fatigue of the asphalt surface. Alligator cracking is a significant structural distress and develops only in places subject to traffic loads. These cracks typically initiate at the bottom of the asphalt layer (where tensile strains

are highest) and propagate upward - so once a fatigue crack is visible, significant damage has already occurred.

At low severity, alligator cracks are evidenced by a series of parallel hairline cracks (usually in a wheel path). Further traffic and deterioration leads to the interconnection of these cracks. Medium severity alligator cracking is a well-defined pattern of interconnected cracks, some spalling may be present. High severity alligator cracks have lost aggregate interlock between adjacent pieces, the cracks may be severely spalled with FOD potential, and most likely the pieces will move freely under traffic. Alligator cracking is a structural failure and cannot be repaired with sealant, the proper repair is full-depth patching.

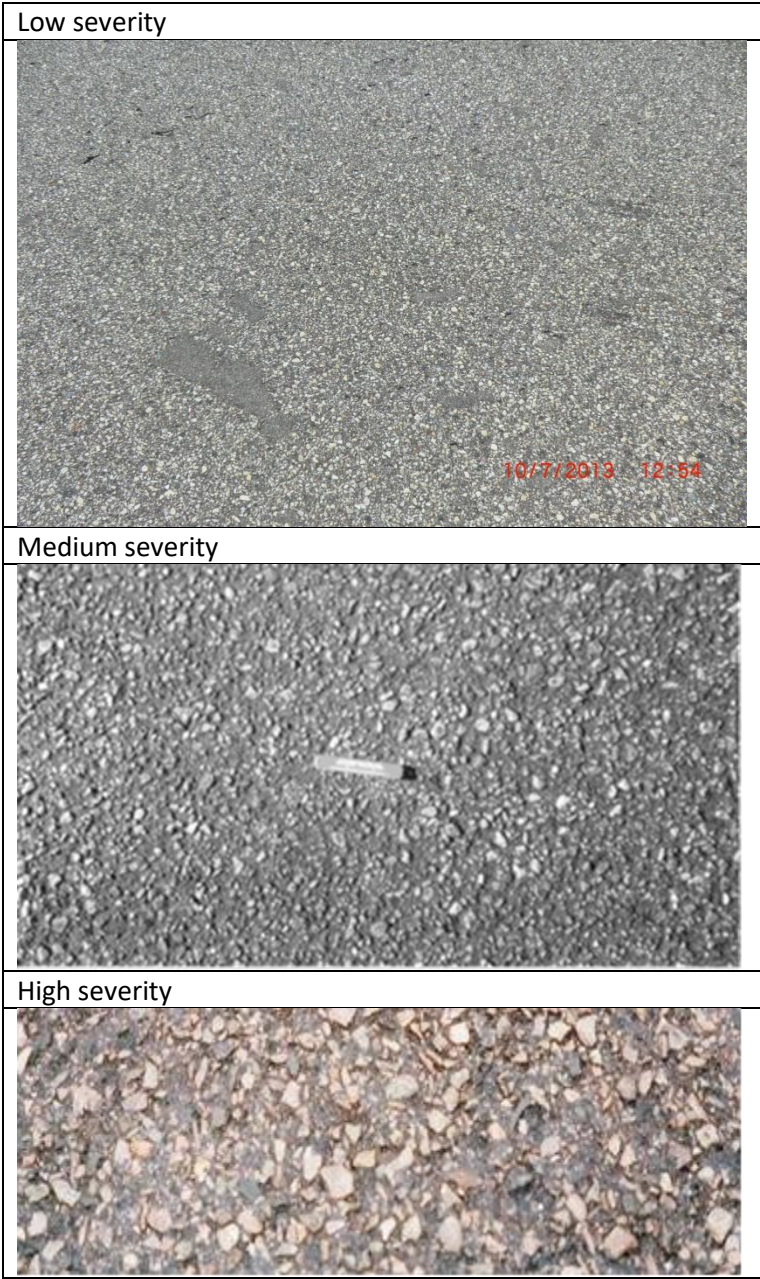
Weathering – At low severity, the coarse aggregate is slightly exposed due to the wearing away of the fine aggregate. At medium severity, the coarse aggregate is exposed up to ¼ the width of the longest side. At high severity, the coarse is exposed greater than ¼ the width of the longest side.

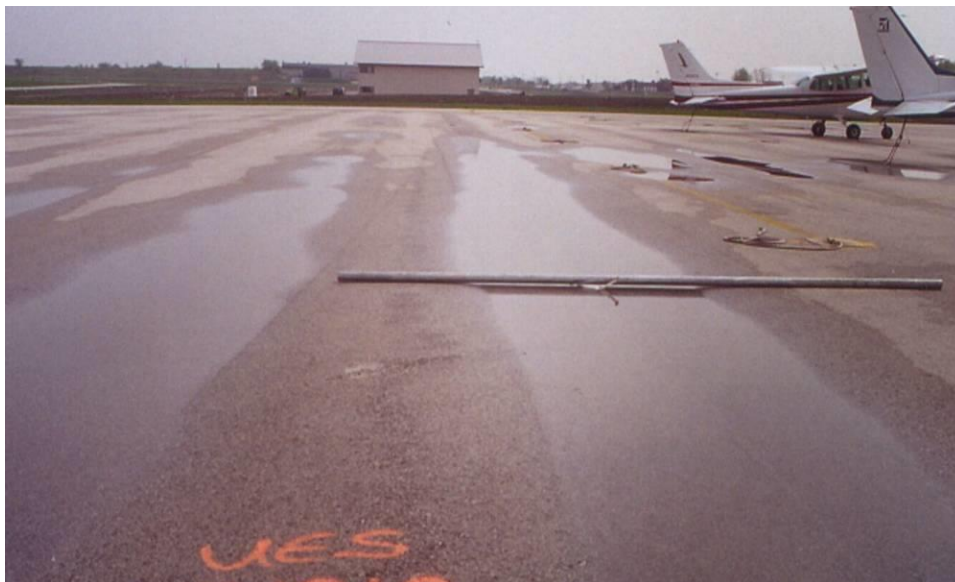
### **Example of Rutting**

Ruts are localized, load related, areas of pavement having elevations lower than the surrounding sections. Rutting is due to base and subgrade consolidation, caused by excessive wheel loads or poor compaction. Ruts indicate structural failure, and can cause hydroplaning. At low severity, ruts have an

average depth of ¼ to ½ inches. At medium severity, ruts have an average depth of ½ to 1 inch. High severity, ruts have an average depth greater than 1 inch. Full-depth patching is the appropriate repair for ruts.

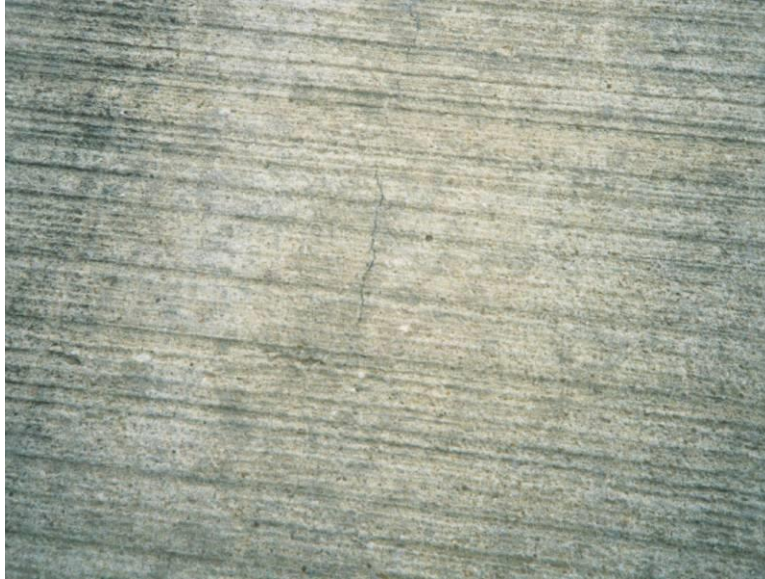
### *Example of Shrinkage Cracking*

Shrinkage cracks are small, nonworking (no spalling along edge) cracks that are visible at the surface but do not penetrate through the full depth of concrete. Shrinkage cracks most commonly occur shortly after construction due to concrete shrinkage during the curing process. Shrinkage cracks are usually so small that they are not visible until staining or material loss at crack edges begins to take place. Shrinkage cracks do not represent a structural weakness, and no corrective action is prescribed.

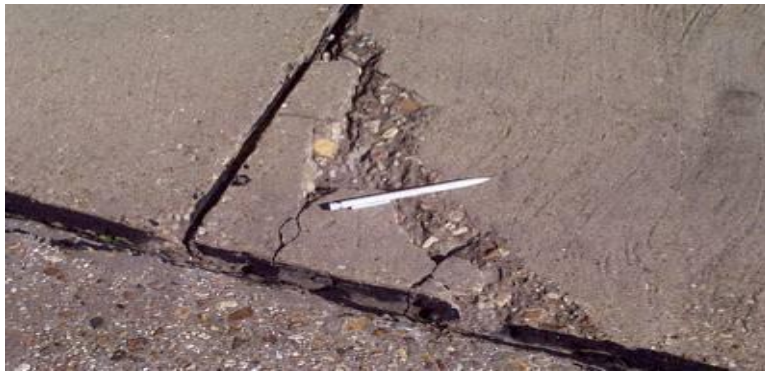
### *Example of Joint and Corner Spalling*

Spalls at slab joints and corners are caused by excessive internal stress in the pavement. Spalls occur when these stresses exceed the shear strength of the concrete. Spalling usually results from thermal expansion during warm or hot weather. As slabs expand, they push against one another at joints. If the joints are filled with incompressibles, such as sand, or if adjacent slabs offset slightly, stresses can become severe, causing spalls. Spalling can be reduced significantly by conscientious maintenance of joint sealant.

Spall repair requires patching. The extent and severity of spalling on a pavement surface suggests appropriate action. For example, at low severity, spalled concrete remains securely in place in the slab. A low-severity spall should be monitored closely for further deterioration and should be patched when

spalled particles become loose in place, or at the next scheduled patching activity in the section. Medium- and high-severity spalls should be repaired immediately to prevent the incidence of FOD. If the pavement can be restored to serviceable condition, spalls should be carefully patched for long-term service. If the pavement is beyond repair, temporary patching should be considered to control FOD.

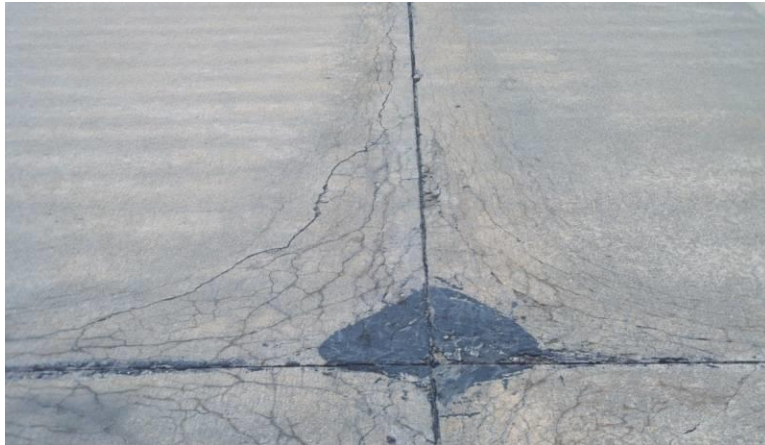
### *Example of Durability Cracking*

Durability cracking (D-cracking) is caused by environmental factors, the most common of which is freezing/thawing. It usually appears as a pattern of hairline cracks running parallel to a joint or crack, or in a corner, where water tends to collect. This type of cracking eventually leads to disintegration of the pavement, creating FOD potential. At low severity, D-cracking is evident, but no disintegration has occurred. As the distress advances to medium severity, the distress pattern is evident over a significant area of the slab, and some disintegration and FOD potential exists. High severity durability cracking is evidenced by extensive cracking with loose and missing pieces and significant FOD potential.
