Pavement Condition Report

Thief River Falls Regional Airport (TVF)

December 2019

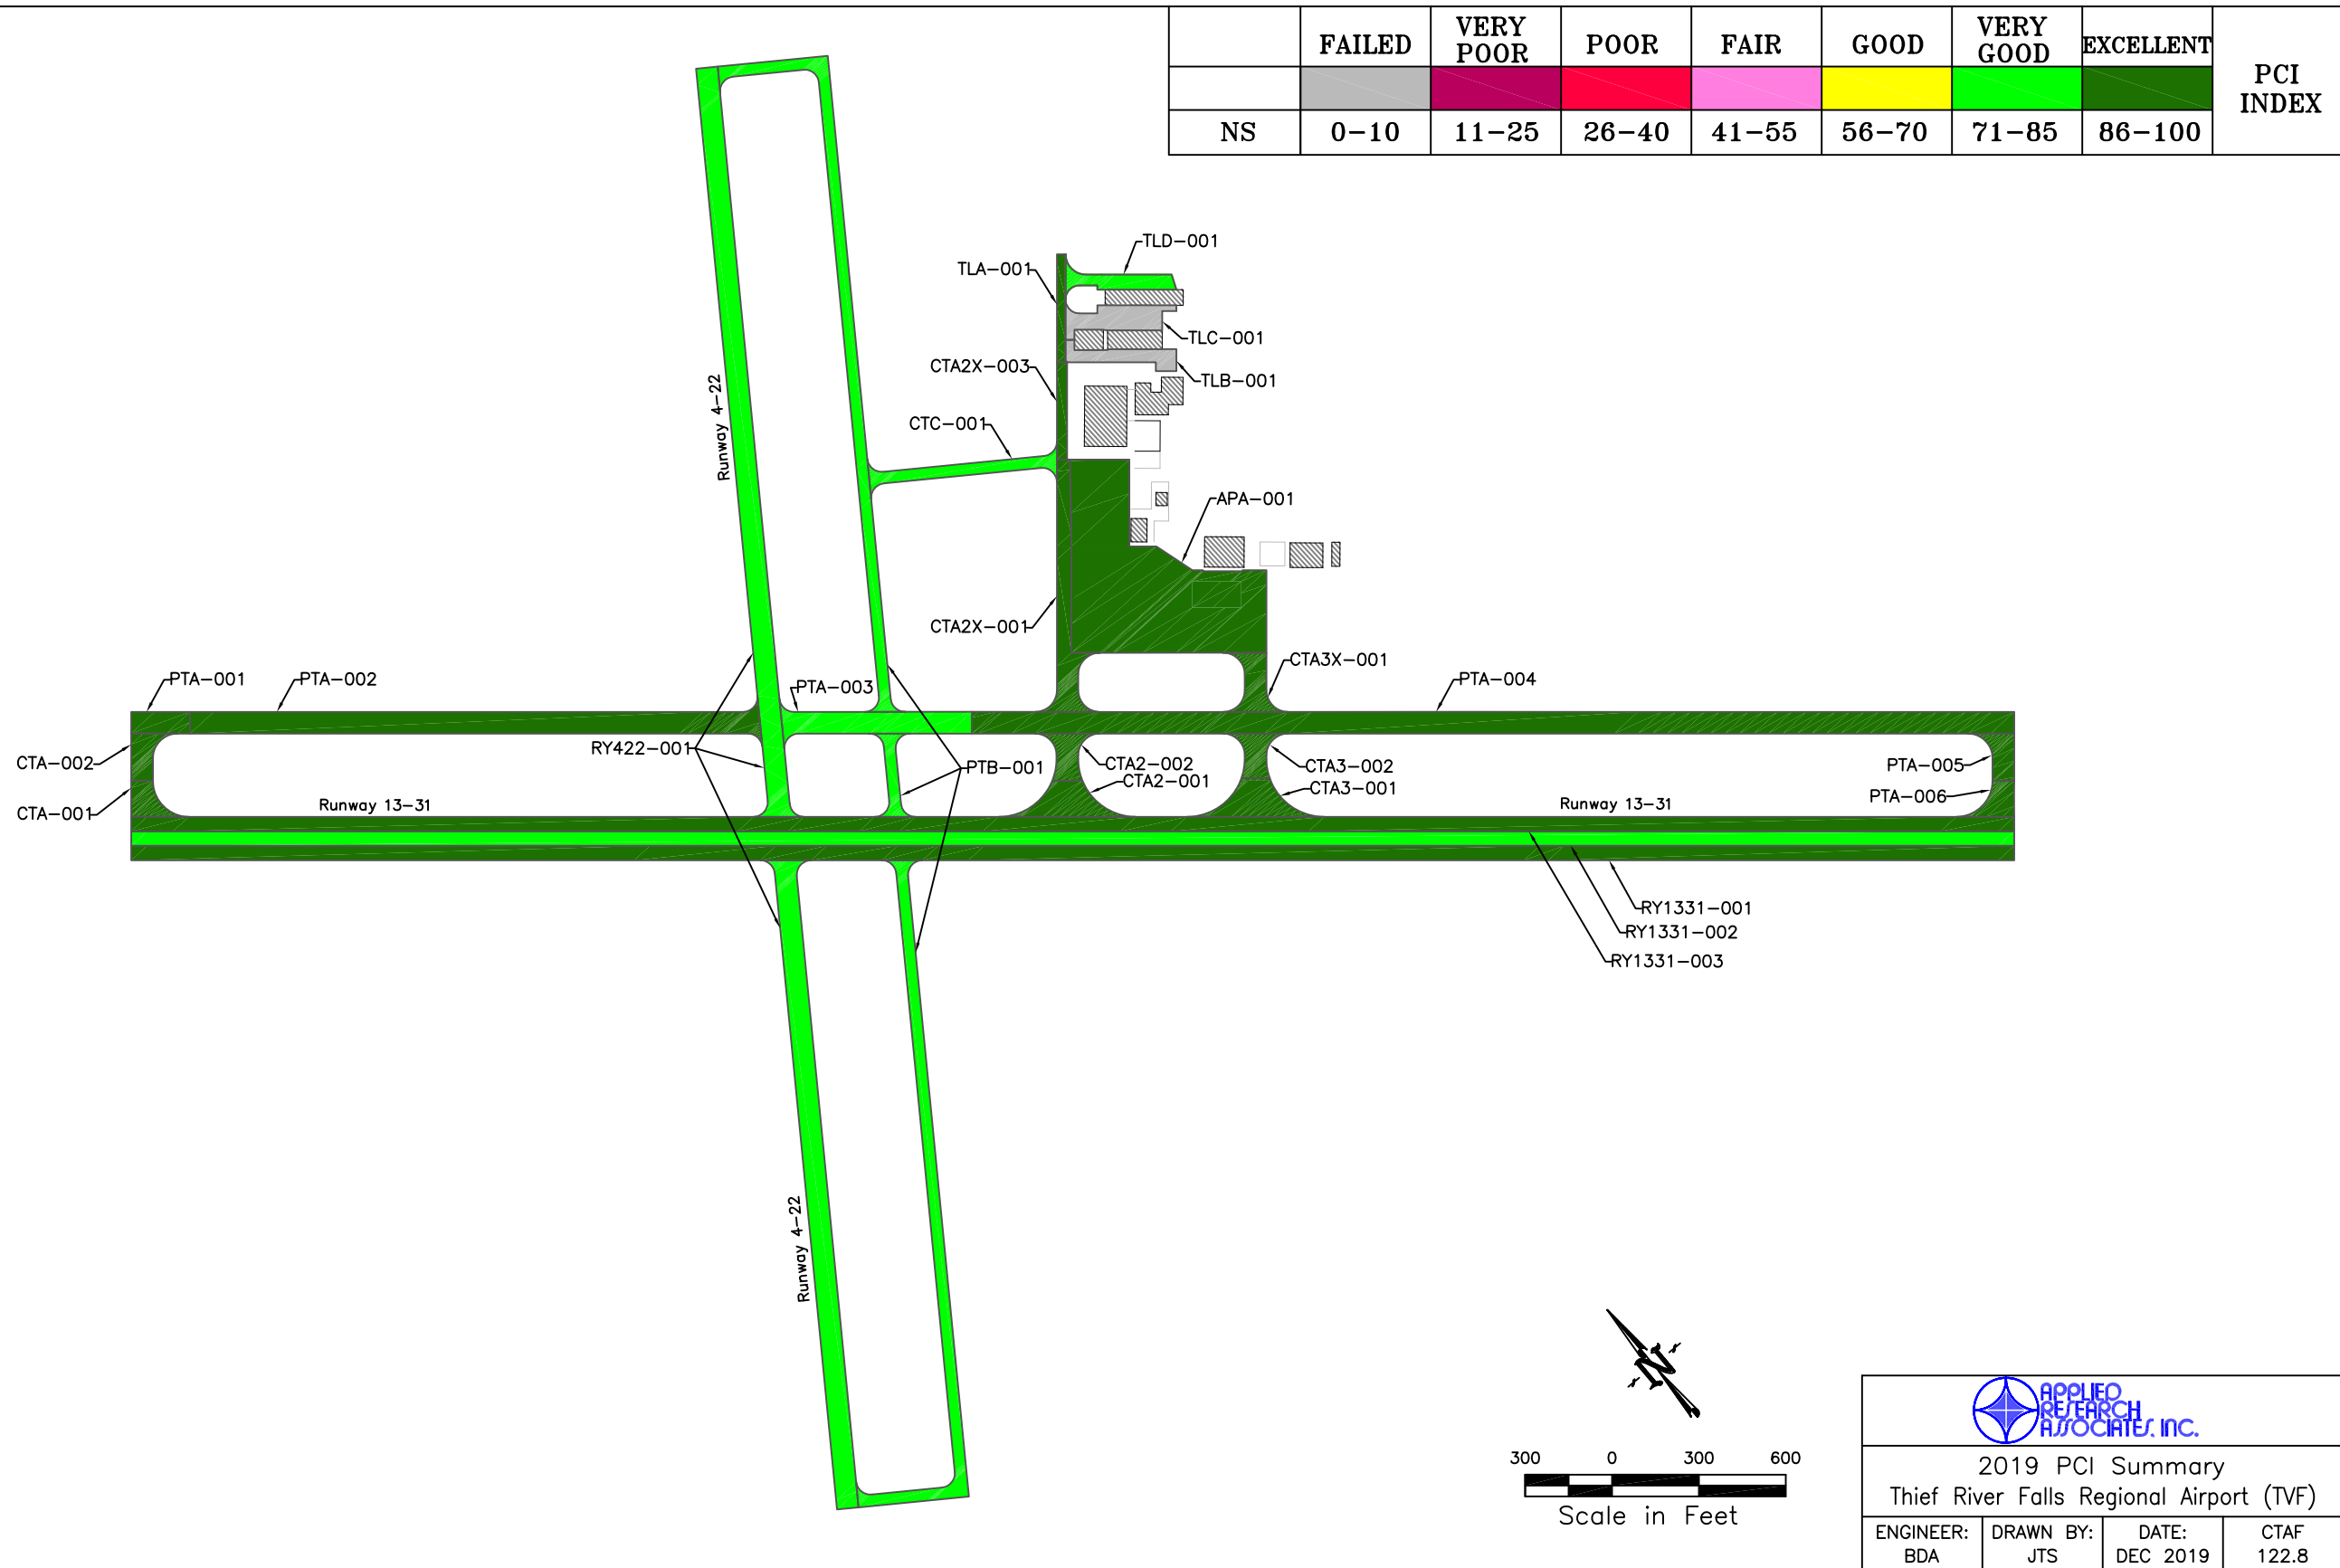
Figure 4. 2019 Pavement Condition Index Rating at Thief River Falls Regional Airport (TVF).

The results of the 2019 PCI inspection are presented in figure 4. The overall area-weighted, inspected PCI for TVF is 86. When summarizing PCI values, an area-weighted calculation is used instead of a straight mathematical average because the area-weighted calculations eliminate the skewing of the PCI due to the disparity of the section sizes.

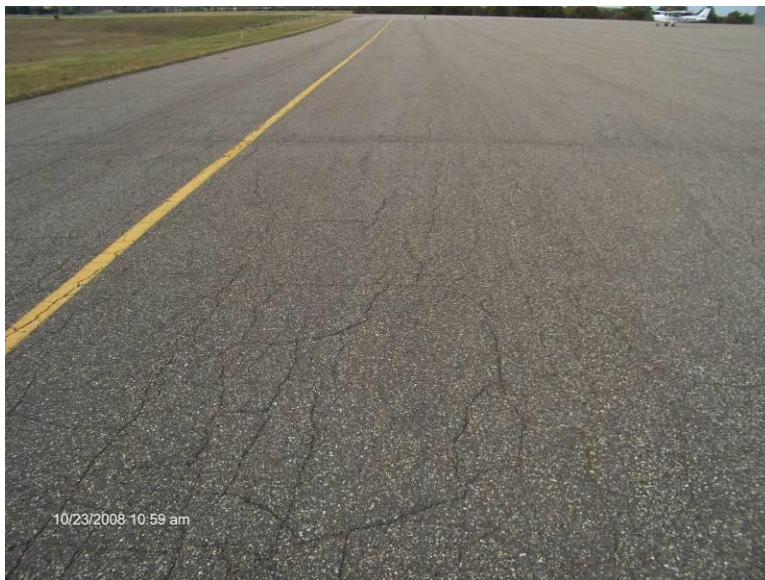
Example of Alligator Cracking

Alligator (or fatigue) cracks are a series of interconnected load-related cracks caused by fatigue of the asphalt surface. Alligator cracking is a significant structural distress and develops only in places subject to traffic loads. These cracks typically initiate at the bottom of the asphalt layer (where tensile strains

are highest) and propagate upward - so once a fatigue crack is visible, significant damage has already occurred.

At low severity, alligator cracks are evidenced by a series of parallel hairline cracks (usually in a wheel path). Further traffic and deterioration leads to the interconnection of these cracks. Medium severity alligator cracking is a well-defined pattern of interconnected cracks, some spalling may be present. High severity alligator cracks have lost aggregate interlock between adjacent pieces, the cracks may be severely spalled with FOD potential, and most likely the pieces will move freely under traffic. Alligator cracking is a structural failure and cannot be repaired with sealant, the proper repair is full-depth patching.
