## **INSPIRATION POINT WAYSIDE REST**

### **Condition Assessment**

TH 16 near junction with CSAH 21  
Carrolton Township, Fillmore County, MN

**November 2013**

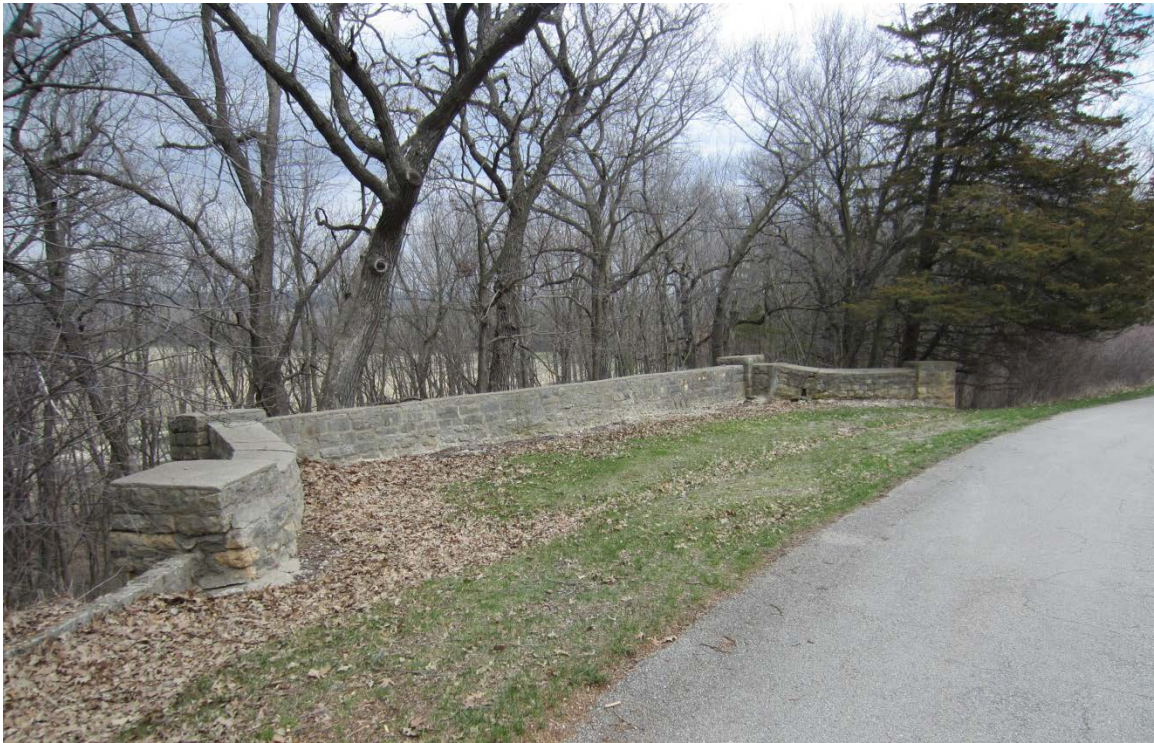
Current photo looking northeast from North Overlook.  
The road can be seen, but only because there are no leaves

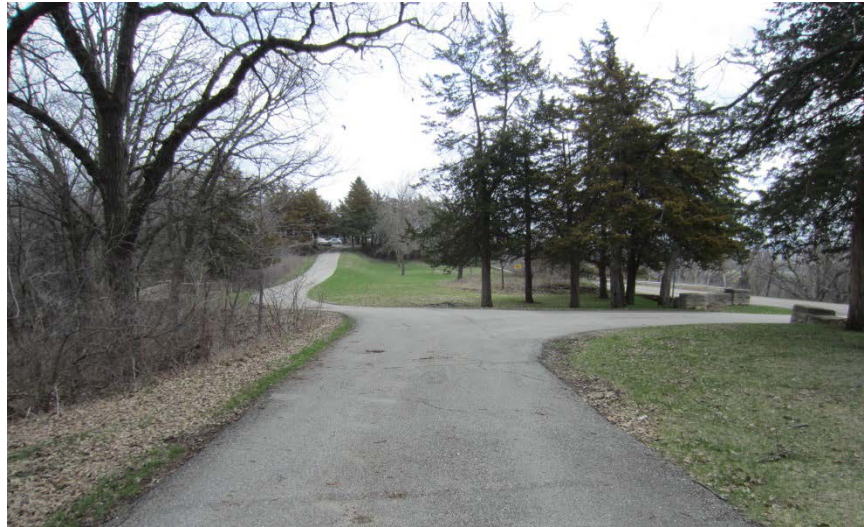
Looking east to Historic Entrance and East Overlook

The bituminous road is in fair condition and has minor areas of cracking. The road appears to have been moved slightly from its original position as the original stone curbs that remain vary between 6" and 18" from the edge of the road.

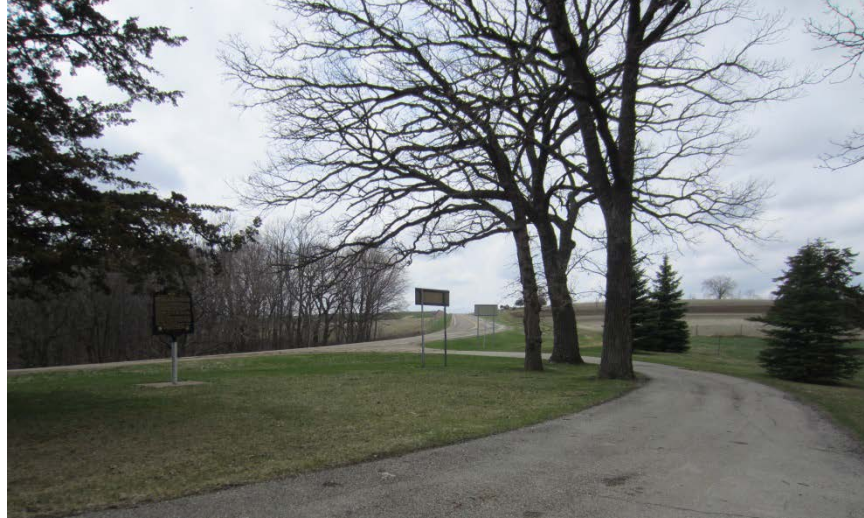
Signs near West Entrance

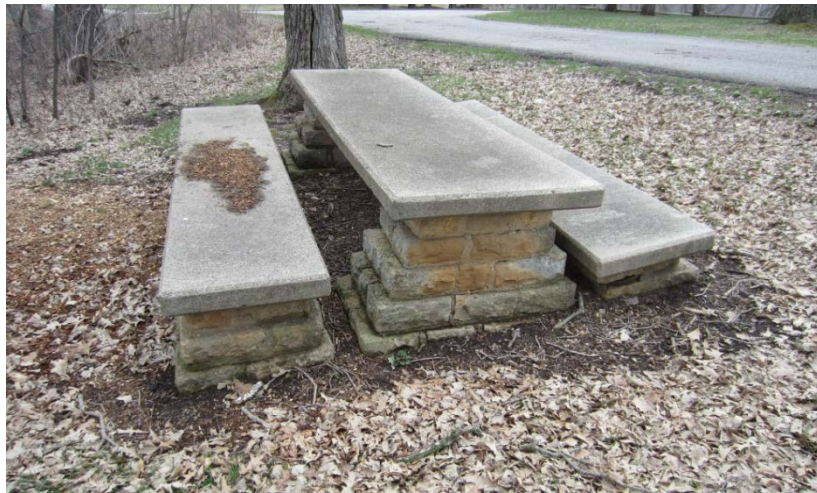
Center Picnic Table and Benches

- Repoint 100% of the masonry legs and the joint between the concrete slabs and the stone. Repoint using techniques that do not damage existing, sound stone. Repointing mortar must match existing, historic mortar in strength, texture, appearance, and tooling. Take extra precautions to match historic, existing mortar, not mortar that was used in more recent repointing installations. Ensure the profiles replicate those of the existing masonry legs and are slightly recessed from the face of the stones.

- Lower the grade in the picnic area (see road recommendations for related work) to expose the bottom edge of the masonry legs.
- Clean exposed surface of all steel reinforcing bars and coat with epoxy to prevent rust. Rusted reinforcing bars expand within concrete and lead to rapid concrete deterioration.

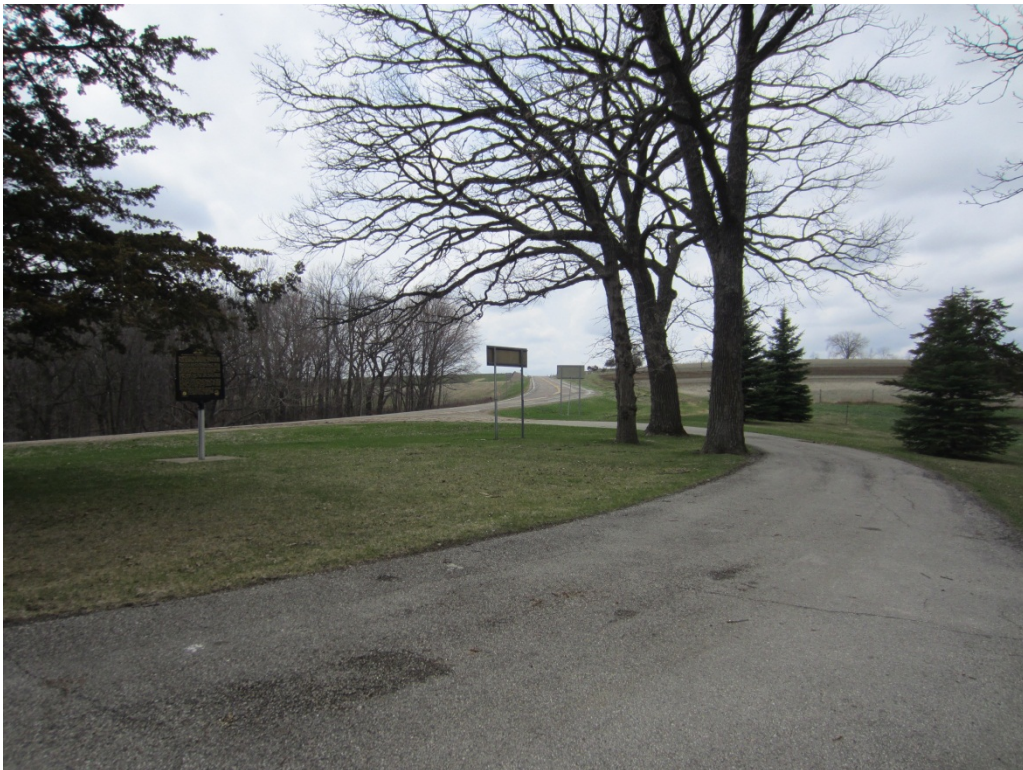
4.4 – Minnesota Historical Society 1998 marker and West Entrance

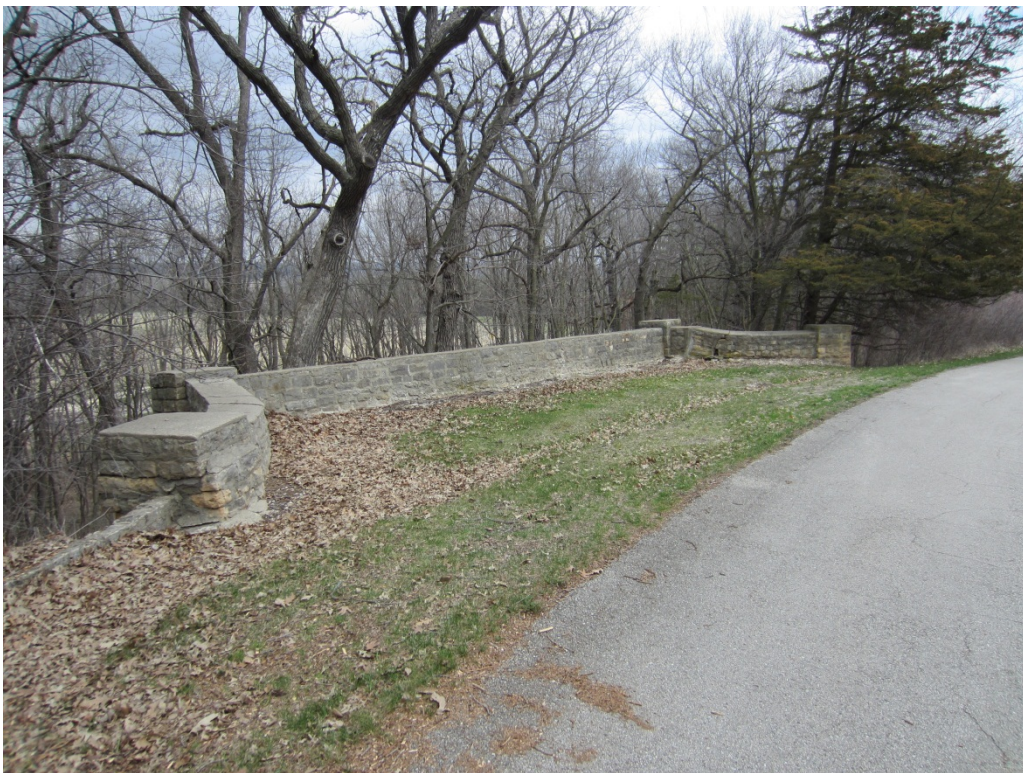
- The original construction documents indicate that the retaining wall of the North Overlook was to be a dry laid stone wall. However the dry stone design intended for other walls was apparently abandoned for a more typical ashlar wall construction. The wall is significantly deteriorated.

4.6 – North Overlook Walls and Parking Area

- Recommendation:
    - Rebuild the retaining wall with mortared joints employing a structural engineer to design a backup wall system that will retain soil behind this wall. Use original, historic stone supplemented by new stone as required. Match configuration of historic wall when rebuilt.

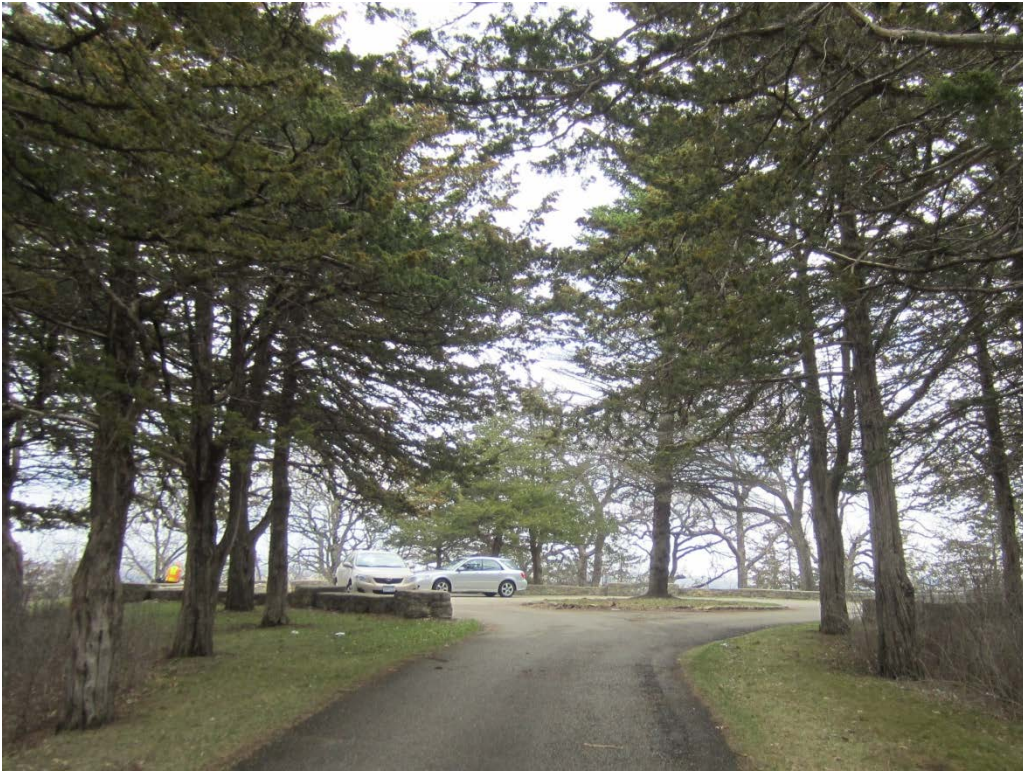
- The South Entrance Walls and East Overlook Wall were poorly constructed, lacking proper dry laid stone techniques.
  - Recommendation:
    - Rebuild the South Entrance Walls and East Overlook Wall using original, historic stone supplemented by new stone as required for proper dry laid stone construction.

4.7 – East Overlook Wall and Parking Area

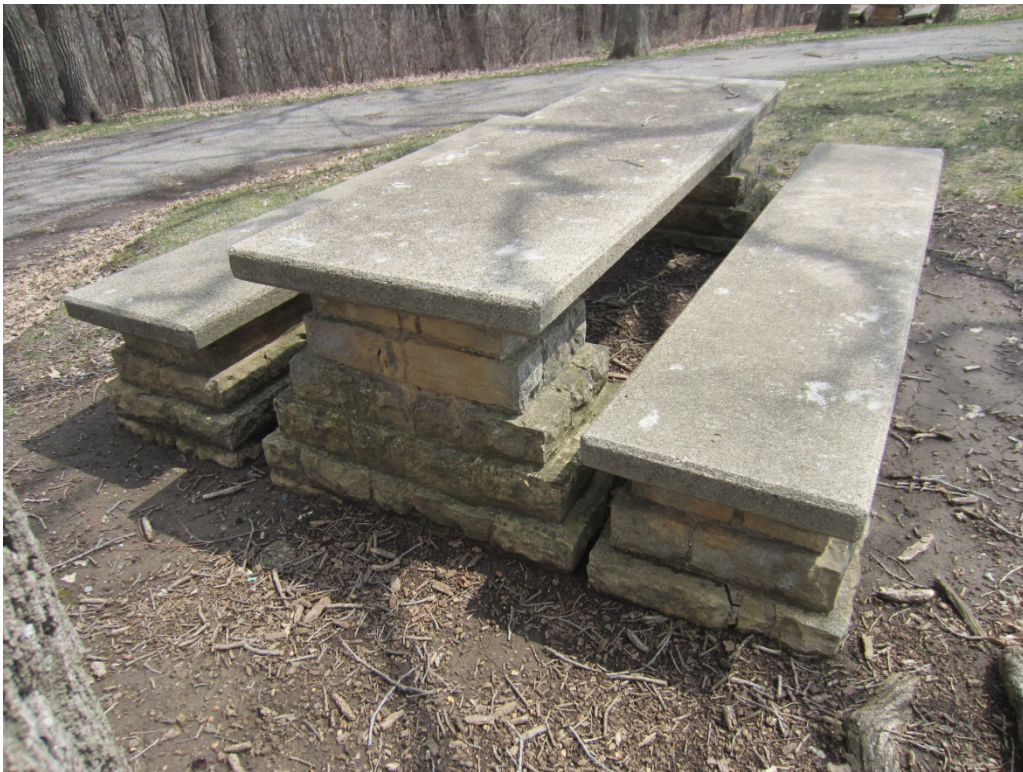
4.8 – West Table with loop of West Drive in the background
