HydInfra Inspection Manual

Culvert and Storm Drainage Systems

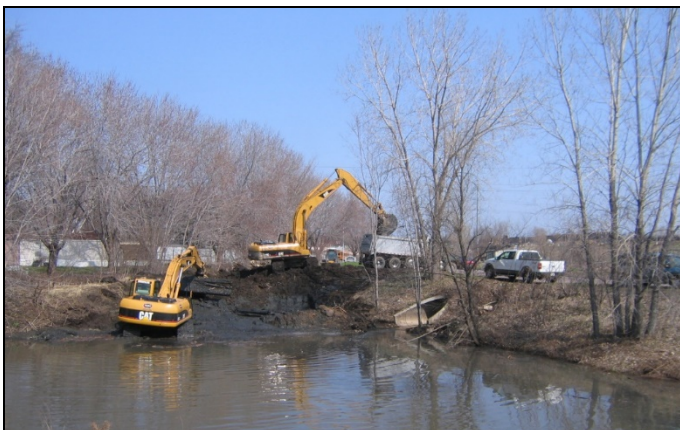
Ponds are designed to detain or retain stormwater and slow the rate of outflow

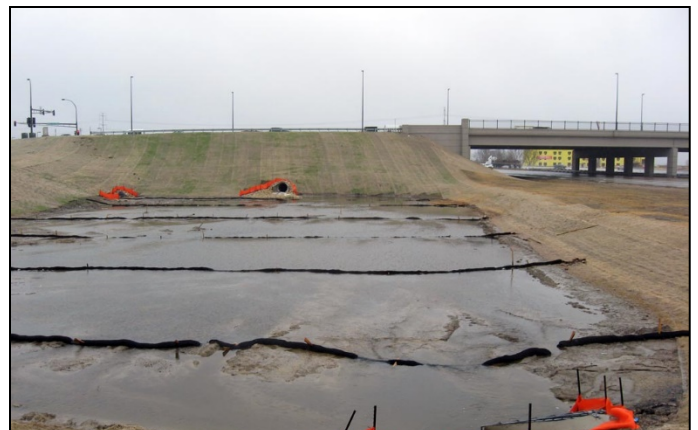
Basins are designed to filter or infiltrate stormwater

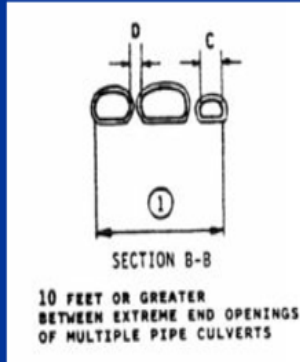
HydInfra Culvert pipes are those less than 10-foot span that do not fit the definition of a Minnesota Bridge:

It is a bridge (and not a HydInfra culvert) if Total Span is 10 feet or greater and the gap between pipes is less than half the smaller pipe's interior diameter.

Two 8 ft. wide culverts with a five ft. space between them would not be a “bridge”.

Two 6 ft. wide culverts with a 2 ft. space between them would be a “bridge”.

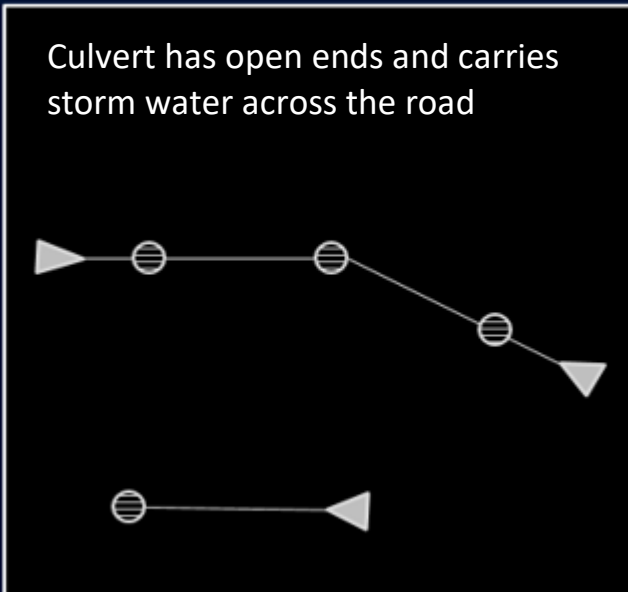
Culvert has open ends and carries storm water across the road

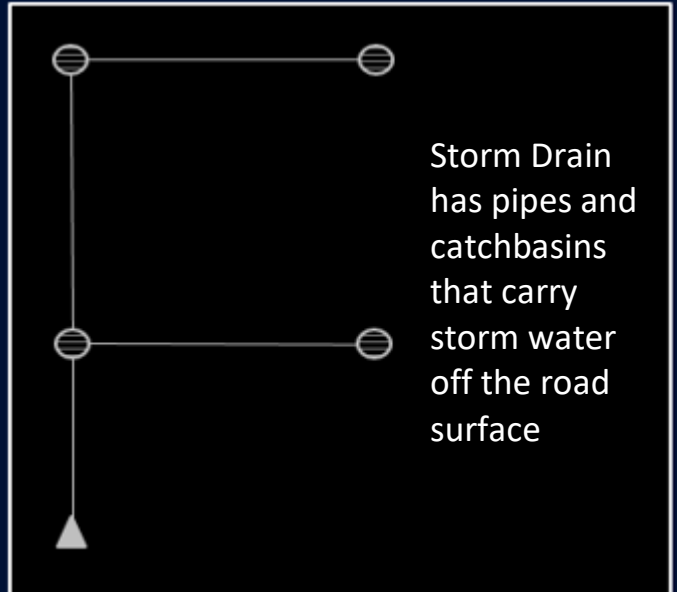
Storm Drain has pipes and catchbasins that carry storm water off the road surface

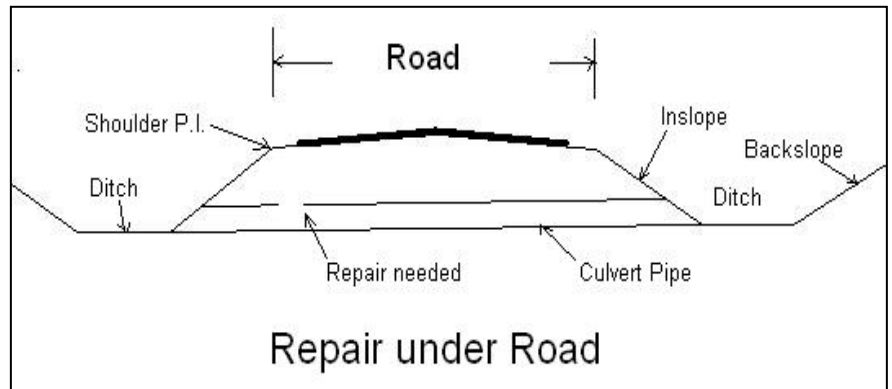
■ **Repair under Road** –

If a repair is needed, the needed repair will encroach on the area between the two shoulder P.I.'s (point of intersection where the road surface intersects with the inslope). The Repair flag must be marked yes for Repair under Road to be valid.

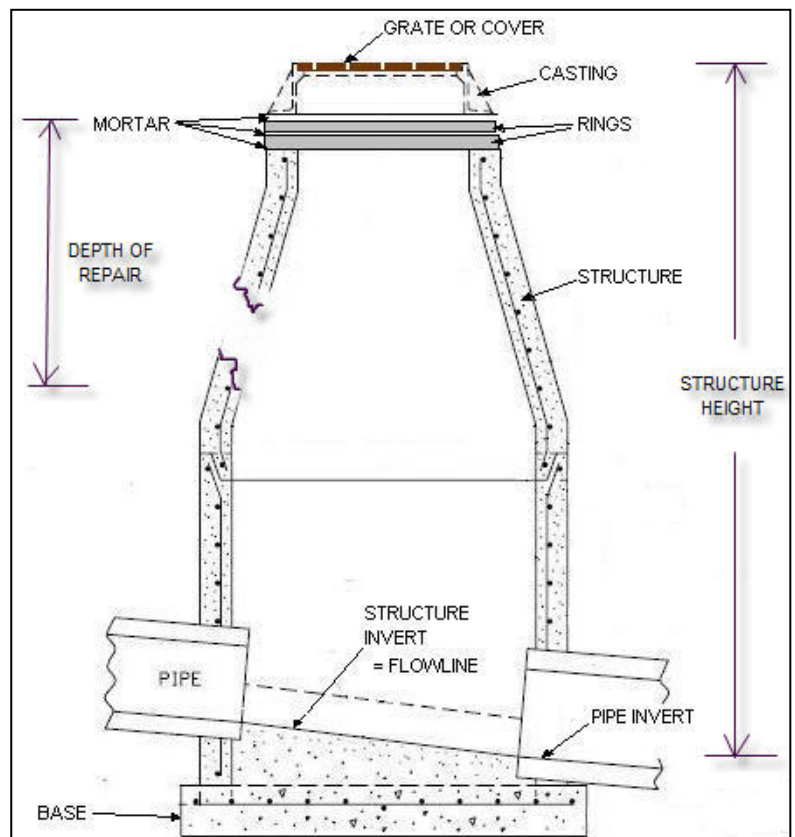
Structure Terms

- **Structure Type** – Manhole, Catchbasin, Drop Inlet, Buried Manhole, Control Structure, Deck Drain, Diverter, Inspection Tee
- **Structure Height** – Measure from top of grate to bottom of invert
- **Repair Depth** – Measure from bottom of casting to bottom of the needed repair (gaps, cracks, holes, missing blocks or brick, etc.)
- **Connected Pipes** – number of pipes attached to the structure
- **Sump** – a basin below the outgoing pipe that is deeper than 1 foot
- **Deteriorated Rings** – The adjusting rings (= layers below the iron casting assembly) are broken or cracked. Rings may also have missing mortar.

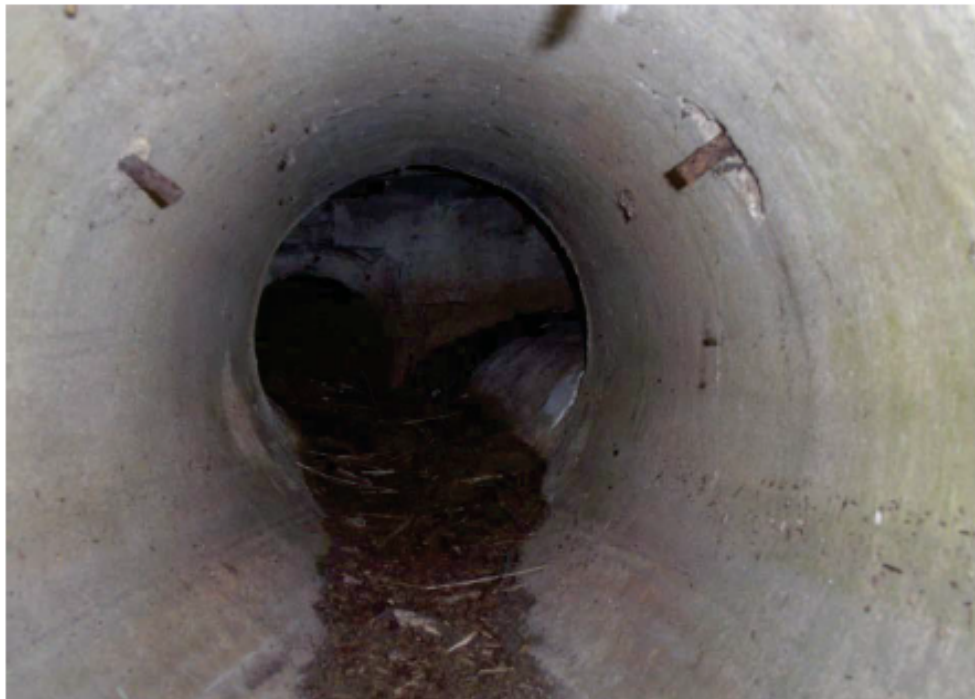
Concrete Pipe

**MATERIAL TYPE:
CONCRETE**

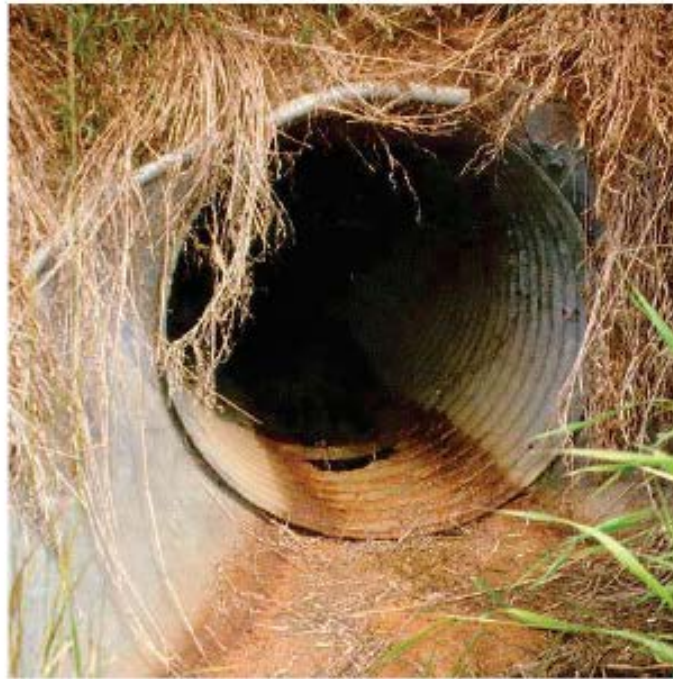
Corg. Steel (CSP)

Zinc-galvanized steel pipe

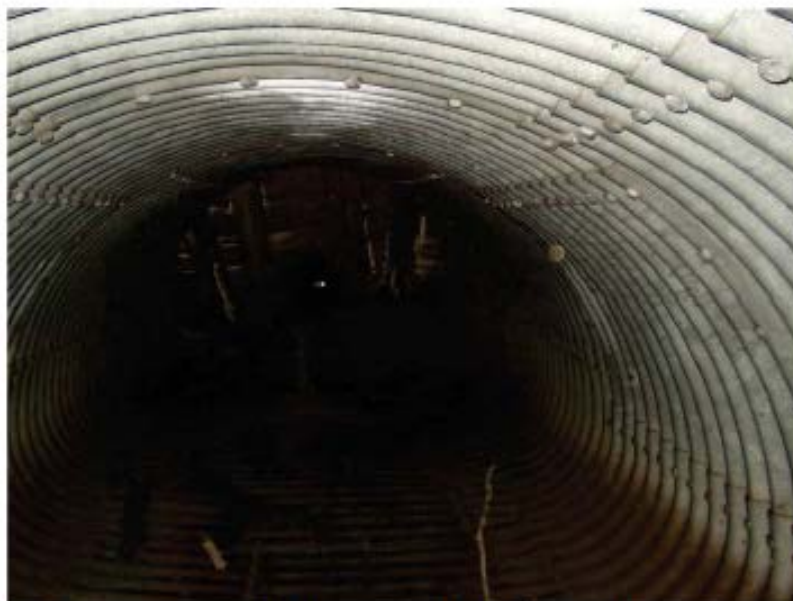
Structural Plate

US 61 Silver
Bay 1.p.
53.26

Galvanized steel plates are bolted together,
was used in larger diameter culverts

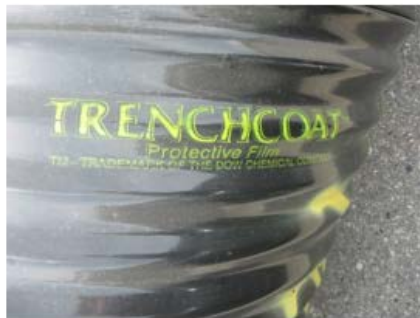
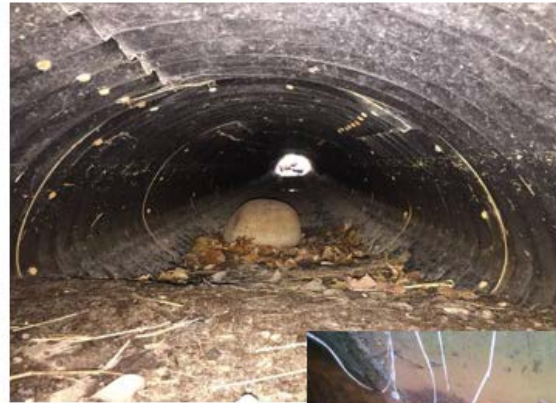
Thin black plastic sheet applied to inside and outside of corrugated steel pipe. Look for peeling at edges.

39 year old Polymeric-coated pipes installed in 1977 held up where galvanized aprons rusted out. Most were Condition 2. District 3, MN 84 Pine River to Longville.

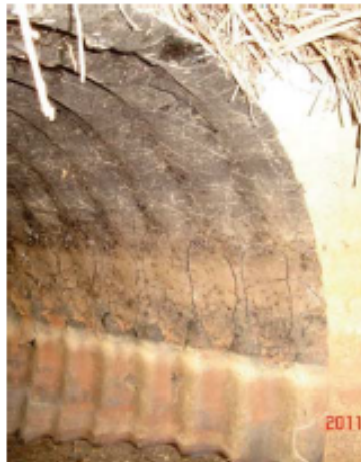
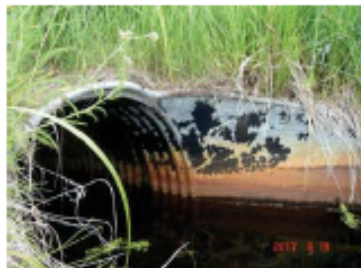
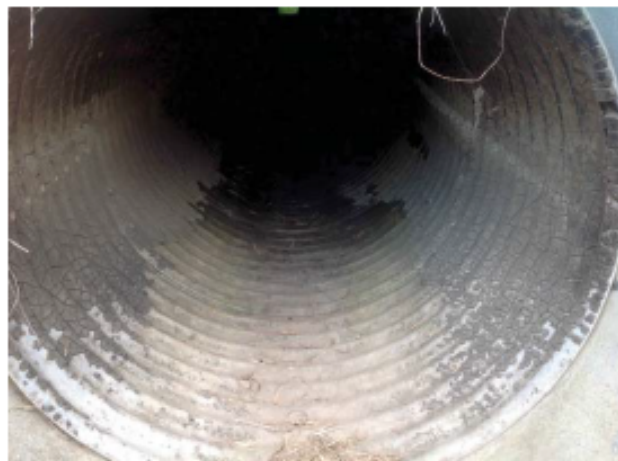
Bituminous-Coated Steel

- Looks like tar on CMP, often flaking
- *May contain asbestos*
- Labeled in Plans as "AB-Bonded"
- Not installed since 1970's but still exists

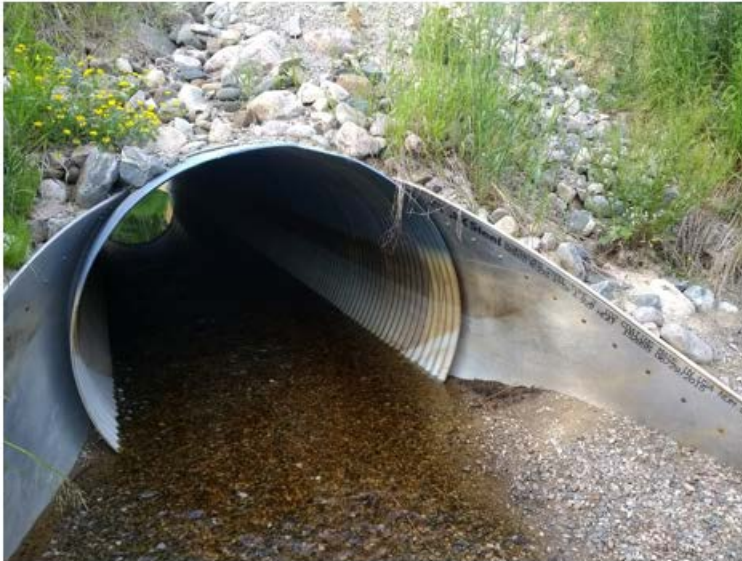
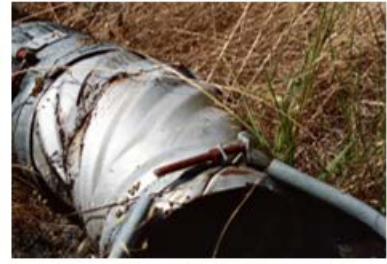
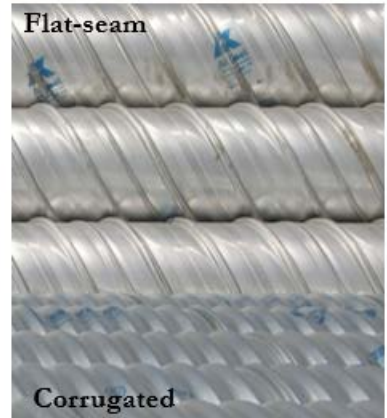
Flat-seam

Corrugated

Look for label on new pipes. Surface has a sheen like an aluminum pop can, but edges may be rusty. Aluminized Steel is magnetic.

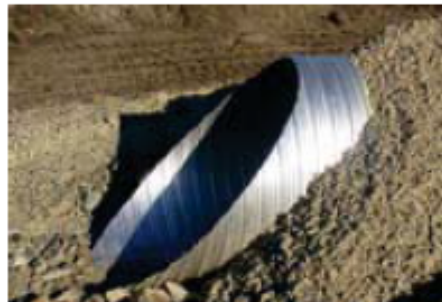
Often miss-identified where pipe material is actually Aluminized Steel, Inspector should look at pipe end edge to identify steel or aluminum material.

All aluminum pipe, not steel so no rust, not magnetic, is more bendable

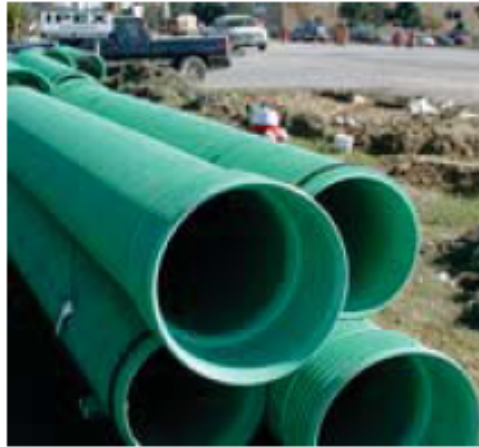
PVC

White or green, more brittle than HDPE, especially in cold

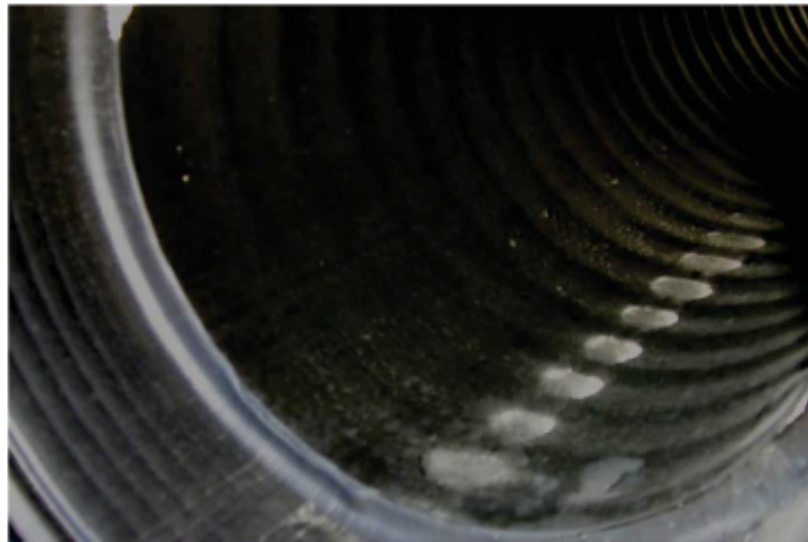
Corg. Plastic (HDPE)

HDPE = High Density Polyethylene has smooth inside and corrugated outside. HDPE is always black

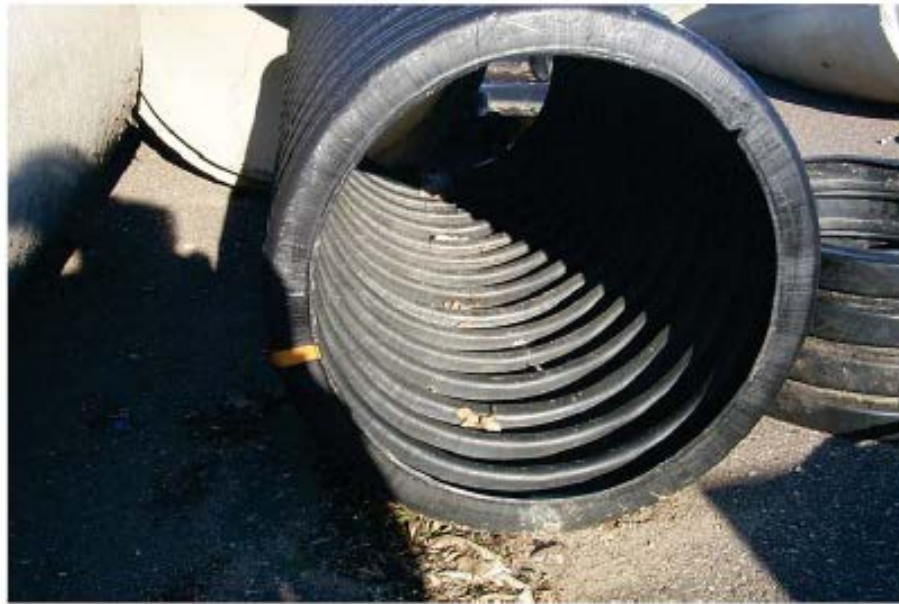
Corg. Plastic (HDPE)

Single wall corrugated HDPE should not be used as highway culverts or storm drain.

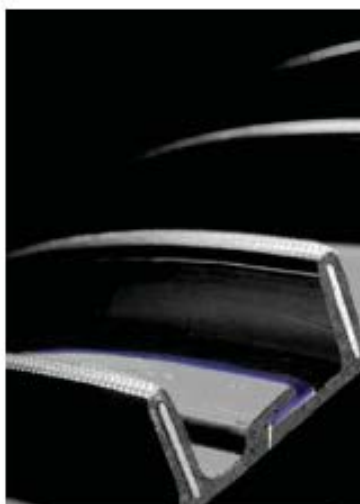
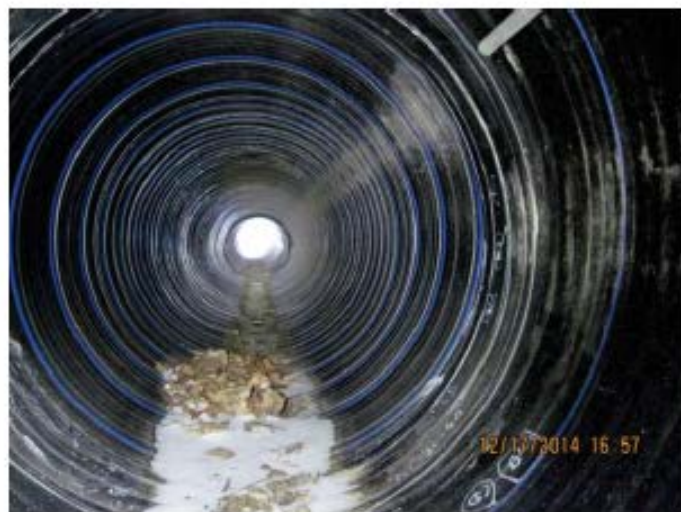
SRPE -
Steel-Reinforced PolyEthylene

Exterior flanges are steel, coated with HDPE

Blue spiraling line shows it's SRPE

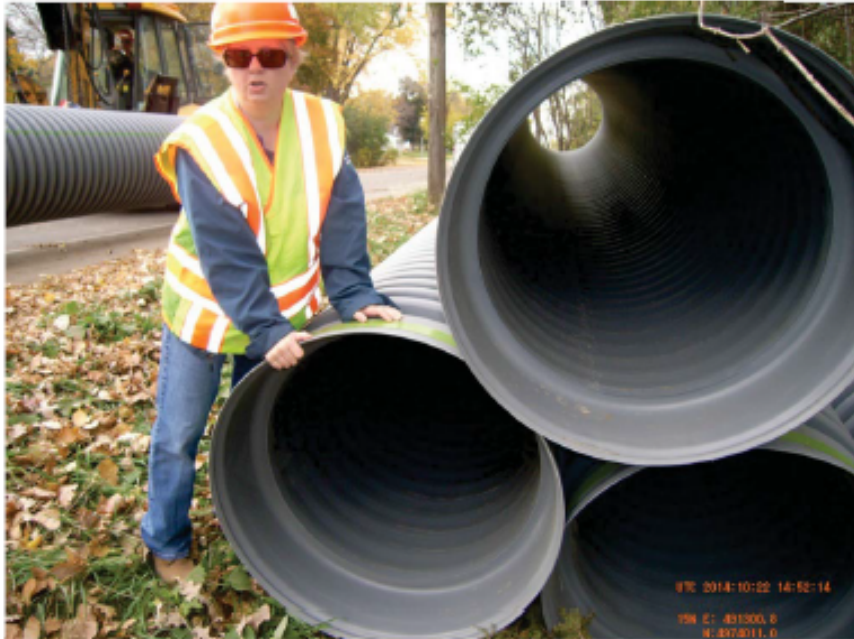
PP = Polypropylene Pipe is grey and stiffer than HDPE

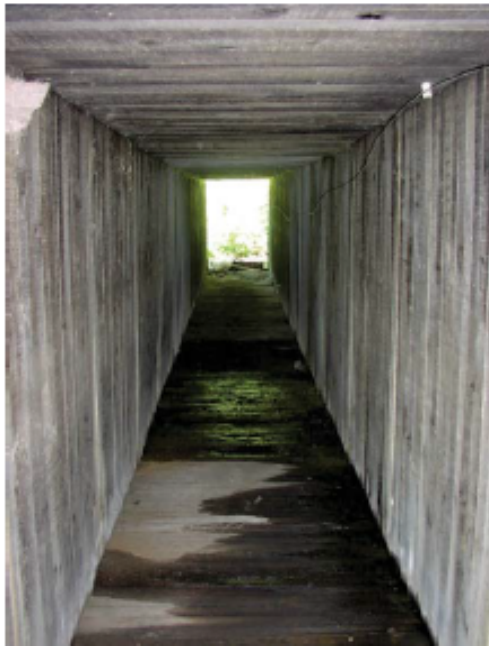
Wooden cattle pass in
D6 on MN 60 r.p.
185.91

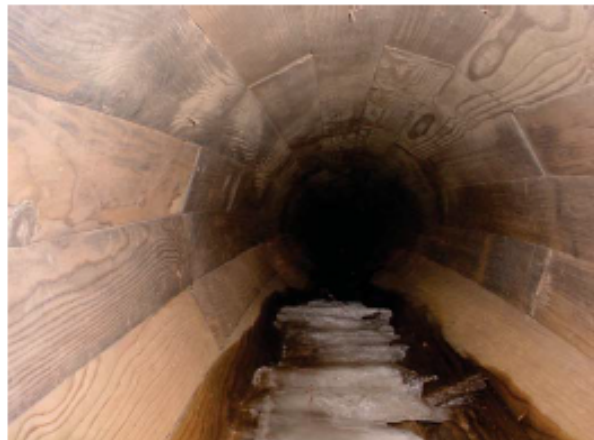
also used in wet box culverts

Wooden Pipe on Grand Ave,
MN 23 in Duluth

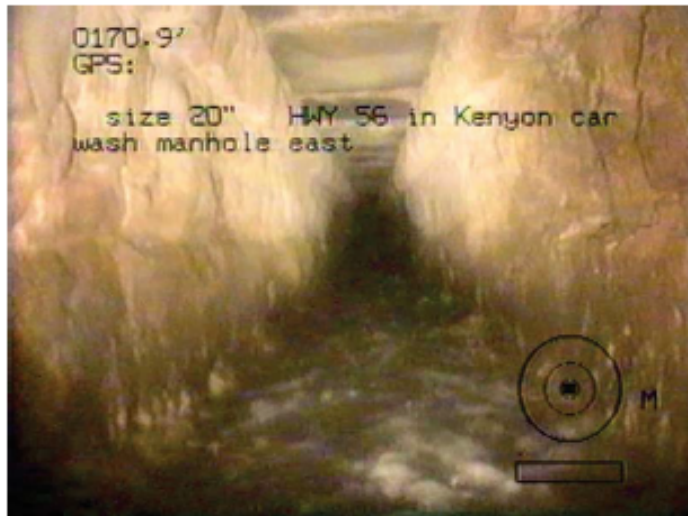
Excavated 20 inch box "pipe" carved from limestone provides outlet for old VCP storm drain -- D6 Hwy 56 Kenyon

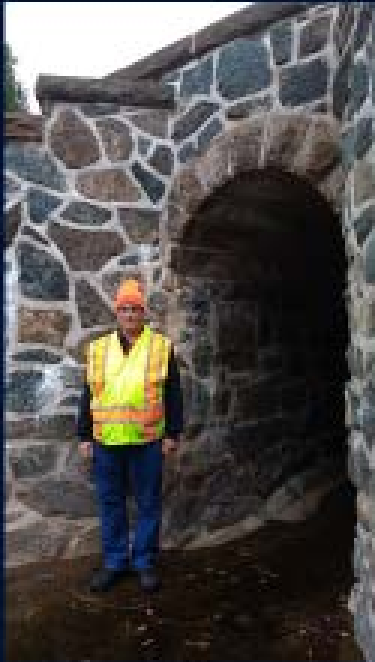
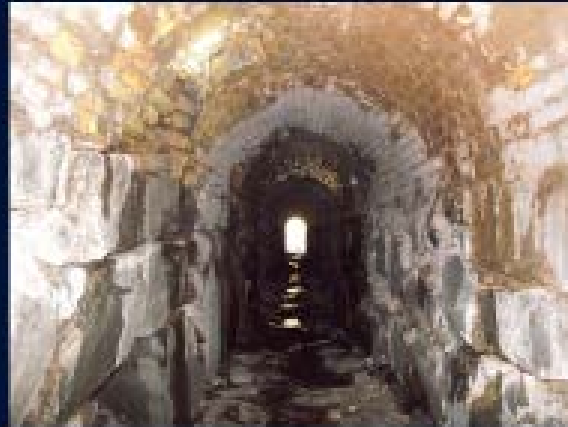
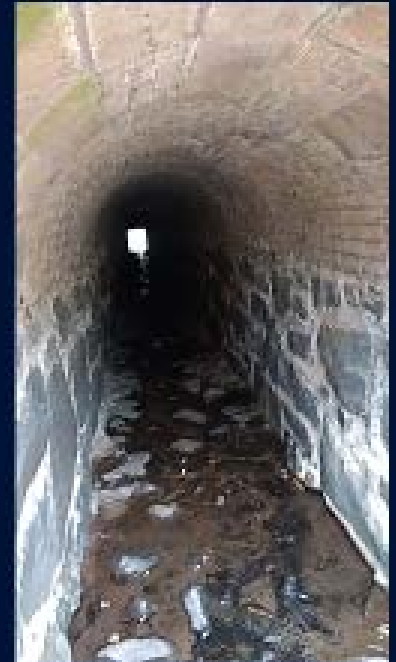
Brick/Masonry – describe in comment

Before Renovation

After Renovation
Photo 26OCT2016

Stone Culvert in Duluth on London Road
National List of Historic Places

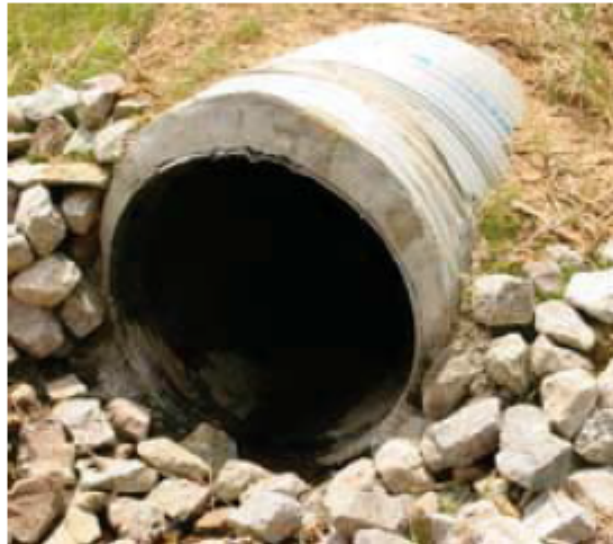
Liner HDPE

Like Snap-Tite or butt-fused HDPE liner has grout between original pipe and liner.

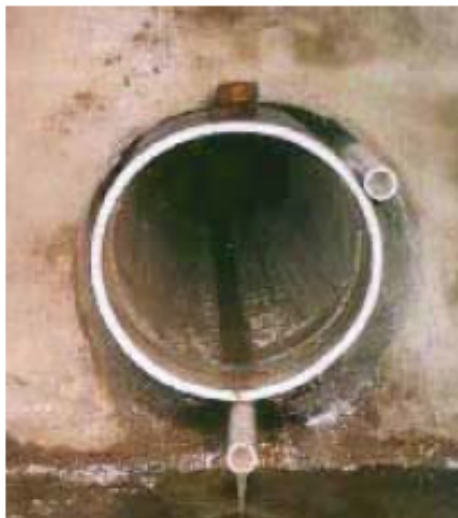
Liner PVC

Photo of PVC liner from Caltrans <http://www.dot.ca.gov/hq/oppd/dib/dib83.pdf>

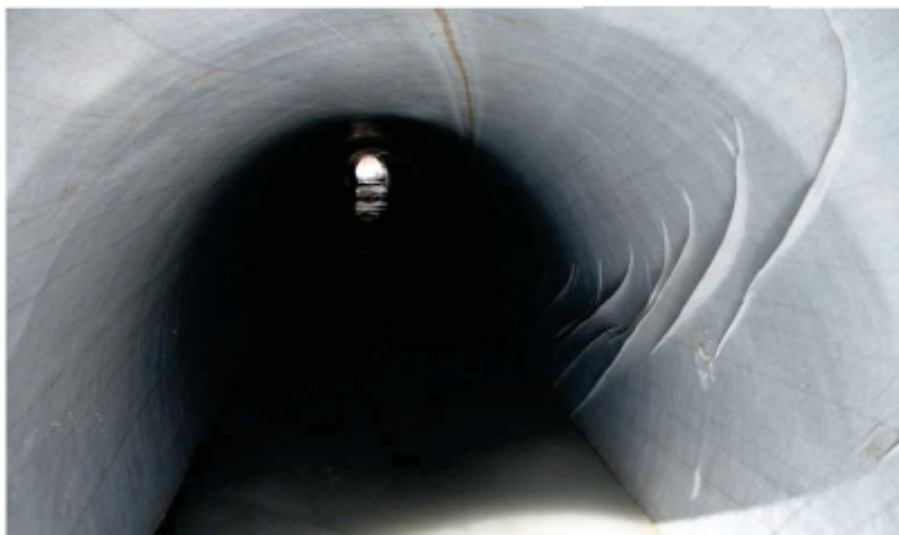
Liner Cured in Place

CIPP Liner is resin-filled fabric, inflated and cured with hot water or steam or UV light till it's rigid

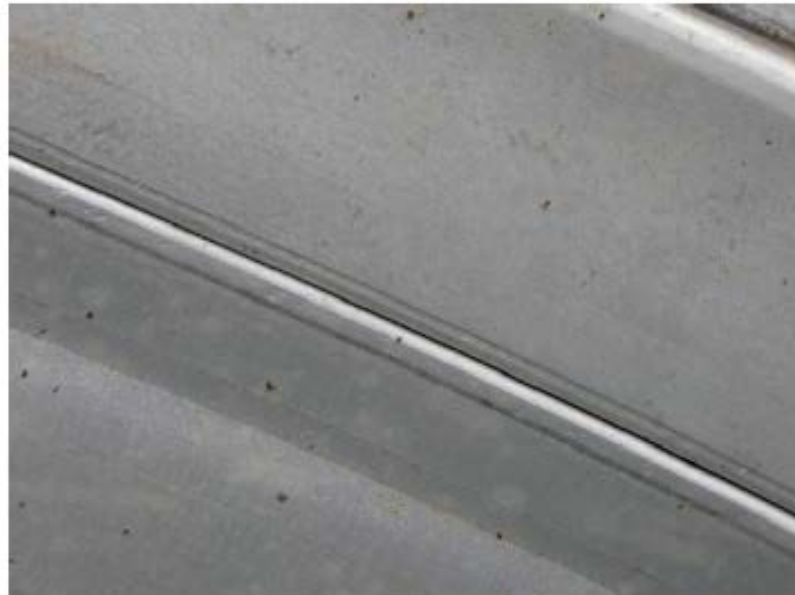
Liner Metal

Steel flat-seamed pipe is sometimes used as liner

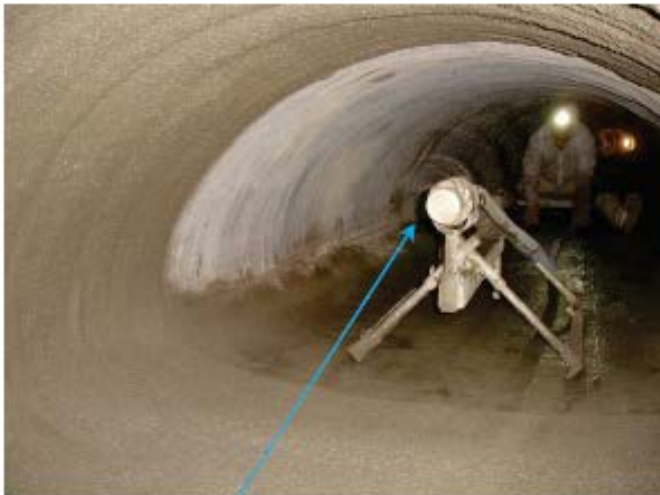
Liner Other

Centrifugally Cast Concrete Pipe

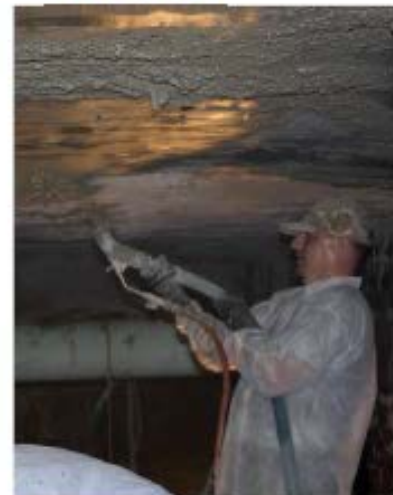
Hand sprayed application

Sprayed-on cementitious pipe liner

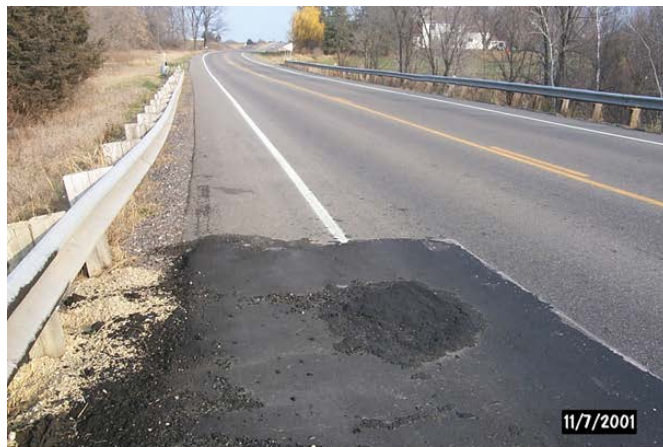
The general conditions of the roadway and adjacent area are used as clues to help determine the condition rating for each hydraulic asset that is inspected. These general conditions may be indicators of concealed structural problems. Pipe failures with loss of road fill are often visible on road surface.

Road surface may indicate condition of pipe

MN 95 near MP 89, near Marine on the St. Croix

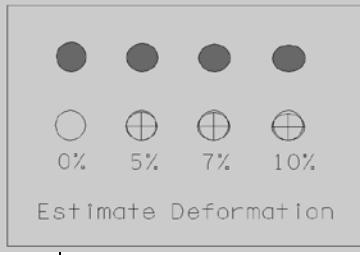
Dual Wall Plastic Pipe or Liners – HDPE or Polypropylene

| Factors: Structural integrity, Integrity of surrounding material | Flags |
|--|---|
| <p>1 Excellent Condition</p> <ul style="list-style-type: none"> • Pipe is straight • Joint separation less than 1" • *Deformation less than 5% of original inside diameter | |

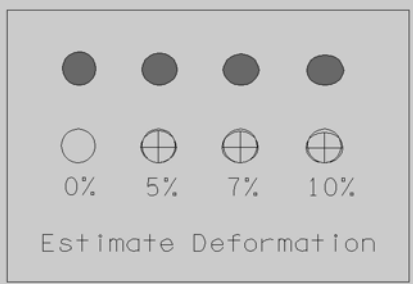
Single Wall Plastic Pipe or Liners – PVC or CIPP

| Factors: Structural integrity, Integrity of surrounding material | Flags |
|--|---|
| <p>1 Excellent Condition</p> <ul style="list-style-type: none"> • Pipe is straight • Joint separation less than 1" • *Deformation less than 5% of original inside diameter | |

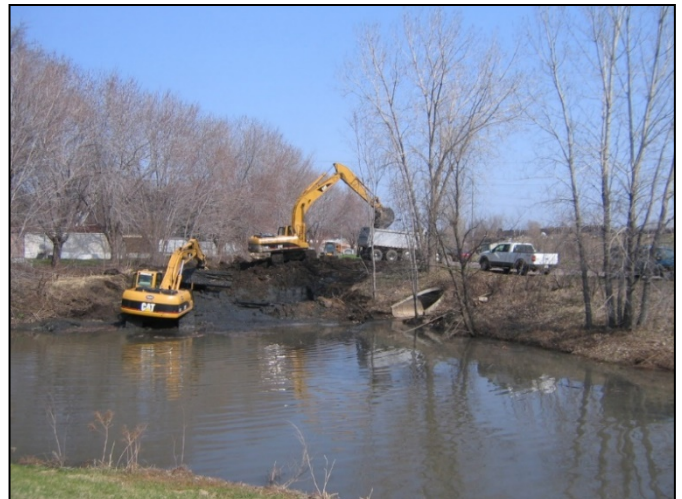
Ponds are designed to detain or retain stormwater and slow the rate of outflow

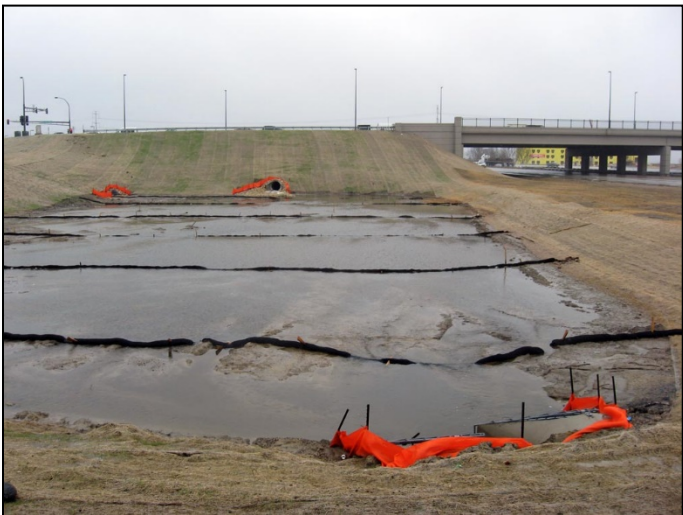
Basins are designed to filter or infiltrate stormwater
