# Pavement Condition Report

## Rochester International Airport (RST)

**December 2017**

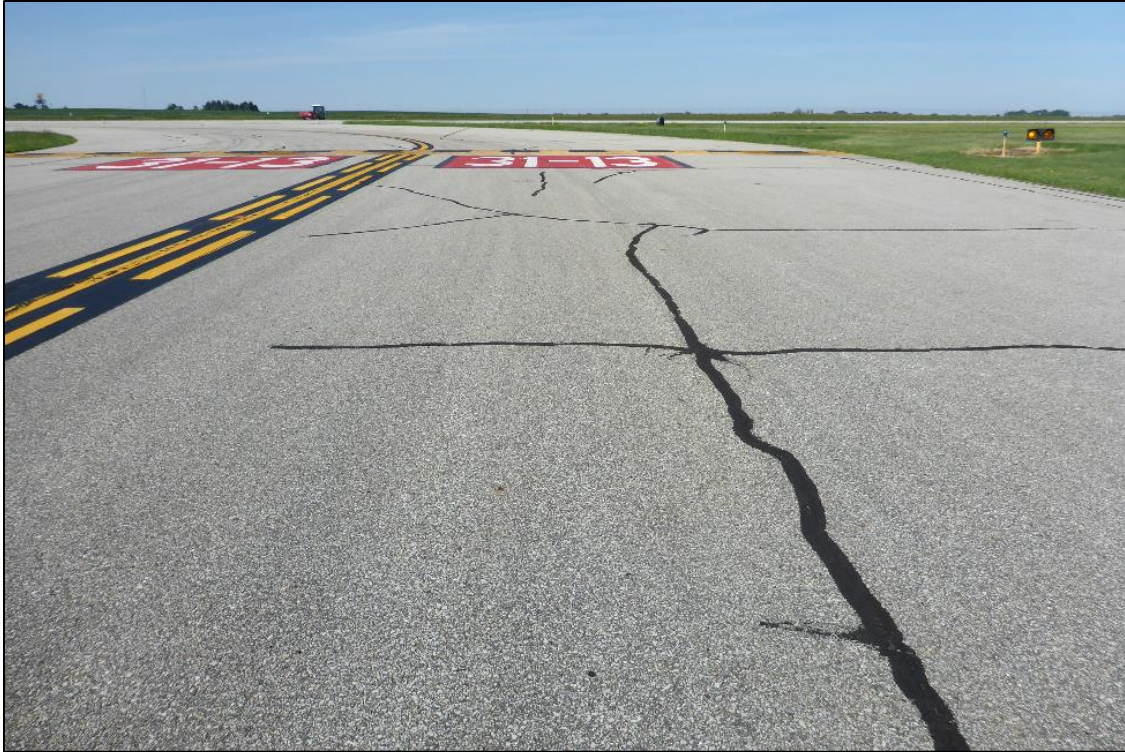
RST CTA8 001 (PCI = 73)

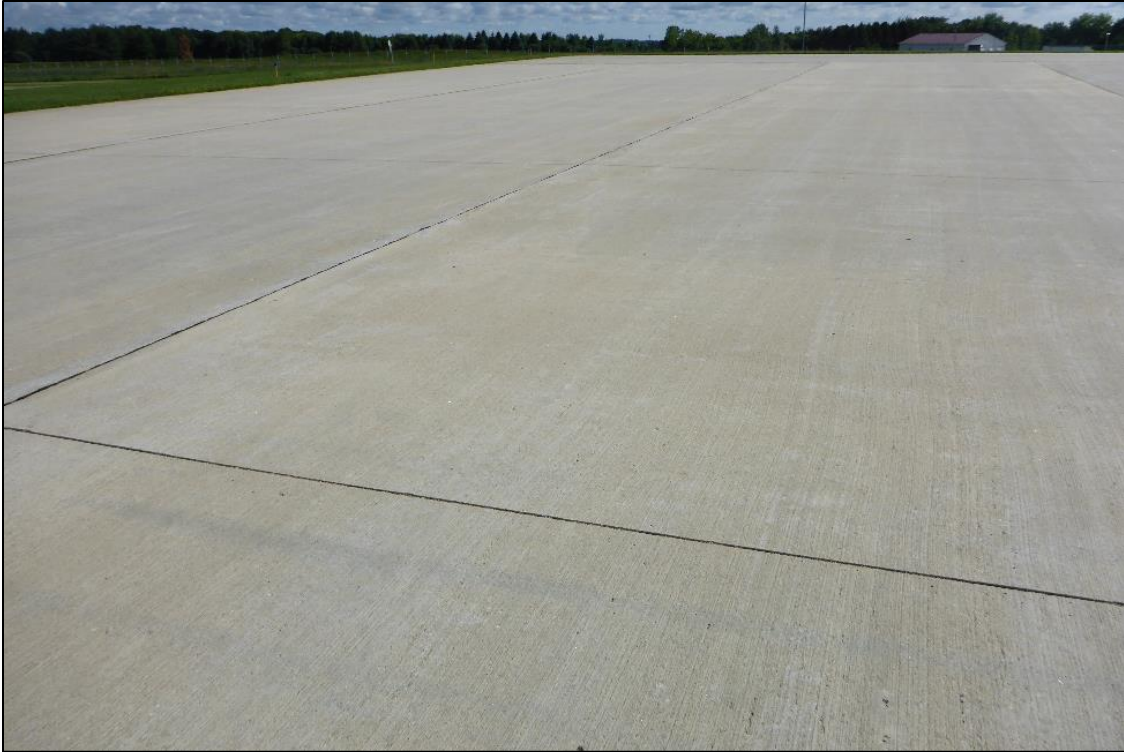
RST CTA10 001 (PCI = 90)

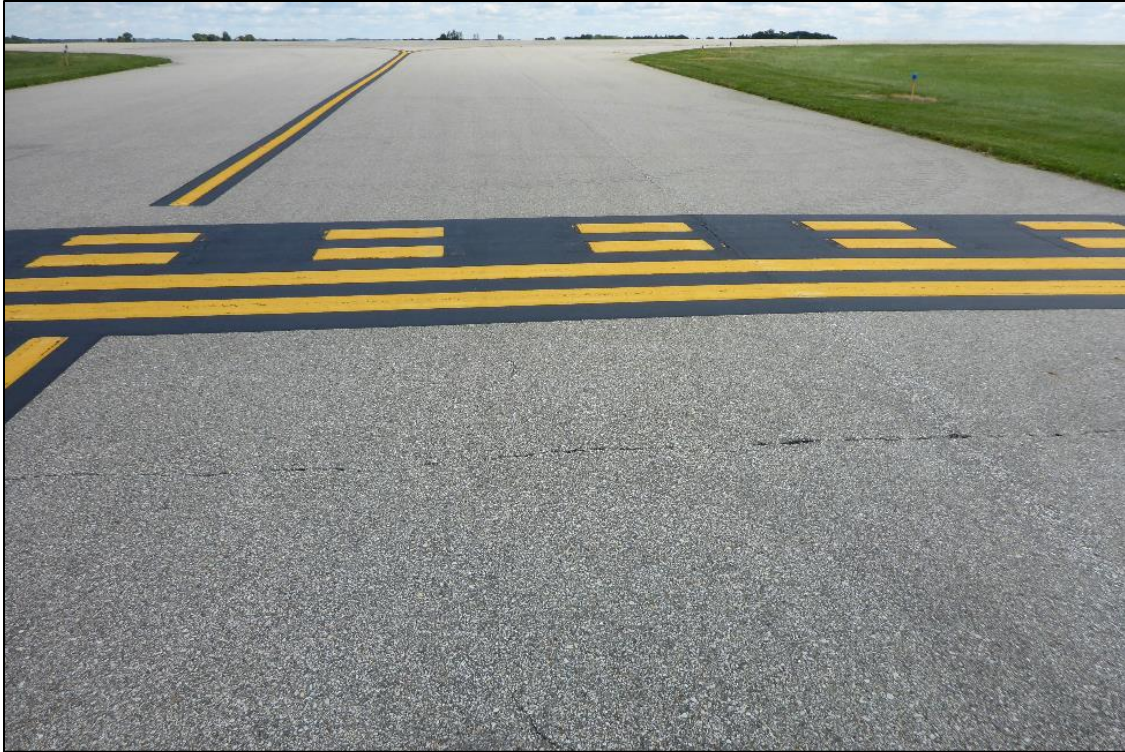
RST CTB2 001 (PCI = 83)

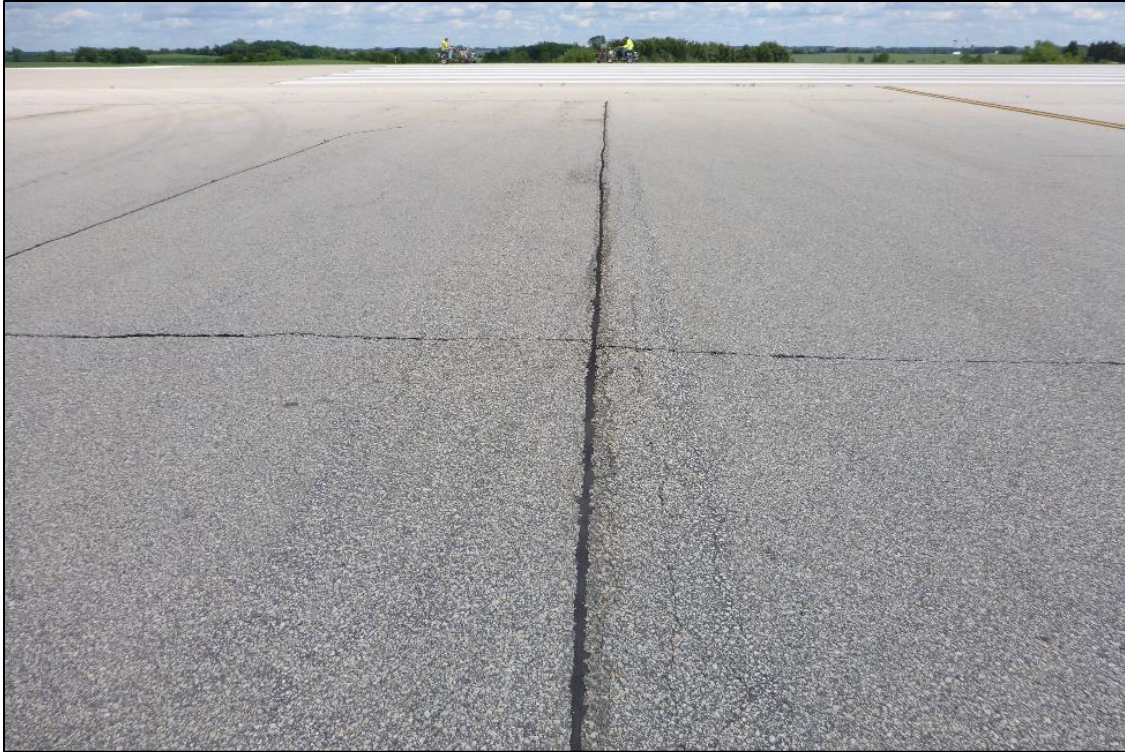
RST CTB4 001 (PCI = 55)

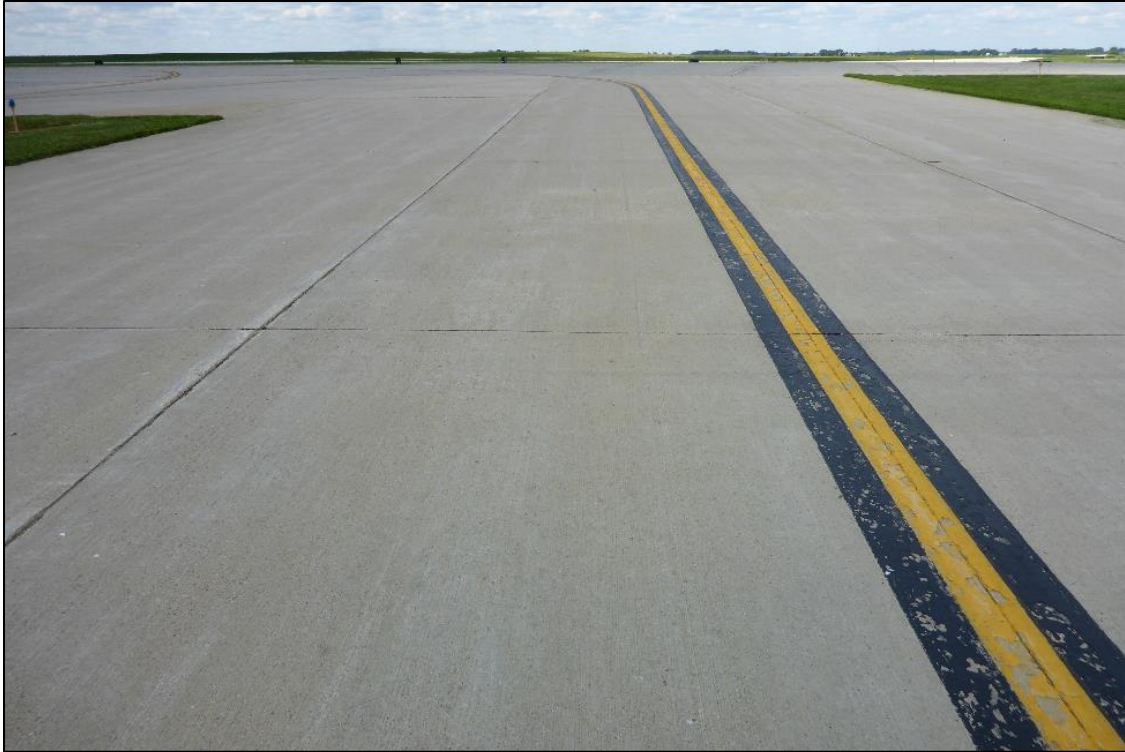
RST CTE 001 (PCI = 93)

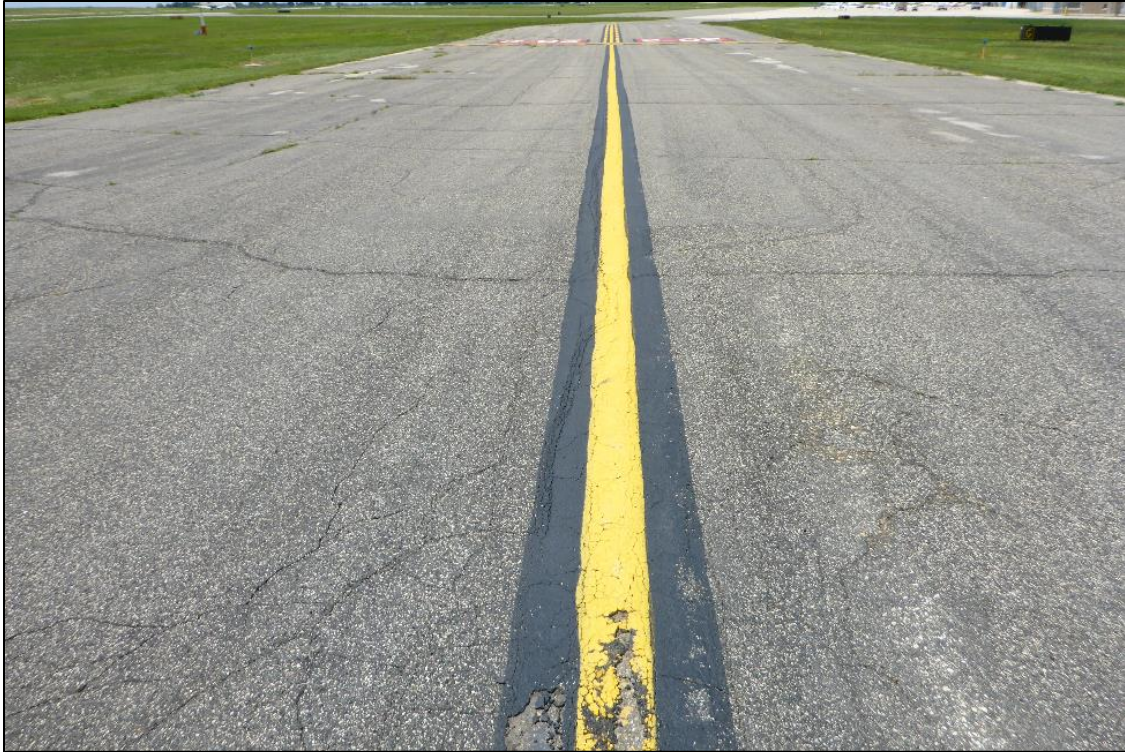
RST CTG 001 (PCI = 49)

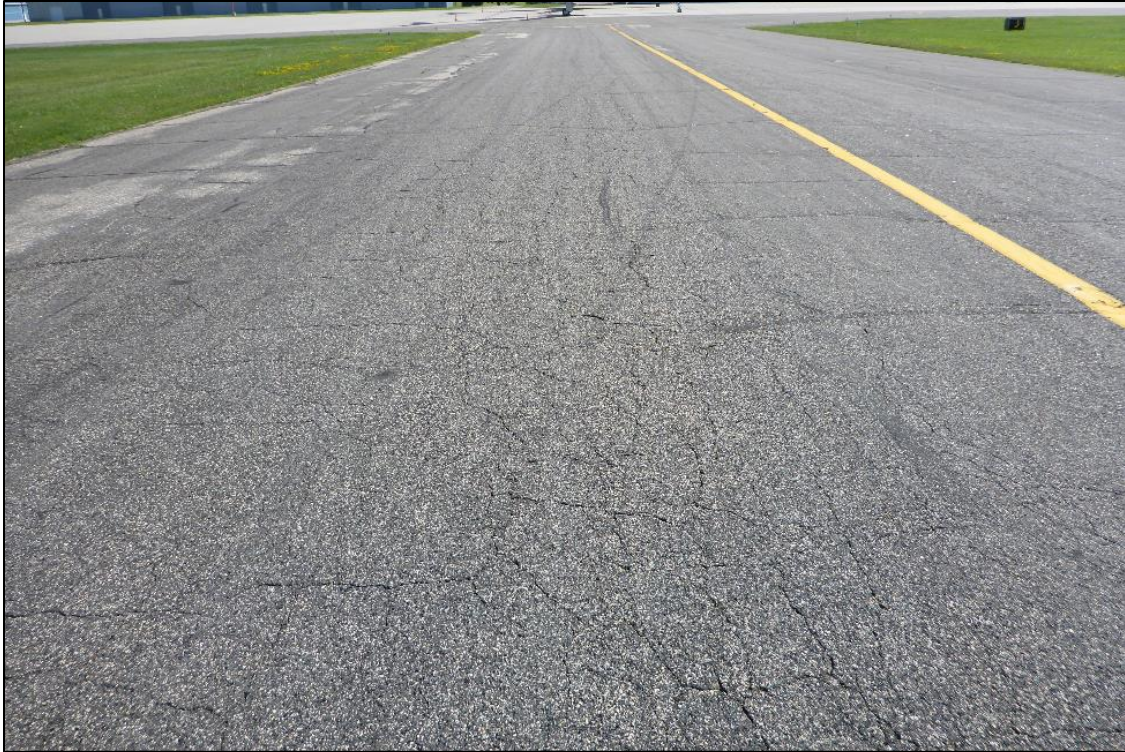
RST CTJ 001 (PCI = 28)

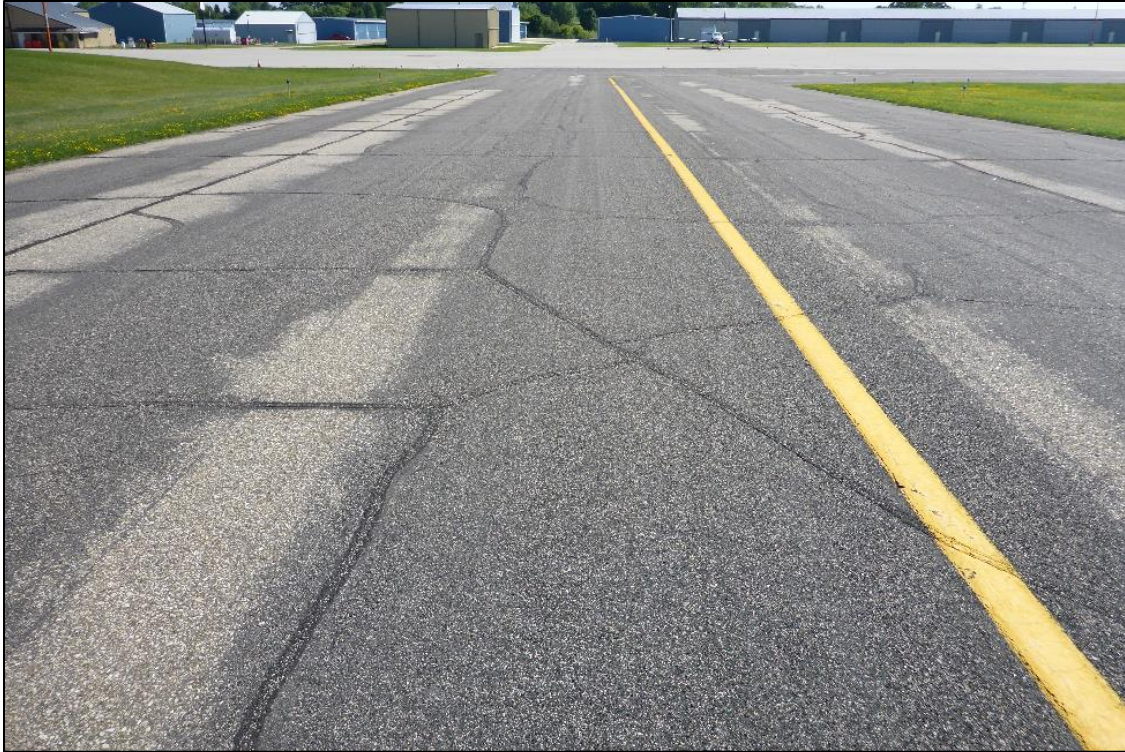
RST CTK 001 (PCI = 59)

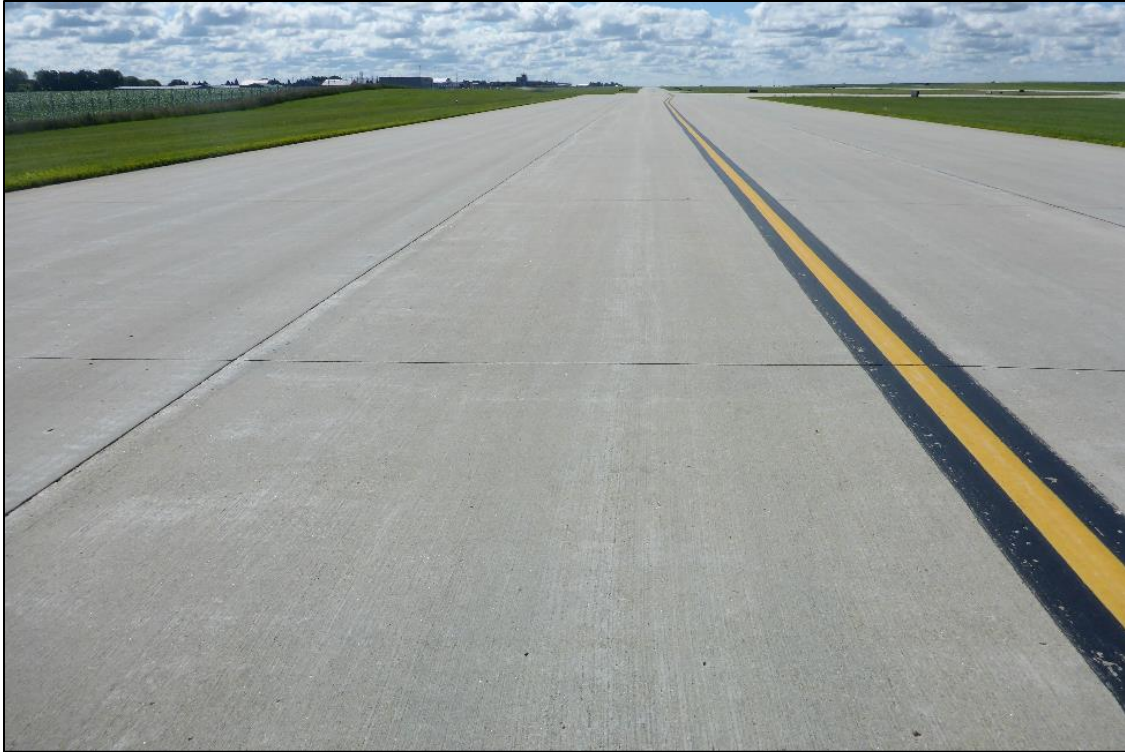
RST PTA 001 (PCI = 100)

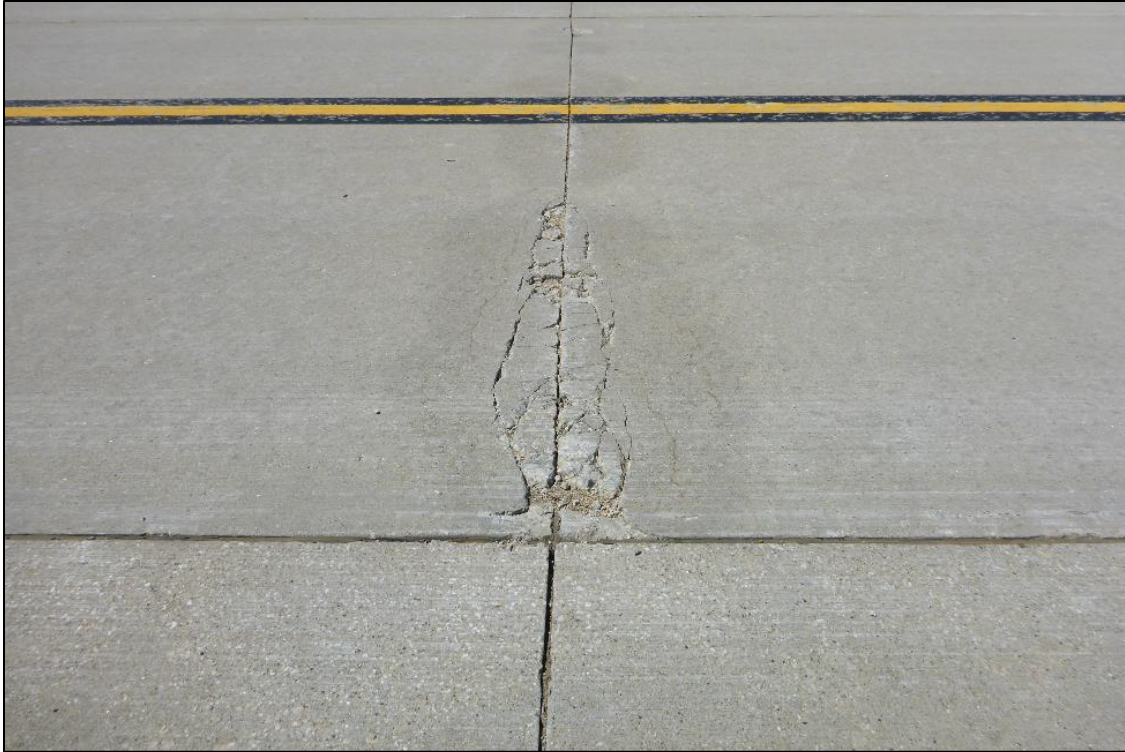
RST PTA 002 (PCI = 83)

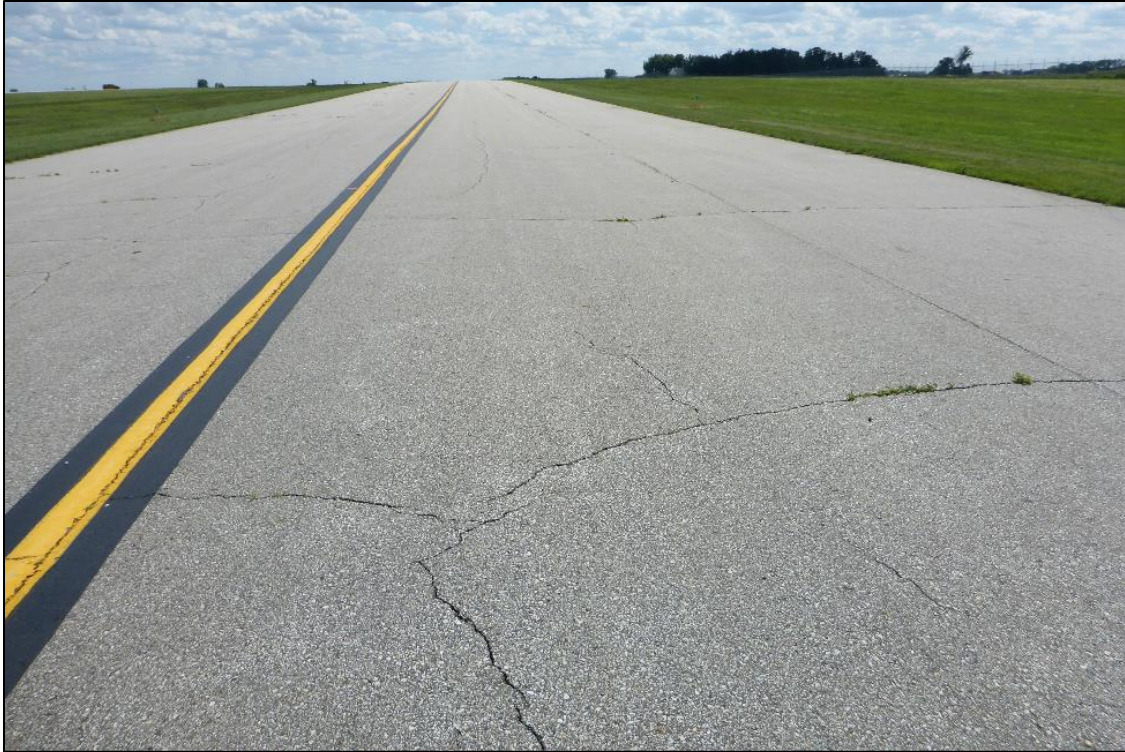
RST PTB 002 (PCI = 68)

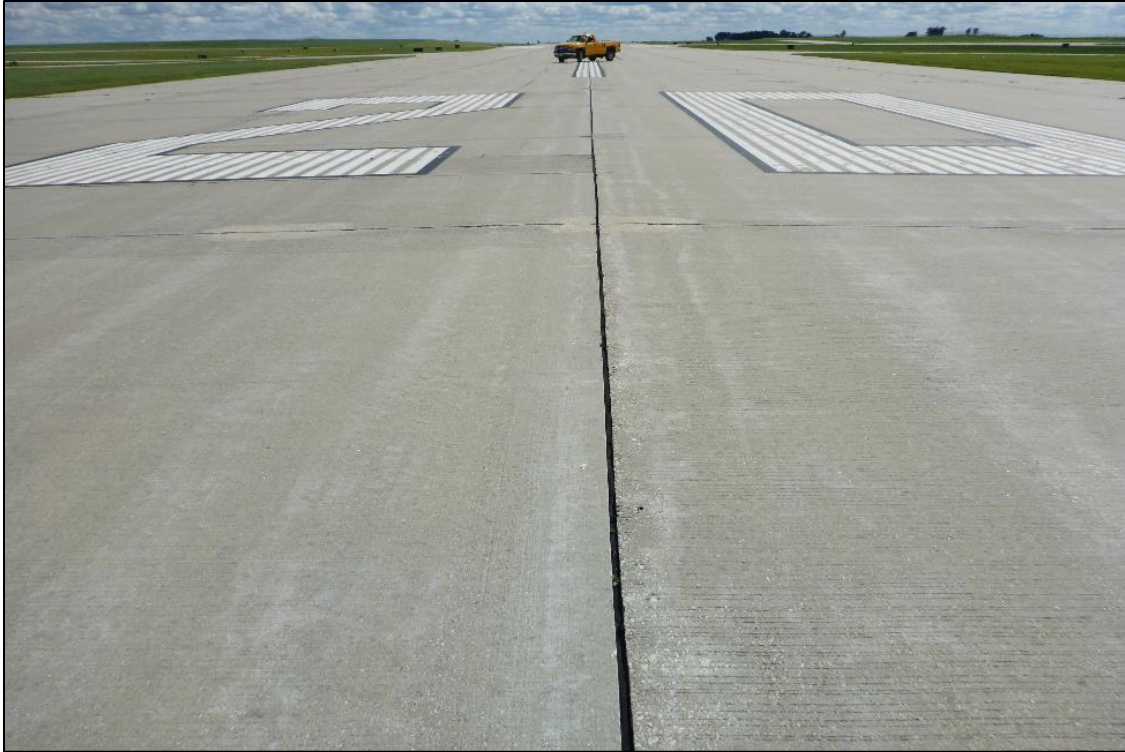
RST RY220 01C (PCI = 44)

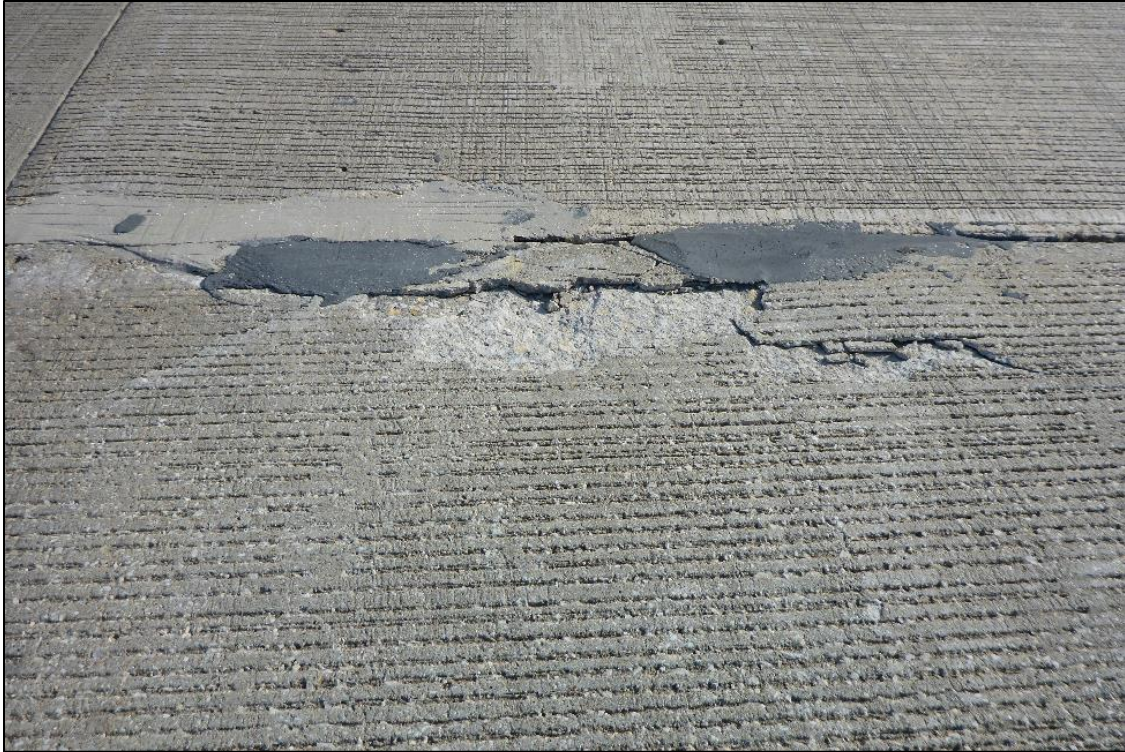
RST RY220 01C (PCI = 44)

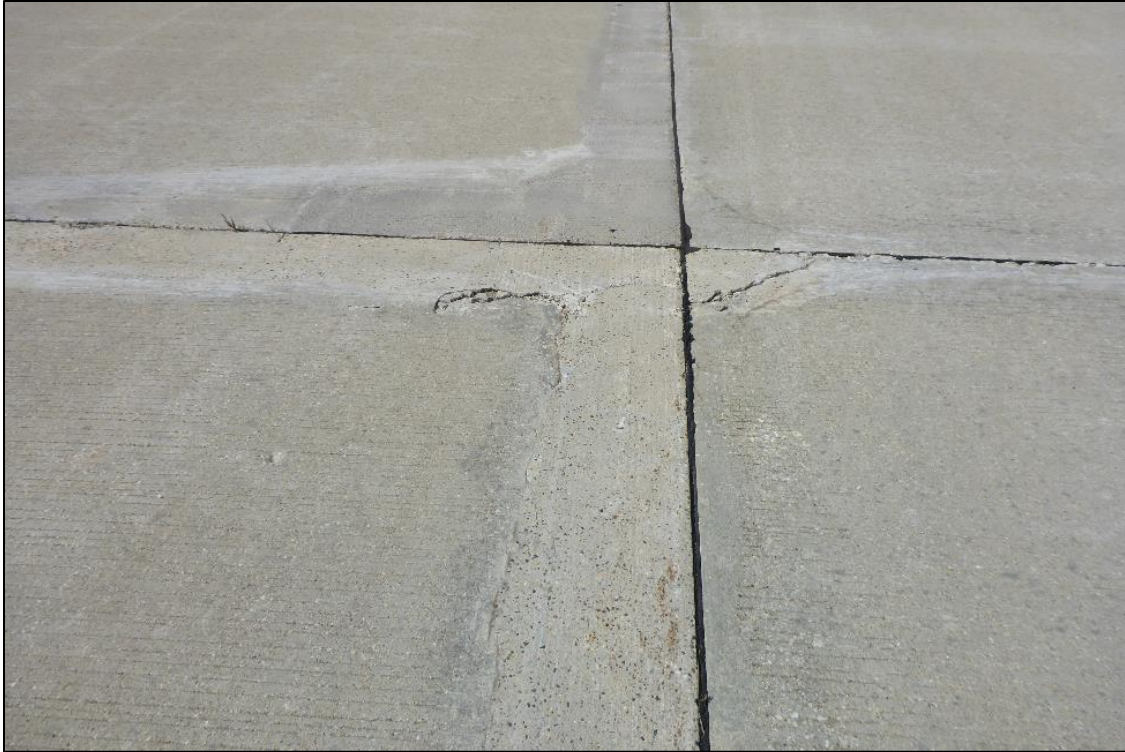
RST RY220 01W (PCI = 40)

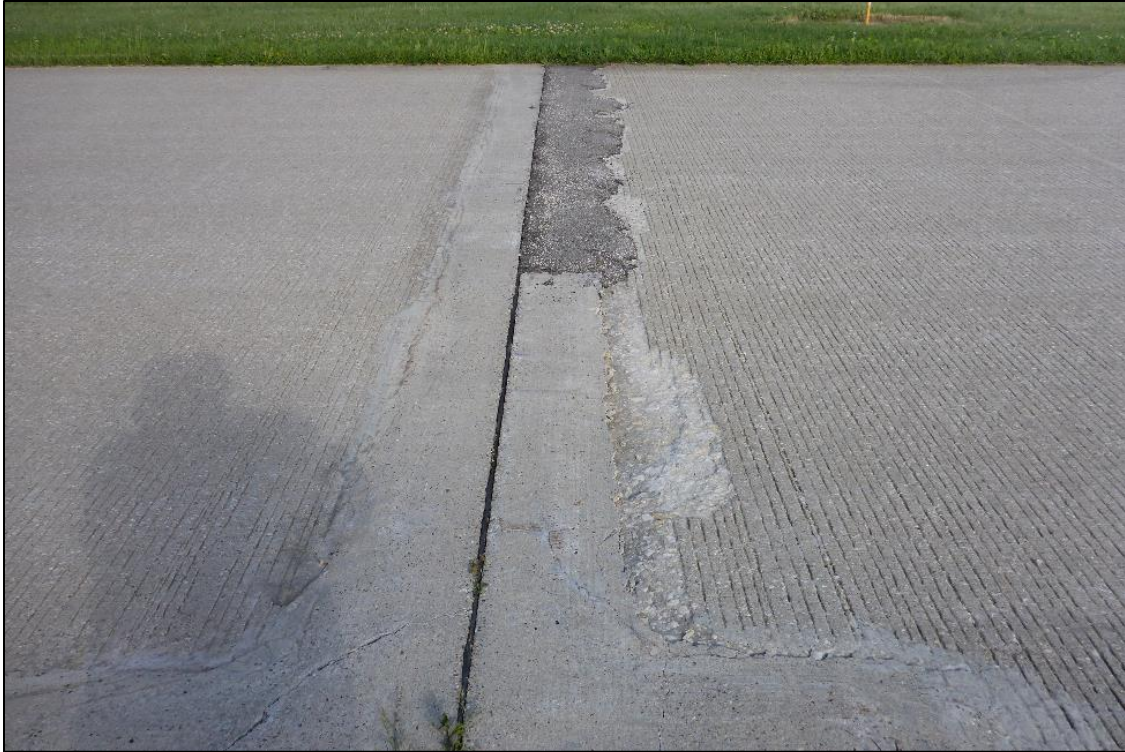
RST RY220 01W (PCI = 40)

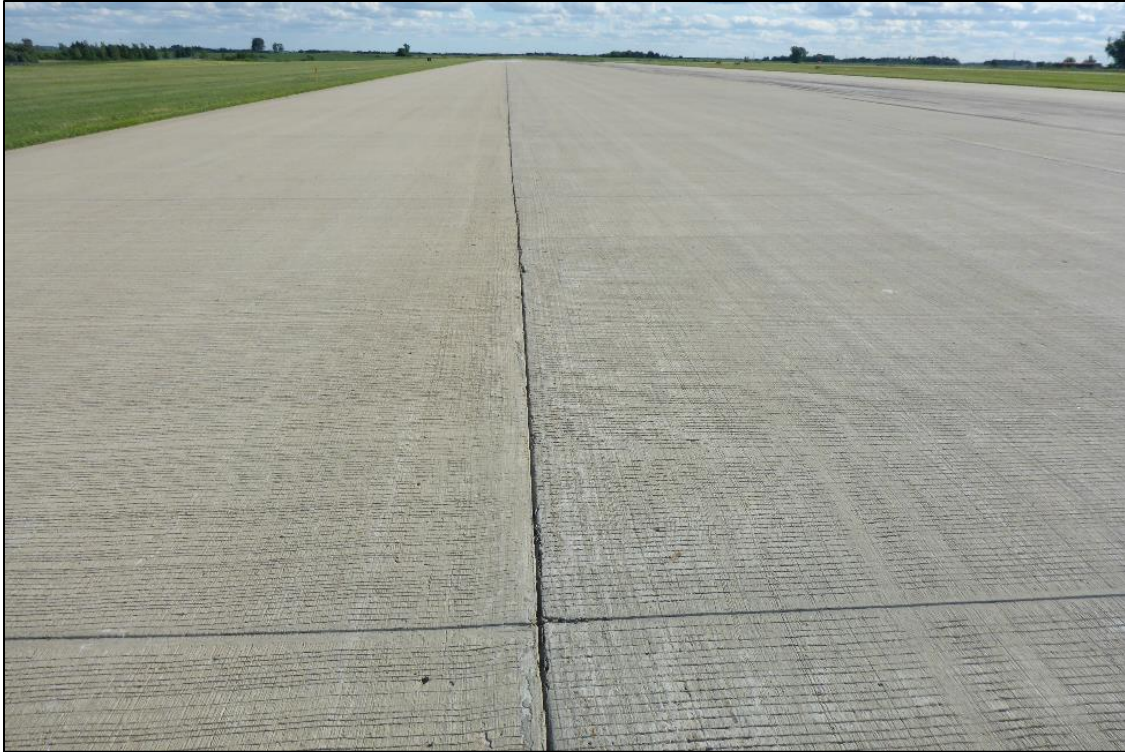
RST RY220 02W (PCI = 91)

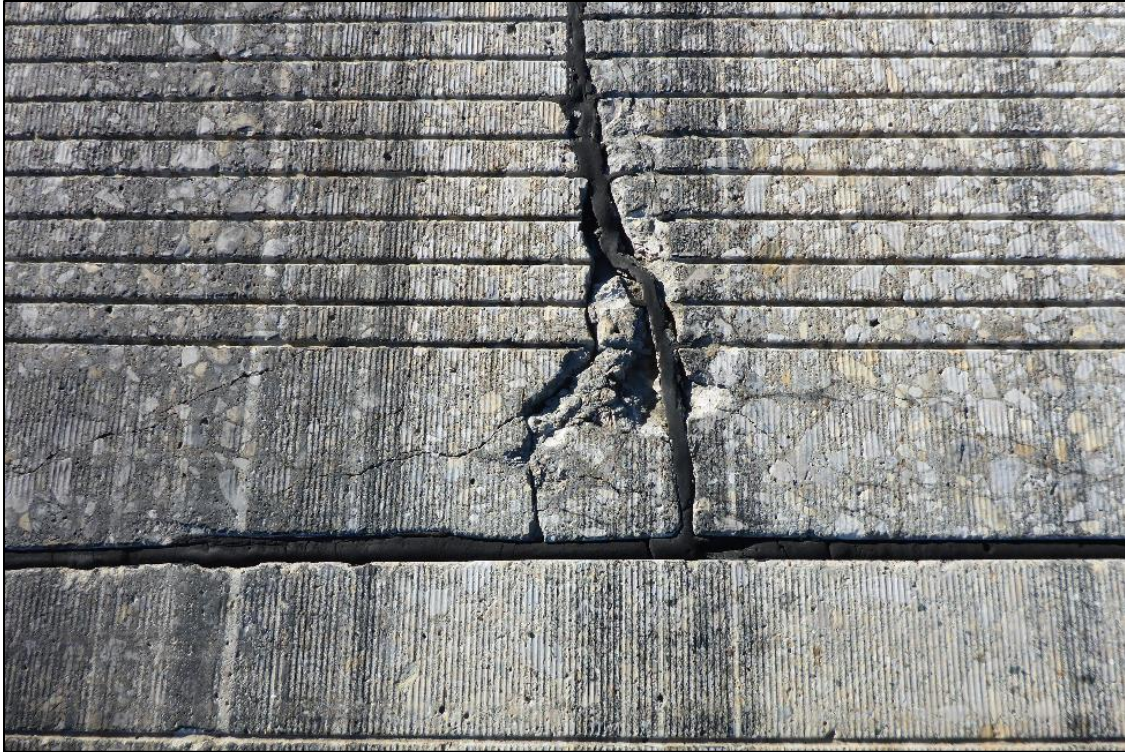
RST RY1331 01C (PCI = 55)

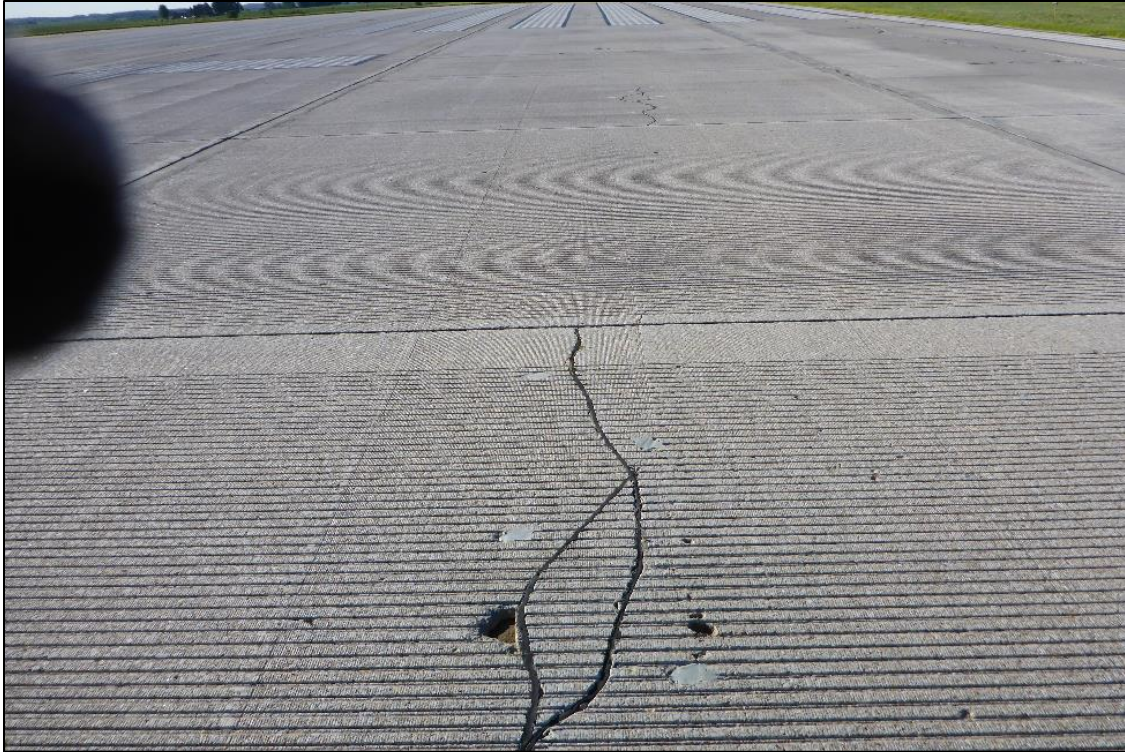
RST RY1331 01W (PCI = 46)

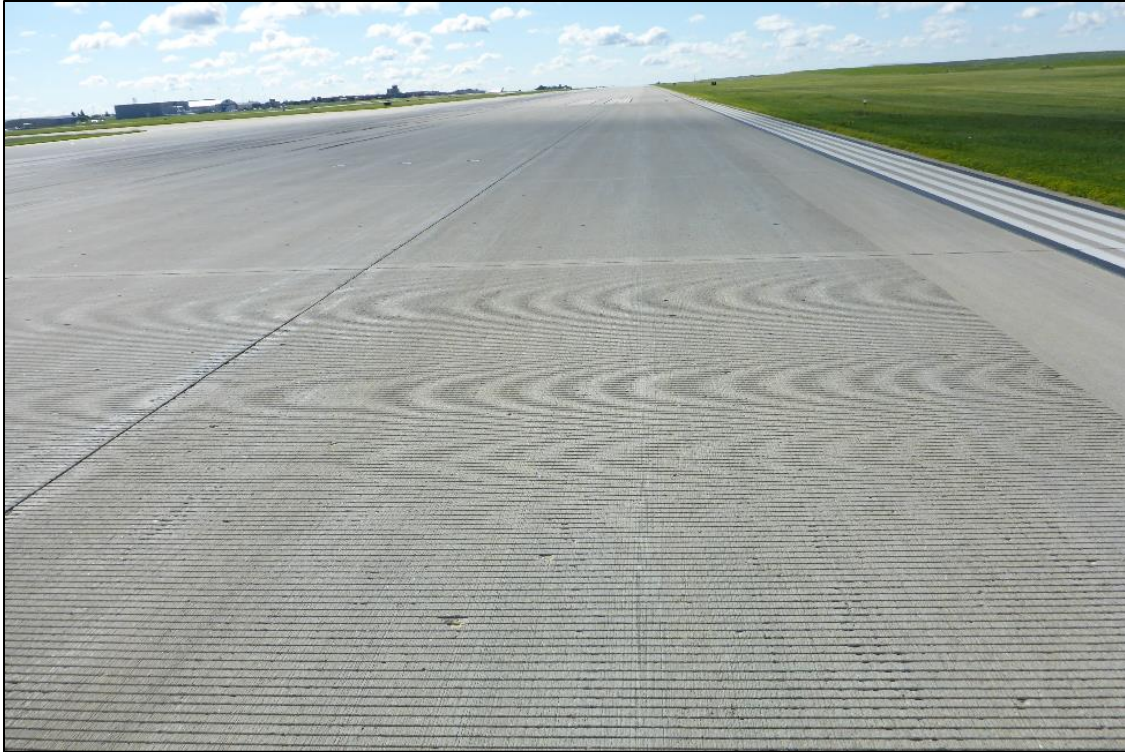
RST RY1331 02W (PCI = 90)

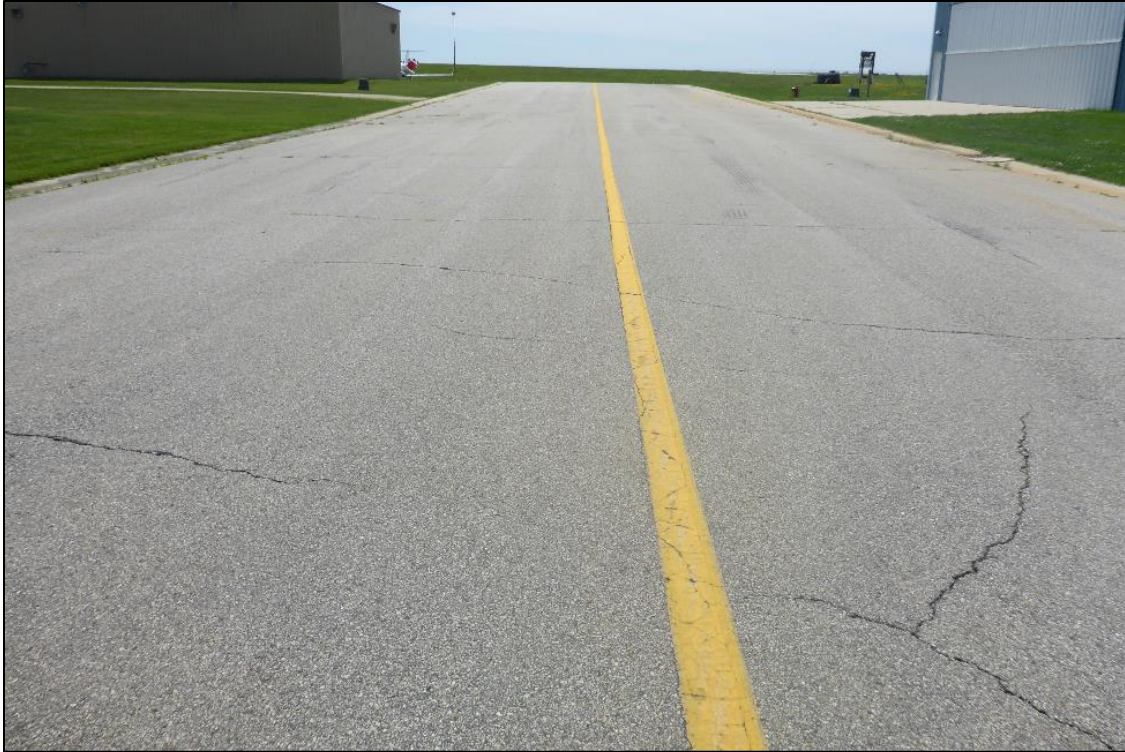
RST TLA 001 (PCI = 100)

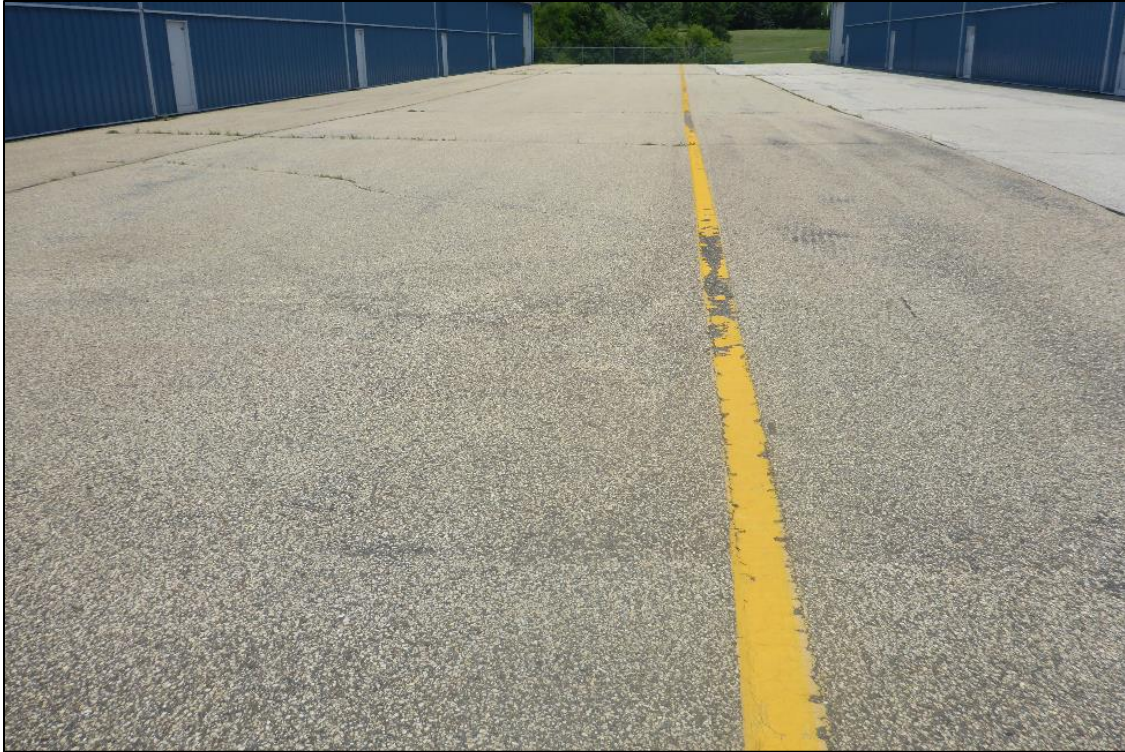
RST TLA 002 (PCI = 55)

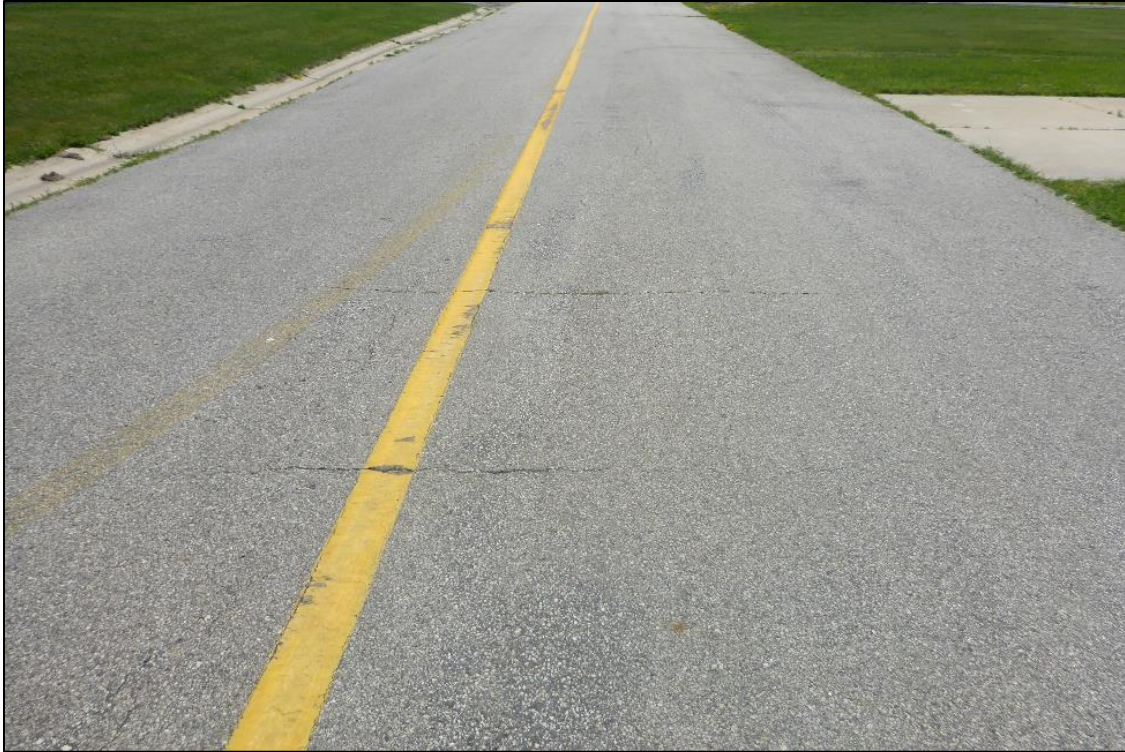
RST TLB 001 (PCI = 86)

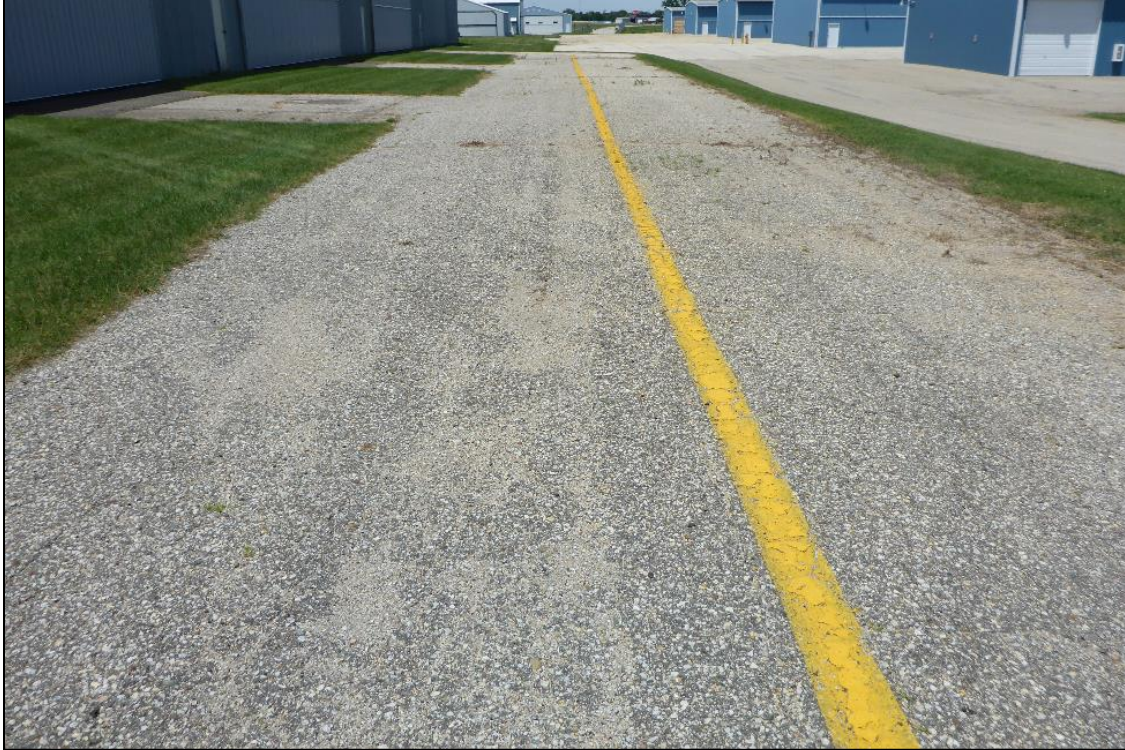
RST TLC 002 (PCI = 0)

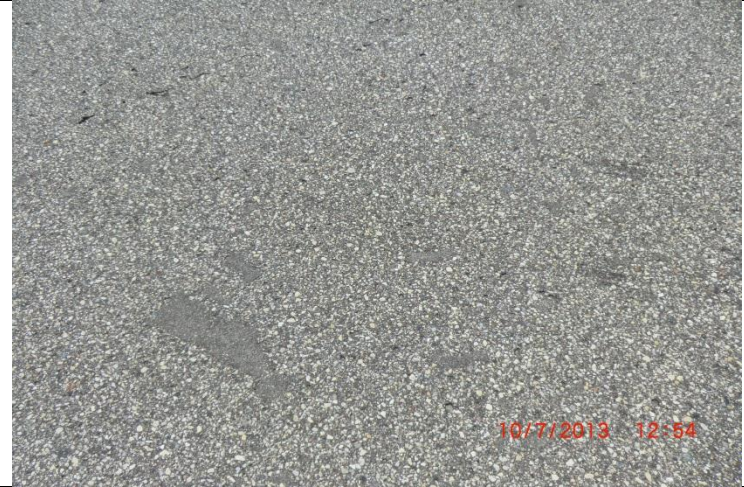
Weathering – At low severity, the coarse aggregate is slightly exposed due to the wearing away of the fine aggregate. At medium severity, the coarse aggregate is exposed up to ¼ the width of the longest side. At high severity, the coarse is exposed greater than ¼ the width of the longest side.

Low severity

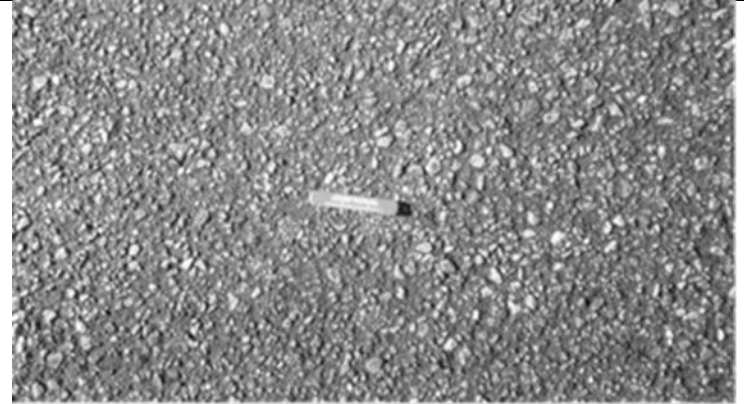
Medium severity

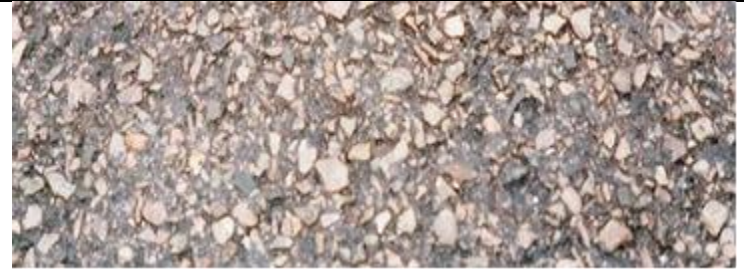
High severity

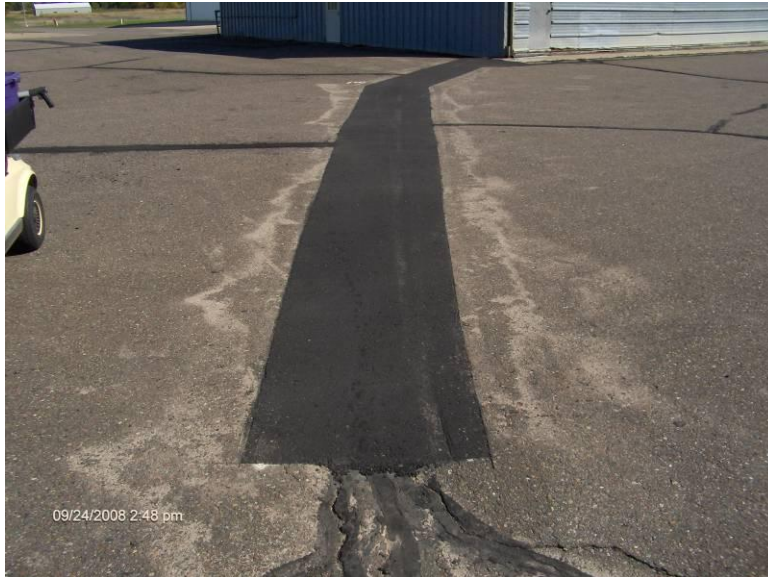
### *Example of Patching*

Patched areas are defined when a portion of the original pavement is replaced with a material intended as a semi-permanent repair. A patch is documented as a defect because it is considered a break in the integrity of the pavement structure. Patches are constructed for a variety of reasons including utility repairs, correcting grade issues, and addressing a defect in the original pavement. The severity level of patches is determined by the amount of distress (i.e. cracking, depression, weathering/raveling, etc.) occurring within the limits of the patched area.
